PUBLIC-DATA FILE 94-37

**THE BIRCH CREEK, MILE 101 STEESE HIGHWAY PLACER MINE
RECLAMATION PROJECT: YEAR ONE RESULTS, 1993
Interim report to USEPA Region X**

Edmond C. Packee Jr.
Graduate Student
School of Mineral Engineering
University of Alaska Fairbanks

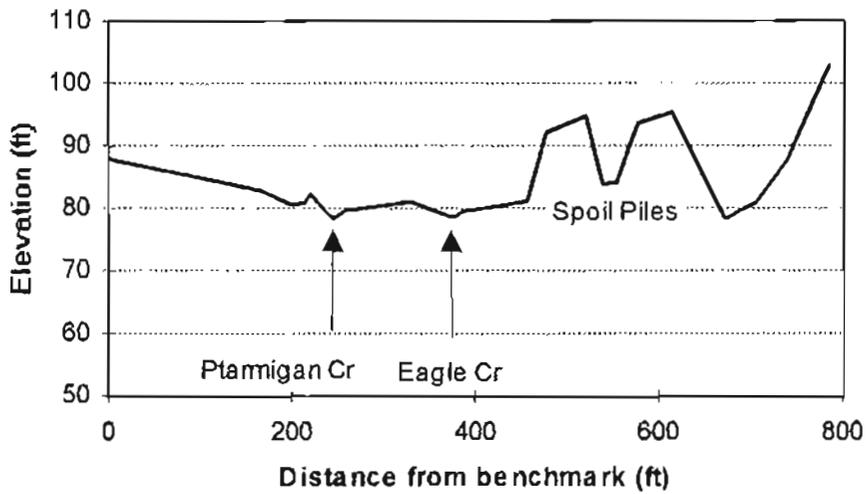
Figure A.2 Cross section #2 (22 June 1993)

Figure A.2) shows steep cut banks resulting from the lateral migration of Eagle Creek. Cross section #3 (Appendix A, Figure A.3) demonstrates the confining influence of spoil piles on flood plain development.

The six cross sections indicate that Eagle Creek and Ptarmigan Creek are eroding the piled overburden. Cross section #2 (Figure A.2) shows steep cut banks resulting from the lateral migration of Eagle Creek. Cross section #3 (Figure A.3) demonstrates the confining influence of spoil piles on Eagle Creek flood plain development. It is not known whether the bank erosion shown in the cross sections exceed the natural rate of bank erosion for either Ptarmigan Creek or Eagle Creek. However, the lateral

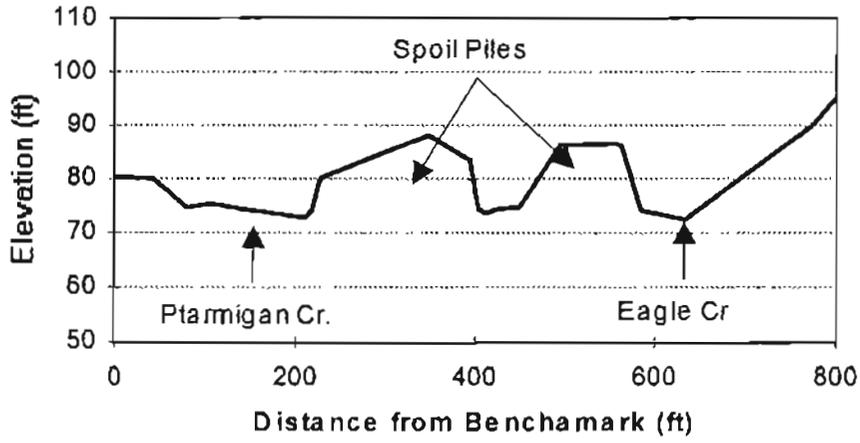
Figure A.3 Cross section #3 (22 June 1993)

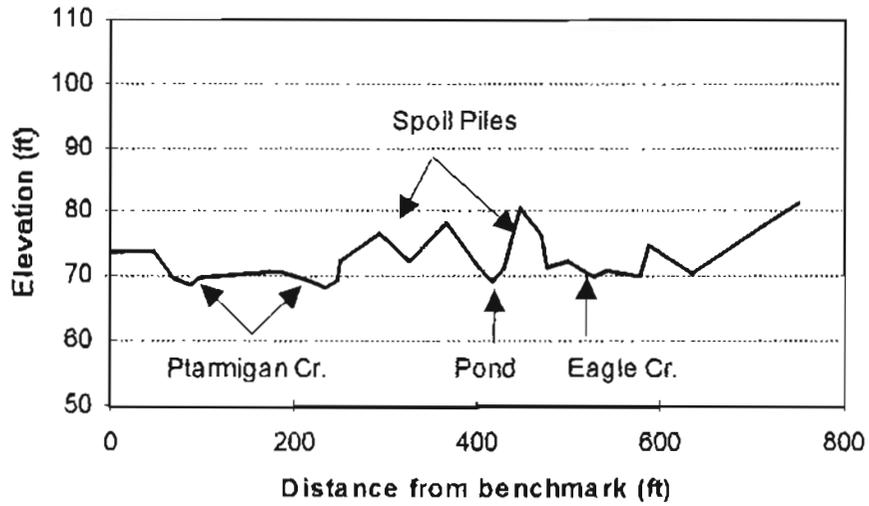
Figure A.4 Cross section #4 (22 June 1993)

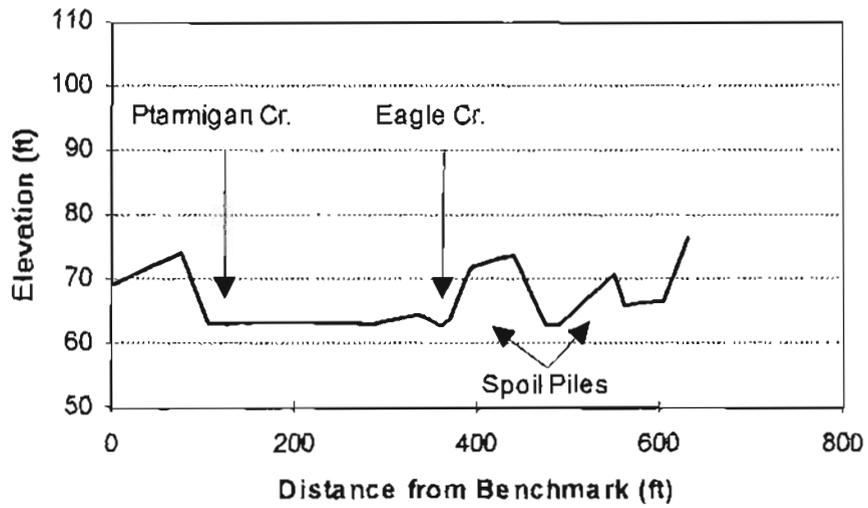
Figure A.5 Cross section #5 (22 June 1993)

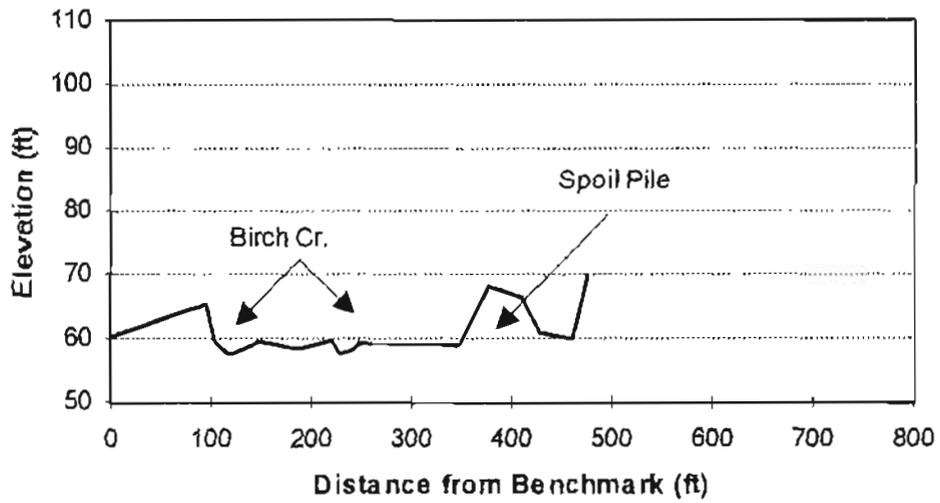
Figure A.6 Cross section #6 (22 June 1993)

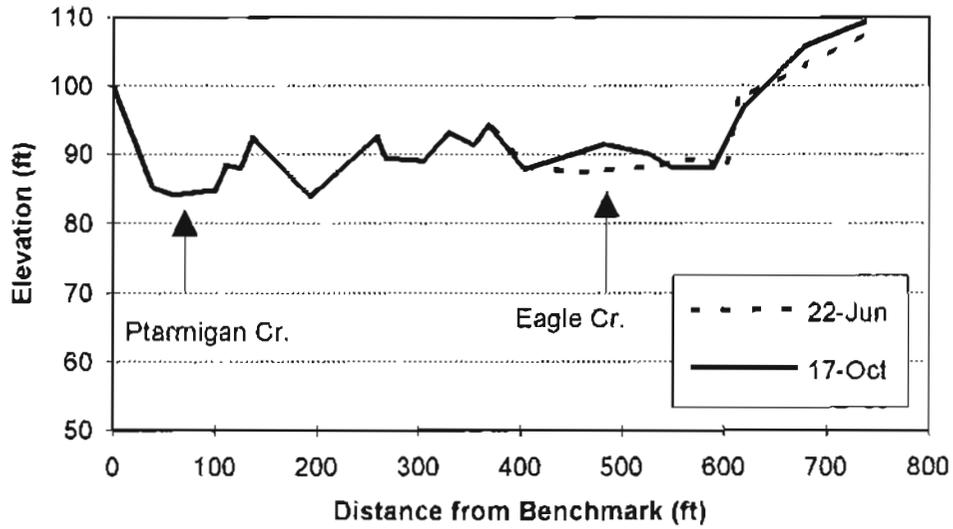
Figure A.7 Cross section #7 (17 October 1993)

The six cross sections were resurveyed and are presented in Appendix A (Figures A.7-A.11). Water surface profiles for the site after reclamation were surveyed. The channel length of Eagle Creek was increased by approximately 1000 feet. The gradient of Eagle Creek was reduced from 0.018 ft/ft to 0.017 ft/ft. The gradient change at the confluence of Eagle Creek and Ptarmigan Creek was reduced to 0.001 ft/ft by moving the confluence downstream 2000 feet. The water surface profiles after reclamation are shown in Figure 13. No further monitoring was performed as unexpected delays resulted in the completion of reclamation in early October rather than late August.

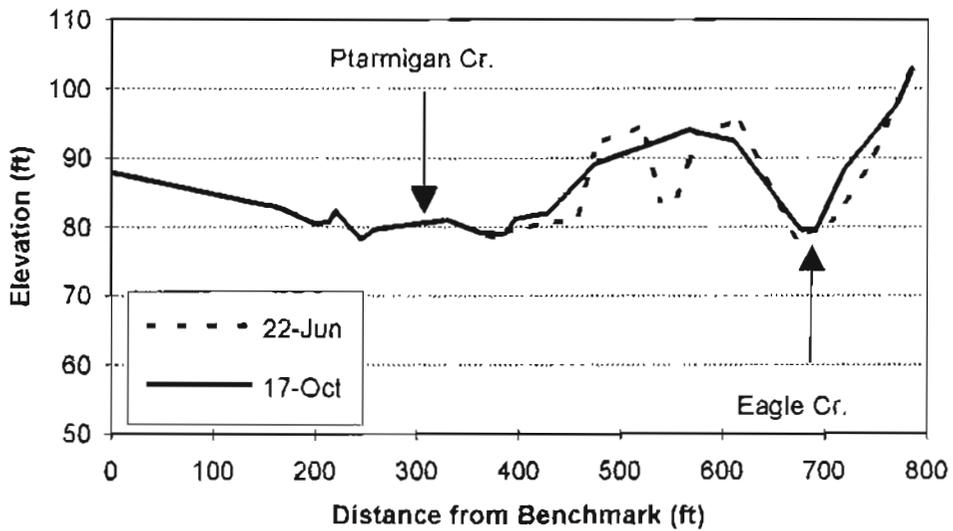
Figure A.8 Cross section #2 (17 October 1993)

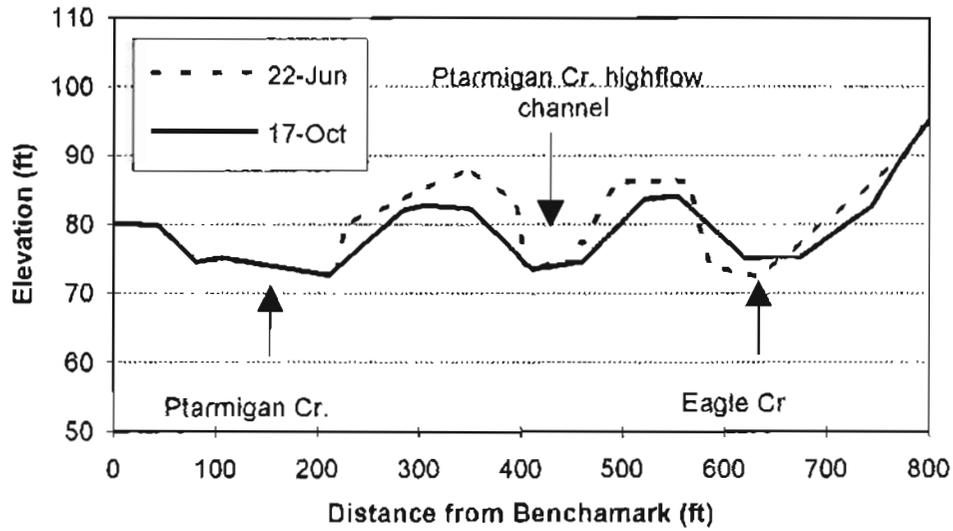
Figure A.8 Cross section #3 (17 October 1993)

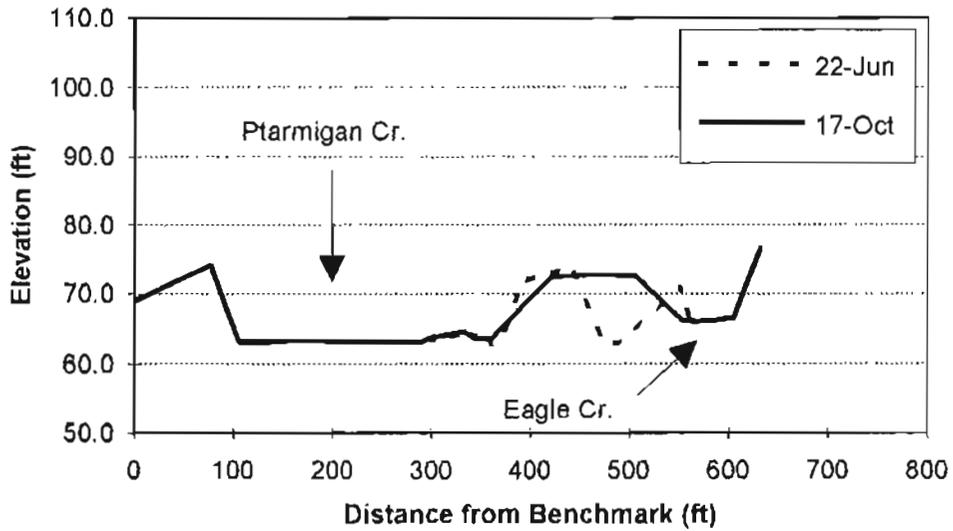
Figure A.9 Cross section #5 (17 October 1993)

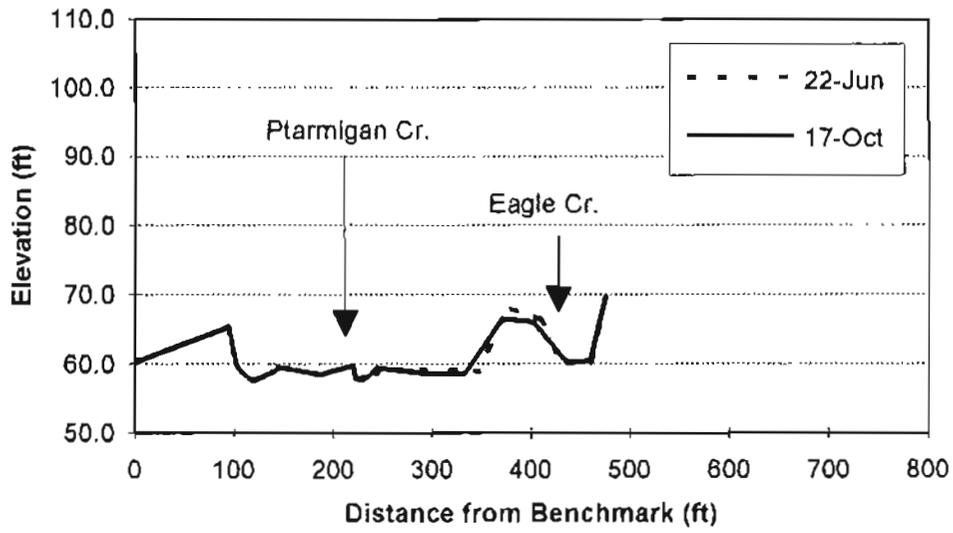
Figure A. 10 Cross section #6 (17)October 1993)

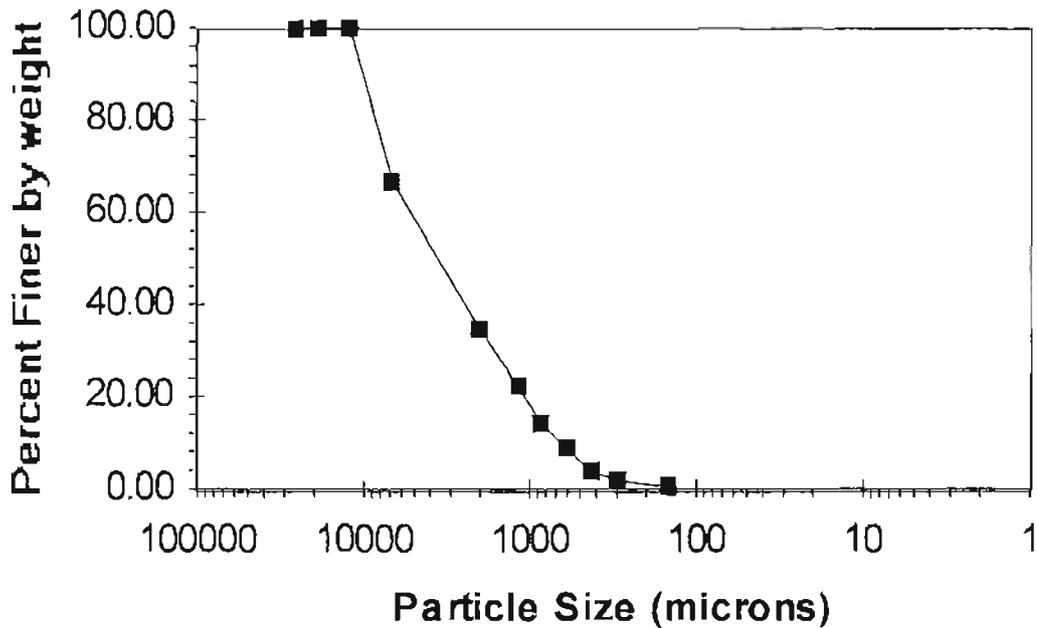
Figure B.1 Cumulative Particle Size Distribution of Ptarmigan Creek Bedload. (1993)

The seasonal particle size distribution of Ptarmigan Creek bedload samples (Figure B.1) indicates most (D_{60}) of the transported material is less than 5 mm in diameter. The seasonal particle size distribution for Eagle Creek bedload samples (Figure B.2) indicates most of the material transported is between 2.0 mm and 12 mm in diameter. The majority of the material transported past the Birch Creek gauge is between 1.0 mm and 10.5 mm in diameter (Figure B.3) The absence of the 12 mm size class from bedload samples at the Birch Creek gauge indicates that deposition of the largest bedload material

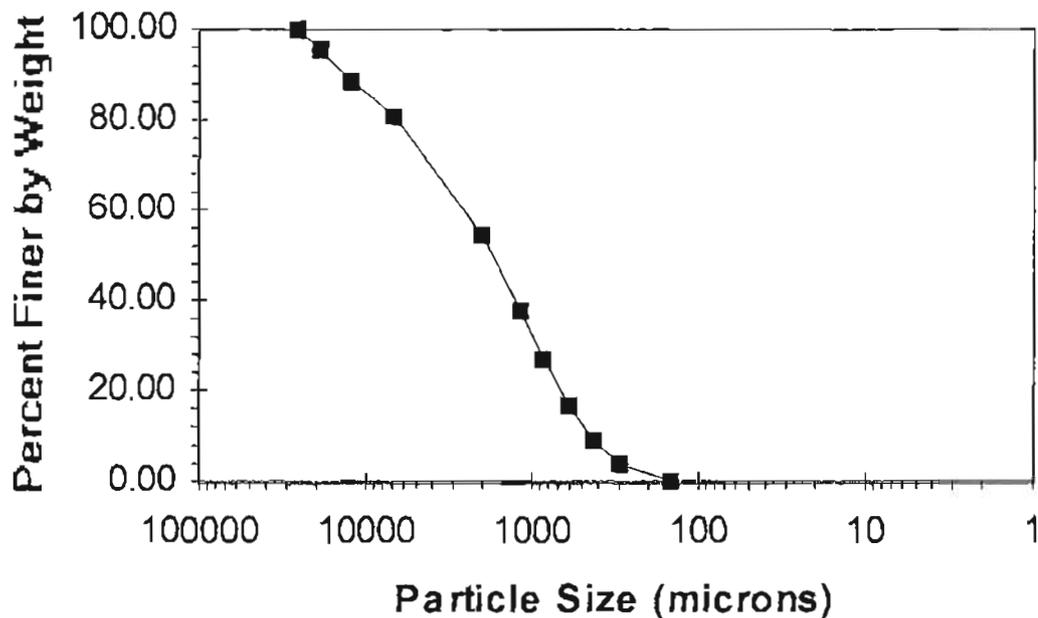
Figure B.2 Cumulative Particle Size Distribution of Eagle Creek Bedload. (1993)

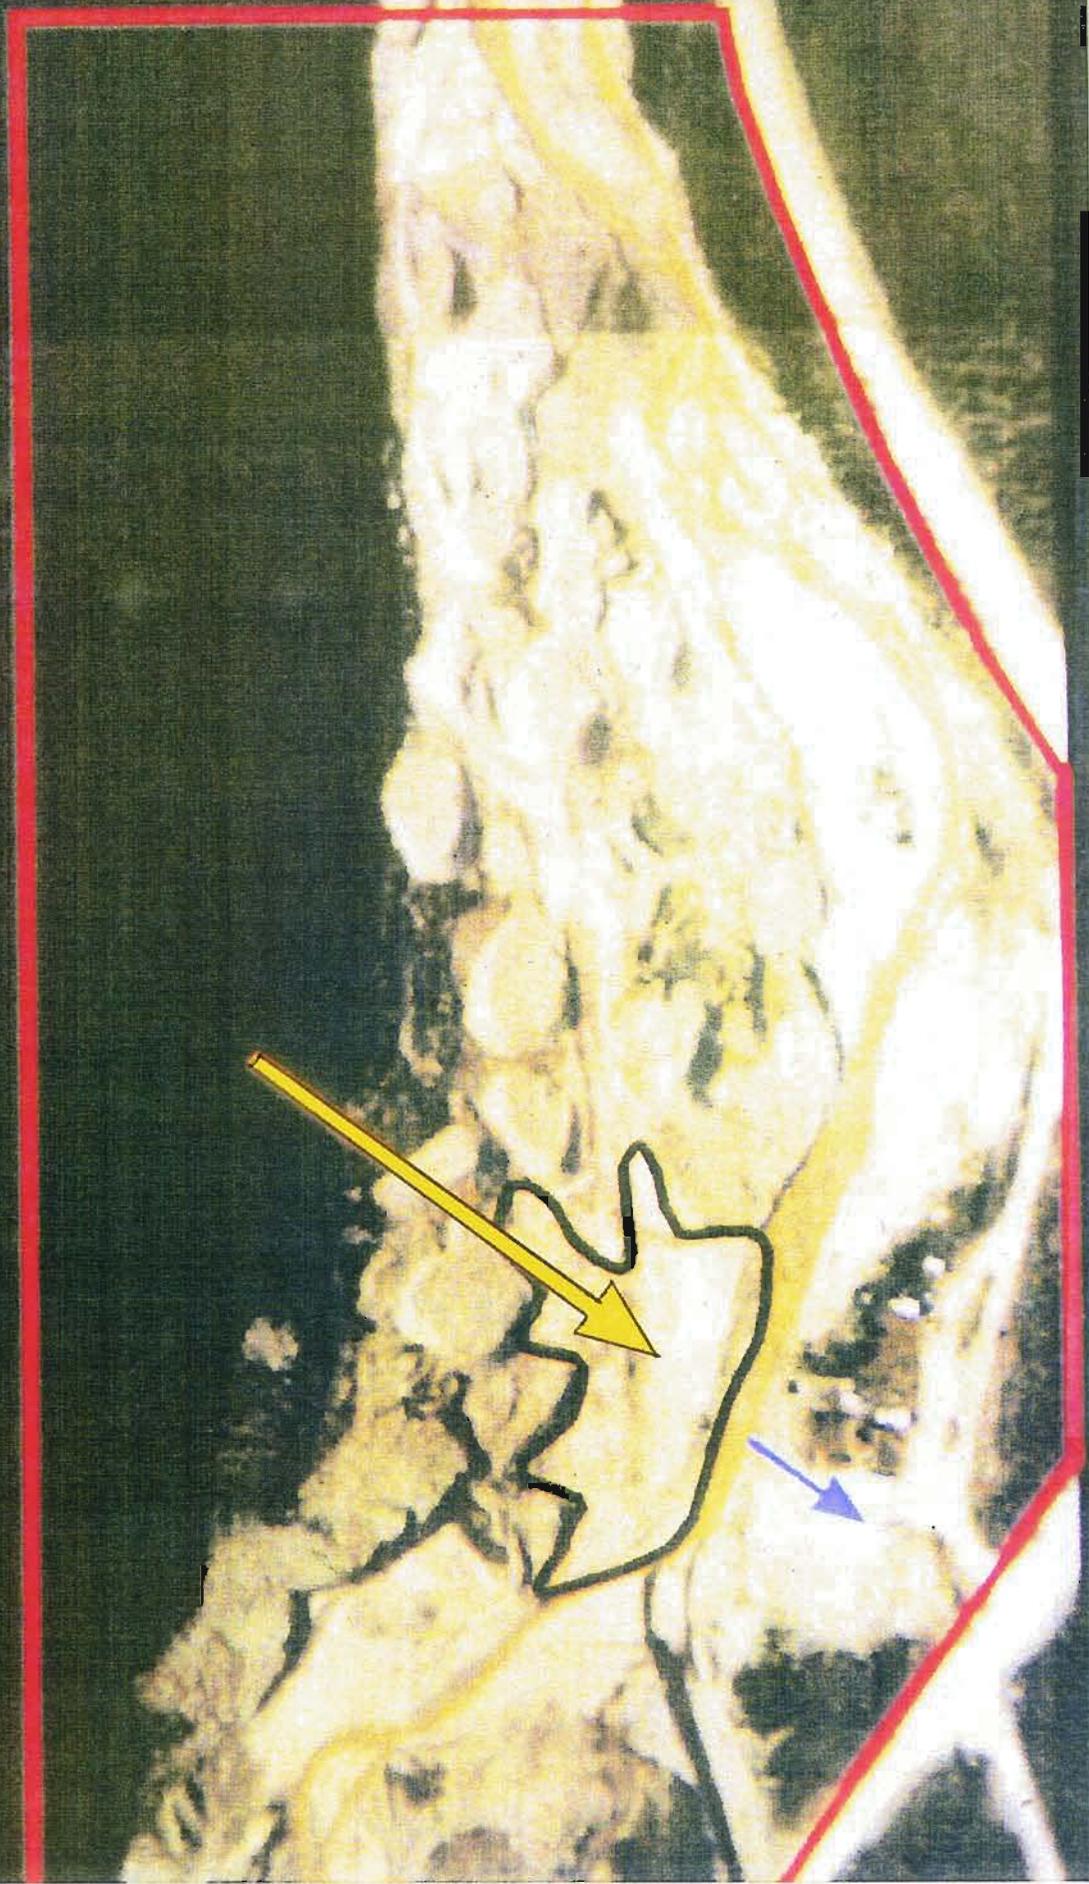
Figure 5. Upper Birch Creek Near 101 Mile Steese Highway (August 1989)

Figures 3 - 6 show available aerial photographs of the Birch Creek site. The aerial photograph taken in 1951 (Figure 3) shows the upper Birch Creek watershed in a relatively undisturbed condition. The 101 Mile Lodge and the Steese Highway are visible, and the approximate boundaries of the current Birch Creek Site are also shown. The 1972 aerial photograph (Figure 4) was taken during the reconstruction of the Steese Highway, during which, a bridge was constructed over Ptarmigan Creek and a section of road was built across the flood plain of Birch Creek downstream of the 101 Mile Lodge. Between 1951 and 1972, Ptarmigan Creek appears to have migrated laterally towards the lodge. The outlined area shows the vegetation that was stripped during subsequent placer mining operations. The large arrow shows subsequent movement of the confluence of Eagle Creek and Ptarmigan Creek. The confining influences of spoil piles in the Eagle Creek and Birch Creek flood plains are shown in the 1989 aerial photograph (Figure 5). Placer mining operations appear to have been confined to Eagle Creek and the southern limits of the Birch Creek flood plain. The new location of the Eagle Creek channel has caused sediment deposition at the confluence with Ptarmigan Creek (outlined), and lateral migration of Ptarmigan Creek towards the Steese Highway (small arrows). The presence of spoil piles prevents Eagle Creek from migrating laterally away from Ptarmigan Creek. The aerial photographs taken by the Alaska Division of Mining in 1993 (Figure 6) show continued growth of the alluvial fan (outlined), at the confluence of Eagle Creek and Ptarmigan Creek. The lateral migration of Ptarmigan Creek appears to have slowed. However, lateral migration of Eagle Creek (small arrows) has forced the channel into the spoil piles, causing downstream bank erosion. The location of the six cross sections are shown in Figure 6.

The water surface profiles prior to reclamation work are plotted in Figure 7. Eagle Creek has a gradient of 0.018 ft/ft and Ptarmigan Creek has a gradient of 0.012 ft/ft. Birch Creek and Ptarmigan Creek have similar gradients through the Birch Creek site (0.012 ft/ft and 0.014 ft/ft, respectively). Birch Creek changes gradient downstream of the project site from 0.0114 ft/ft to .0167 ft/ft, a gradient closer to that of Eagle Creek. The loss of 0.06 ft/ft gradient between Eagle Creek and Ptarmigan Creek reduces of stream energy at the confluence, causing the deposition of sediment and formation of the alluvial fan seen in Figure 5 and Figure 6.
