PUBLIC-DATA FILE 94-48

**HYDROLOGIC INVESTIGATION OF COASTAL WATERS AND
STREAMS FOR THE PROPOSED SHEPARD POINT ROAD, ORCA INLET,
NEAR CORDOVA, ALASKA**

Mary A. Maurer and Stan Carrick
Alaska Department of Natural Resources
Division of Mining and Water Management
Alaska Hydrologic Survey

September 1994

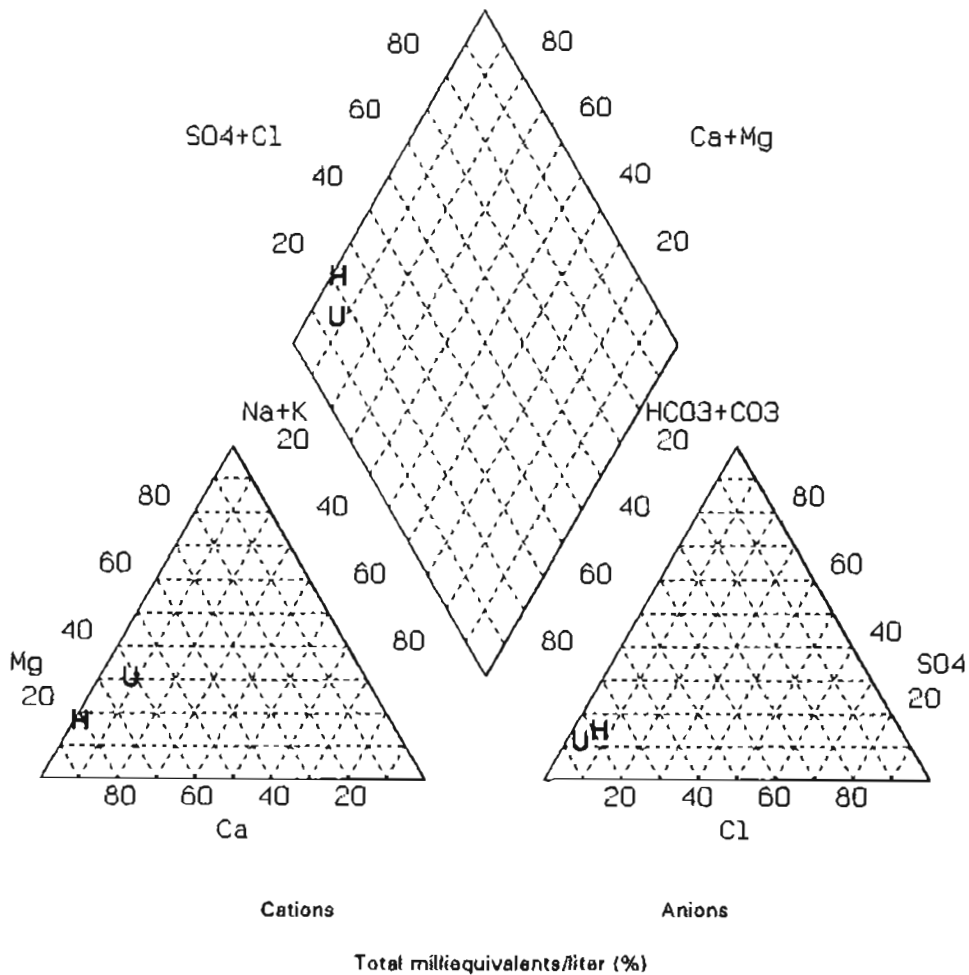
<u>Symbol</u>	<u>Site</u>	<u>Water type</u>
H	Humpback Creek	Calcium bicarbonate
U	Unnamed Creek	Calcium bicarbonate

Figure 2. Trilinear diagram showing water-type classification of water collected from Humpback Creek and unnamed creek on July 12, 1994.

A trilinear diagram is used to illustrate the chemical character or "water type" of a stream (Hem, 1985). Ratios of selected cations (calcium, magnesium, and sodium plus potassium) and anions (bicarbonate, chloride, and sulfate) for each water analysis are shown in a trilinear diagram as percentages of the total cations and anions, in milliequivalents per liter (meq/L). Thus a "water type" can be described on the basis of predominant cations and anions found in the water. Humpback Creek and the unnamed creek have calcium bicarbonate water (fig. 2). These data indicate that the streams have similar geochemistry.

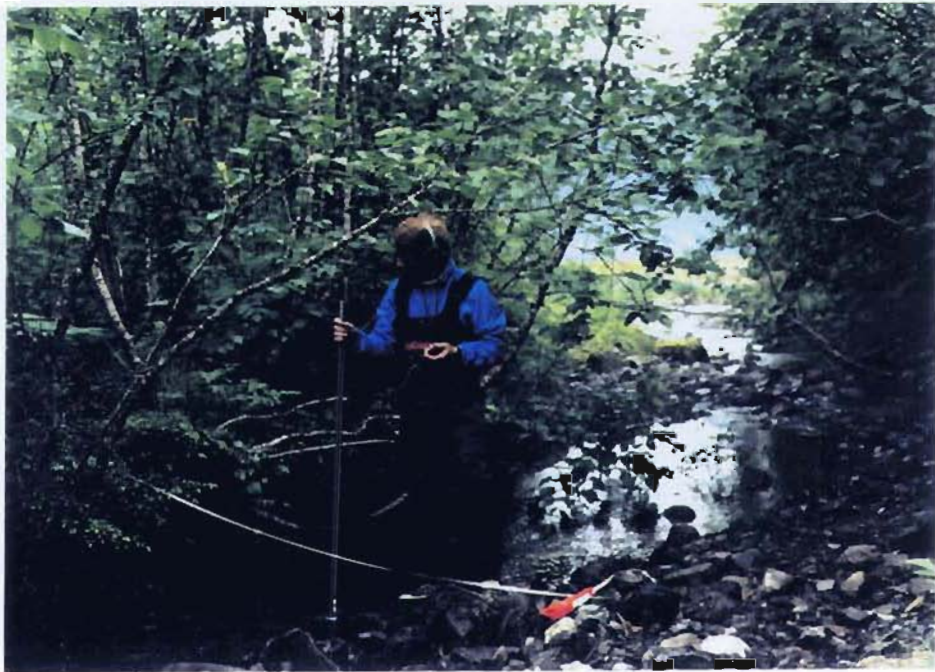
Stan Carrick measuring stream discharge of an unnamed creek, 1/4 mile south of Humpback Creek, near Cordova, Alaska. July 12, 1994

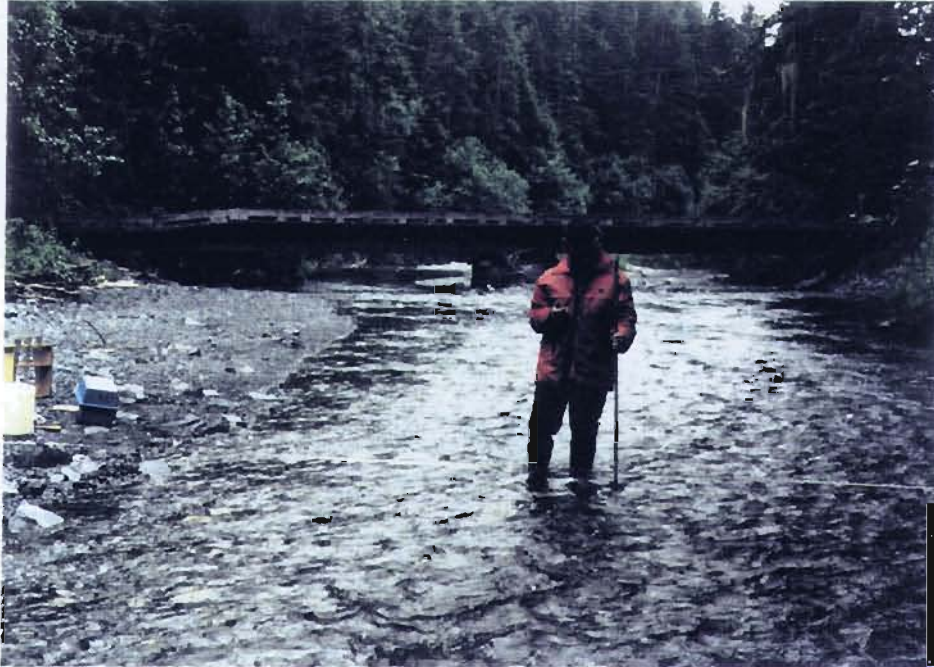
Stan Carrick measuring stream discharge of Humpback Creek, near Cordova, Alaska. July 12, 1994

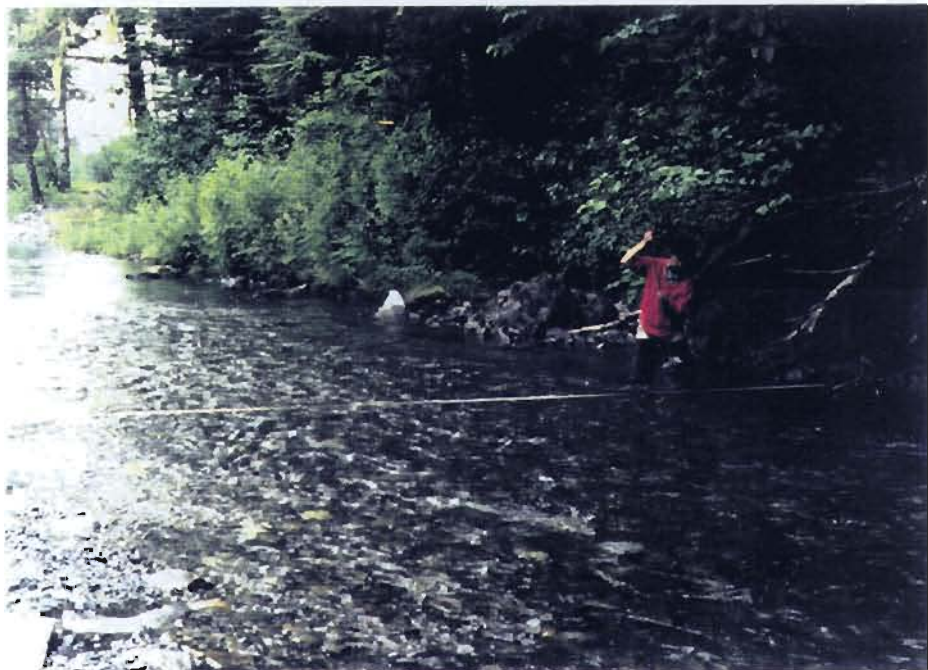
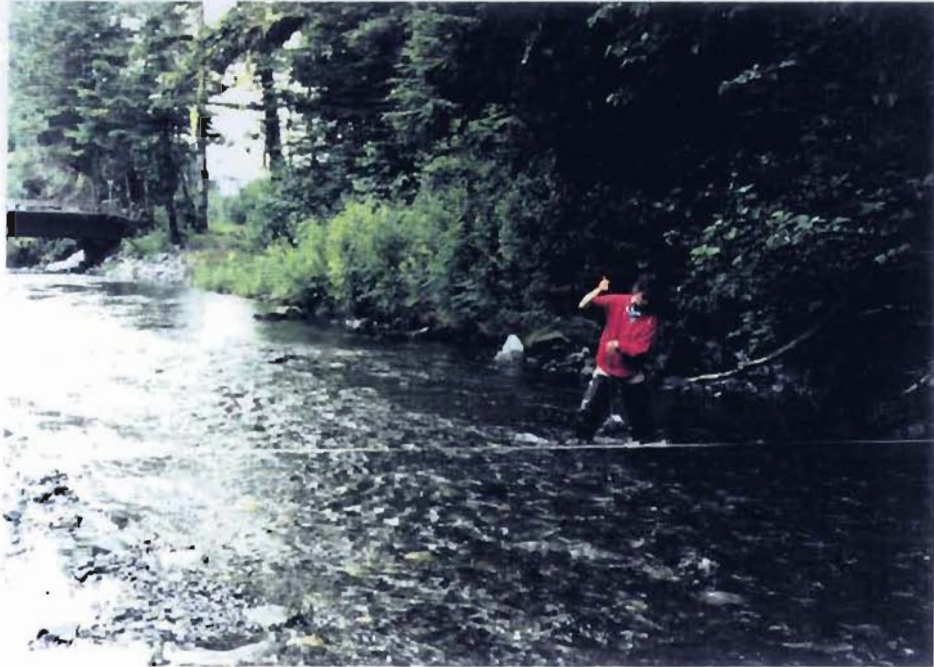
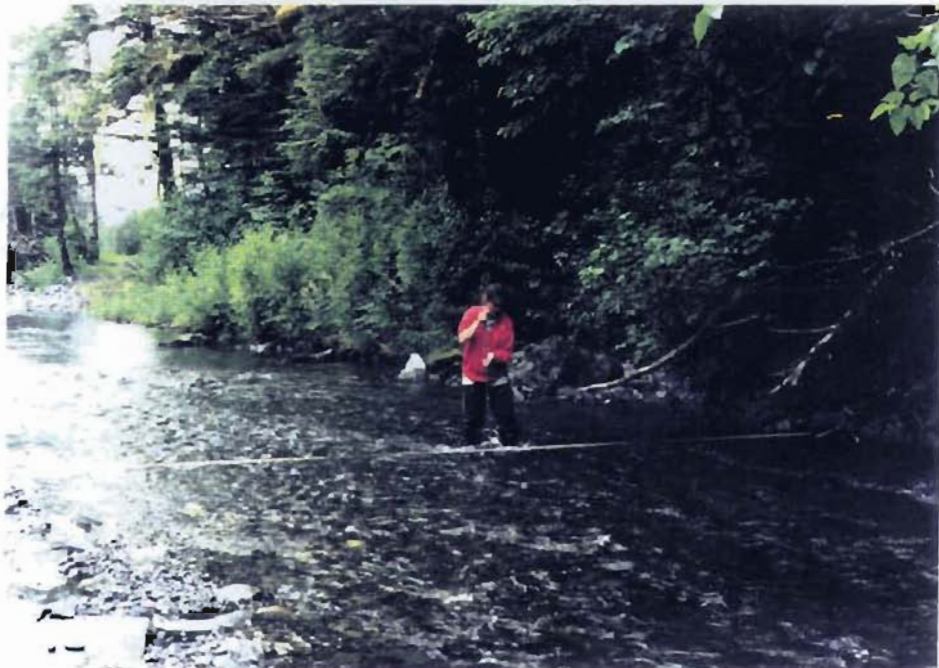
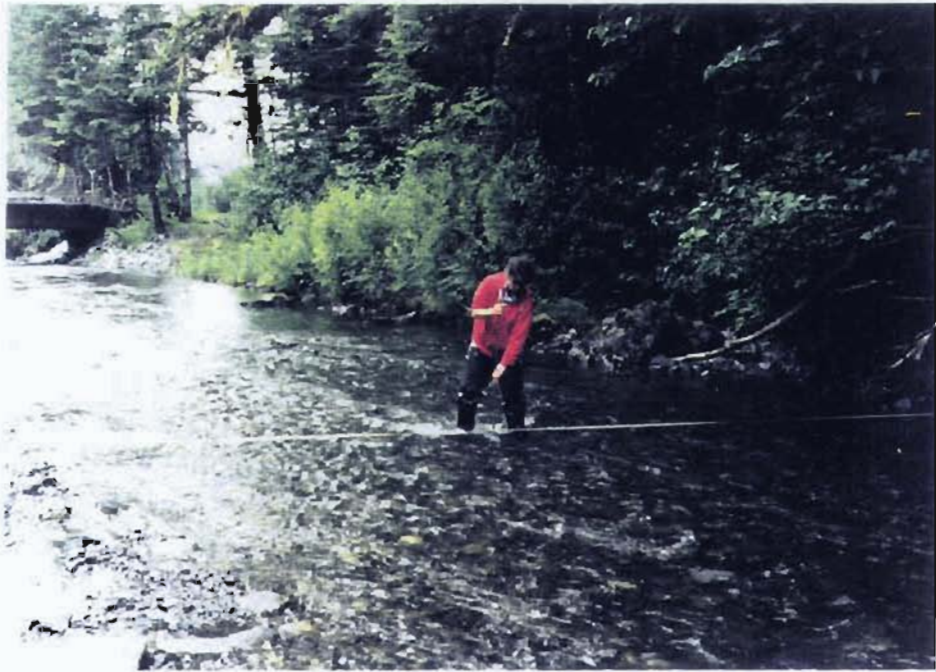
Mary Maurer collecting water with a depth-integrating sampler in Humpback Creek, near Cordova, Alaska. July 12, 1994

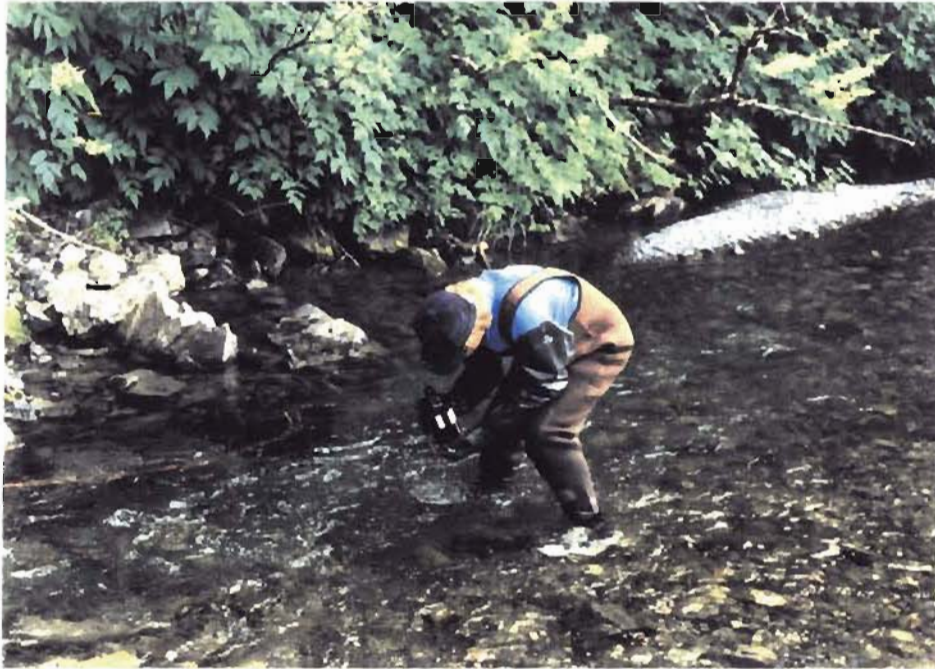
Stan Carrick collecting water for hydrocarbon analysis in Humpback Creek, near Cordova, Alaska. July 12, 1994

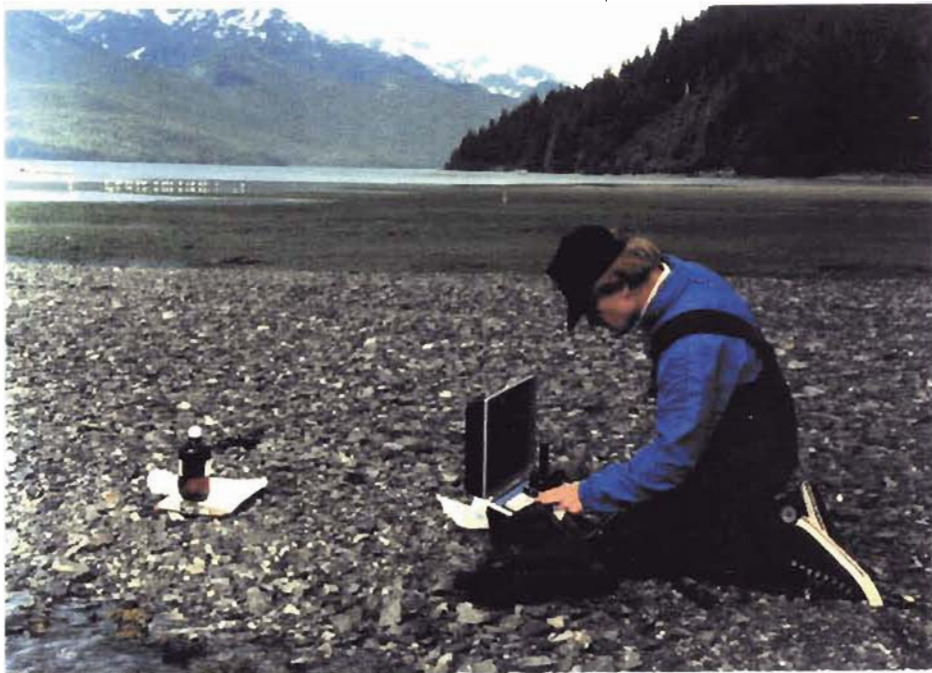
Stan Carrick taking turbidity measurement at ocean site, intertidal area of Humpback Creek, Orca Inlet, near Cordova, Alaska. July 12, 1994
