REPORT ON THE EMERICKS NICKEL PROSPECT, MT. HAYES QUADRANGLE

Robert H. Saunders
State Mining Engineer

November
1961

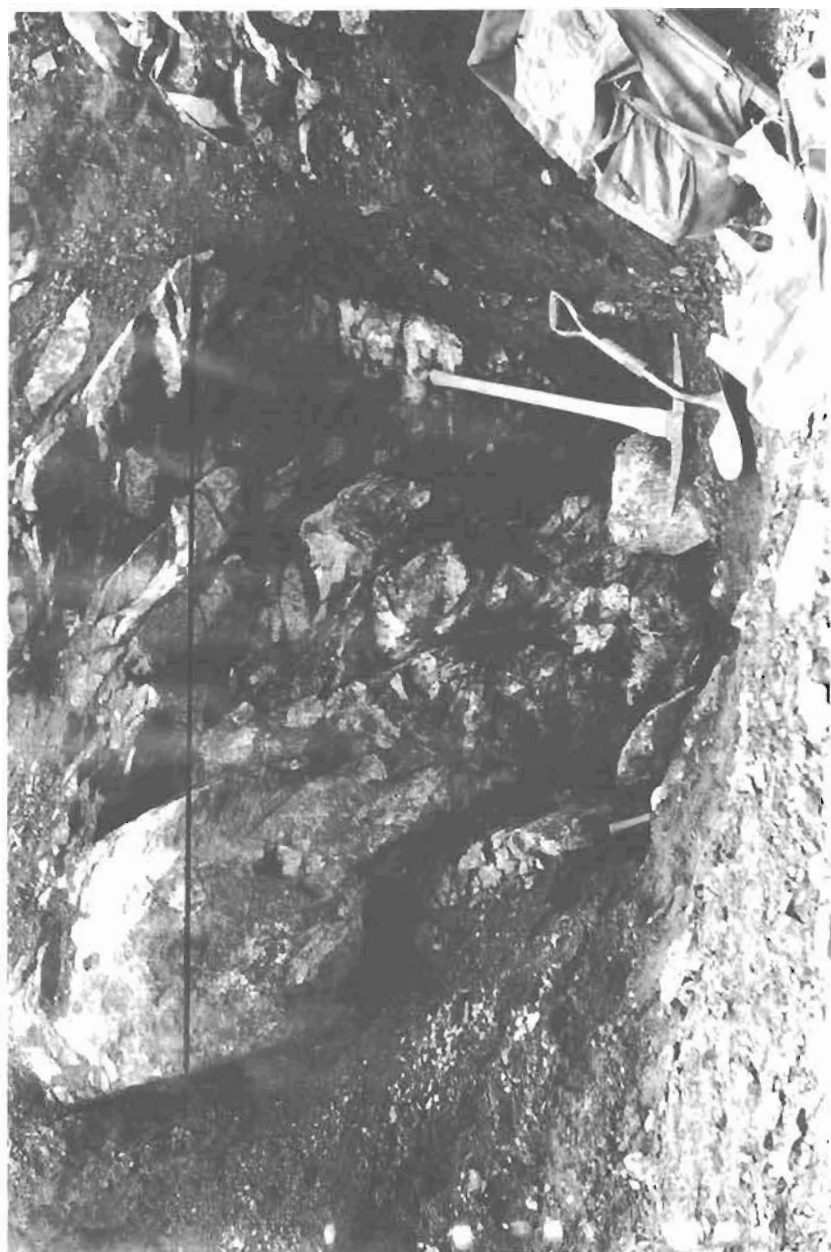
Fig. 2. Photograph of Eight-Foot-Wide Lens. Inked line lies across
Lens where sample 7 was cut.
