PROPERTY EXAMINATION REPORT

FINE CHANCE GOLD LODE, VALDEZ DISTRICT 4+ 86-9

James A. Williams
March 1955

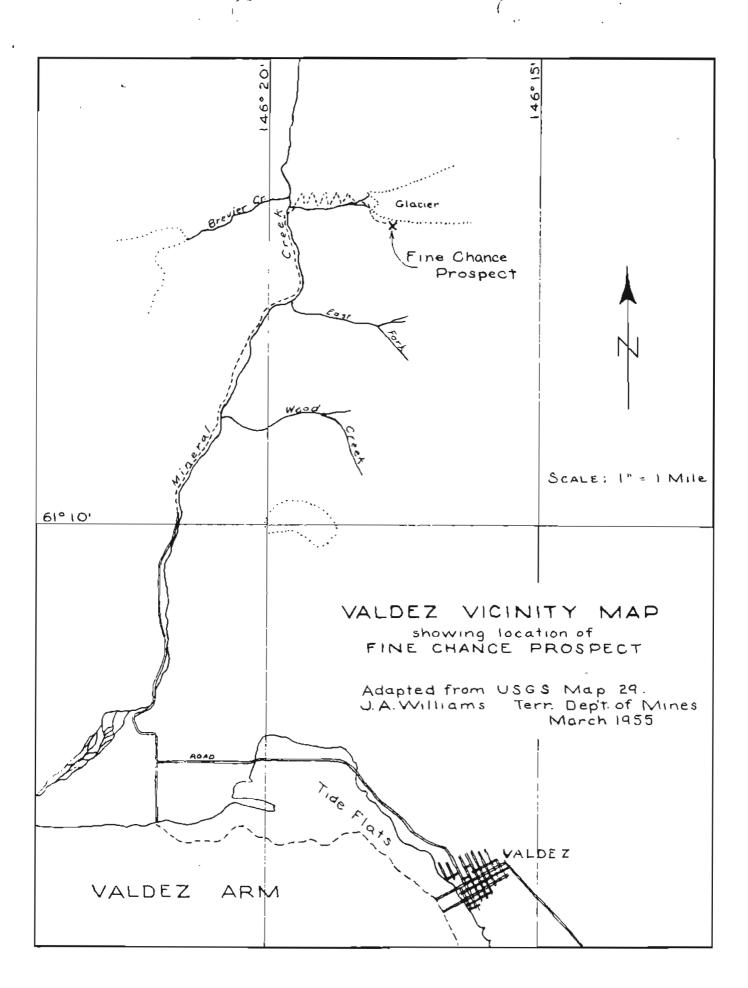
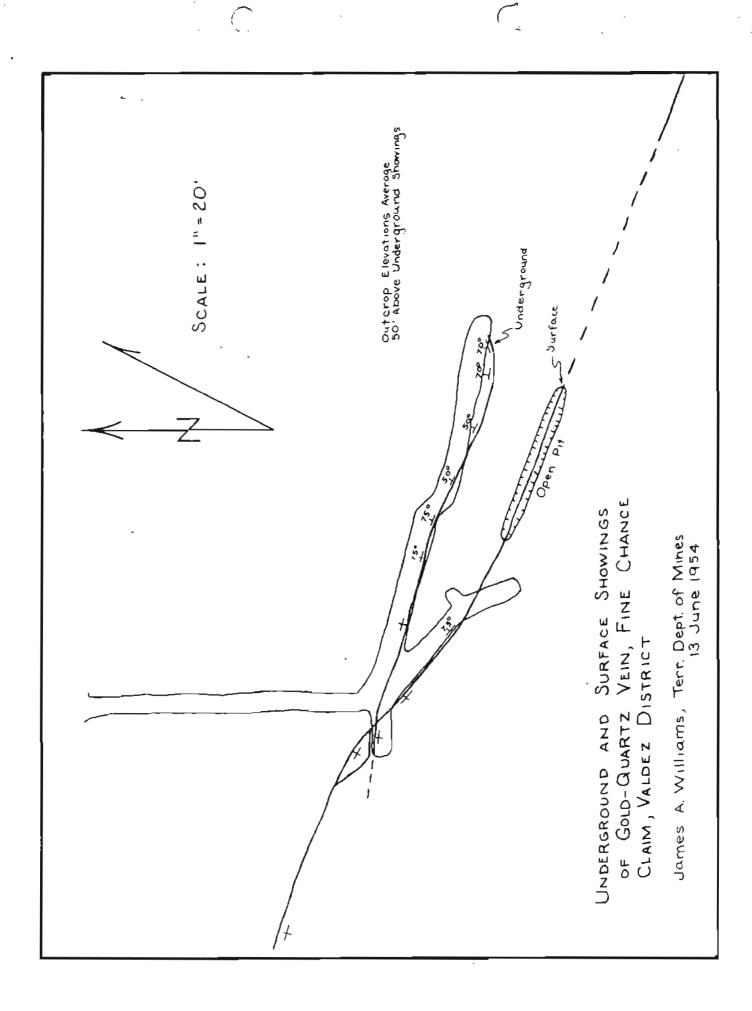
The survey was made by tape and Brunton, and when plotted and sketched, resulted in the attached sketch. The average difference in elevation between the underground and surface exposures is 50 feet. It can be easily seen from the relative positions and dips of the various parts of the exposures, that there is only one vein, and that the erratic dip causes the difference in strike between the two exposures.

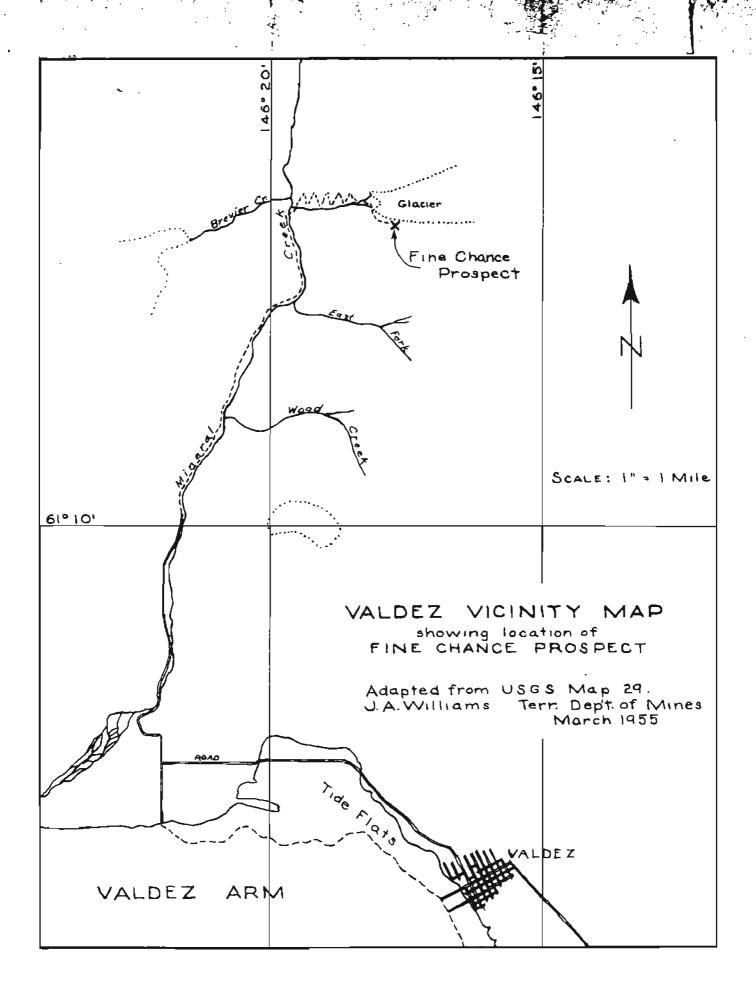
Creek, then 7 miles up Mineral Creek, only about 2 of which can be traversed by car. Just before reaching Brevier Creek, a good switchback trail leads across Mineral Creek, across Glacier Creek and up the slope on the north side of Glacier Creek to the Little Giant and Rose Claims where Quitsch's camp is located at about 2500 feet elevation. A good building for general living purposes exists here. Pilgrim visited this property in 1930, and his map of the claims and workings is in the files. His descriptive report is in the Biennial Report for the biennium ending March 31, 1931. From the Little Giant, a trail leads up and to the southeast to the Fine Chance Claim. Because fog and rain obscured the landscape most of the time on this part of the trip, little of the terrain was seen. Several small portions or spurs of the glacier above were crossed but travel was not difficult. The vein exposures are located at the top of a bluff overlooking the glacier to the north, and are at an elevation of about 4000 feet. The glacier is in a well-defined cirque, but small ski planes can land on it at certain times of the year when conditions are right. A vicinity map is attached.
