# ASSESSING POWDER CLOUD IMPACT ON ELECTRICAL TRANSMISSION LINES AT SNOWSLIDE CREEK AVALANCHE PATH IN SOUTHEAST ALASKA

## Frequent power outages and high maintenance costs in avalanche terrain

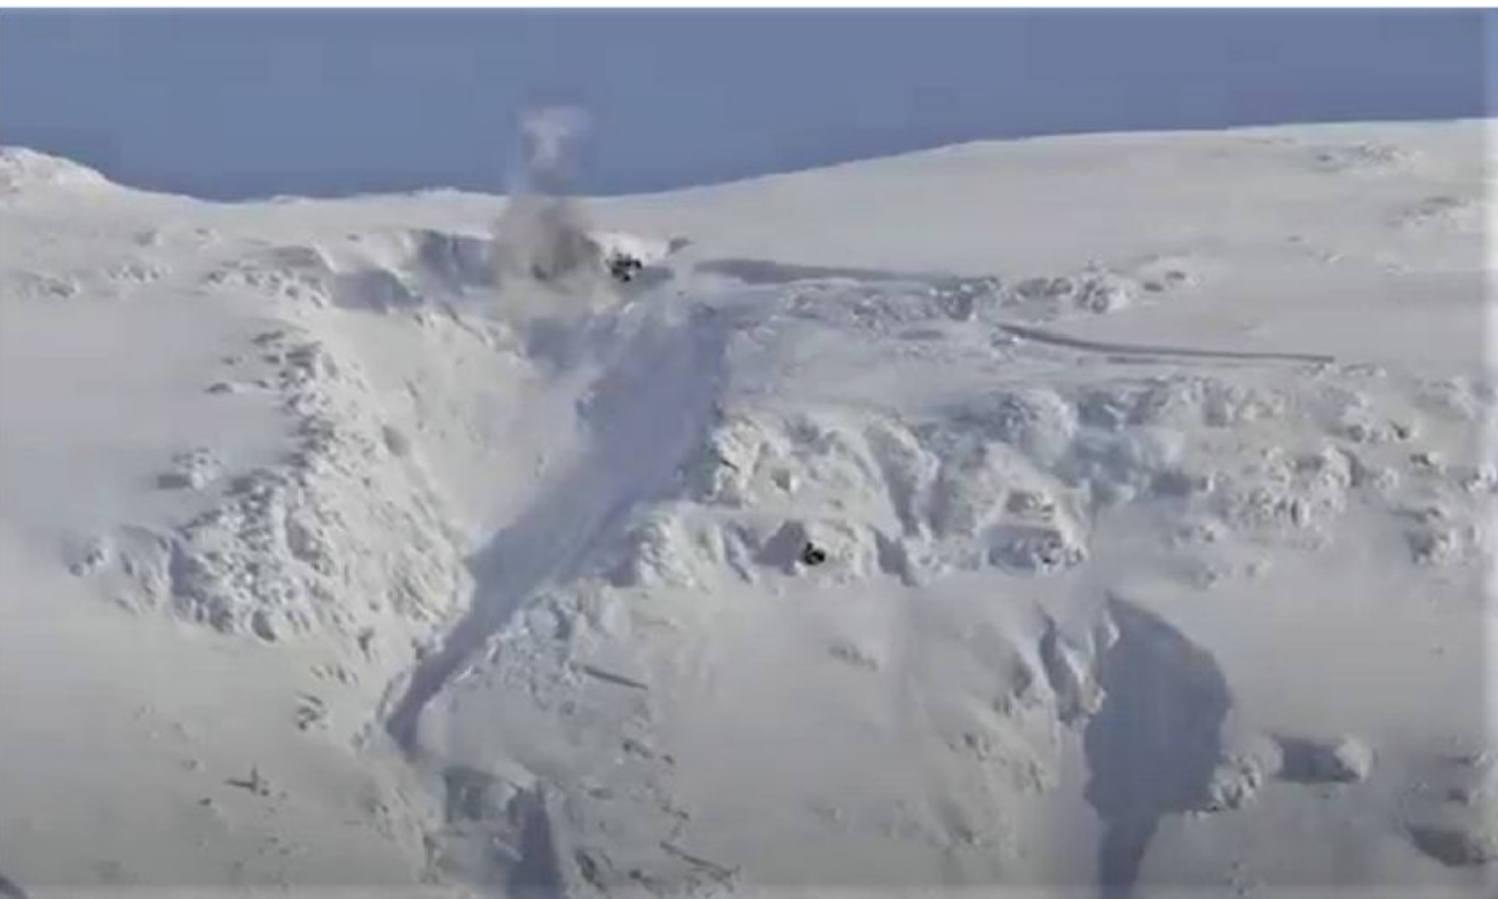
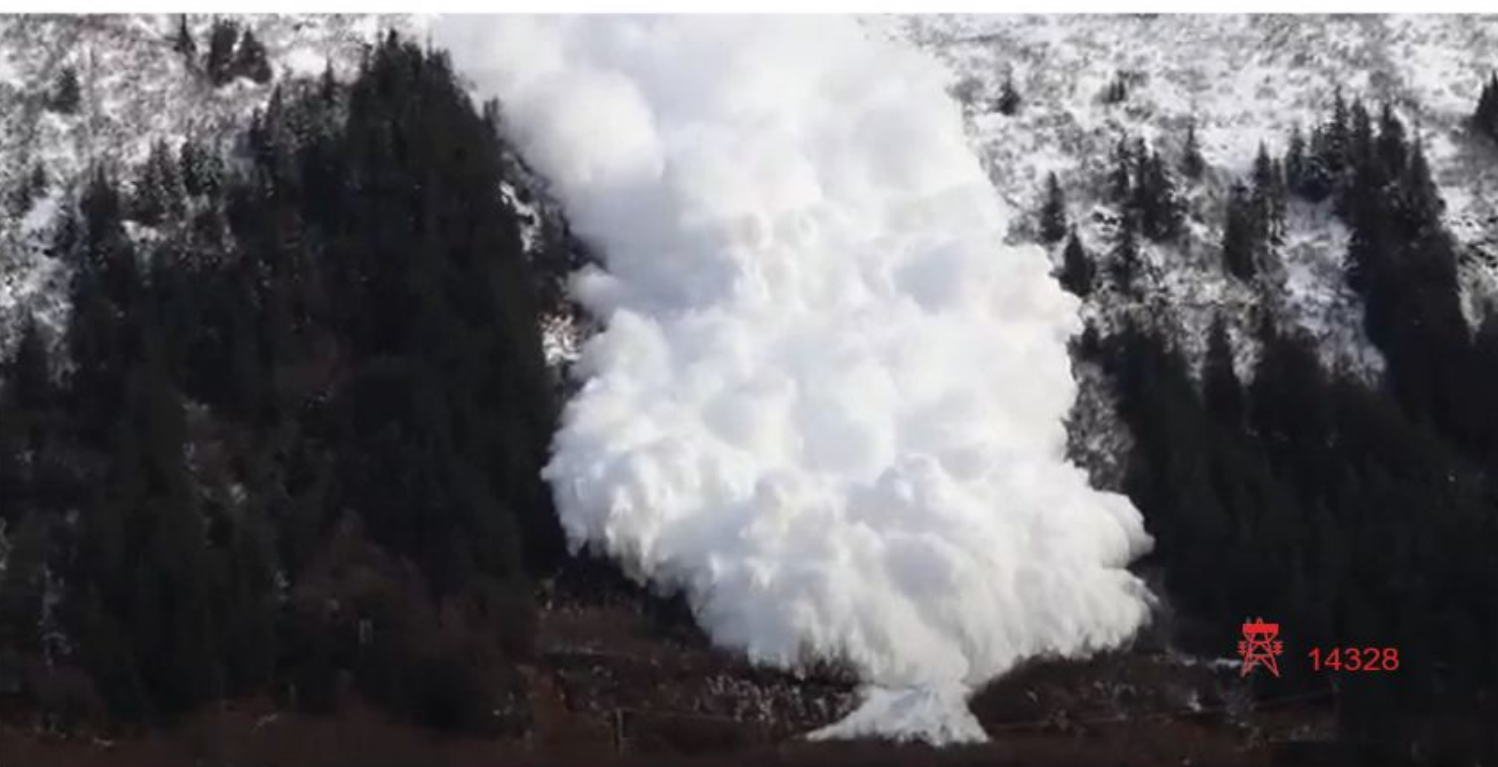
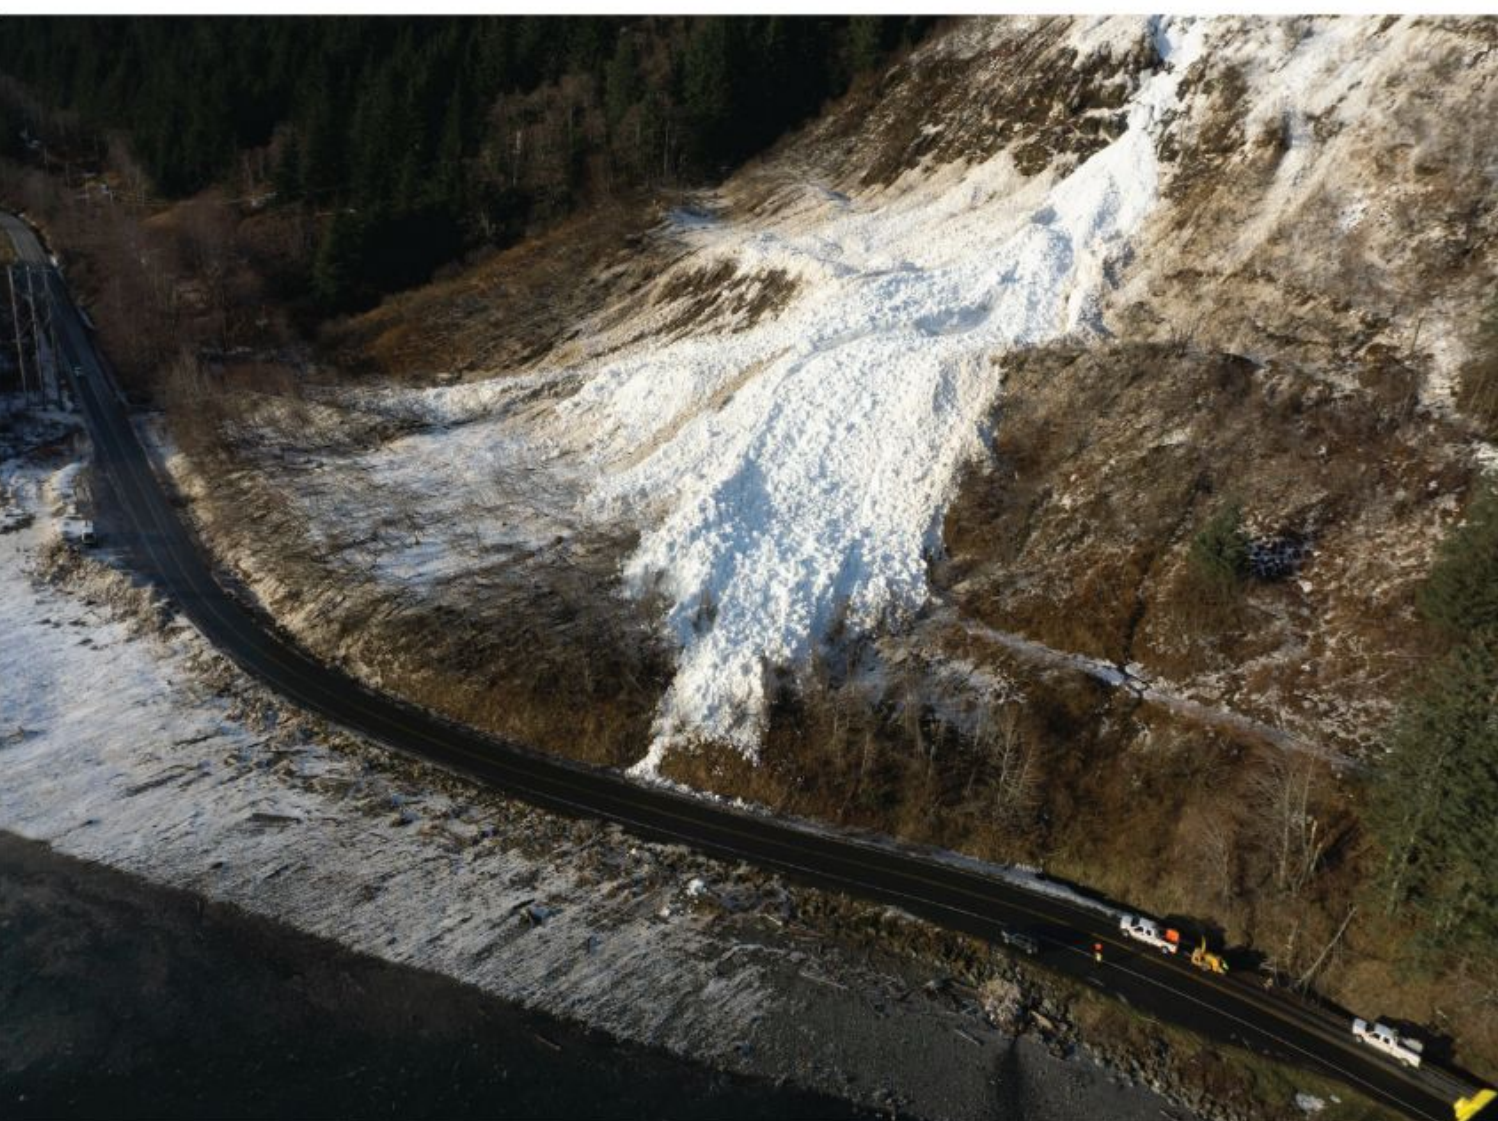
Figure 1: (Top left) Avalanche is triggered by heli-bombing, (Middle left) Powder cloud reaches upper powerline, (Bottom left) Deposition of the dense core which stopped short of Thane Road, and remnant powder cloud debris on the beach (Photos: AEL&P); (Map - right) Lidar-derived snow depth change from March 3 to March 4, 2021, showing areas of release/erosion (yellow-red) and deposition (blue).

On March 4, 2021, an avalanche was artificially triggered in Snowslide Creek. Most of the dense portion of the avalanche stopped within the deflection dam with only a small portion spilling over; however, **the powder cloud snapped the breakaway connections** to the towers and the conductor was carried into Gastineau Channel, resulting in a costly repair for AEL&P (See Figure 1).
