PROFESSIONAL REPORT 81

SNOW AVALANCHE ATLAS, SEWARD HIGHWAY, SOUTH-CENTRAL ALASKA

By G.D. March and L.G. Robertson

This atlas is intended as an operational guide to snow avalanche paths that affect the Seward Highway and its spur roads.

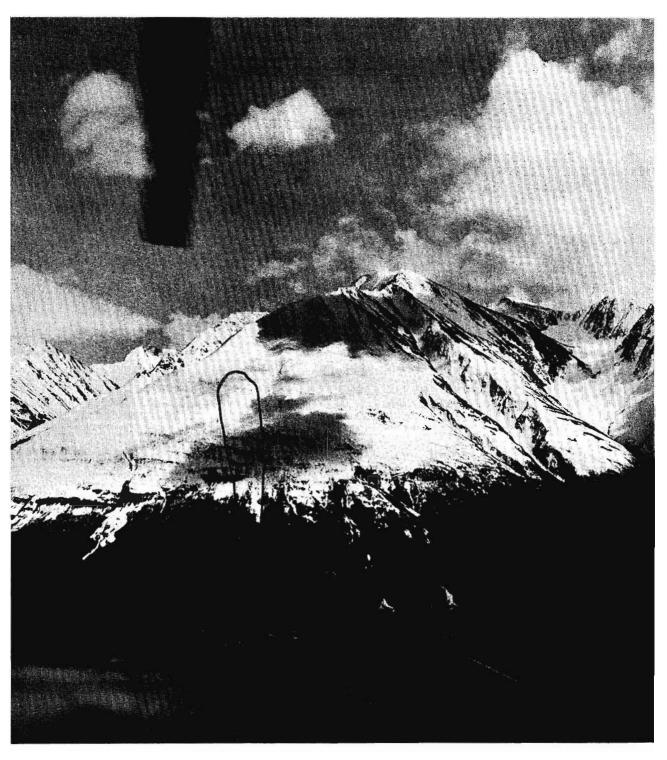
NUMBER: 1,1-3 MILE: 18.5 NAME: Primrose

LOCATION: 0.6 mi (0.9 km) north of Snow River bridge

HISTORY: Feb. 16, 1946: Railroad blocked

NOTES: Powerline crosses lower track
