# **STORM IMPACT SURVEY DATA FOR SELECTED ALASKA COASTAL COMMUNITIES IN RESPONSE TO EXTRA-TROPICAL CYCLONE MERBOK, SEPTEMBER 2022**

**Raw Data File 2022-14**

2022  
STATE OF ALASKA  
DEPARTMENT OF NATURAL RESOURCES  
DIVISION OF GEOLOGICAL & GEOPHYSICAL SURVEYS

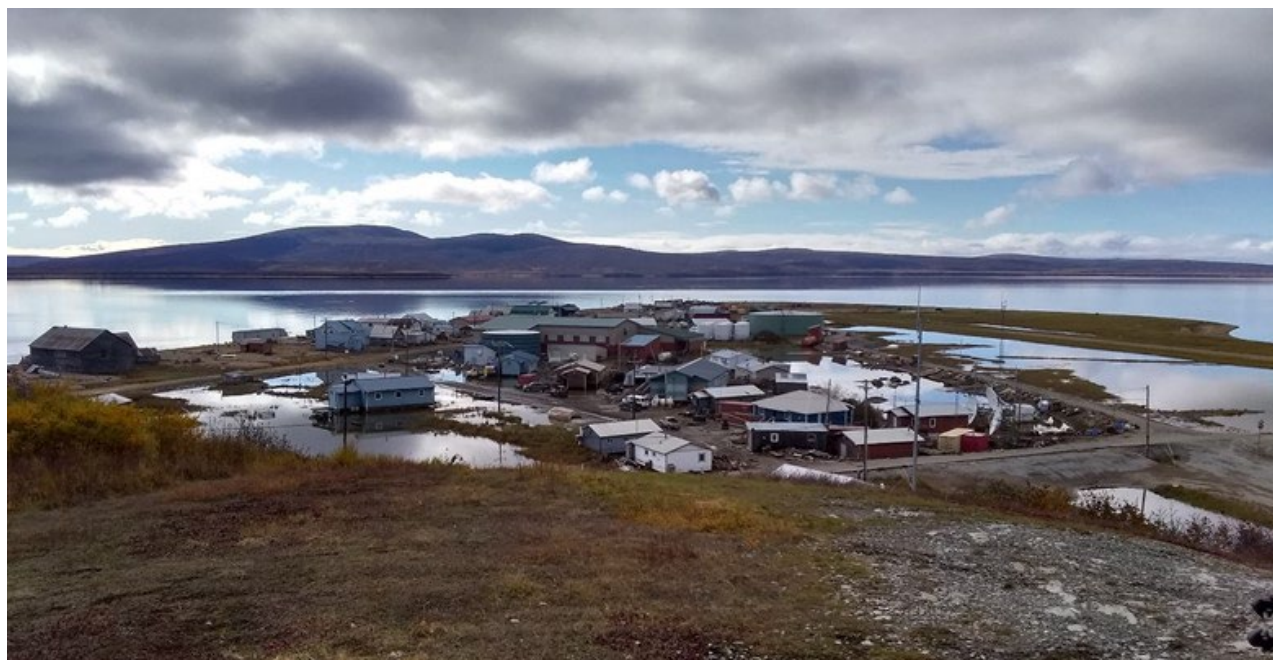
Photo from south end of airstrip looking southwest at flooding in Golovin, Alaska, on September 20, 2022, following Extra-Tropical Storm Merbok. Photo: Alaska Division of Geological & Geophysical Surveys.

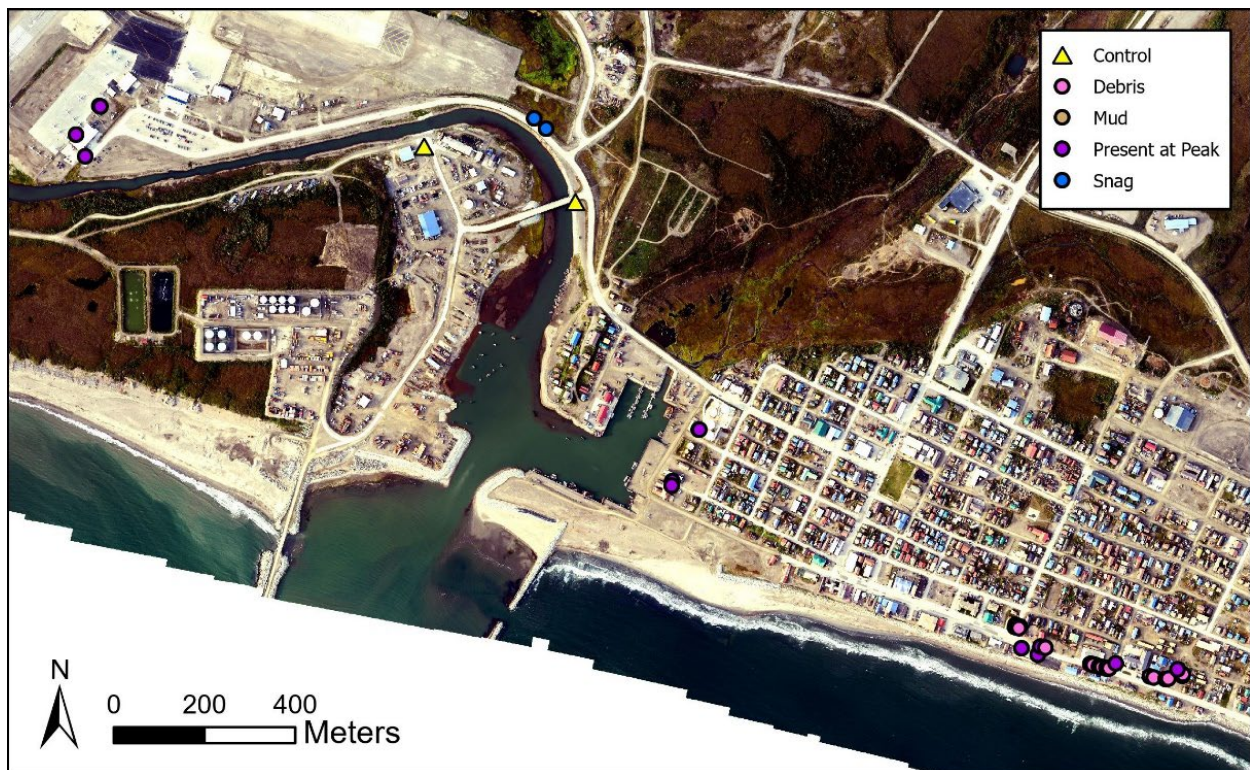
**Figure 1.** Map of point distribution in Nome, Alaska.

The field team arrived in Nome on September 19, 2022, and conducted a GNSS survey from approximately 2:00 PM to 6:00 PM AKDT. A base station was set up over known benchmark 946 8756 H with a published solution found at <https://www.ngs.noaa.gov/OPUS/getDatasheet.jsp?PID=BBFB37&ts=22075165807>. This provided real-time kinematic (RTK) corrections to the ground rover. The team photographed and measured 46 HWM points, recording the GNSS position, type of high water feature, height above ground (if applicable), and description of each mark (fig. 1).

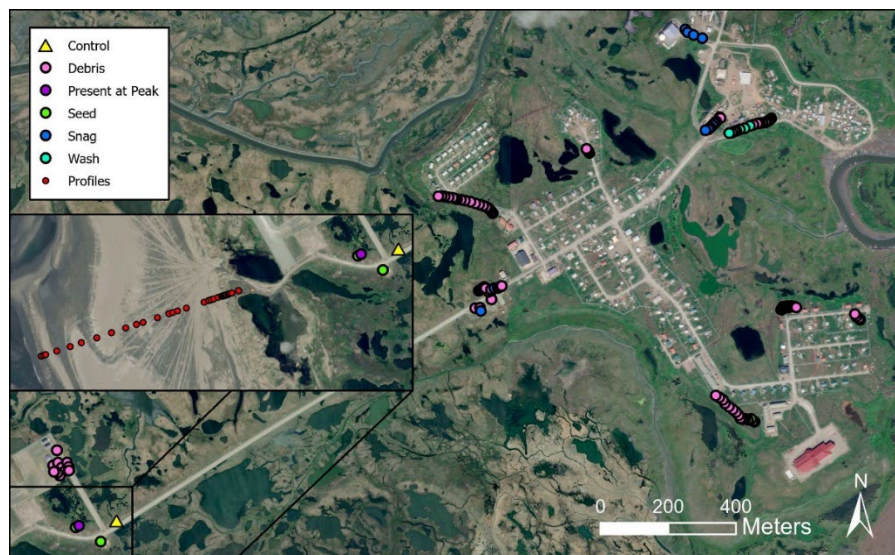
**Figure 3.** Map of point distribution in Hooper Bay, Alaska.

The field team arrived in Hooper Bay on September 20, 2022, and conducted a GNSS survey from approximately 11:45 AM to 5:15 PM AKDT. A base station was set up over known property corner 803 with published horizontal coordinates found on Bethel Recording District Plat 2019-3. The team photographed and measured 121 HWM points, recording the GNSS position, type of high water feature, height above ground (if applicable), and description of each mark. They also collected one coastal profile transect consisting of 35 GNSS positions (fig. 3).

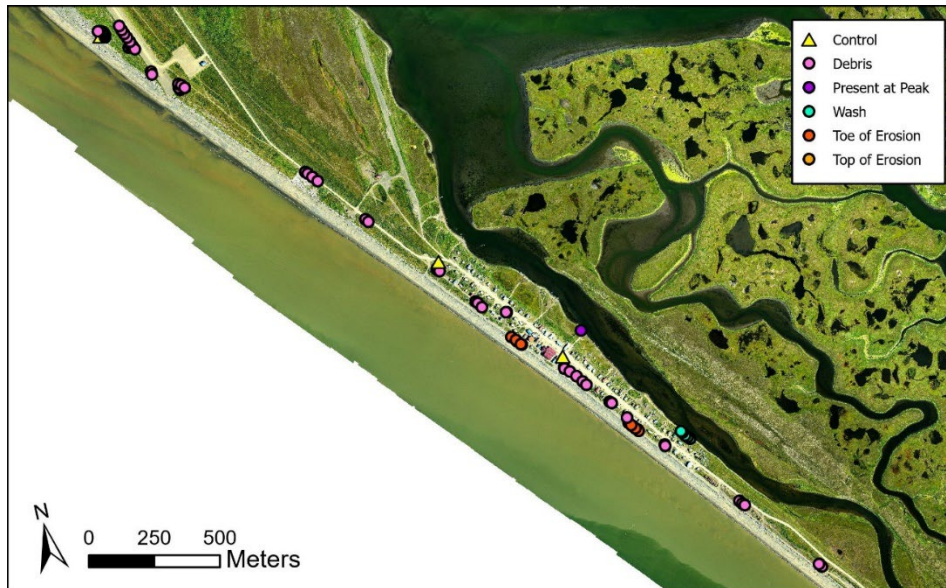
**Figure 6.** Map of point distribution in Shaktoolik, Alaska.

HWM points, recording the GNSS position, type of high water feature, height above ground (if applicable), and description of each mark. They also collected 12 ground elevation and erosion points (fig. 6).

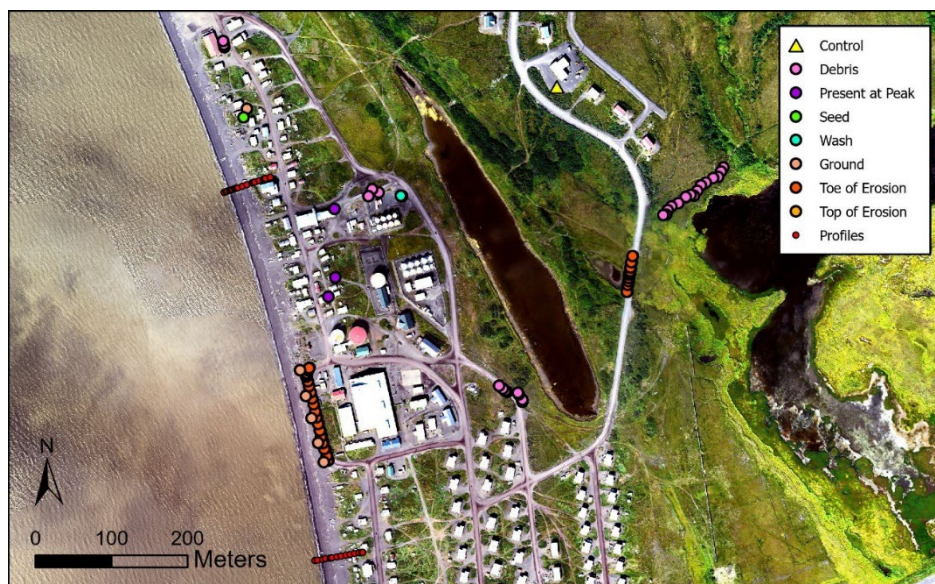
**Figure 7.** Map of point distribution in Stebbins, Alaska.

height above ground (if applicable), and description of each mark. They also collected 64 ground elevation and erosion points, as well as two coastal profile transects (37 points; fig. 7).
