PHOTOGRAMMETRY-DERIVED ORTHOIMAGERY AND ELEVATION DATA FOR SAINT MICHAEL, ALASKA, COLLECTED JULY 8, 2022

Raw Data File 2024-22

2024
STATE OF ALASKA
DEPARTMENT OF NATURAL RESOURCES
DIVISION OF GEOLOGICAL & GEOPHYSICAL SURVEYS

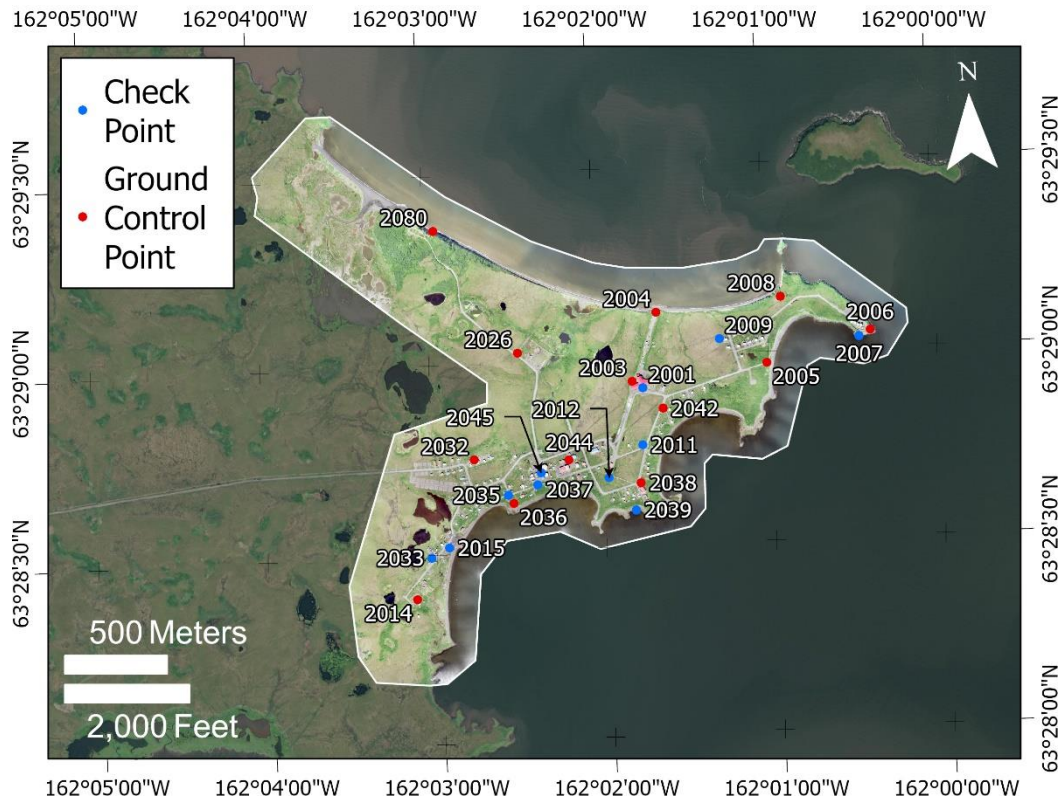
Figure 2. Location of photo-identifiable ground control points (GCP; red) and check points (CHK; blue).

On July 8, 2022, DGGS set up a Global Navigation Satellite System (GNSS) base station using a Trimble R10 receiver sampling at 5 Hz over a temporary benchmark. This provided real-time kinematic (RTK) corrections to the ground rover, a Trimble R8s GNSS receiver. DGGS measured the location of 25 photo-identifiable ground control points (GCPs) with the ground rover (fig. 2).

DGGS used Agisoft Metashape Professional (Version 1.8.3 build 14331) software for photogrammetric processing following the steps and settings outlined in Over and others (2021). During processing, DGGS used 13 GCPs for photograph alignment and lens distortion parameter optimization (fig. 2, table 2), leaving 12 GCPs as horizontal and vertical check points (fig. 2, table 3). A confidence filter was applied to the resulting dense point cloud, eliminating all points derived from fewer than three discrete camera positions. Additional noise was removed from the dense point cloud through visual inspection.

We quantified the horizontal accuracy of the DSM and orthoimage by comparing the known locations of 12 photo-identifiable check points measured with GNSS against their modeled locations in the photogrammetric products (fig. 2, table 3). These are independent checkpoints not used during processing. X and Y errors are calculated as the root-mean-square (RMS) error of offsets, 0.032 m and 0.033 m, respectively. The total horizontal error is the root-sum-square error of X and Y RMS errors, 0.046 m.

We quantified the vertical accuracy of the DSM using the same 12 check points used to quantify the horizontal accuracy (fig. 2, table 3). The RMS error of Z offsets is 0.025 m. The total RMS error of the DSM (X, Y, and Z) is 0.053 m.
