SOIL INDEX PROPERTIES AND RADIOCARBON AGES OF THE HAINES-TAKSHANUK MOUNTAINS-CHILKAT PENINSULA AREA STATEMAP PROJECT, SOUTHEAST ALASKA

Raw Data File 2024-27

SOIL INDEX PROPERTIES AND RADIOCARBON AGES FOR THE HAINES-TAKSHANUK MOUNTAINS-CHILKAT PENINSULA AREA STATEMAP PROJECT, SOUTHEAST ALASKA

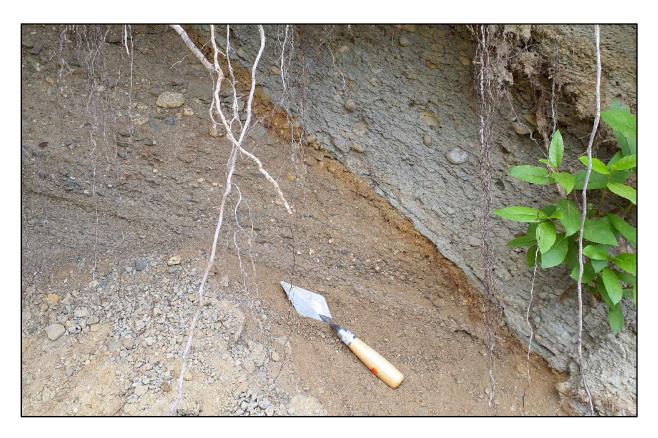
Photograph showing a distinct contact between two soil layers in the Haines area. The trowel is 24.5 centimeters (9.6 inches) long.

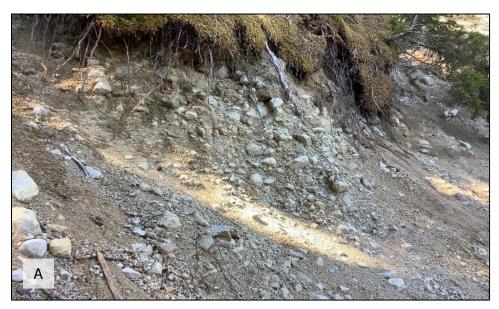
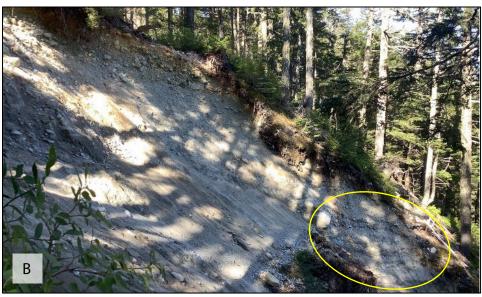
Figure A1. Images of 23MMD008 sample location: (A) sampled soils from right flank; (B) left flank near head scarp demonstrating stratified soils (indicated by yellow ellipse).

Site Description: Head scarp and body of debris flow; occurred in ice-contact deposit with

Sample(s) From: Soil matrix in right flank of head scarp area

Soil Stratigraphy: 0 to >20 m (est.) White-gray, poorly graded gravel with sand and with cobbles and

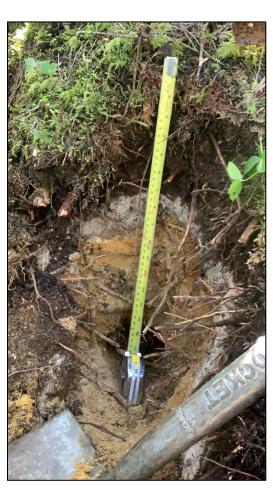
Figure A2. Near-surface soil stratigraphy from 23MMD009 test pit.

Soil Stratigraphy: 0 – 0.18 m Brown organic mat

$0.18 - 0.24 \,\mathrm{m}$ White, silty sand

0.24 – 0.50 m Brown-orange, silty sand; iron oxidized, contains

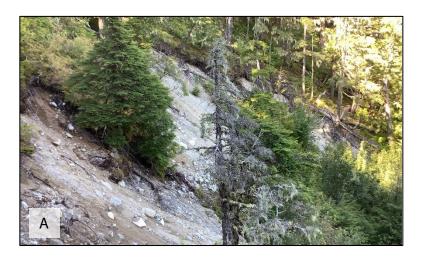
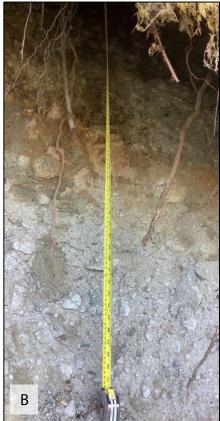
Figure A3. Images of 23MMD010 sample location: (**A**) looking north at soil exposed across the head scarp area; (**B**) stratigraphy in head-scarp exposure.

Soil Stratigraphy: 0 – 0.3 m Brown organic mat

0.3 – 1.5 m Brown-orange, poorly graded sand with gravel; iron oxidized

1.5 to >10 m (est.) White-gray, poorly graded sand with gravel; contains

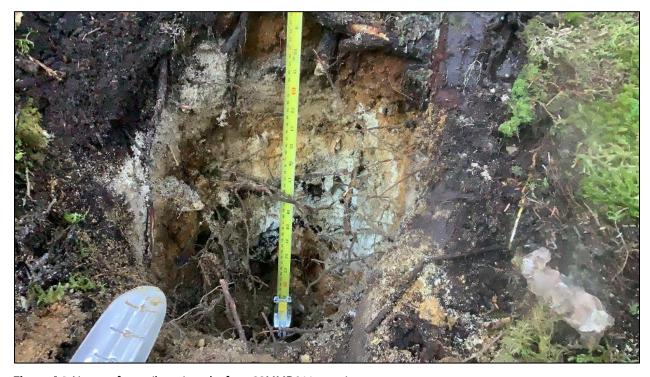
Figure A4. Near-surface soil stratigraphy from 23MMD011 test pit.

Soil Stratigraphy: 0 – 0.10 m Dark brown organic mat

0.10 – 0.18 m White-gray, silty sand

0.18 – 0.24 m Red-brown, silty sand; iron oxidized

0.24 – 0.45 m Alternating red-brown and white, silty sand layers

0.45 – 0.65 m (bottom of hole) White, silty sand; gravel and cobble

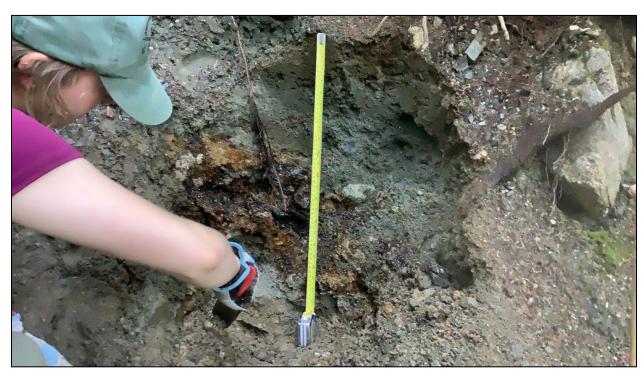
Figure A5. Left flank of debris flow where samples 23MMD012 – 014 were collected.

Soil Stratigraphy: (depths from bottom of organic mat):

0 – 0.27 m Dark gray silty sand with gravel, cobbles

0.27 – 0.50 m Black organic well graded sand with silt, interlayered

0.50 - 0.65 m (bottom of hole) Gray poorly graded sand with silt and gravel,

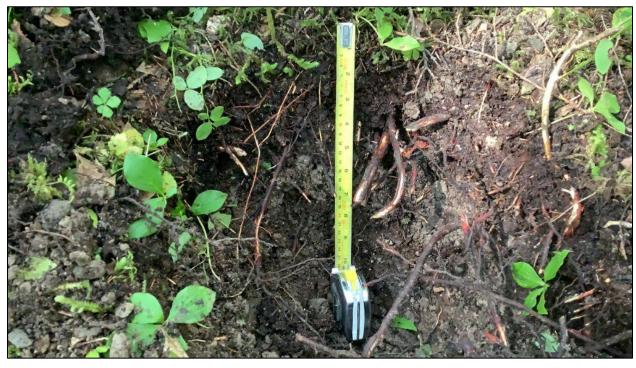
Figure A6. Near-surface soil stratigraphy from 23MMD016 test pit.

Soil Stratigraphy: 0 – 0.13 m Dark brown organic mat

0.13 – 0.29 m (bottom of hole) Gray poorly graded gravel with silt

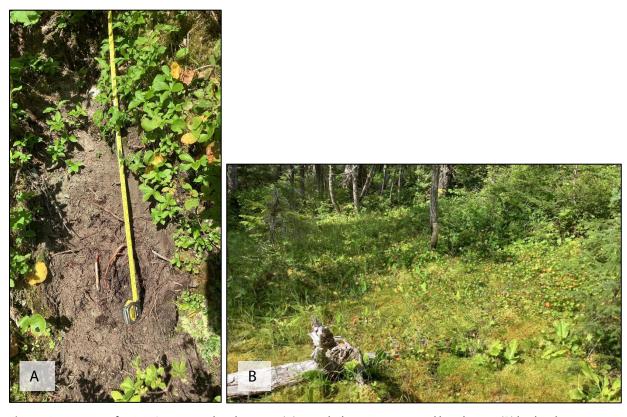
Figure A7. Images of 23MMD017 sampling location: (**A**) sampled area in vegetated head scarp; (**B**) hydrophytic vegetation with standing water on head of paleolandslide.

Site Description: Head scarp of paleolandslide, down-dropped head covered in hydrophytic

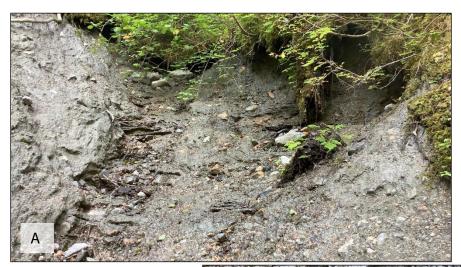
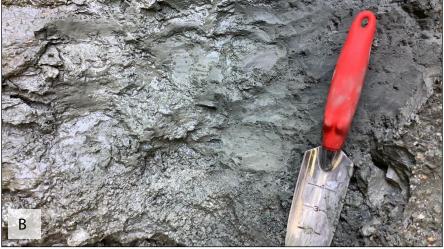
Figure A8. Images of 23MMD018 sampling location: (**A**) looking towards the head scarp of the landslide area with exposed bedding within drainage; (**B**) cleaned exposure of interbedded silt and sand.

Site Description: Landslide in valley wall; exposure of varves (silty clay and sand), overlying gravel;

Sample(s) From Gray sandy silty clay with gravel in exposed stratigraphy in landslide; bedding

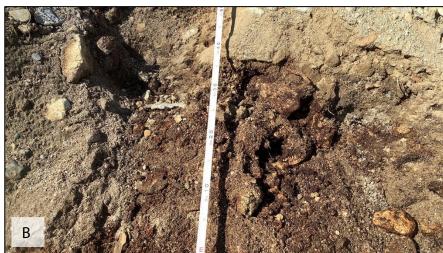
Figure A9. Images of 23MMD019 sampling location: (**A**) base of described stratigraphy with saturated sand (midphotograph) over uplifted marine deposits; (**B**) organic-rich horizon.

Soil Stratigraphy: (depths estimated from measuring tape draped from access road in gravel pit):

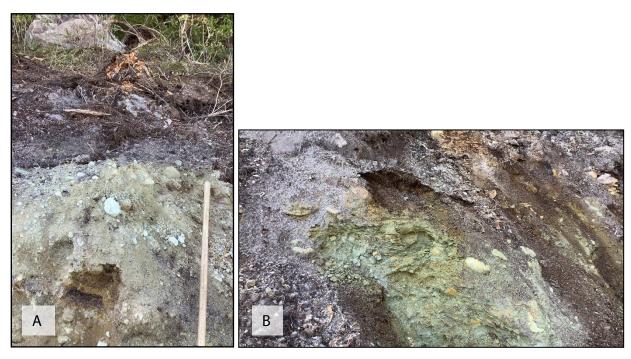
Figure A10. Images of (A) 23MMD025 and (B) 23MMD026 sampling locations.

Sample(s) From 23MMD025: Organic poorly graded sand with gravel ~1.15 m below ground

23MMD026: Silty sand below 23MMD025; bedding strike/dip 235°/20° right

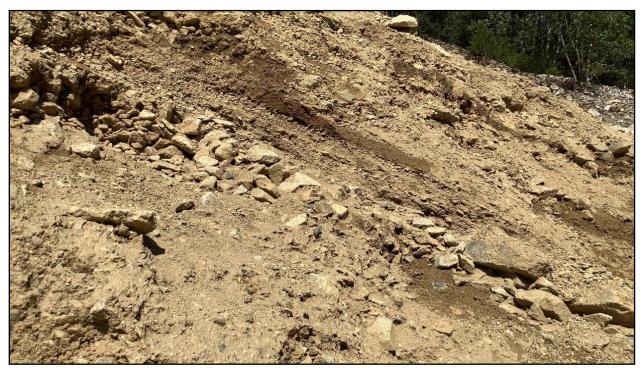
Figure A11. Sampled stratified talus.

Sample(s) From Poorly graded sand with silt and gravel (stratified talus) in cut slope of material

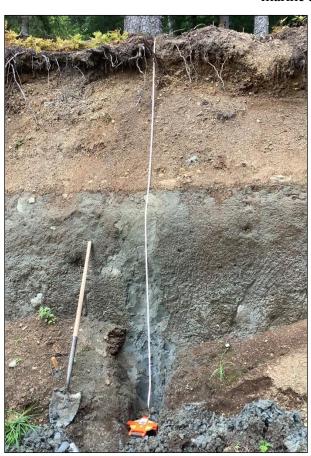
Figure A12. Image of stratigraphic section, including uplifted beach deposits and marine deposits.

Soil Stratigraphy: 0 – 0.3 m Organic mat

0.3 – 2.3 m Brown well graded sand with gravel (uplifted beach

2.3 – 4.2 m (bottom of hole) Silty clayey sand (light gray 2.3 – 3.0 m,

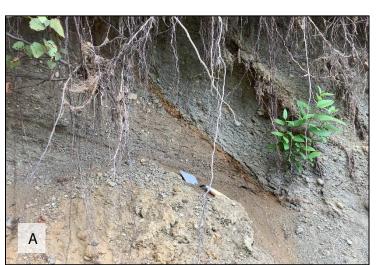
Figure A13. Images of sample locations: (**A**) debris flow truncating fluvial deposits at iron-oxidized contact; (**B**) stratified fluvial deposits.

Site Description: Cut slope in material site; exposure contains contact between possible debris

Sample(s) From 23MMD031: 0.9 m below ground surface in gray silty sand with gravel; debris

23MMD032: 1.2 m below ground surface in gray poorly graded sand with

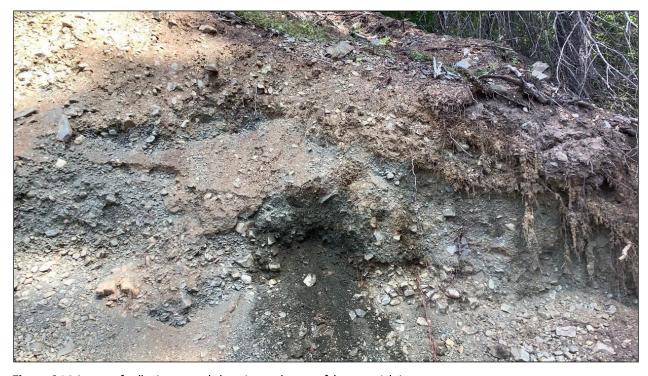
Figure A14. Image of colluvium sample location at the top of the material site.

Site Description: Cut slope at top of material site, containing colluvium

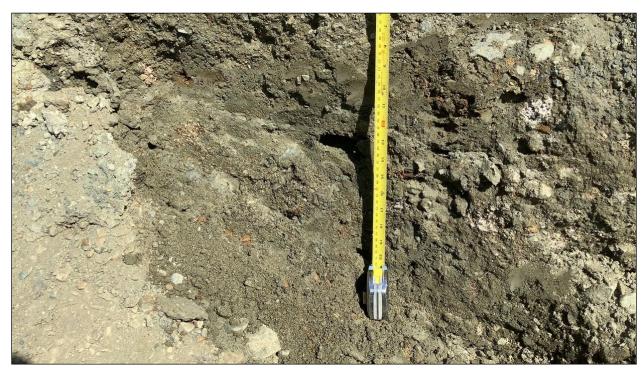
Figure A15. Image of glacial till sample location near the top of the material site.

Site Description: Cut slope near top of material site; exposure contained glacial till

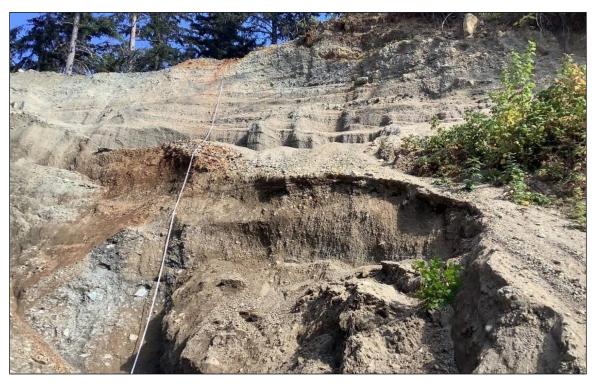
Figure A16. Image of middle section of the material site.

Soil Stratigraphy: (depths from switchback cut into slope):

0 – 3.05 m Gray poorly graded gravel with sand (glacio-fluvial deposits,

7.35 – 16.8 m Gray well graded sand with silt and gravel, minor stratification
