DENDROGEOMORPHIC EVIDENCE OF FREQUENT MASS MOVEMENT USING REACTION WOOD IN BLACK SPRUCE: ALASKA HIGHWAY MILEPOST 1267, NORTHWAY JUNCTION, ALASKA

Alexander K. Stewart, Catherine E. Heinrich, and Trent D. Hubbard

Report of Investigations 2017-7

State of Alaska
Department of Natural Resources
Division of Geological & Geophysical Surveys

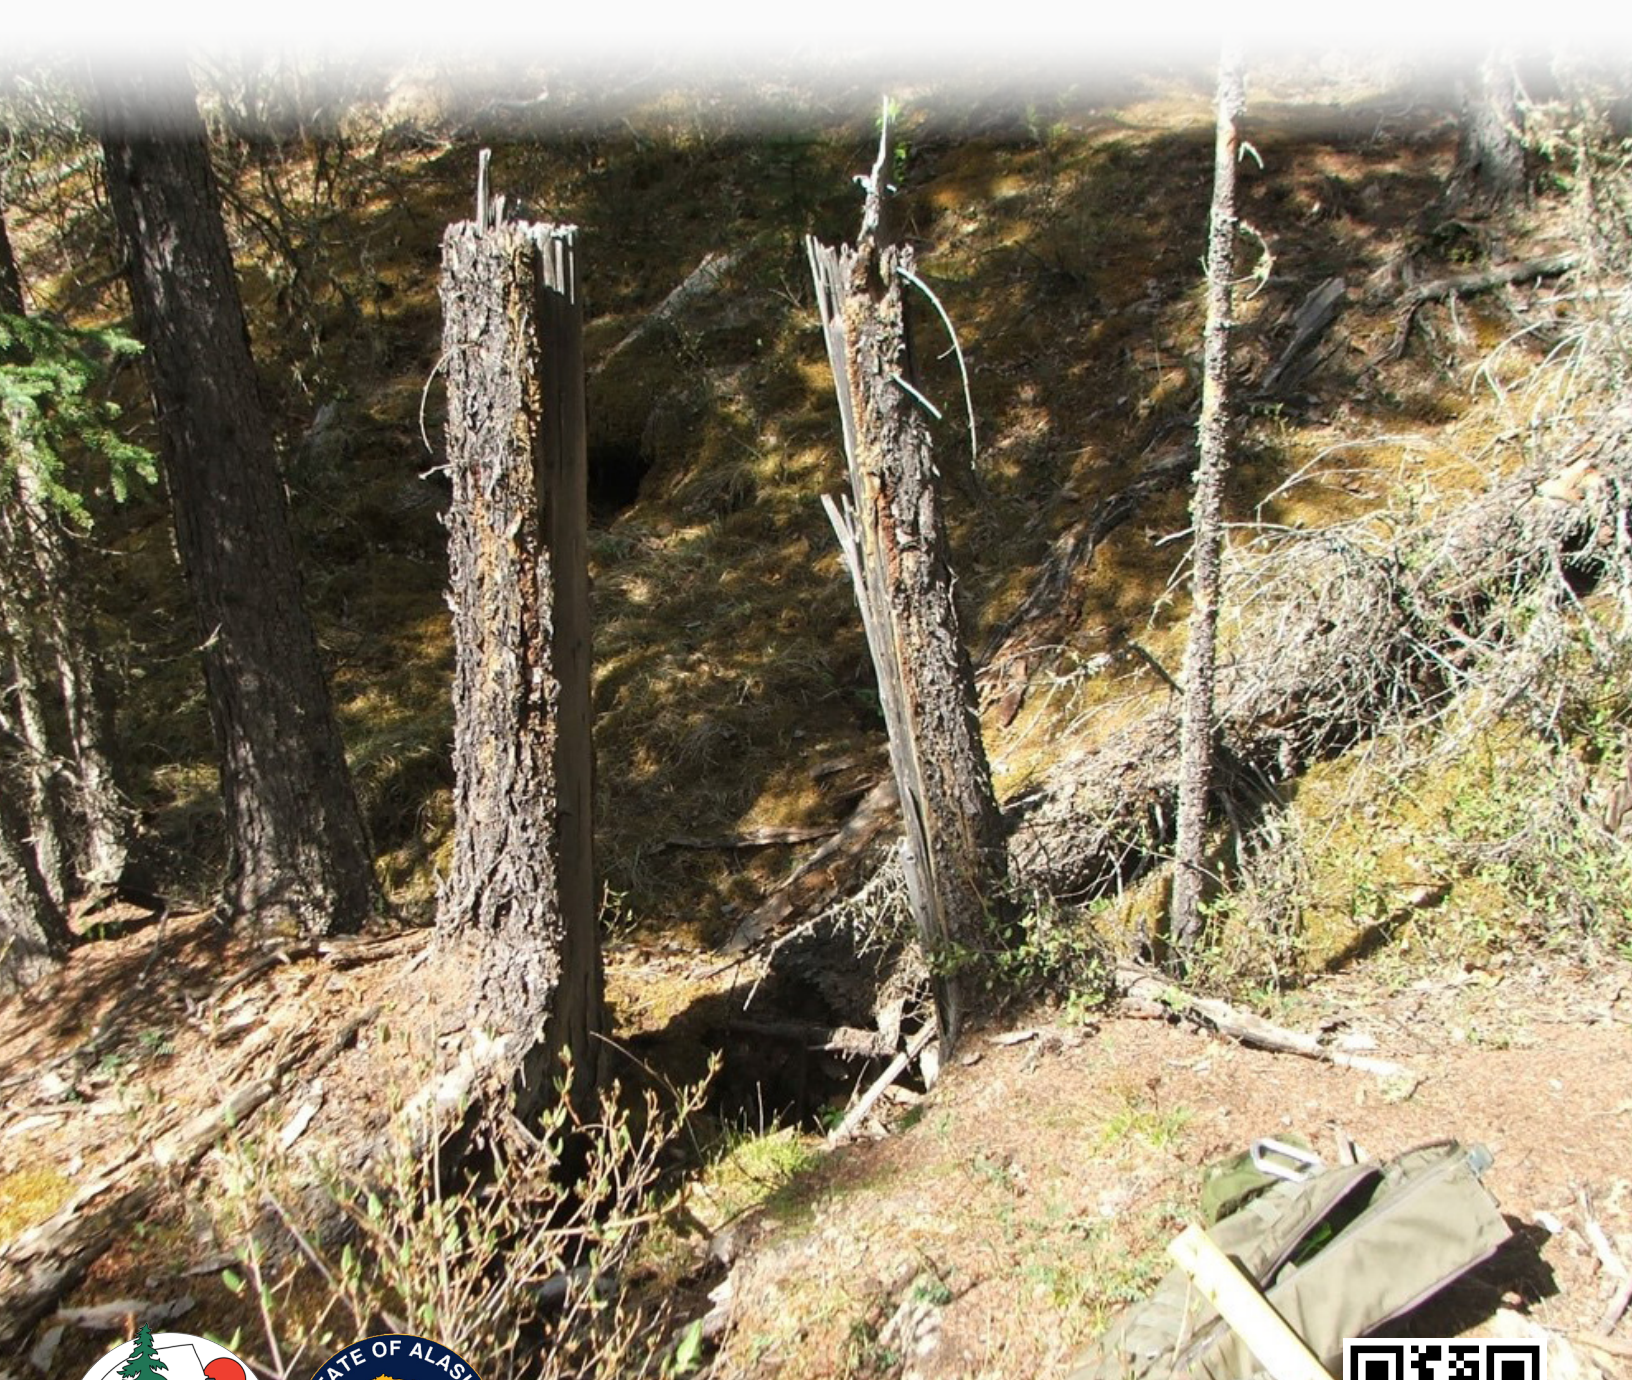
Split black spruce trunk resulting from extensional mass movement, Northway Junction, Alaska. Photo by Alexander K. Stewart.

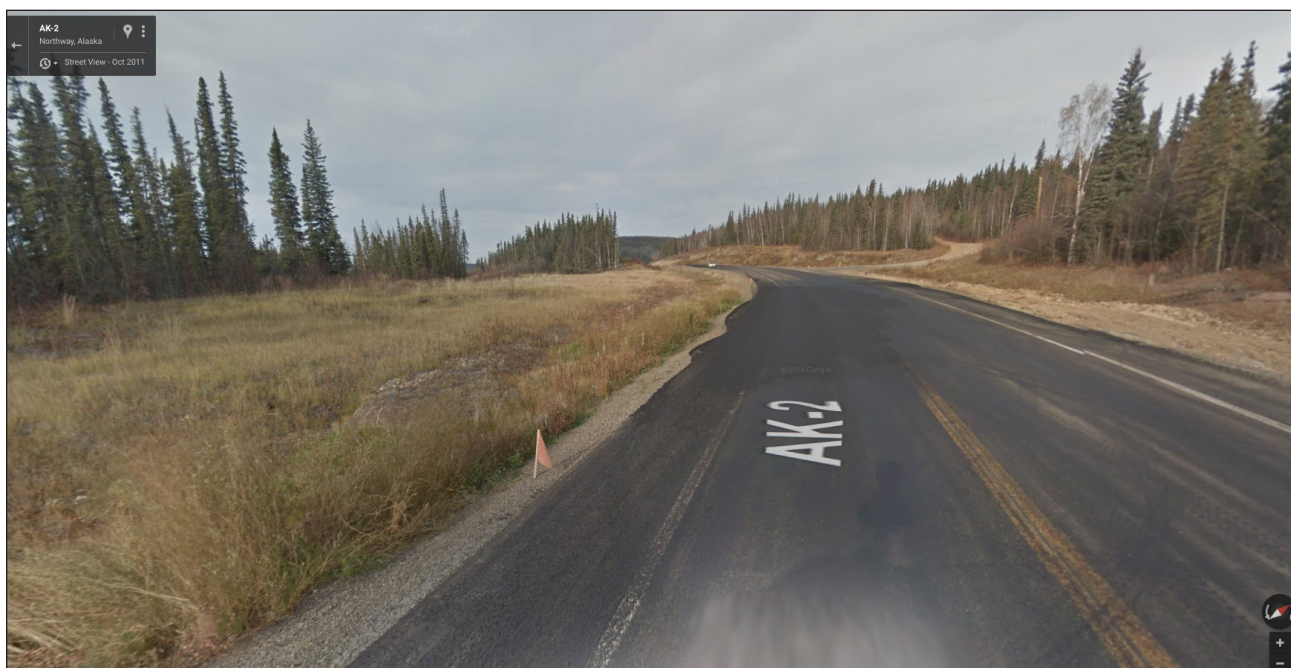
Figure 2. Google Earth Street View (October 2011) facing west-northwest along the Alaska Highway near milepost 1267. Notice the recently flagged and patched roadway in the east-bound lane; the first break in the tree line to the south of the roadway is the old, pre-2004 roadway.

additional resource allocation for the area (Bennett, 1994). Since the 2004 northward realignment of the road after the mass-movement event, continued road movement has required repairs along this new section in most of the years since (Reger and others, 2012a; Jeff Currey [DOT&PF], written commun., 2014). Despite the best engineering efforts, as of 2004 this section of the AH is still undergoing mass-movement-related roadway issues and will likely need significant attention in the near future (fig. 2).

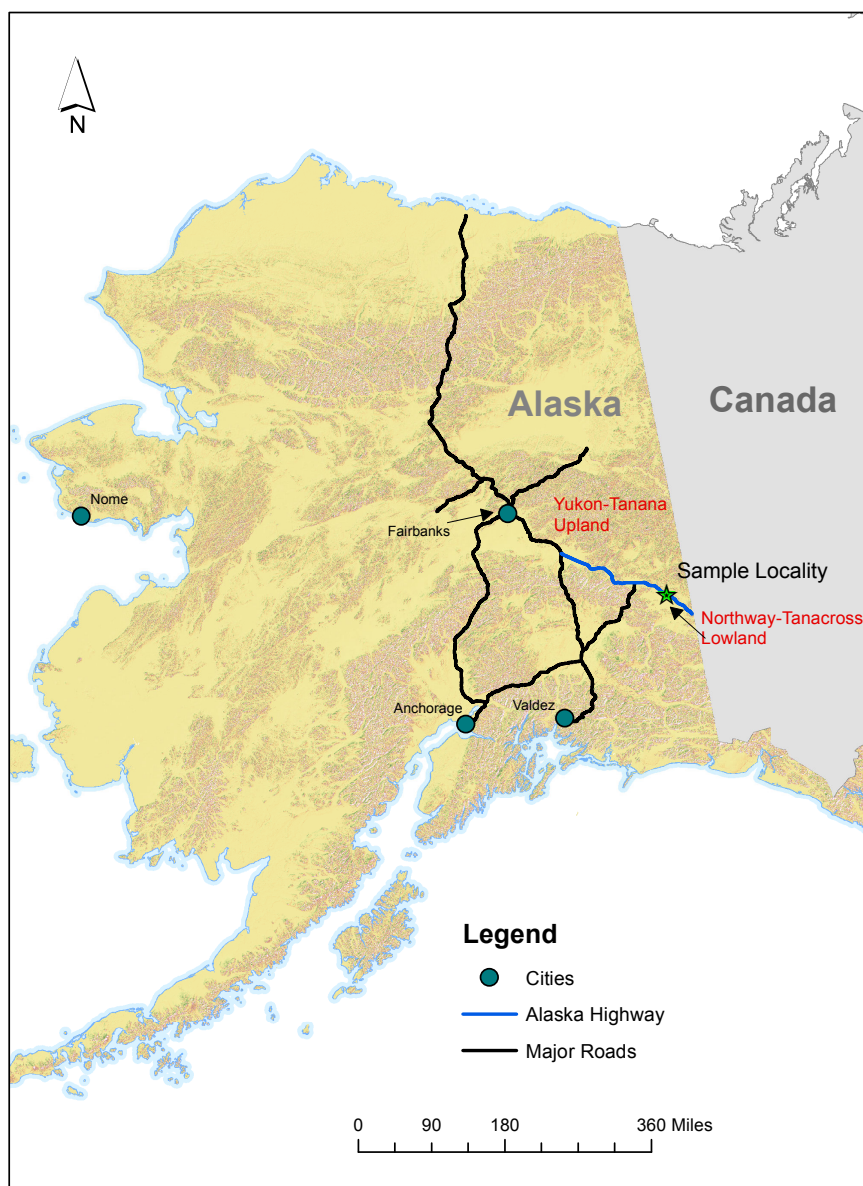
Figure 3. Shaded relief map of Alaska with sampling site location marked with star.

The focus of this study is an active, retrogressive landslide complex expanding toward the Alaska Highway near Northway Junction, Alaska, at approximately 63.046°N, 141.829°W (fig. 3), in the Tetlin National Wildlife Refuge. These three large, retrogressive mass movements are at the southern margin of the Yukon–Tanana Upland adjacent to the Northway–Tanacross Lowland, which is part of the Alaska Boreal Interior (taiga) and, more specifically, the Interior Bottomlands (Wahrhaftig, 1965; Wiken and others, 2011). The Northway–Tanacross Lowland separates the Yukon–Tanana Upland from the easternmost Alaska Range. Our approximately 4-hectare sampling site was on the landslide complex on the southwestern side of the Alaska Highway (AH) 42 km west of the Canada border (figs. 1 and 3).

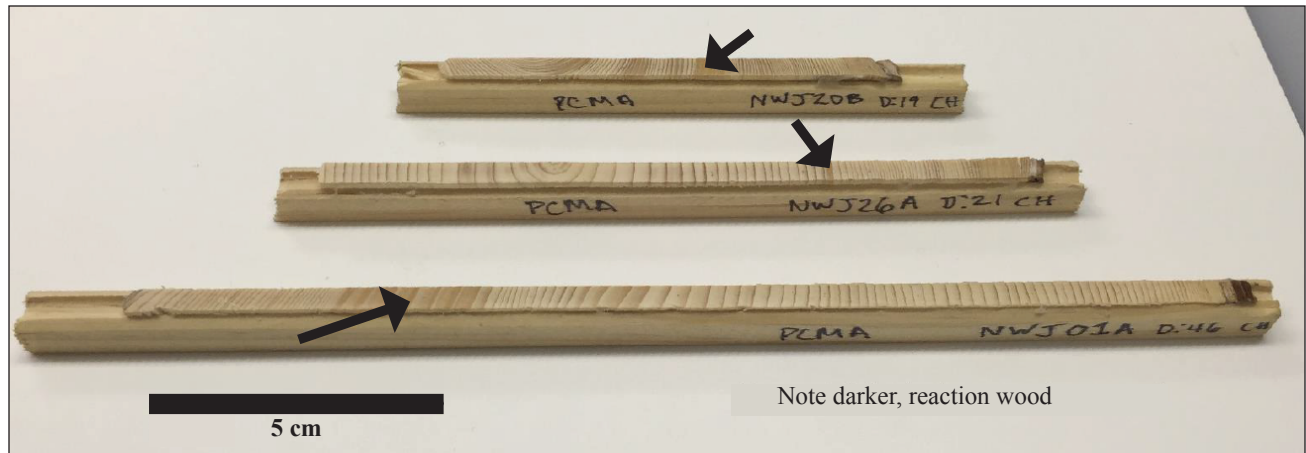
Figure 7. Three samples highlighting reaction wood in three separate trees. Arrows point out sections of reaction wood (darker than surrounding sections).

to very-fine (9 micron) polishing sanding film. Sanding and polishing allowed direct observation of individual cells and interpretations of ring boundaries and reaction wood (fig. 7).

Once all cores were mounted and sanded, they were dot-counted to allocate a growth year to each ring and then skeleton plotted (Schweingruber and others, 1990). Based on the poor quality of wood from samples 09a, 09b (tree NWJ09), 13a, and 30b, these samples were removed from the dataset. For the remaining 56 samples (representing 29 trees) we used the modified skeleton plot developed by Shroder (1978) to manage our visual-growth analysis (Fantucci, 1999), leading to an event-response graph focused on reaction-wood formation. A reaction-wood response was only recorded if 50 percent or more of the ring consisted of reaction-wood cells, which resulted in a distinctly darker coloration (Stoffel and Corona, 2014) (fig. 7).

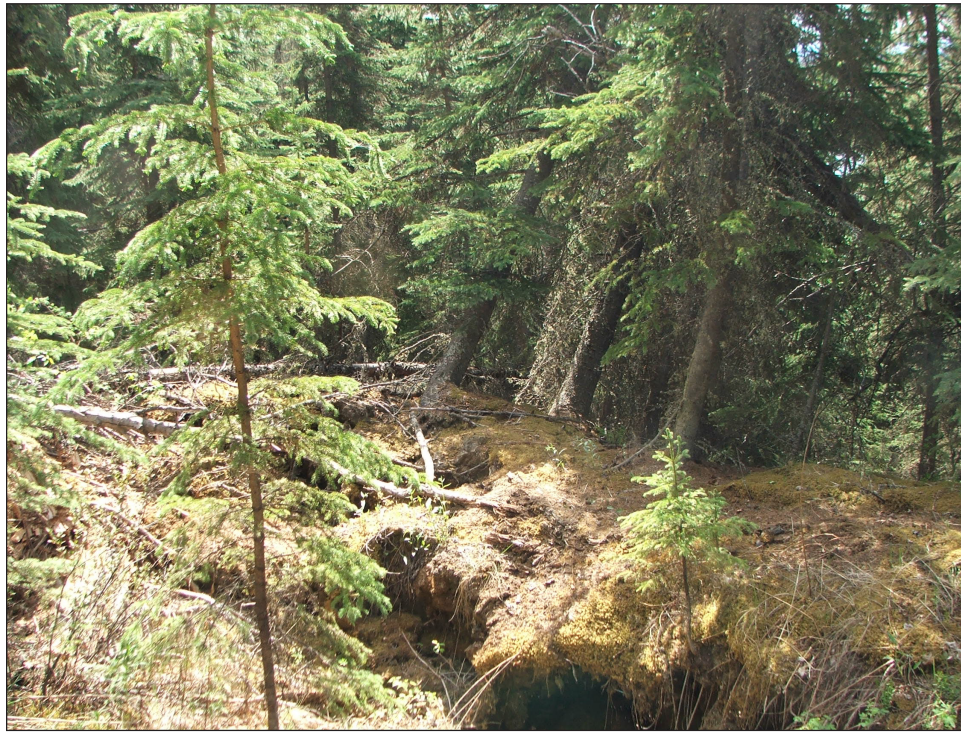
Figure 8. Multiple tilting black spruce trees atop a tensionally created mass-movement block; note the correcting posture of the larger tree at right center and the 2–5-year-old sapling, which is growing vertically (just right of the crack edge).

Onsite tree selection was preferential with only visibly tilted trees being sampled (fig. 8). Using a Swedish increment borer, we collected two samples each from 30 black spruce trees ($n=60$). One core was taken through the reaction wood (core a), or from the direction of tree tilt, and another was taken at a 90° angle to the first (core b), as suggested by Fantucci and McCord (1995) and Stoffel (written commun.). At each location we recorded

($\sigma = 8.1^\circ$) compared to 11.2° ($\sigma = 5.6^\circ$) in the eastern section ($n = 13$). Analysis of tilt angle and average thaw depth (as of June 1, 2014) results in a positive Spearman's correlation of greater tilt angles associated with deeper thaw depths (fig. 14). This relationship is likely the result of deeper thawing (or localized thaw sinks) leading to strength degradation, which can prime or exacerbate the failure of the landscape (McColl, 2015). This deeper thaw, combined with disrupted sediments from the tensional spread of the mass-movement event and subsequent tree tilting, sediment dilation, and/or tree throw, can lead to increased surface area for thawing processes, leading to a landscape highly susceptible to failure (Benninghoff, 1952; McColl, 2015) (fig. 8).

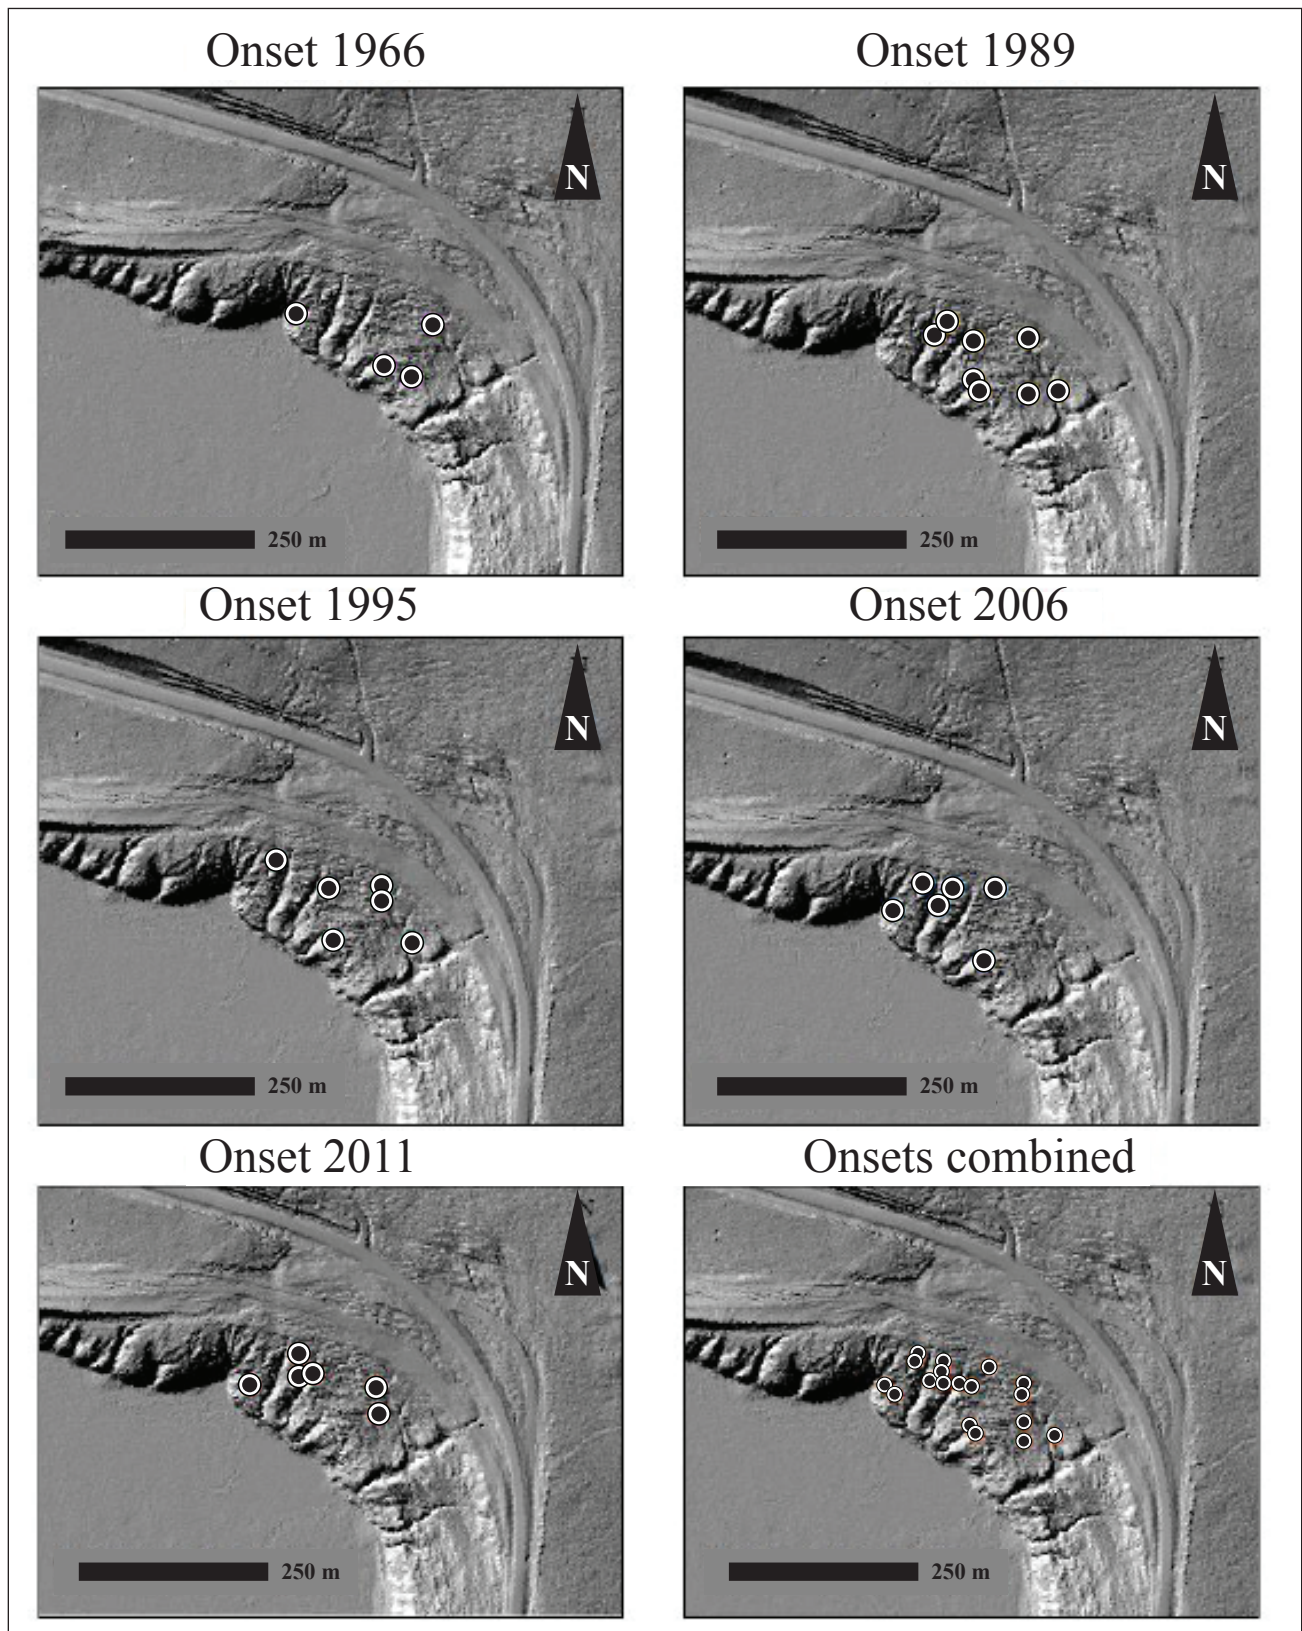
Figure 13. Series of onset maps, which represent dates of reaction wood occurrence in samples based on the working assumption that reaction wood occurs within a year of tilting event (for example, 1989 reaction wood recorded represents a 1988 tilting event). Note the overall distributions of onset are, more or less, site-wide.

Spatial evaluation of select reaction-wood years, based on hypothesized previous-year tilting (1966, 1989, 1995, 2006, and 2011; fig. 13), reveals site-wide disturbances during each event with a slight weighting to the western side of the site (> 55 percent; for example, 2006). Tilting angles were generally more severe in this western section ($n = 16$), with an average tilt angle of 13.4°

1987, with no recognized failure associated with the 1942 construction of the highway. In the late-growth or post-growth season of 1988–1989, a sitewide mass-movement event destabilized the site, with continued, significant (re)mobilizations inferred in 1994, 2005, 2010, and, by extension, 2013 (figs. 10 and 13).
