Report of Investigation 2021-1B Napakiak

COASTAL FLOOD IMPACT ASSESSMENTS FOR ALASKA COMMUNITIES—NAPAKIAK

Richard M. Buzard, Jacquelyn R. Overbeck, Katie Y. Miller, and Jessica E. Christian

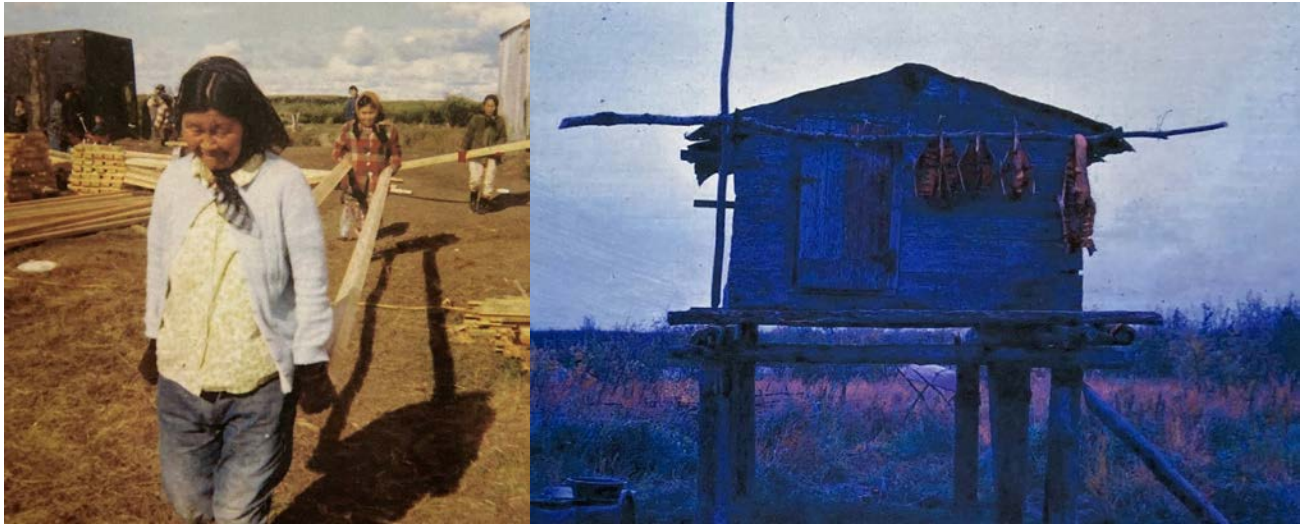
Figure 1. (Left) Napakiak women begin elevating homes in the 1960s. (Right) This 1960s Napakiak house is raised above frequent flood levels. This also prevented dogs from stealing fish. Photo: Community of Napakiak.

1960s, residents began elevating homes, but the effort took decades (fig. 1). Multiple floods in the 1970s inundated every home and required evacuations. By the late 1980s, Napakiak had raised most homes high enough to significantly reduce evacuations and flood impacts overall. This improvement was apparent in August 1990, when the flood of record only flooded 12 homes.

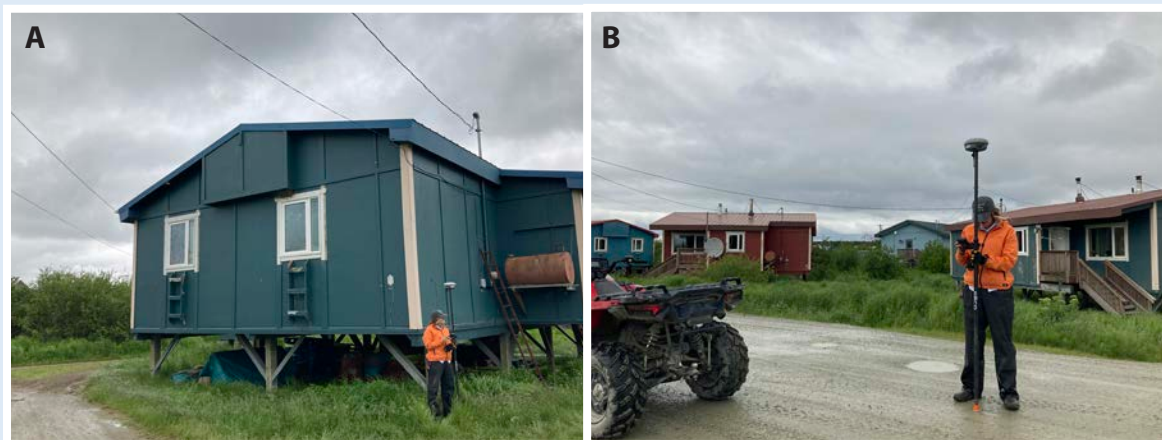
Figure 3. A. House where water reached 3 to 4 ft above ground in the August 17, 1990, flood. B. Road crown nearby that flooding has not exceeded.

Road crown	3	60.69528103	-161.98420244	6732547.913	337092.669	5.462	17.92
Water at doghouse	5	60.69598649	-161.98439789	6732626.917	337085.574	5.149	16.89

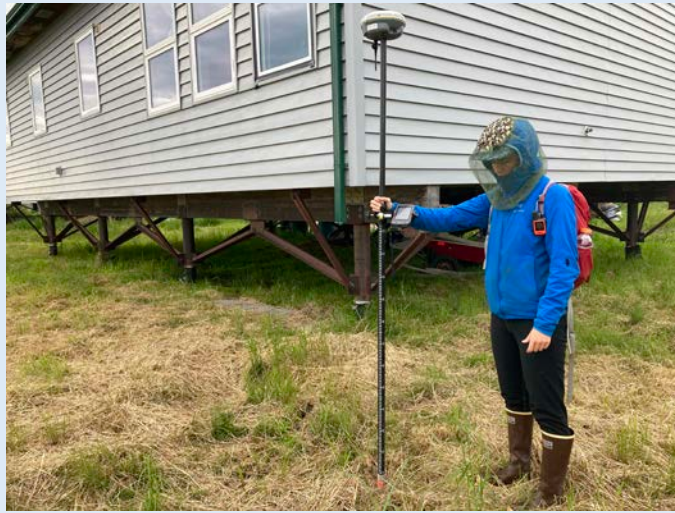
Figure 5. Elevation point at house where water reached 42 inches above ground in October 2012.

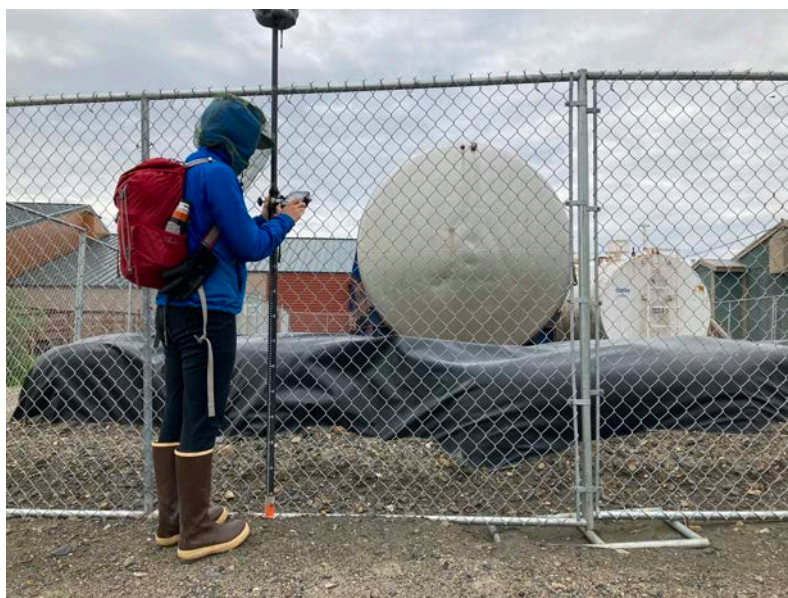
Figure B2. Height of berm surrounding school tank farm

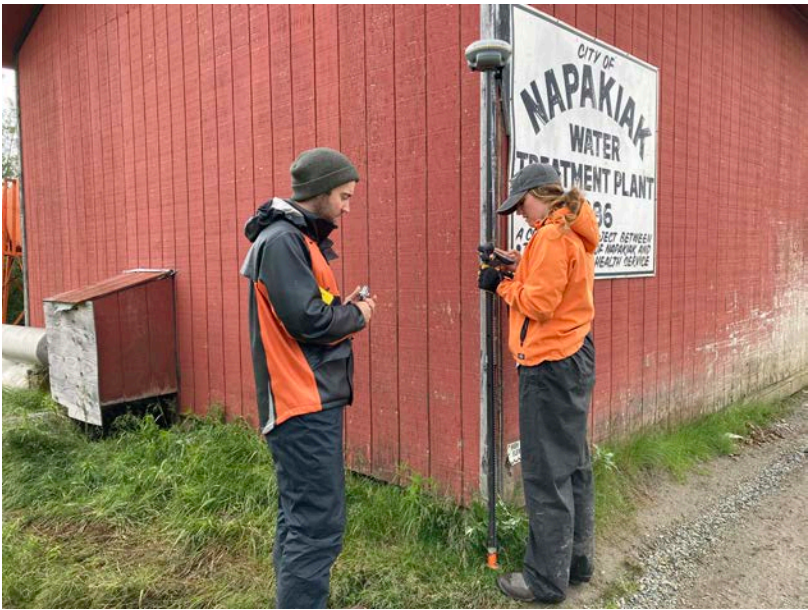
Figure B5. Water treatment plant.

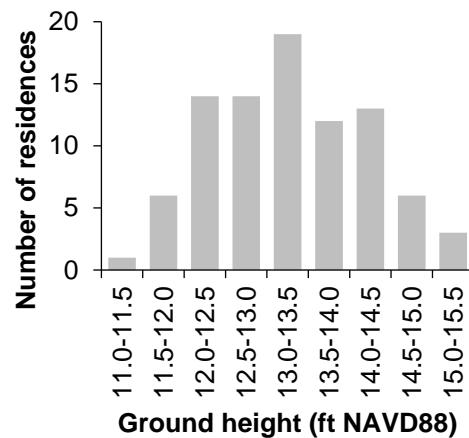
Figure B8. Histogram of the highest ground height below all residences. 90 percent of residences are on ground between 11.8 and 14.6 ft NAVD88, averaging 13.3 ft NAVD88.

The ground under the lowest 10 percent of homes is 12.0 ± 0.2 ft NAVD88. Water reaching and exceeding this height can potentially damage property on the ground.
