COASTAL FLOOD IMPACT ASSESSMENTS FOR ALASKA COMMUNITIES—GOLOVIN

Report of Investigation 2021-1E Golovin

Coastal Flood Impact Map Golovin, Alaska

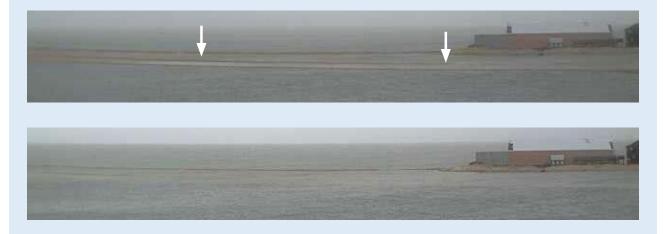
Figure 6. Photographs taken by FAA camera looking north over abandoned airstrip toward abandoned fish processing plant during the October 5, 2012, storm. The section of airstrip in view was completely visible in the top image (white arrows), but fully inundated in the lower image.

The only source that mentioned this storm was the 2013 Alaska State Hazard Mitigation Plan (Division of Homeland Security & Emergency Management, 2013). Images from the Golovin FAA camera downloaded at the time of the event showed the abandoned airstrip partially submerged at the peak of the flood (fig. 6). Using the DEM, this section of airstrip measured 3.7 ± 0.4 ft MHHW. It was estimated that water did not exceed 1 ft above the airstrip, thus this storm reached 4.2 ± 1.3 ft MHHW (table 12).
