## EROSION EXPOSURE ASSESSMENT—WALES

Report of Investigation 2021-3 Wales

## WALES EROSION EXPOSURE ASSESSMENT

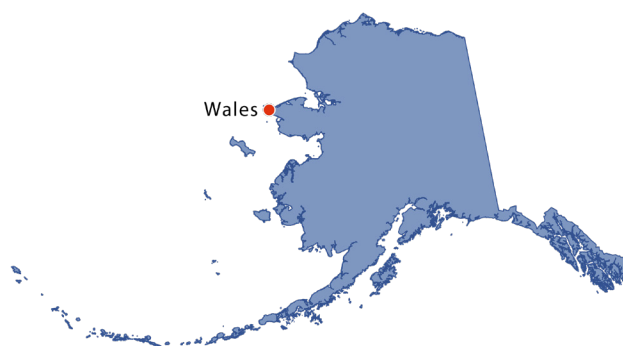
Wales is located on the western tip of the Seward Peninsula, between the Bering Strait and the Chukchi Sea. The community is constructed on vegetated and non-vegetated sand dunes. Erosion in Wales occurs in the form of scouring during high water events such as storm surge that redistribute sand across the beach and dunes (U.S. Army Corps of Engineers [USACE], 2007). This coastal erosion process is non-linear because dunes can recover after storm events; sand transported to the near-shore during a storm is redistributed to the beach,

and vegetation grows back. Dune and beach erosion disturb the land surface and can damage or undercut structures. Wales is exposed to erosion that may undermine infrastructure in the following 60 years, but we cannot forecast beach and dune erosion in Wales using the method by Buzard and others (2021) because the model depends on linear erosion of a clearly identified shoreline. The shorelines delineated from aerial imagery show erosion could be up to 5.6 feet per year, but there is great uncertainty because the shorelines are not easy to identify due to wave action (Overbeck and others, 2020).

Beach erosion and storm damage can be monitored with repeat beach elevation measurements using GPS or digital elevation models. DGGS extracted elevation profiles from a 2004 lidar digital elevation model at transects along the beach. DGGS also conducted GPS surveys in 2012 and 2015 along the same transects. At least three storms impacted Wales during this time: October 2004, September 2005, and November 2011 (USACE, 2009; Kawerak, 2012). Continued monitoring and a longer record of beach elevation can help identify whether and when infrastructure may become exposed to erosion.
