# COASTAL FLOOD IMPACT ASSESSMENT FOR KIPNUK, ALASKA

Report of Investigation 2024-5

State of Alaska  
Department of Natural Resources  
Division of Geological & Geophysical Surveys

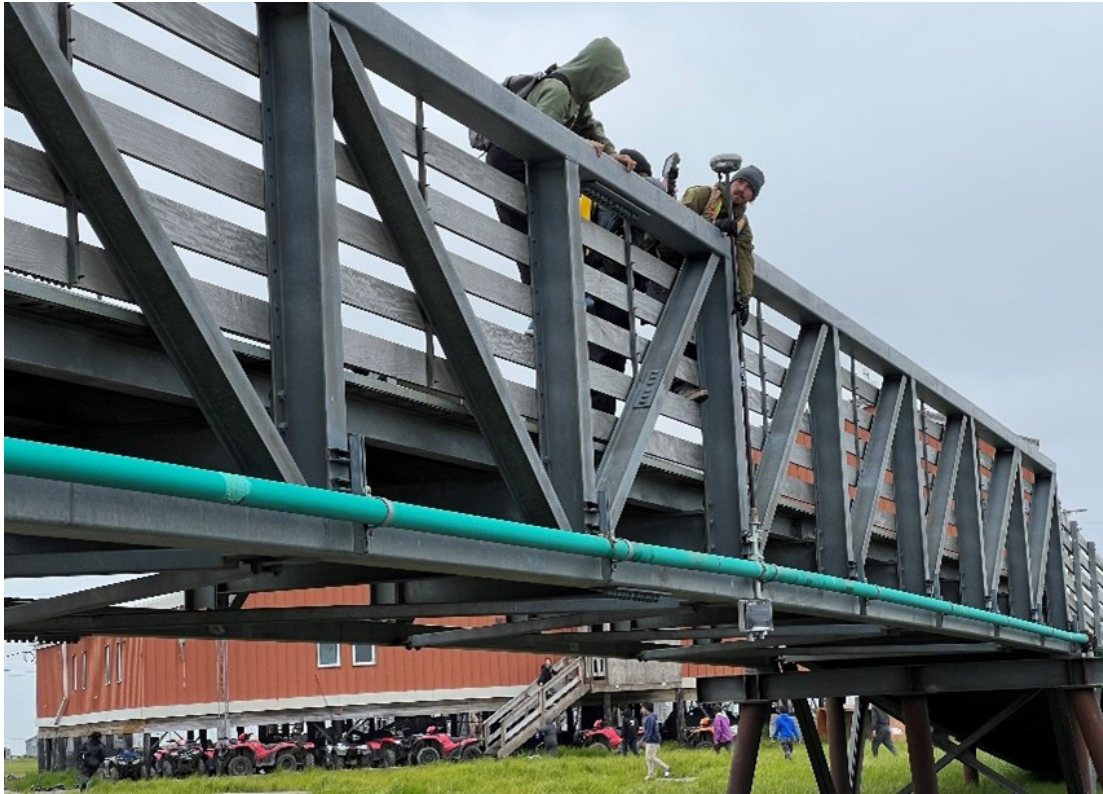
**Figure 2.** Stilltek iGage radar water level sensor installation in Kipnuk, Alaska, located on the south side of bridge.

DGGS installed a Stilltek iGage radar water level sensor in Kipnuk on June 21, 2022. This sensor was replaced on October 16, 2023, and is attached to the south side of the bridge connecting the central portion of the village to the northern portion of the village (figs. 1 and 2). Data collected

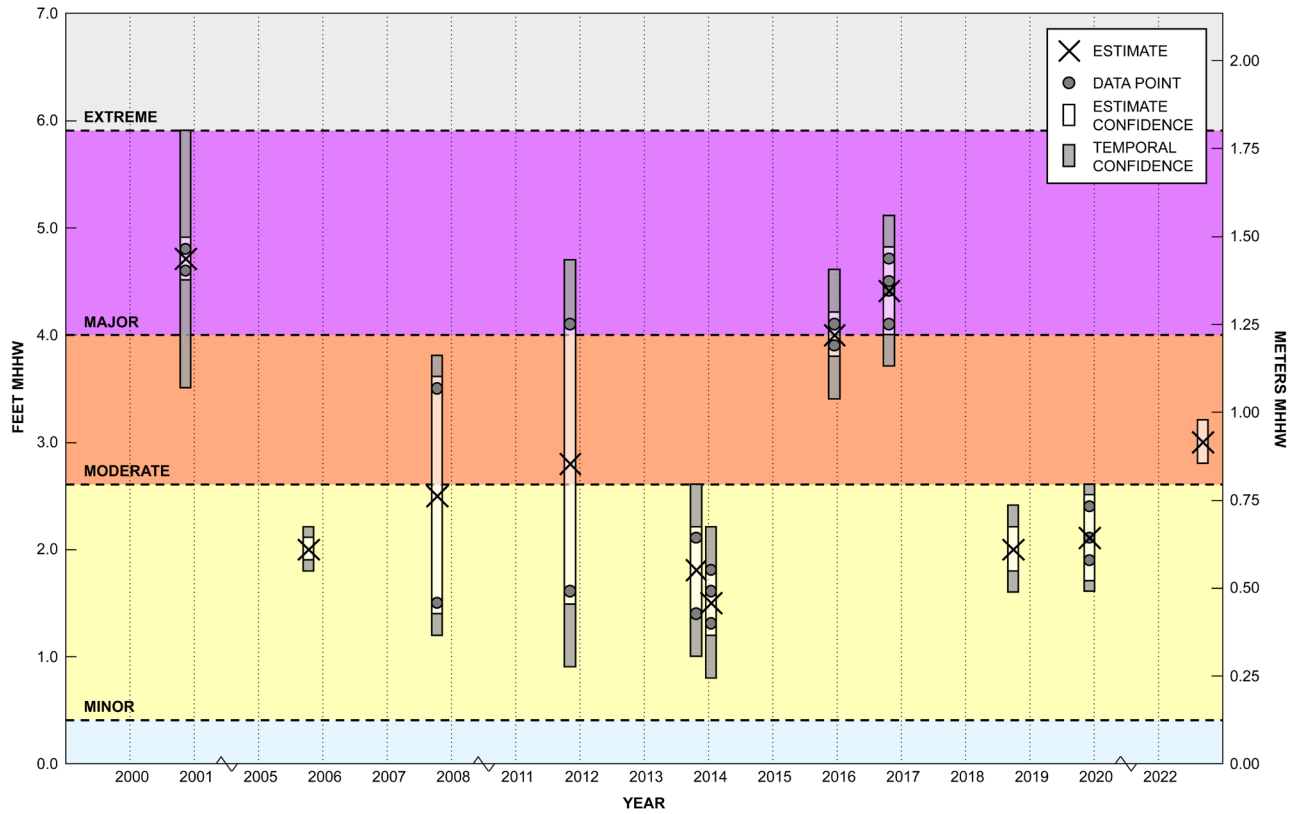
**Figure 3.** Timeline of estimated flood events and visual representation of flood height estimates and confidences for Kipnuk, Alaska. Flood height estimates were calculated following the methods developed by Horen, Poisson, and others (2024). Estimates are denoted by black X symbols. Data points used during estimation are represented by dark-gray dots. Estimate confidences are displayed as vertical, light-gray boxes. Temporal confidences are displayed as vertical, dark-gray boxes. Each flood height estimate may only be classified into a single flood impact category, but total estimate confidences may exceed the upper and lower bounds of the data used during estimation and may span more than one flood impact category.

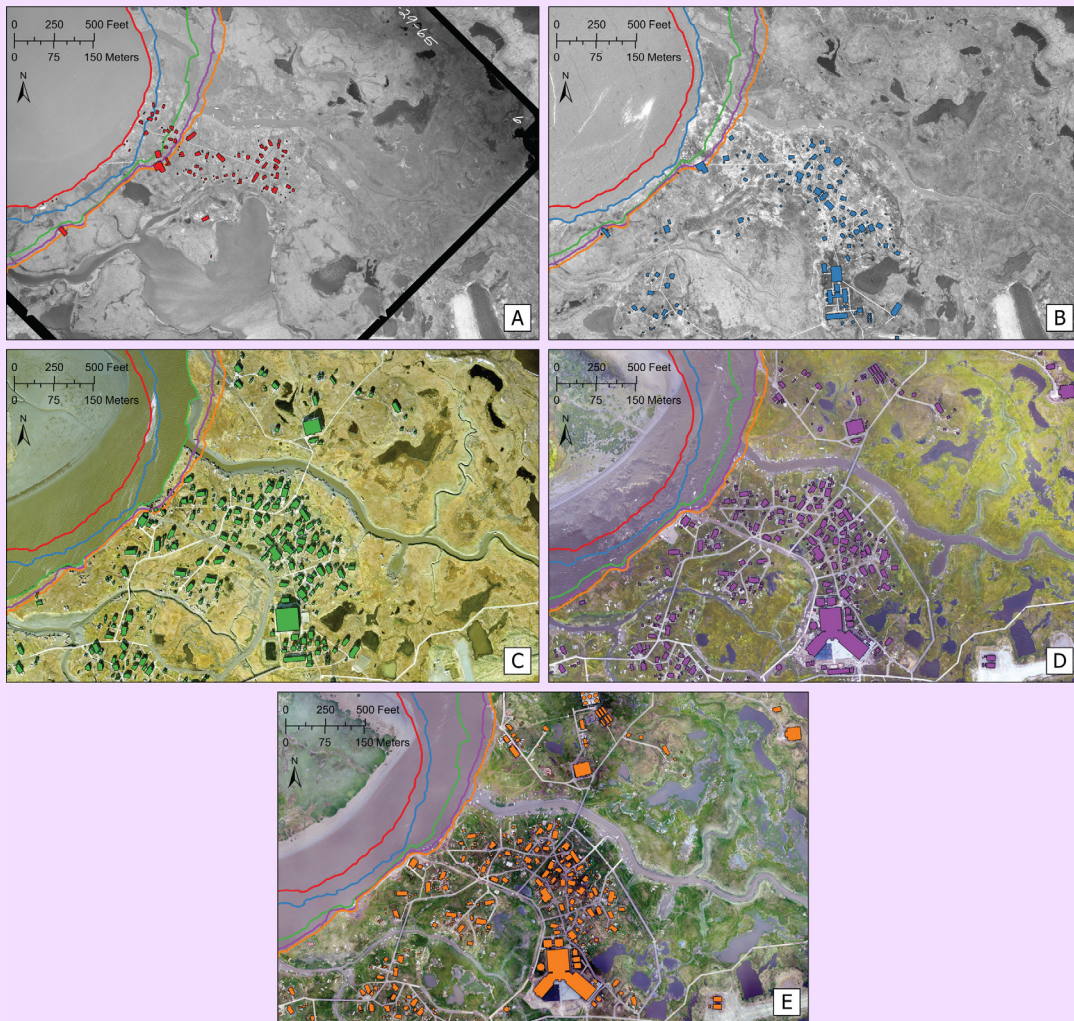
**Figure 5.** Aerial photographs and orthoimagery of Kipnuk, Alaska, comparing the riverbank and buildings from: (A) 1965, red; (B) 1975, blue; (C) 2004, green; (D) 2015, purple; (E) 2022, orange.

Due to the large gap in time between the 2004 and 2023 data, we investigated the likelihood that the heights of residential first floors may have changed between these observations. From a 2011 Hazard Impact Assessment (Golder Associates Inc., 2011) and a 2016 engineering study (AECOM, 2016), we are aware that differential movement (compressive sink and/or frost heave) is common for building foundations in Kipnuk, leading to frequent releveling. This information, along with a recommended minimum building height from the 2016 study (AECOM, 2016), would suggest that changes in first-floor heights should be expected over time in Kipnuk. From visual comparison of historical aerial photographs (1965 and 1975) and the three available orthoimages (2004, 2015, and 2022), we noted demolition, relocation, and new construction has been common in Kipnuk (fig. 5). Comparison of building footprints shows that four residences had been demolished between 2004 and 2022, with 40 residences built over this same timeframe, three of which had first-floor heights within the range of the six lowest residences surveyed in 2023. We were able to identify sufficient remnants of two of the demolished structures such that we were able to extract first-floor heights for these buildings from the 2022 DSM.

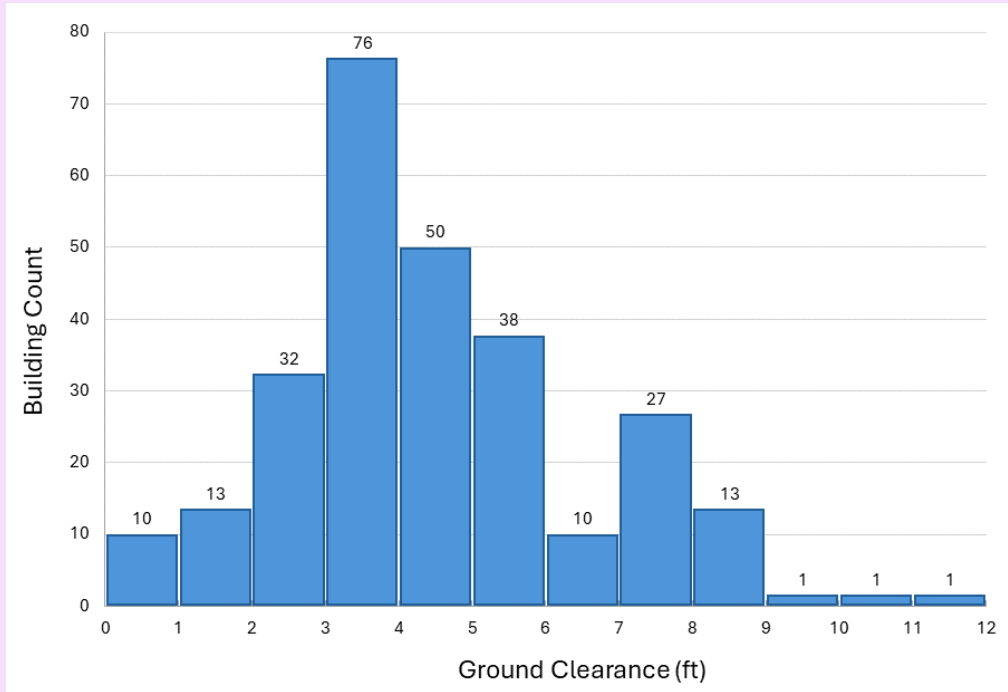
**Figure 6.** Histogram of ground clearances of buildings present in 2023 in Kipnuk, Alaska.

Using the 2021 DTM, we extracted the average ground heights beneath buildings and subtracted those results from the first-floor heights to calculate ground clearance information. The average building present in 2023 in Kipnuk was situated  $4.4 \pm 2.0$  ft ( $1.35 \pm 0.62$  m) above the ground (fig. 6). Among residential buildings, 16 had a ground clearance more than one standard deviation below the average, with the three lowest residential first-floor heights that existed in both 2004 and 2023 falling within this category. Based on our investigation, it is likely that the first-floor heights of the residences used in this estimate are reasonable representations of the conditions in 2004.

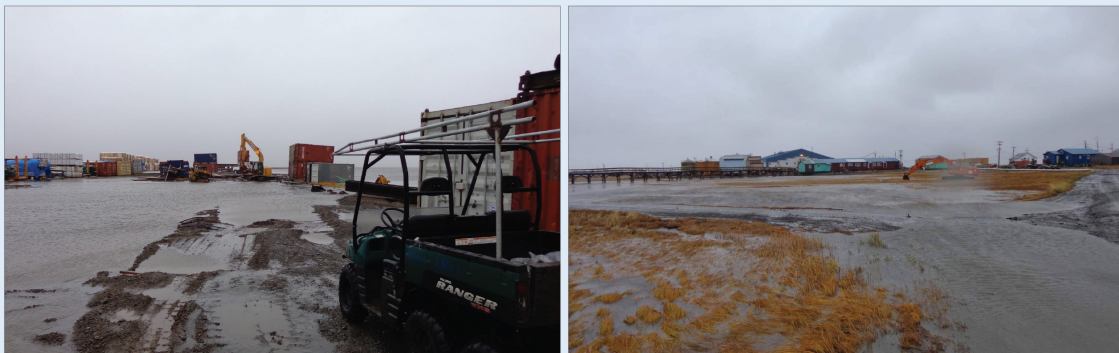
Figure 7. Photographic evidence of the flood event on October 5, 2012, in Kipnuk, Alaska.

Photographic evidence of this flood event was provided by a local resident. A lack of permanent reference points prevented the identification of the approximate location in the image on the left (fig. 7). The intersection depicted in the image on the right (fig. 7) was altered prior to the collection of the available DEM datasets.

Due to these limitations, a flood height could not be estimated for this event.

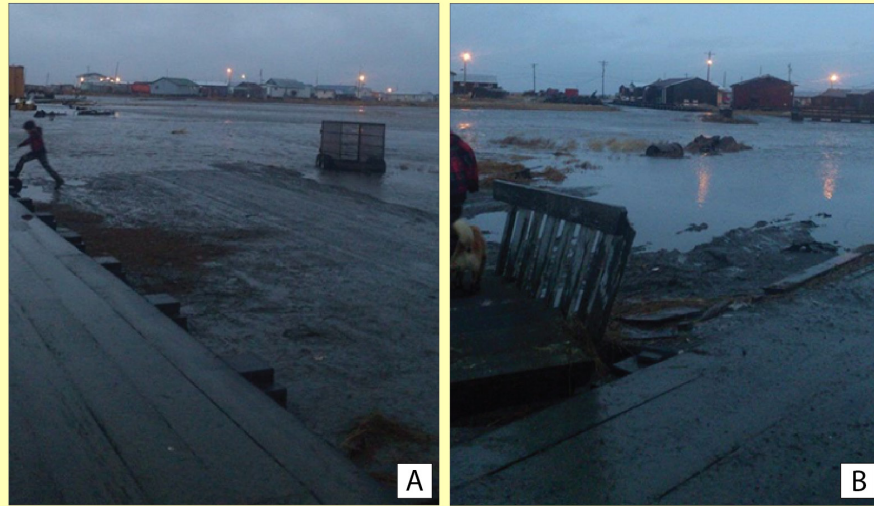
**Figure 8.** Photographic evidence of the flood event on October 25, 2013, in Kipnuk, Alaska. Water levels reached 1.4 ft (0.44 m) (A) and 2.1 ft (0.64 m) MHHW (B).

Two pieces of photographic evidence of this flood event were provided by a local resident. The presence of permanent infrastructure as reference points allowed us to identify the approximate location in both images.

To estimate this flood, we identified the buildings and boardwalks in the images, located these within the 2022 orthoimagery, and overlaid this orthoimagery with a simple bathtub model applied to the 2021 DTM to approximate the flood height depicted in the photographs (fig. 8). The images matched flood heights of 1.4 ft (0.44 m) and 2.1 ft (0.64 m) MHHW. An average of these two heights was calculated to estimate a flood height of 1.8 ft (0.54 m) MHHW.

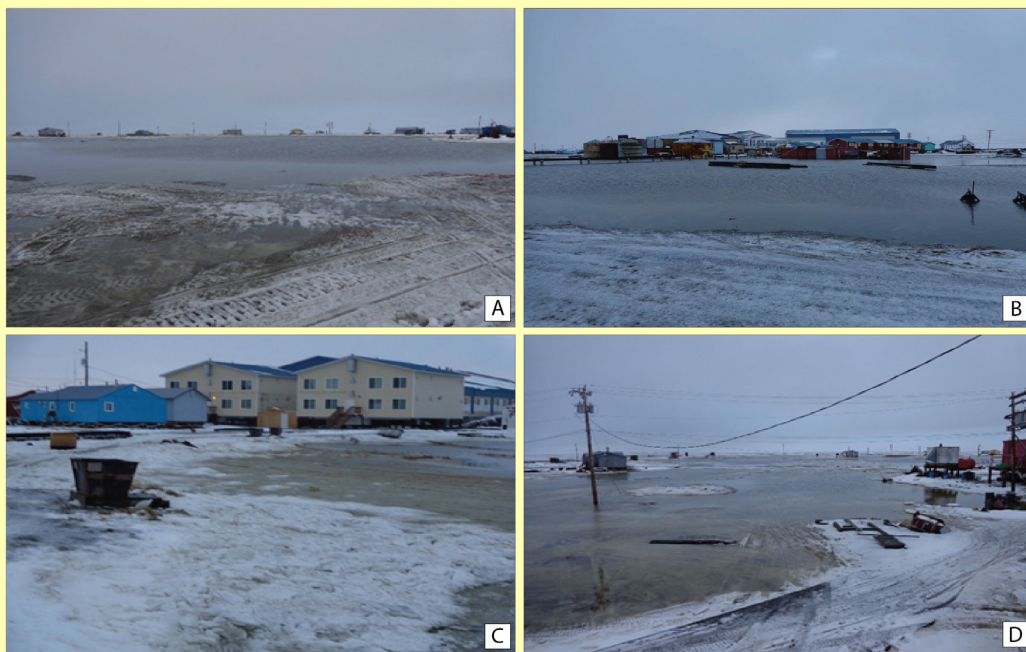
**Figure 9.** Photographic evidence of the flood event on January 22, 2014, in Kipnuk, Alaska. Water levels reached 1.3 ft (0.39 m) (A), 1.8 ft (0.54 m) (B), 1.3 ft (0.39 m) (C), and 1.6 ft (0.49 m) MHHW (D).

To estimate this flood, we identified the buildings and infrastructure in the images, located them within the 2022 orthoimagery, and overlaid this orthoimagery with a simple bathtub model applied to the 2021 DTM to approximate the flood height depicted in the photographs. The images matched flood heights of 1.3 ft (0.39 m), 1.8 ft (0.54 m), and 1.6 ft (0.49 m) MHHW (fig. 9). An average of these heights was calculated to estimate a flood height of 1.5 ft (0.45 m) MHHW.

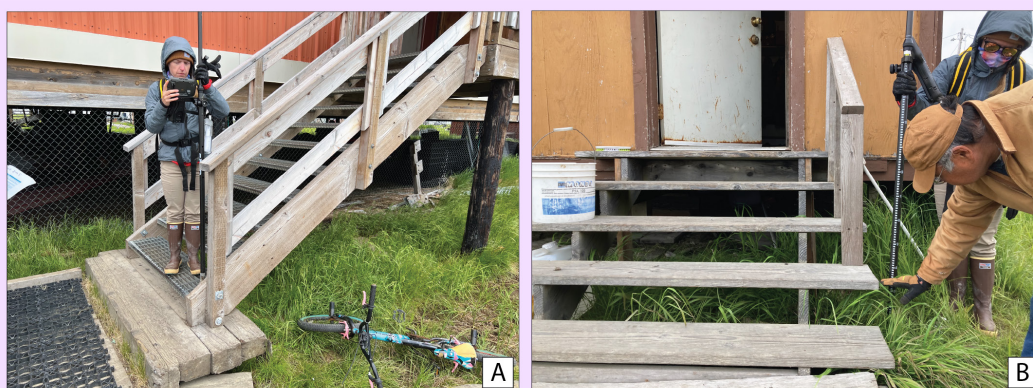
**Figure 10.** GNSS observations of reported heights of the flood event on December 14, 2015, in Kipnuk, Alaska. Water levels reached 3.9 ft (1.18 m) MHHW at the bottom stair of the council building (A) and 4.1 ft (1.25 m) MHHW at the second stair of Tim Swanson's home (B).

To estimate this flood, we collected 2 GNSS observations during the 2022 survey (table 9; app. B) based on community reports (fig. 10). An average of these heights was calculated to estimate a flood height of 4.0 ft (1.22 m) MHHW.

Though this flood estimate is categorized as major based on the average, the confidence range associated with this estimate could also potentially place this flood event within the moderate impact category.

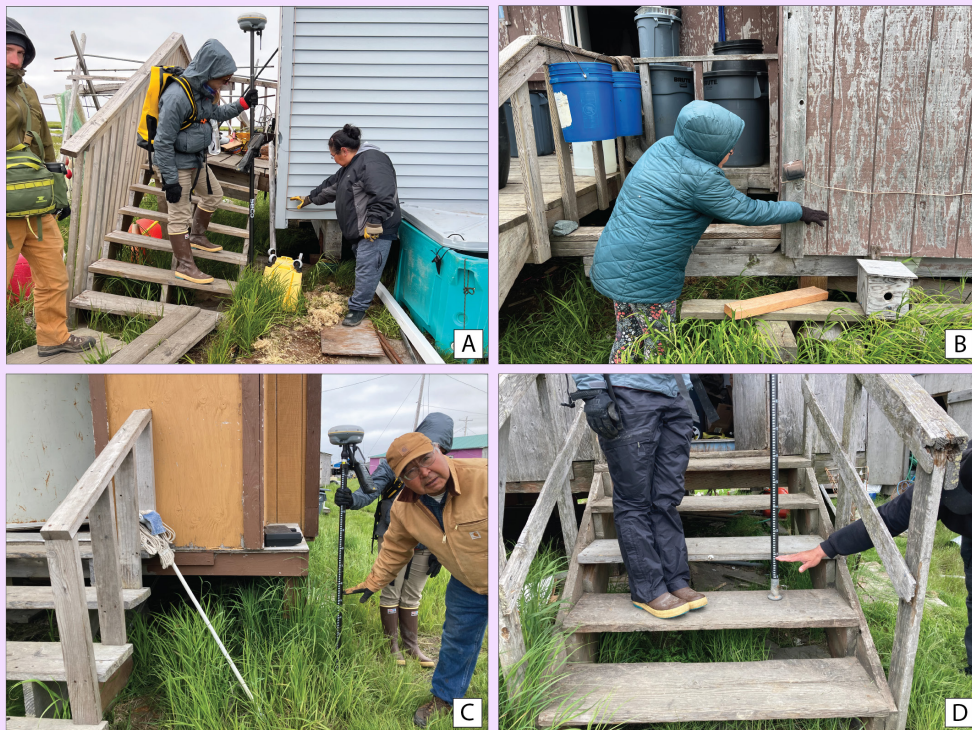
**Figure 12.** Examples of community members reporting the height of the flood event on October 28, 2016, in Kipnuk, Alaska.

To estimate this flood, we collected 8 GNSS observations (fig. 11; table 10; app. B) during the 2022 survey based on community reports (fig. 12). Two of these observations were not used during estimation as they were deemed to be outliers, diverging from the average by greater than one standard deviation. An average of these heights was calculated to estimate a flood height of 4.4 ft (1.35 m) MHHW.

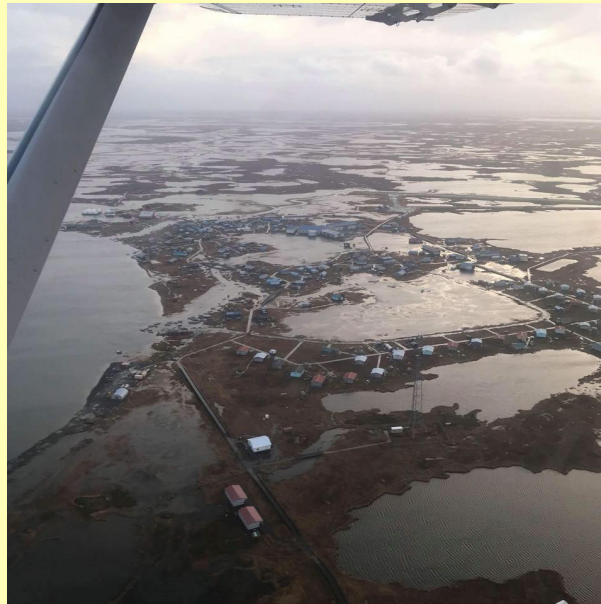
**Figure 13.** Photographic evidence of the flood event on October 4, 2018, in Kipnuk, Alaska.

An aerial photograph of flooding was posted to social media on October 4, 2018, showing flood water throughout Kipnuk (fig. 13).

To estimate this flood, we overlaid the 2022 orthoimagery with a simple bathtub model applied to the 2021 DTM to approximate the flood height depicted in the photograph.
