COASTAL FLOOD IMPACT ASSESSMENT FOR KWIGILLINGOK, ALASKA

Report of Investigation 2025-1

State of Alaska
Department of Natural Resources
Division of Geological & Geophysical Surveys

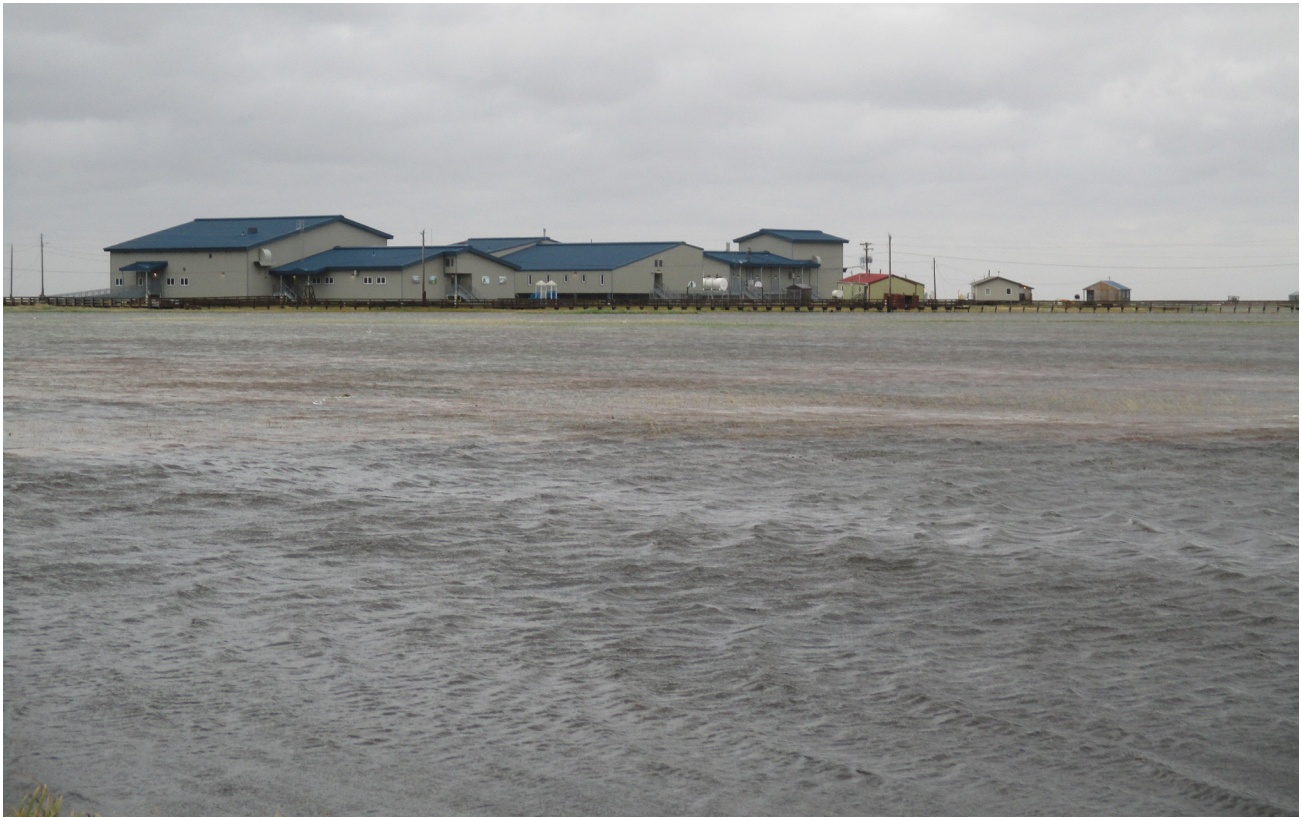
Flood waters inundating tundra near the school in Kwigillingok, Alaska, in September 2019. Photo: Lewis Amik III.

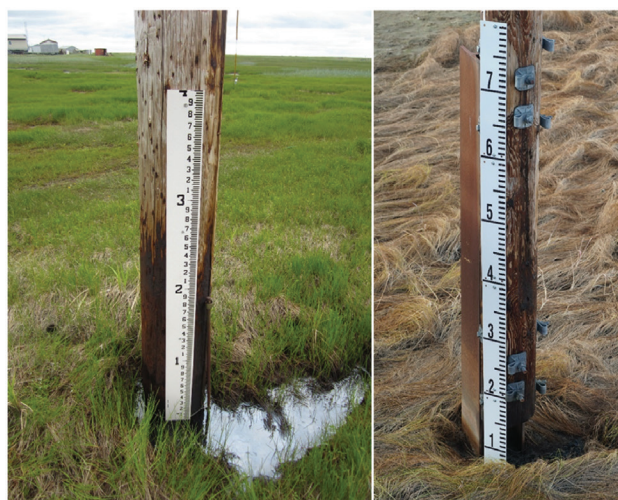
Figure 1. Flood staffs installed in Kwigillingok, Alaska, in 2017 (left) and 2023 (right).

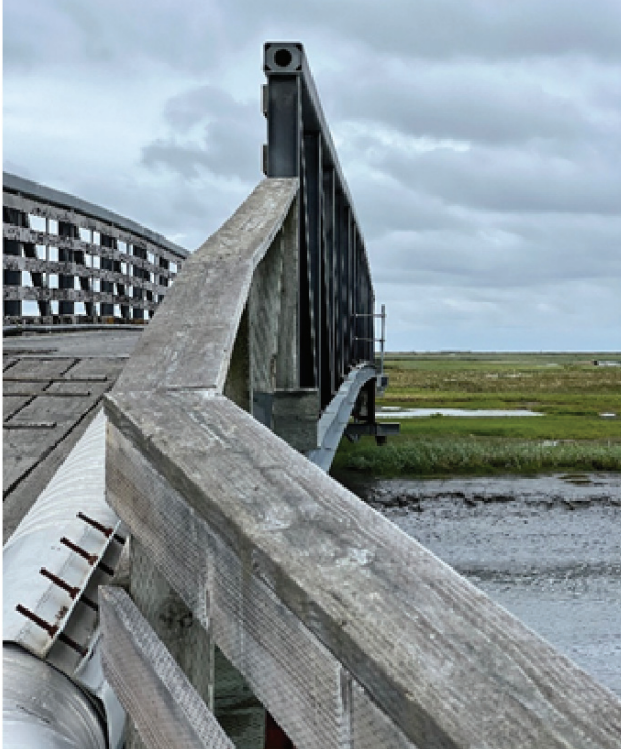
Figure 4. Stilltek iGage radar water level sensor installation in Kwigillingok, Alaska, located on the southeast side of the bridge.

DGGS installed a Stilltek iGage radar water level sensor in Kwigillingok in August 2021. This sensor was replaced on June 17, 2022, and again on October 17, 2023. The sensor is attached to the southeast side of the bridge north of the village (figs. 3 and 4). Data collected by this sensor, updated hourly, are available from Alaska Water Level Watch at portal.aaos.org/#meta-data/110872/station/data. The vertical accuracy of these data is ± 0.2 ft (0.07 m).

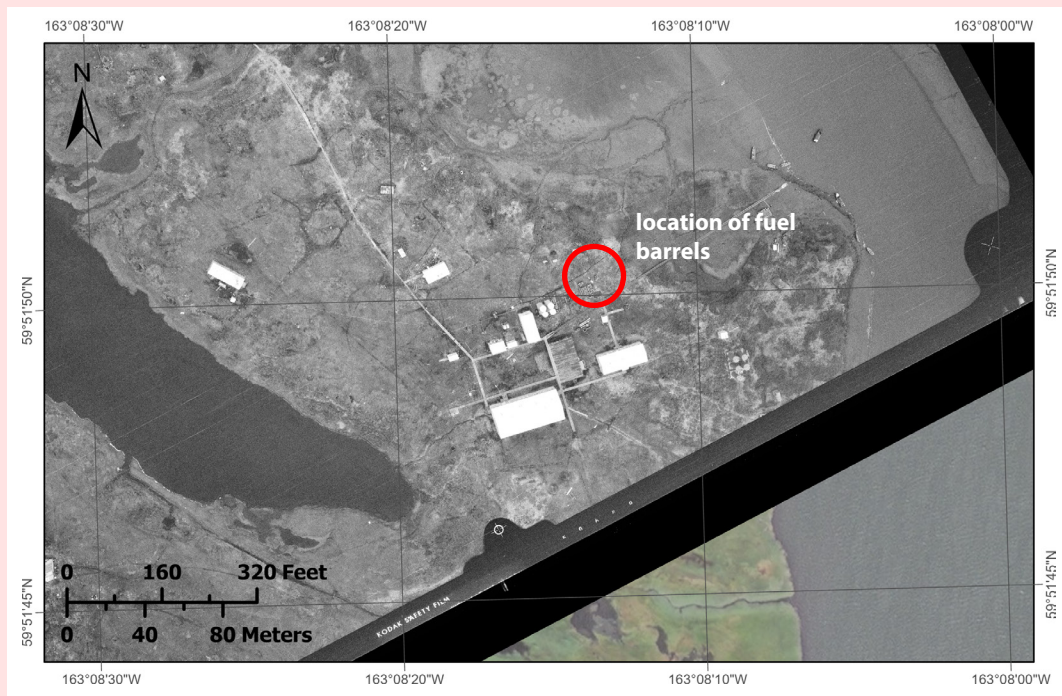
Figure 6. 1975 USGS aerial image of the BIA Fuel Storage area in Kwigillingok, Alaska. Red circle indicates location of fuel barrels.

The 2004 CPM (DCRA, 2004) has an area labeled “BIA Fuel Storage (not in use),” and the 1975 aerial image shows extensive barrel storage and tanks in this area (fig. 6).

To estimate this flood, we georeferenced the 1975 aerial image, identified the area indicated on the 2004 CPM, and overlayed the image with a simple bathtub model (Horen, Poisson, and others, 2024) applied to the 2021 DTM to approximate the height at which flood waters would reach the barrels shown in the aerial image.

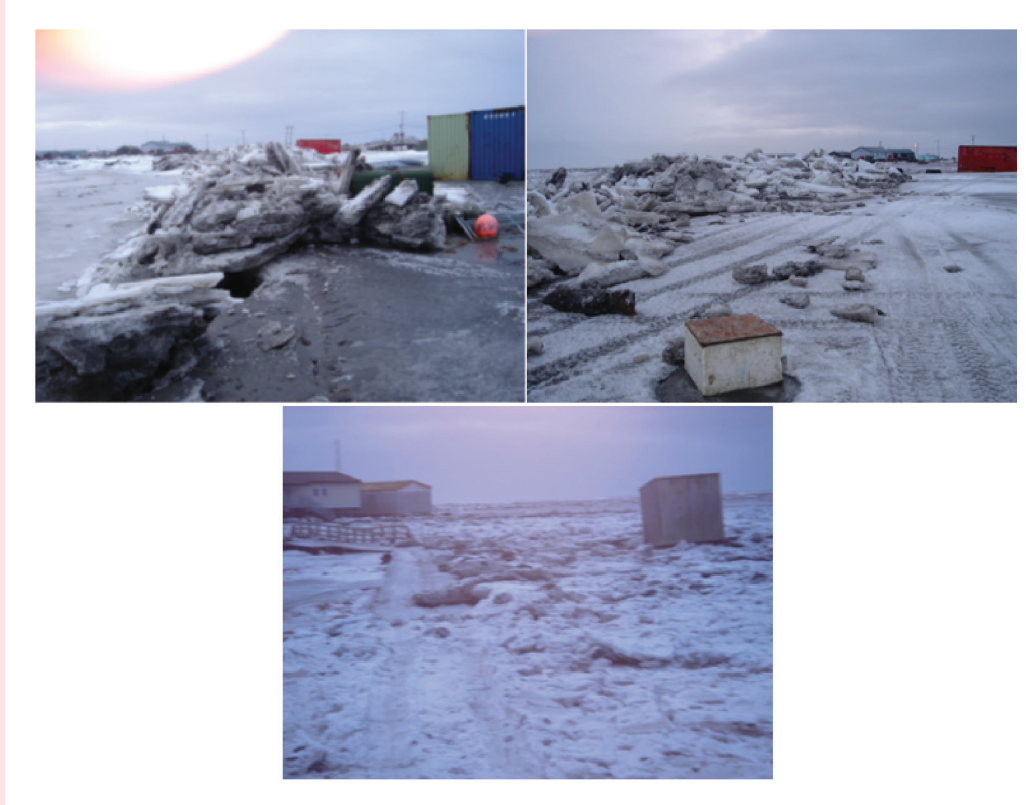
Figure 7. Flooding and venuq at the barge landing (top-left and top-right) and boardwalk near the armory (bottom) in the winter of 2007 in Kwigillingok, Alaska (Village of Kwigillingok, 2015).

would overtop the riverbank at 1.5 ft (0.46 m) MHHW and the extent of the ice debris at 1.8 ft (0.56 m) MHHW, the former of which formed the lower limit of the estimate range. We modeled a minimum and maximum likely water height at the boardwalk location, 2.2 ft (0.67 m) and 2.3 ft (0.69 m) MHHW, respectively, the latter of which formed the upper limit of the estimate range. An average of these four heights was calculated to estimate a flood height of 2.0 ft (0.60 m) MHHW.

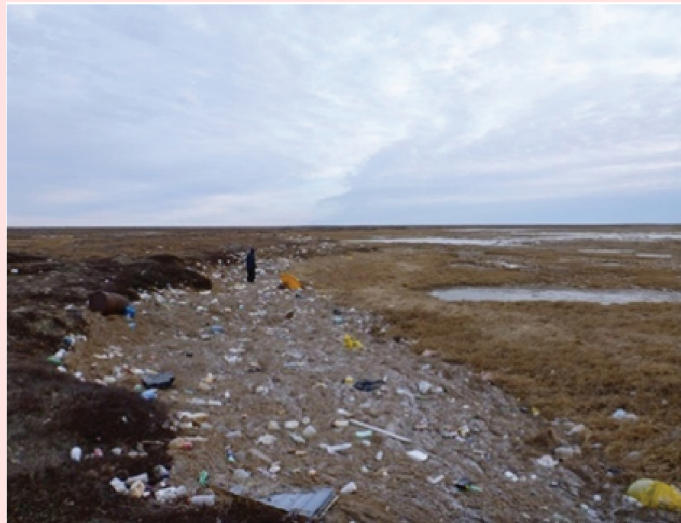
Figure 8. Landfill flooding in October 2012 in Kwigillingok, Alaska, (credit: Ryan Maroney [Village of Kwigillingok, 2015]).

The Village of Kwigillingok (2015) HMP states “community residents reported a significant flood event in 2012” with “damage to bridges and other structures.” Additionally, the HMP included a photograph (fig. 8) and description of flooding affecting “the landfill across the river from the village” (Village of Kwigillingok, 2015). A Coastal Impact Assistance Program, Waste Erosion Assessment and Review report from the Alaska Department of Environmental Conservation (ADEC) noted “during the storm of October 2012, the landfill flooded to depths of two feet, washing away much of the waste as far as a mile inland of the landfill” (ADEC, 2012).

To estimate this flood, we identified the landfill in the 2022 orthoimagery and overlaid this orthoimagery with a simple bathtub model applied to the 2022 DSM because this was the only DEM with coverage of the landfill area. The landfill begins to flood at 0.6 ft (0.17 m) MHHW, and we added 2.0 ft (0.61 m) to this height.

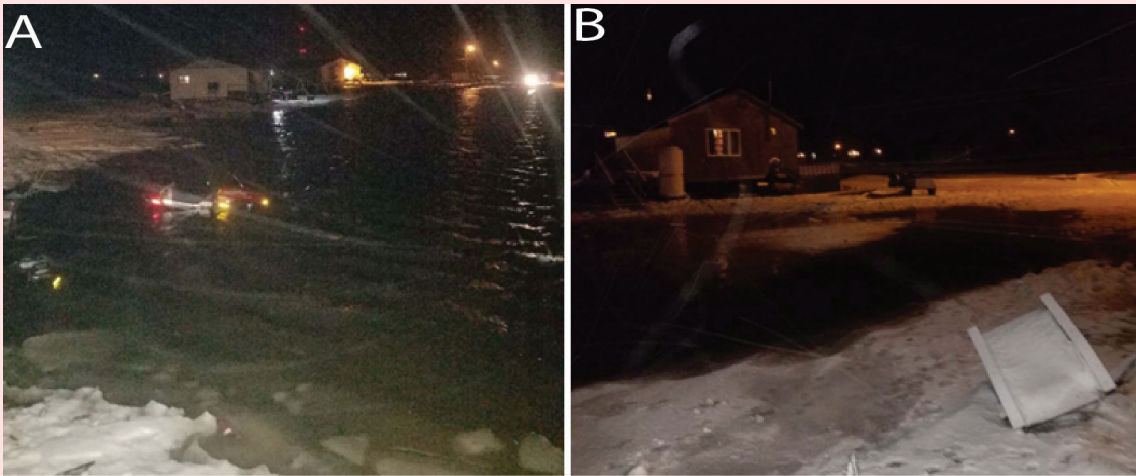
Figure 10. Photographs of flooding taken approximately 330 ft (100 m) southwest of Naruyatalik subdivision in Kwigillingok, Alaska, on December 14 at 11:00 PM (A) facing south toward store and (B) facing north (credit: Lewis Amik III [AIJ, 2017]).

To estimate this flood, we identified the buildings and boardwalks in the photographs, located these within the 2015 orthoimagery, and overlayed this orthoimagery with a simple bathtub model applied to the 2015 DSM to approximate the height flood waters reached. An average of these six heights (table 7) was calculated to estimate a flood height of 2.2 ft (0.67 m) MHHW.

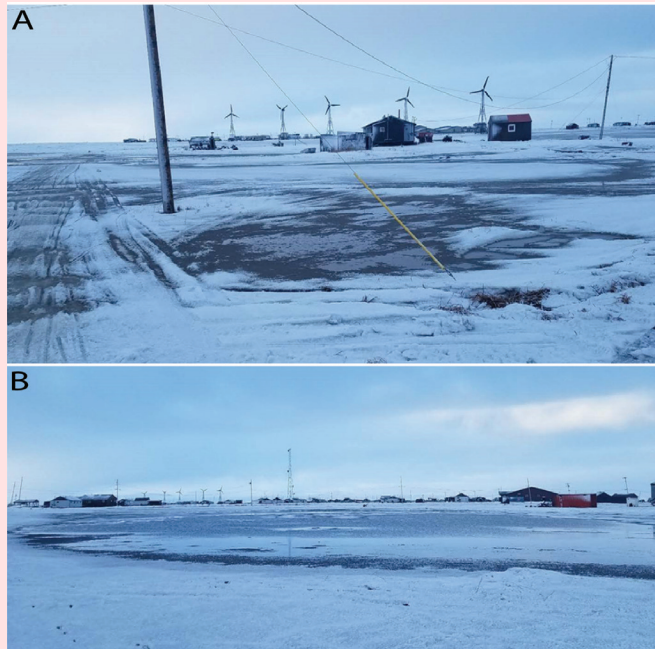
Figure 11. Photographs of flooding in Kwigillingok, Alaska, on December 15, 2017, taken around 3:00 PM (A) approximately 300 ft (90 m) northeast of the police office facing north and (B) approximately 500 ft (150 m) south of National Guard building, facing north-northwest (credit: Lewis Amik III [AIJ, 2017]).

According to the December 2017 Storm and Weather Narratives report from AIJ (2017), “flooding began at 11pm on Dec. 14 and lasted until Dec. 16 at 1:30pm, when the tide went down. The water came up fast, and as a result, residents could not access the downtown area through the trails. The boardwalk system was accessible in some areas.” The narrative report (AIJ, 2017) and the Kwigillingok Community Profile report from AIJ (2019a) reported no damage associated with this event. Lewis Amik III and Ephraim Andrew provided photographs of the flooding to AIJ (2017) (figs. 10–12).

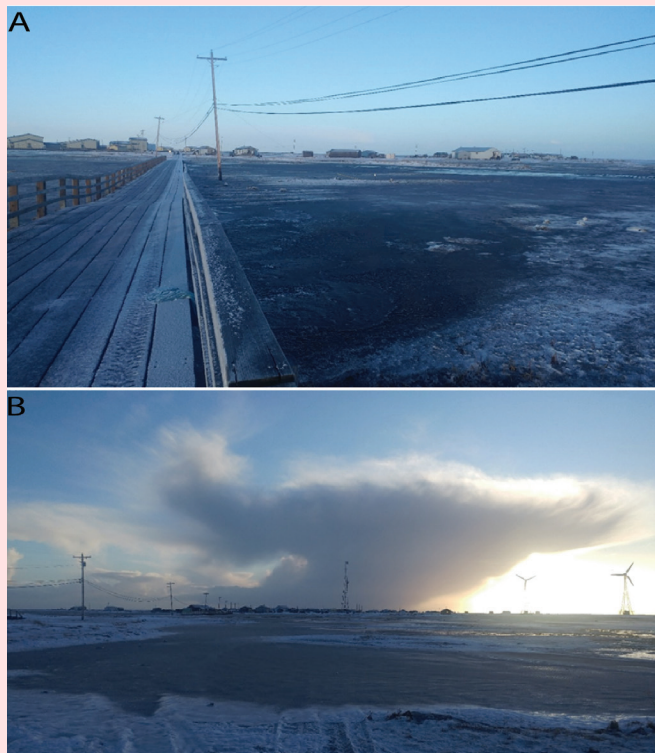
Figure 12. Photographs of flooding in Kwigillingok, Alaska, on December 15, 2017, taken around 3:00 PM (A) approximately 985 ft (300 m) south of store, facing north-northwest and (B) approximately 115 ft (35 m) south of school, facing south-southwest (credit: Ephraim Andrew [AIJ, 2017]).

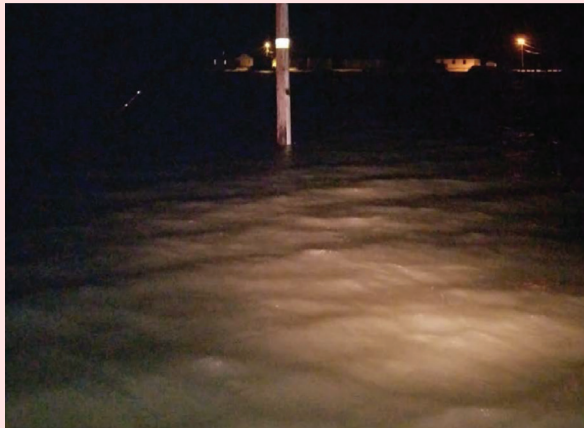
Figure 13 (above). Photograph of flood staff at the peak of high tide on January 14, 2018, in Kwigillingok, Alaska, reading a water level of 2.6 ft (0.78 m) MHHW (credit: Lewis Amik III [AIJ, 2018a]).

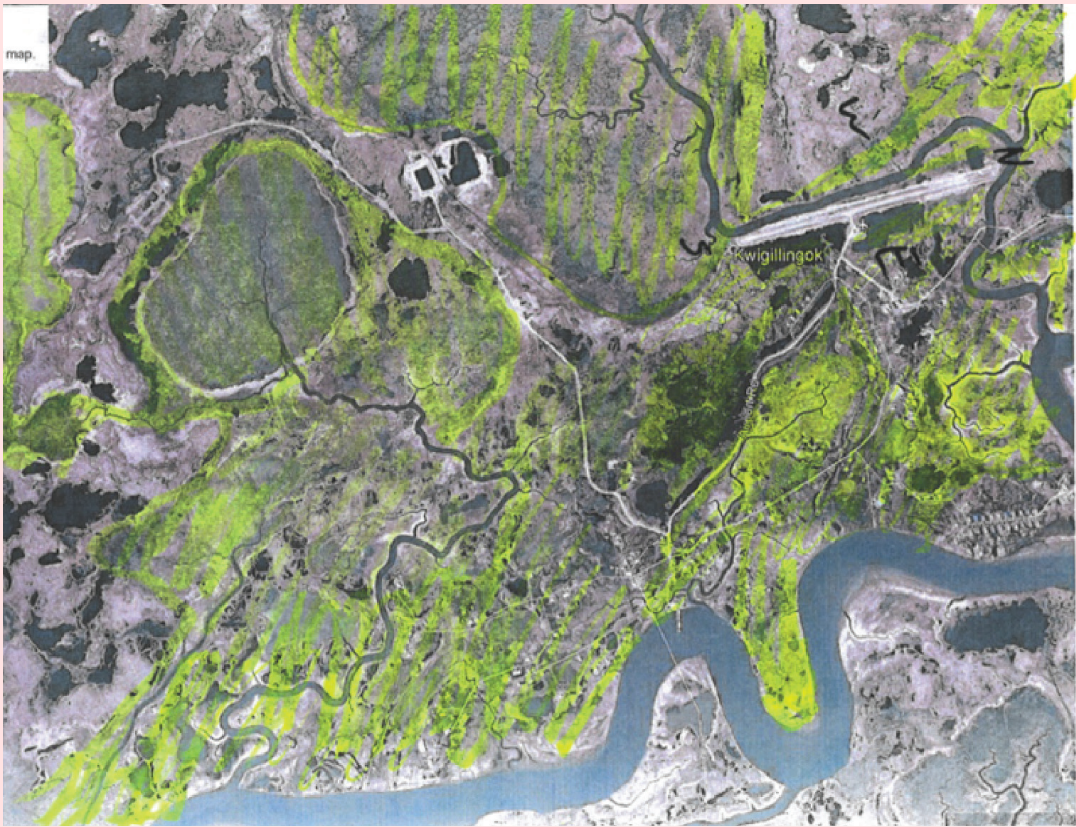
Figure 15. Map with areas of flooding highlighted in yellow corresponding to the flood event on October 4, 2018, in Kwigillingok, Alaska (credit: Gavin Phillip [AIJ, 2018b]).

To estimate this flood, we overlaid the 2015 orthoimagery with a simple bathtub model applied to the 2021 DTM to approximate the extents depicted in the map provided to AIJ (2018b; fig. 15). We found the highlighted areas matched a flood height between 1.7 and 2.3 ft (0.51 and 0.71 m) MHHW. An average of these two heights was calculated to estimate a flood height of 2.0 ft (0.61 m) MHHW.

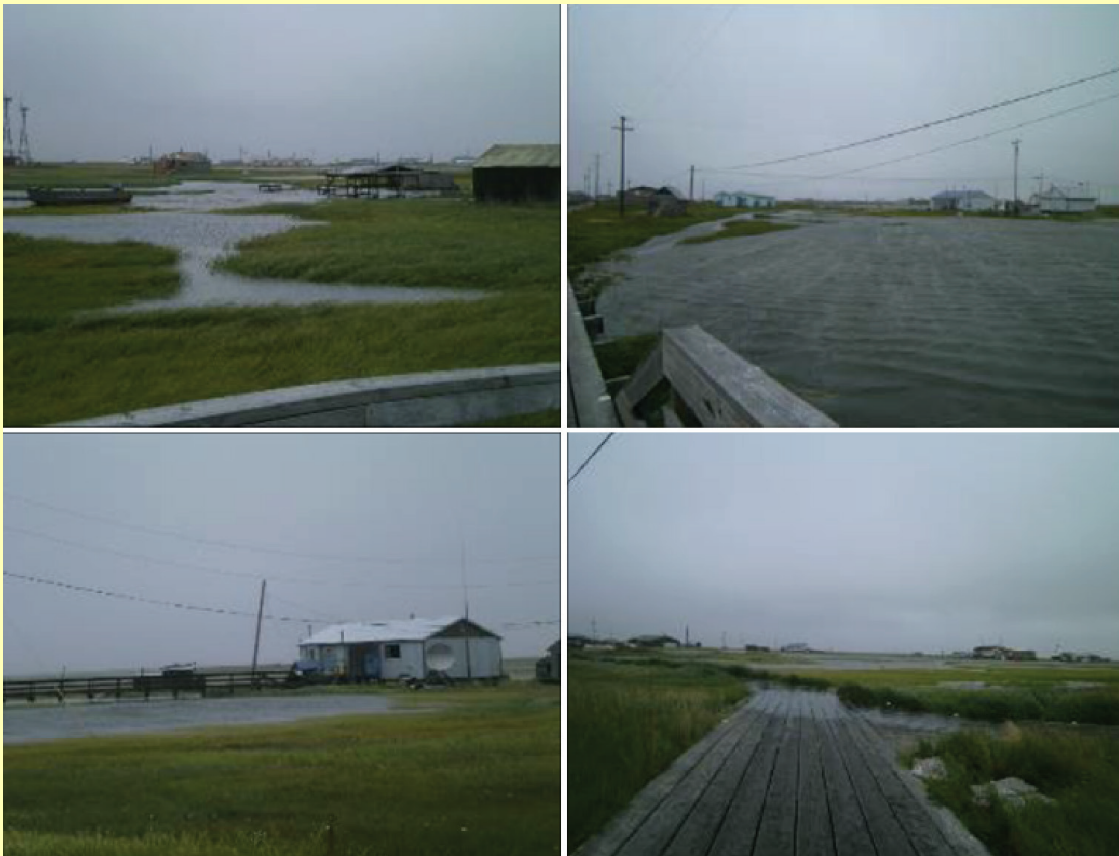
Figure 16. Photographs of flooding on August 2, 2019, in Kwigillingok, Alaska (credit: Darryl John [AIJ, 2019b]).

To estimate this flood, we identified the riverbank height—0.0 ft (0.00 m) MHHW—and added the average of the reported heights above this feature, 1 and 2 ft (0.30 and 0.61 m), for a flood estimate of 1.5 ft (0.46 m) MHHW. To corroborate this finding, we identified the buildings and boardwalks in the photographs provided to AIJ (2019b; fig. 16), located these within the 2022 orthoimagery, and overlaid this orthoimagery with a simple bathtub model applied to the 2021 DTM to approximate the heights of flood water depicted in the photographs.

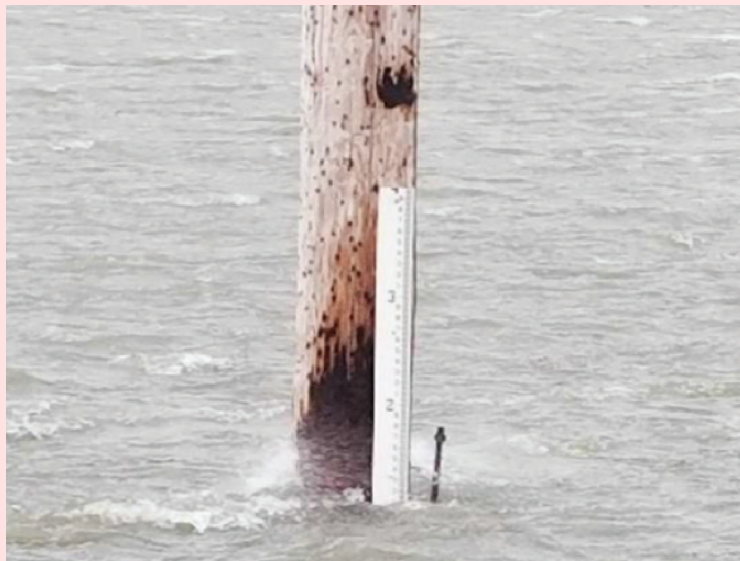
Figure 17. Photograph of flooding in relation to the 2017 flood staff, taken on September 11, 2019, in Kwigillingok, Alaska (credit: Lewis Amik III [AIJ, 2019c]).

To estimate this flood, we identified the flood staff height reading depicted in the photograph—1.1 ft (0.34 m)—and added this to the height of the flood staff—1.0 ft (0.30 m) MHHW—for a flood estimate of 2.1 ft (0.63 m) MHHW. To corroborate this finding, we identified the buildings and boardwalks in the photographs provided to AIJ (2019c; fig. 18), located these within the 2022 orthoimagery, and overlaid this orthoimagery with a simple bathtub model applied to the 2021 DTM to approximate the heights of flood water depicted in the photographs. The modeled extents of flooding are consistent with the areas indicated in the photographs provided to AIJ (2019c).

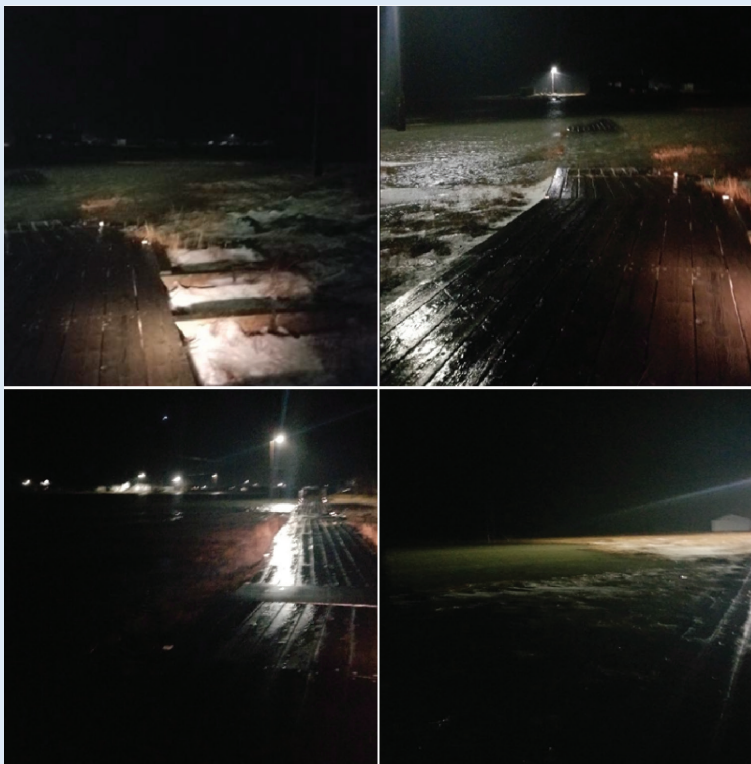
Figure 19. Photographs of flooding on November 26, 2019, in Kwigillingok, Alaska.

The AIJ (2019d) November 2019 Storm and Weather Narratives did not report any specifics regarding flood height or infrastructure impacts during an event on November 26. Photographs of flooding during the event were provided to AIJ by Lewis Amik III (AIJ, 2019d; fig. 19), however, we were unable to locate the areas depicted because the photographs were taken at night, did not contain identifiable infrastructure, and were not thoroughly described in the report.

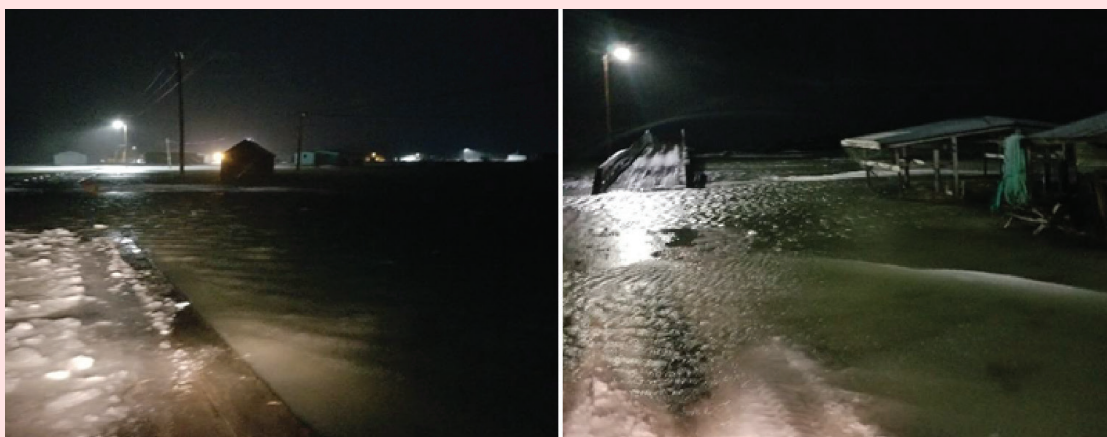
Figure 20. Photographs of flooding on December 9, 2019, in Kwigillingok, Alaska (AIJ, 2019e).

To estimate this flood, we identified the locations from which the photographs were taken and the infrastructure depicted, located these within the 2022 orthoimagery, and overlaid this orthoimagery with simple bathtub models applied to the 2021 DTM and the 2022 DSM to approximate the height of the flood waters depicted. We applied the simple bathtub model to the 2022 DSM for the photographs taken on December 9 (fig. 20) because of the prominence of the boardwalks and bridges, which would be absent from the 2021 DTM. These photographs matched flood heights of 2.3 ft (0.71 m) and 2.7 ft (0.81 m) MHHW. We applied the simple bathtub model to the 2021 DTM for the photographs taken on December 10 (fig. 21) because of the prominence of the bare ground along the banks of the stream, which would be obscured by vegetation in the 2022 DSM. These photographs matched flood heights of 1.0 ft (0.31 m) and 1.5 ft (0.46 m) MHHW, significantly lower than the results from the photographs taken the previous night.

Due to the large disparity in the heights depicted, we chose to base our estimate on only the heights derived from the photographs taken on the night of December 9. An average of these two heights was calculated to estimate a flood height of 2.5 ft (0.76 m) MHHW.

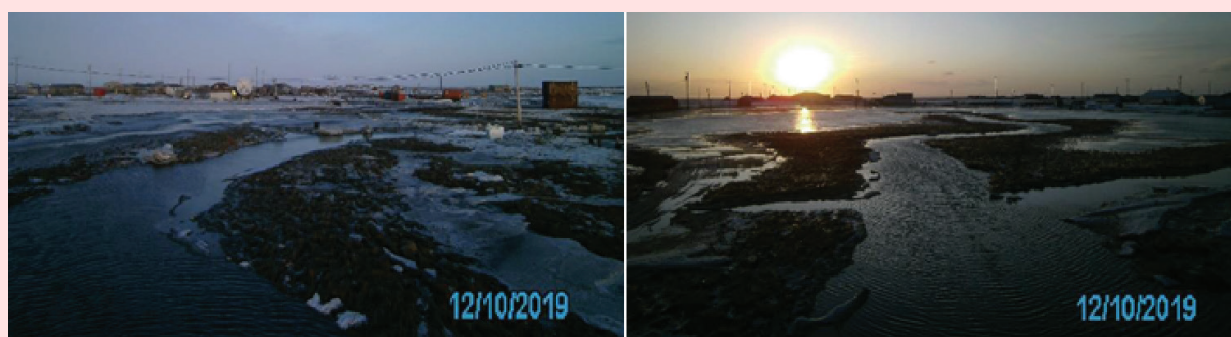
Figure 21. Photographs of flooding on December 10, 2019, in Kwigillingok, Alaska (AIJ, 2019e).

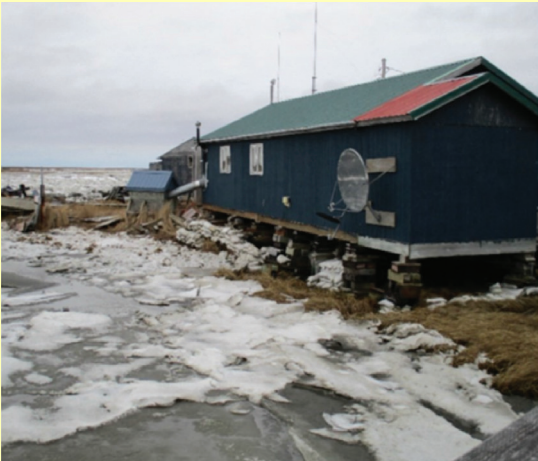
Figure 22. Photograph of ice debris and flooding on November 20, 2020, in Kwigillingok, Alaska (credit: Gary Evon [AIJ, 2021]).

To estimate this flood, we identified the building depicted in one of the photographs included in the AIJ (2021) report (fig. 22), located it within the 2015 orthoimagery because the structure appears to have been moved sometime between June 2021 and June 2022, then overlaid this orthoimagery with a simple bathtub model applied to the 2021 DTM to approximate the height of the flood water depicted.
