COASTAL FLOOD IMPACT ASSESSMENT FOR DEERING, ALASKA

Report of Investigation 2025-3

State of Alaska
Department of Natural Resources
Division of Geological & Geophysical Surveys

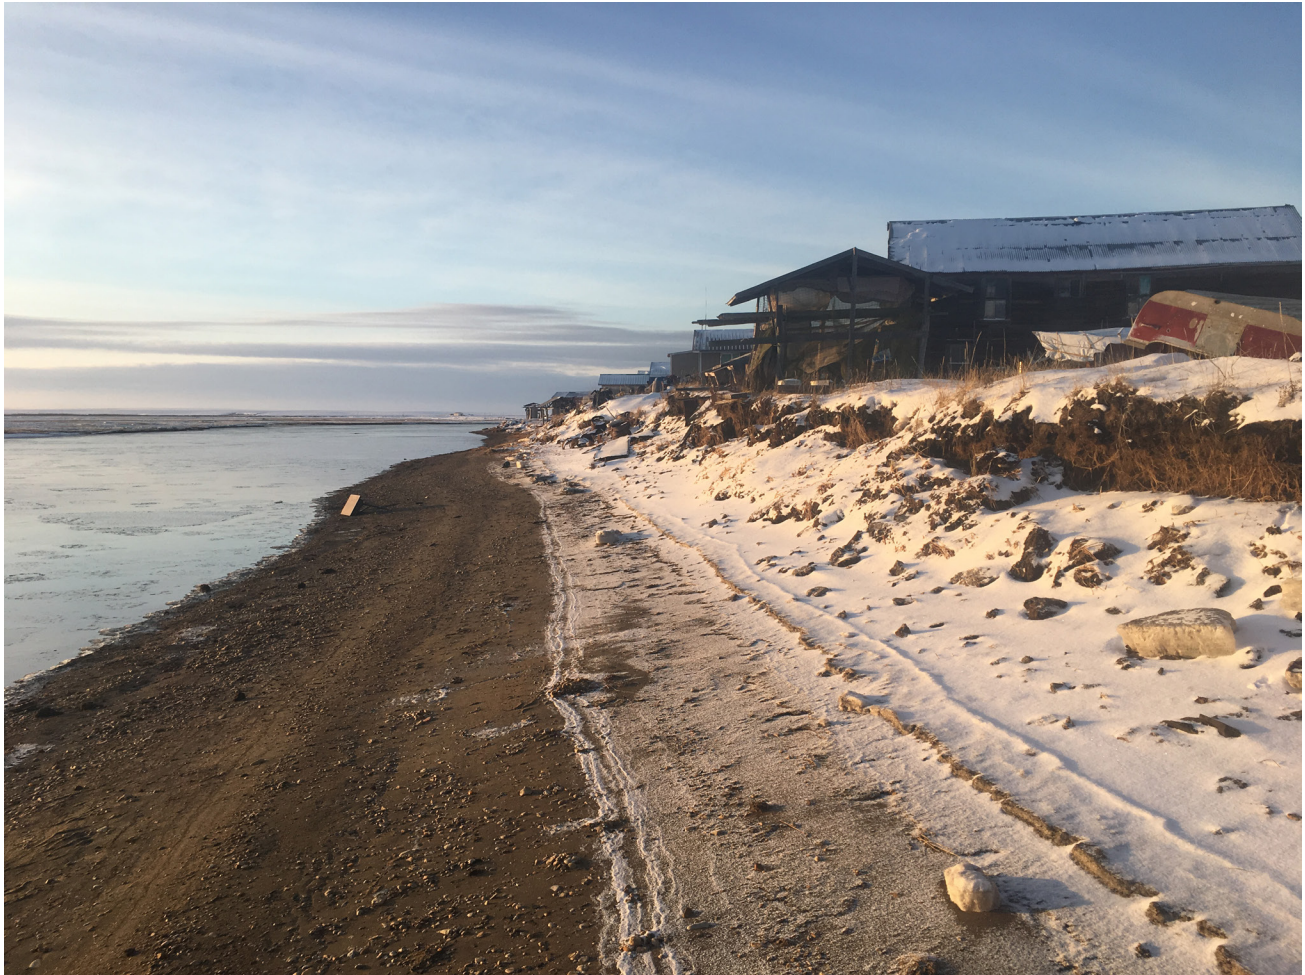
Photograph of the Deering, Alaska, shoreline following a November 11–12, 2017, storm. Photo: Alaska Department of Homeland Security & Emergency Management.

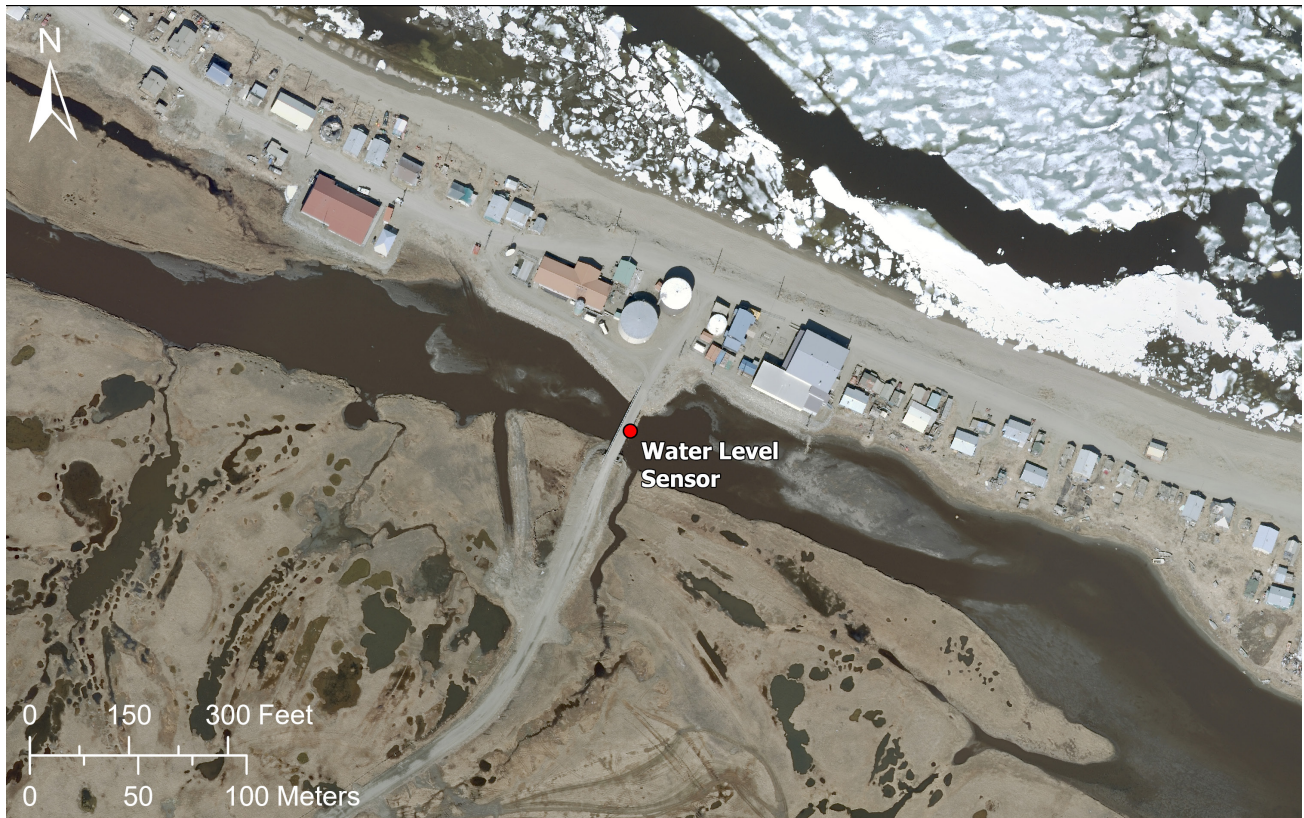
Figure 1. Location of Stilltek iGage radar water level sensor in Deering, Alaska.

To estimate this flood, we gathered water level data from the Stilltek iGage water level sensor (fig. 1 and 2) during the relevant period. Our estimate is the peak recorded water level (fig. 18).

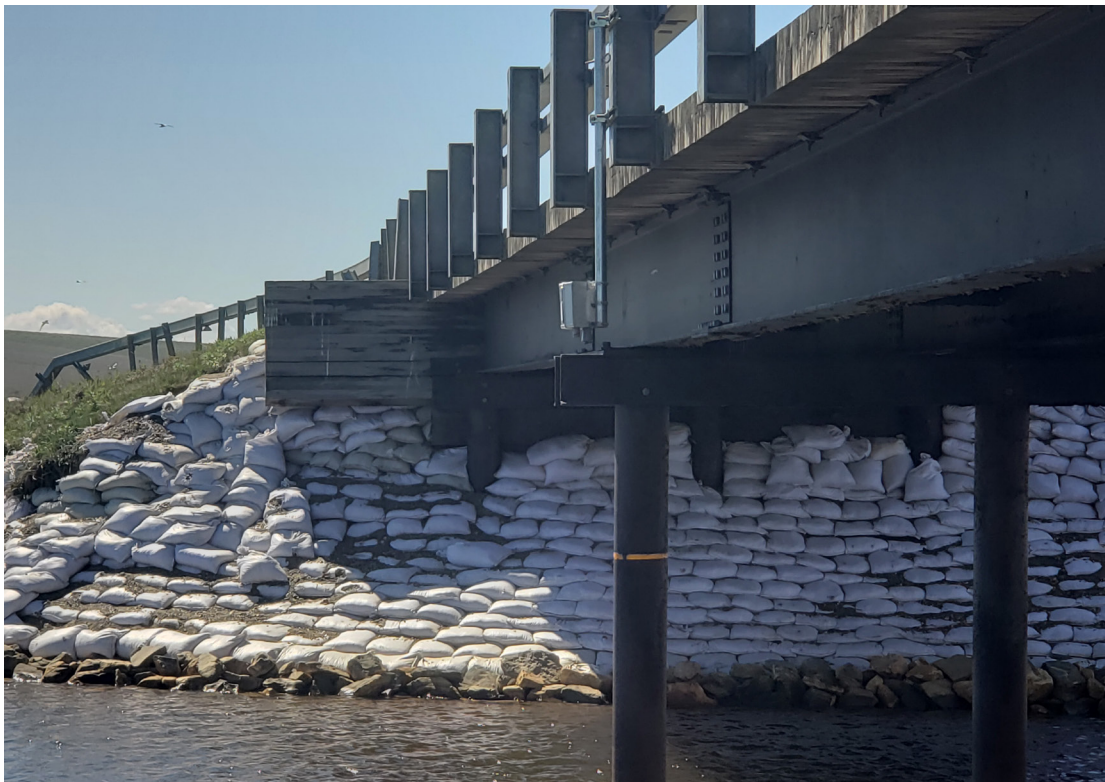
Figure 2. Stilltek iGage radar water level sensor installation on the south side of the bridge in Deering, Alaska.

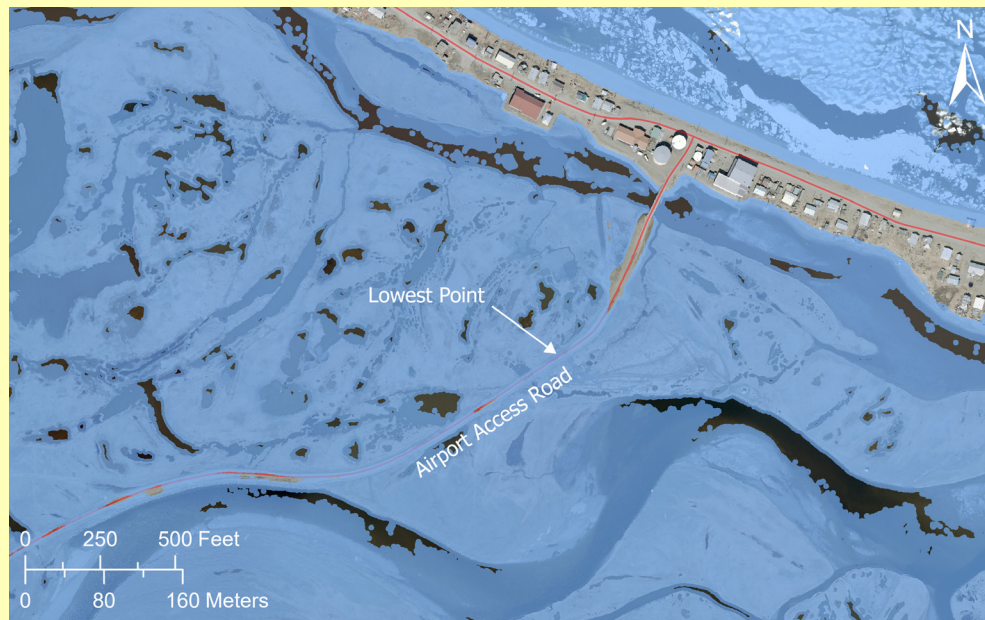
Figure 9. Airport access road within the 2013 orthoimagery overlaid with a simple bathtub model applied to the 2015 DTM simulating a water height of 3.9 ft (1.19 m) MHHW.

To estimate this flood, we located the airport access road within the 2013 aerial imagery and overlaid this with a simple bathtub model applied to the 2015 DTM to approximate the minimum height at which water would inundate the road across its full width, 2.9 ft (0.89 m) MHHW; this formed the lower limit of our estimate. We then added 1.0 ft (0.30 m), the maximum recommended safe depth for flooded roads (NWS, 2023), to form the upper limit of our estimate. An average of these two heights was calculated to estimate a flood height of 3.4 ft (1.04 m) MHHW (fig. 9).

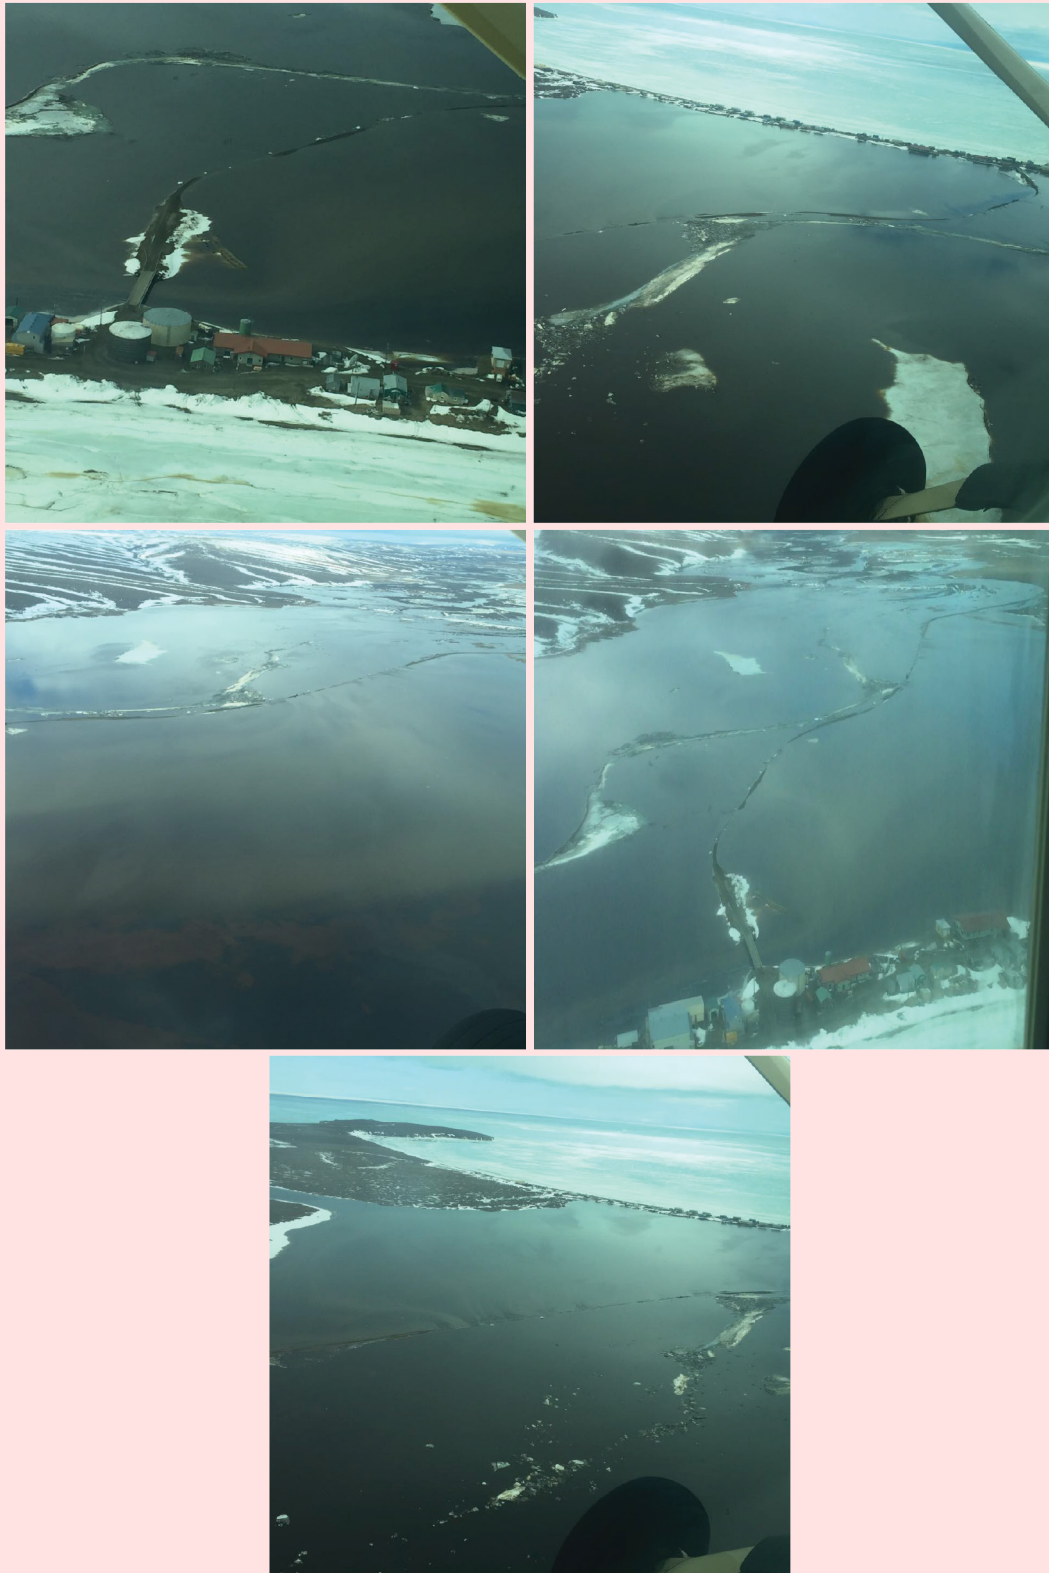
Figure 14. Photographic evidence of flooding along the Deering airport access road just south of the village.

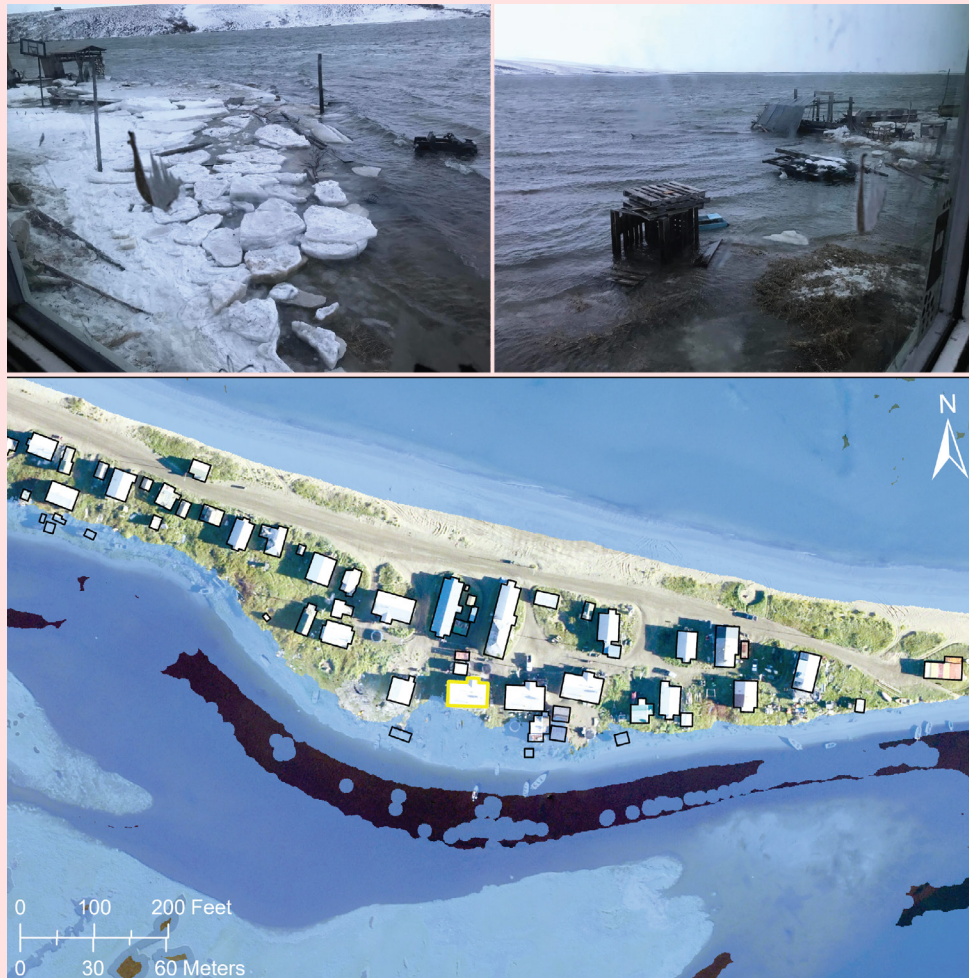
Figure 15. Photographic evidence (top) of flooding south of residence (yellow) in the 2016 orthoimagery, overlaid with a simple bathtub model applied to the 2015 DTM simulating a water height of 4.7 ft (1.44 m) MHHW to approximate the flooding depicted.

The ADN published an article on November 15, 2017, detailing storm-related flooding in multiple villages over the previous weekend, November 11 and 12. Speaking with Northwest Arctic Borough Deputy Director of Public Services, Dickie Moto, about flooding in Deering, ADN quoted, “The high water got right to the houses, right to the foundations on Front Street. The high water took a lot of people’s stuff away. It impacted a couple of local shops, took their foundations off” (ADN, 2017). Photographs retrieved from social media show water reaching a home on the south side of the village (fig. 15).

To estimate this flood, we identified the residence from which the photographs were taken, located it within the 2016 orthoimagery, and overlaid this with a simple bathtub model applied to the 2015 DTM to approximate the water height depicted in the photographs, 4.7 ft (1.44 m) MHHW (fig. 15). We then identified occupied buildings along Front Street, extracted the ground heights from beneath building footprints digitized from the 2016 orthoimagery, and determined the lowest of these to be 6.0 ft (1.84 m) MHHW (fig. 16). Finally, using the 2023 first-floor survey, we determined the lowest first-floor height from among the identified buildings, 7.2 ft (2.18 m) MHHW (fig. 17). An average of these three heights was calculated to estimate a flood height of 6.0 ft (1.82 m) MHHW.
