## COASTAL FLOOD IMPACT ASSESSMENT FOR KIVALINA, ALASKA

Report of Investigation 2025-5

State of Alaska  
Department of Natural Resources  
Division of Geological & Geophysical Surveys

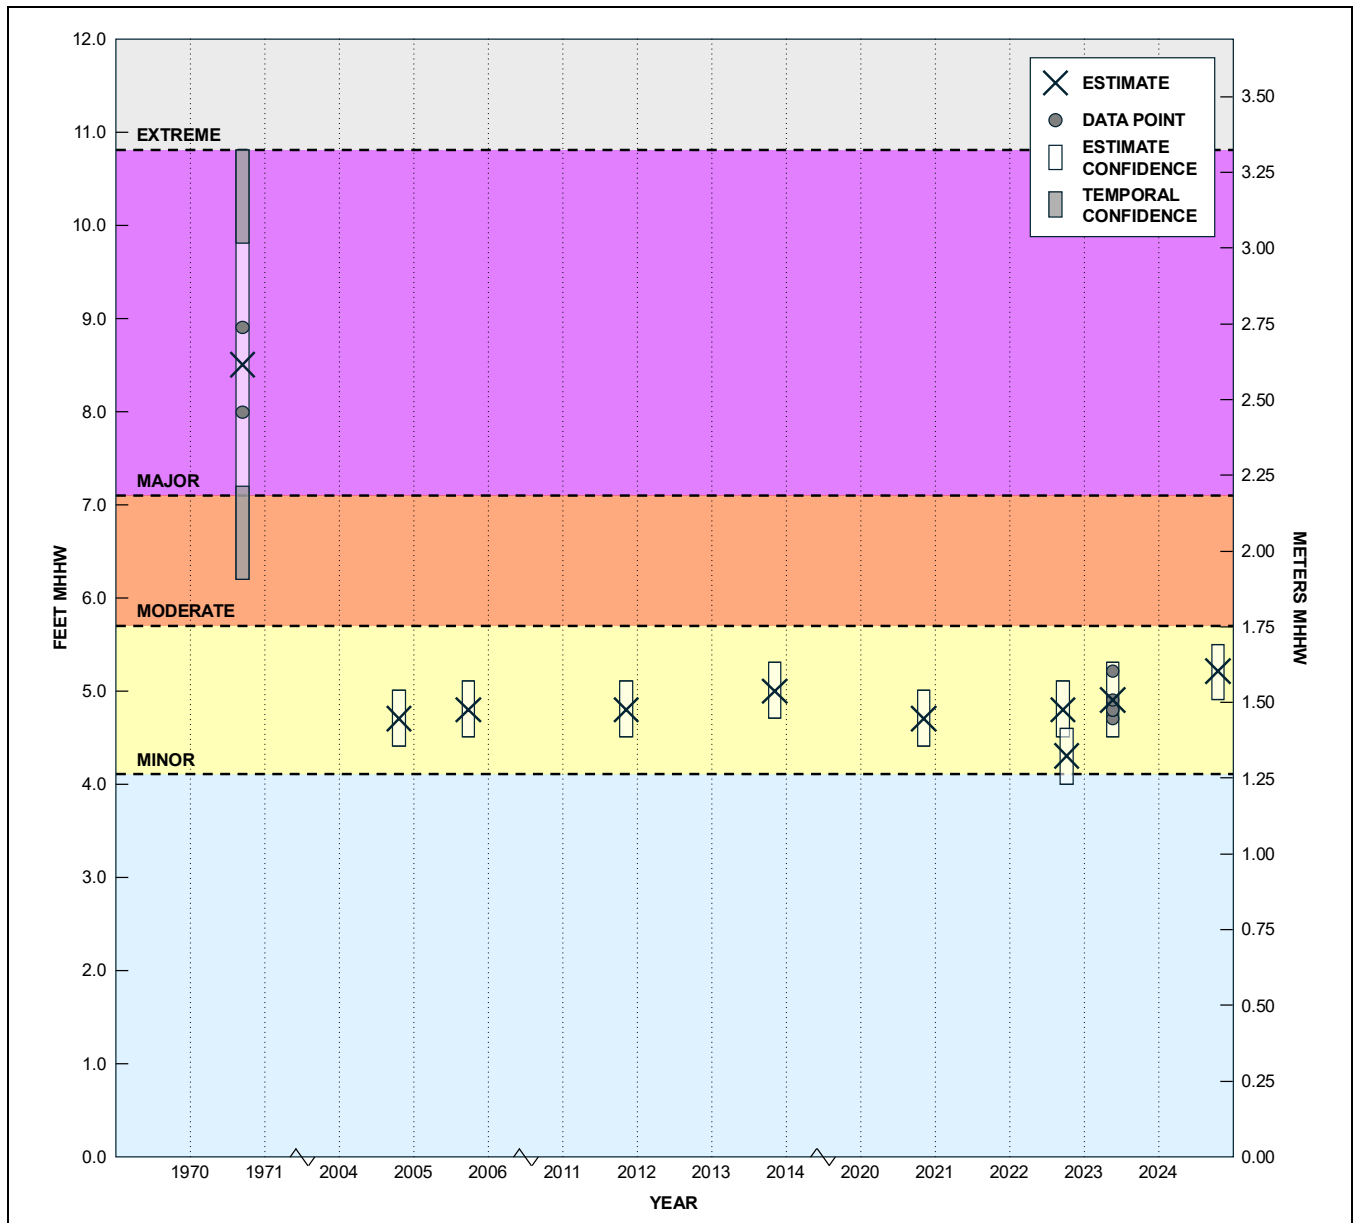
**Figure 3.** Timeline of estimated flood events and visual representation of flood height estimates and confidences for Kivalina, Alaska. Flood height estimates were calculated following the methods developed by Horen and others (2024). Estimates are denoted by black X symbols. Data points used during estimation are represented by dark-gray dots. Estimate confidences are displayed as vertical, light-gray boxes. Temporal confidences are displayed as vertical, dark-gray boxes. Each flood height estimate may only be classified into a single flood impact category, but total estimate confidence may exceed the upper and lower bounds of the data used during estimation and may span more than one flood impact category.

For each flood event, a list and summarization of sources is included, as well as an explanation of the data used and steps performed during estimation, where relevant. Each flood height estimate is classified into a single flood impact category but estimate confidences may span more than one category. Table 6 provides a complete list of the flood events found during our research, with estimated floods categorized and listed in order from highest to lowest, and floods not estimated listed in chronological order. Figure 3 provides a timeline of the estimated flood events and a visual representation of the flood height estimates and confidences.

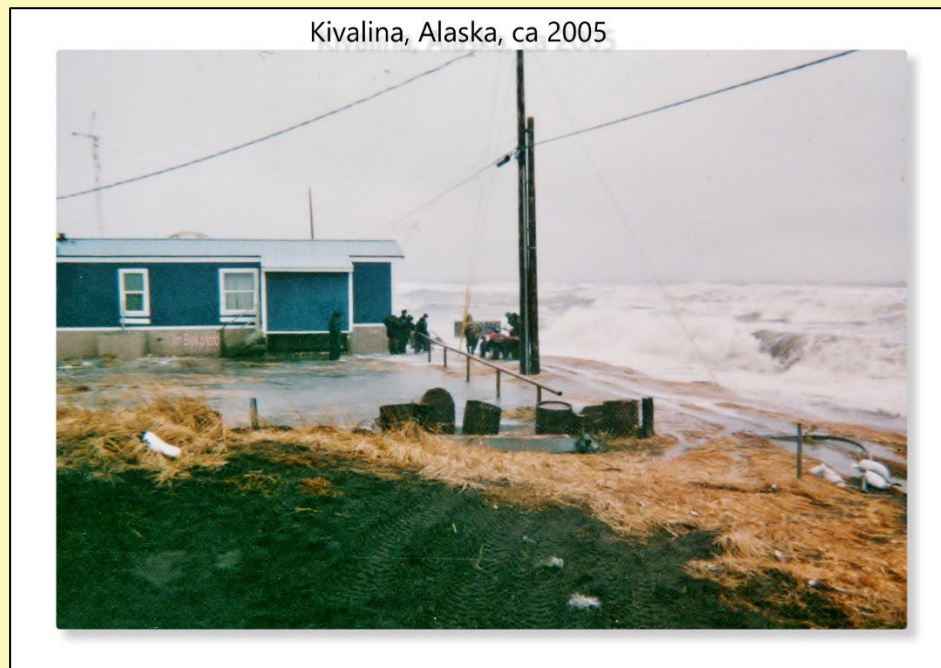
**Figure 6.** Photograph of flooding and erosion near the school principal’s residence on September 23, 2005, in Kivalina, Alaska. Credit: Jim Evak.

An NCEI storm report details a storm on September 23–24, 2005, that resulted in “25–30 feet of beach erosion, along a 500 foot length of shoreline, at the southeast end of” Kivalina, as well as “20 feet of beach erosion toward the airstrip, encroaching on the taxiway,” with “several telephone poles near the edge of shore... toppled due to erosion underneath,” and the school principal and their family evacuated their home during the storm “as water moved right to the edge of the structure” (NCEI, 2005).

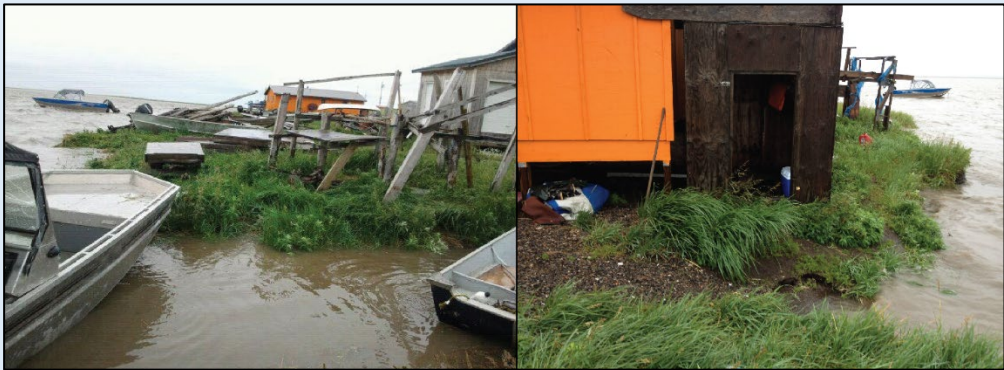
**Figure 9.** Photographs of flood waters encroaching residences on the lagoon side of Kivalina, Alaska, in August 2012. Credit: Unknown.

The City of Kivalina Hazard Mitigation Plan (FEMA, 2015) lists flooding on August 13, 2012, due to “record flows on the Wulik River” resulting from “a week of record rainfall,” noting “the high water washed several sections of the surface water piping into the river and overtopped the city’s landfill, washing landfill debris into the community.”

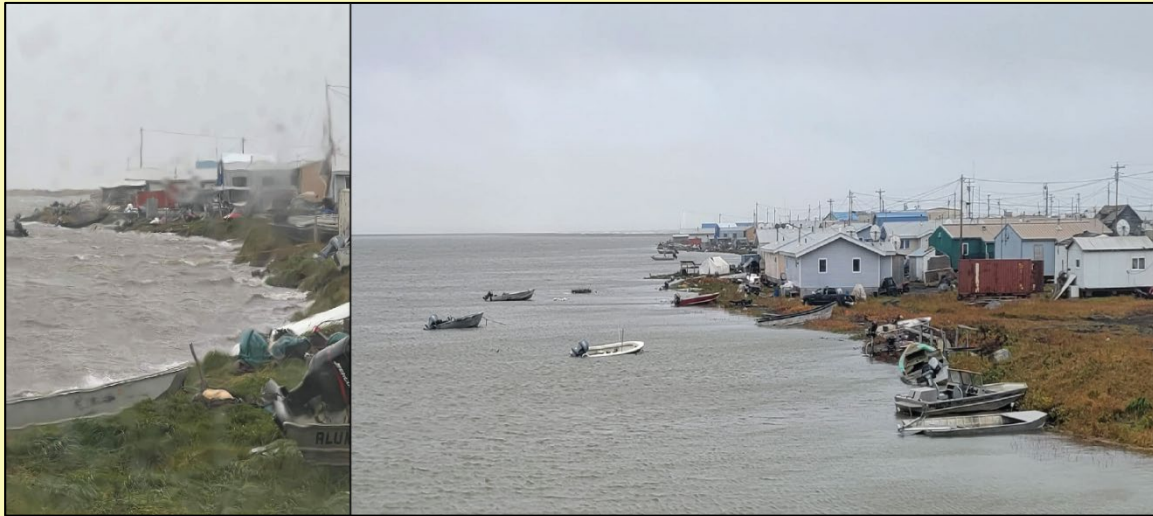
**Figure 12.** Photographs of flood waters encroaching residences on the lagoon side of Kivalina, Alaska, during Ex-typhoon Merbok, in September 2022. Credit: Unknown.

An NCEI (2022a) storm report notes “the remnants of Typhoon Merbok in the northern Pacific Ocean began approaching the Bering Sea on Thursday, September 15, 2022... The storm continued to move northeast into the Chukchi Sea Saturday afternoon, September 17th” with “minor flooding of low lying areas and erosion from wave runoff” observed in Kivalina.

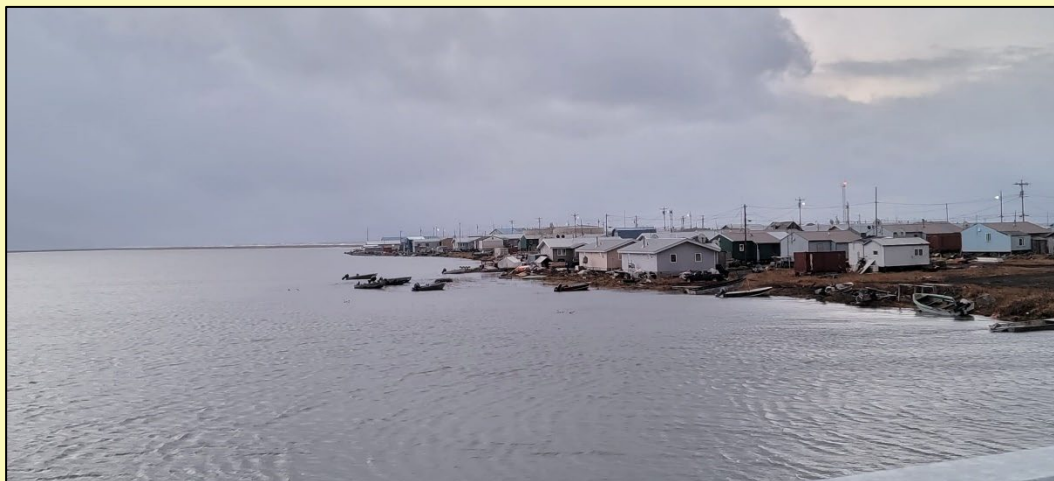
**Figure 14.** Photograph of flood waters encroaching residences on the lagoon side of Kivalina, Alaska, in October 2022. Credit: Unknown.

An NCEI (2022b) storm report details a coastal flood event resulting from strong winds “causing water levels to rise from the Seward Peninsula to Utqiagvik,” the highest water in Kivalina occurring on the morning of October 7, 2022, with “minor flooding... of low lying [areas].”

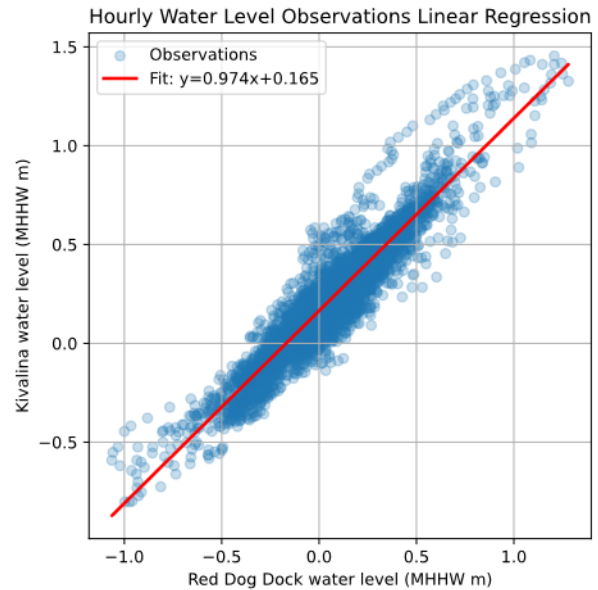
**Figure C1.** Linear regression fit for hourly water level observations recorded at Red Dog Dock and Kivalina, Alaska between June 7–October 31, 2022, and May 29–October 5, 2023.

An overlap of consistent, high-quality data is available for both Kivalina and Red Dog Dock between June 7–October 31, 2022, and May 29–October 5, 2023. DGGS performed a comparative analysis of these data to determine what relationship, if any, exists between the water levels recorded at these locations. We first cross-correlated the datasets using the direct method (by sums) to identify any temporal lag, finding a 93.6 percent signal match after applying shifts of  $-3$  hours  $\pm 6$ -minutes and  $-2$  hours  $\pm 6$ -minutes to the 2022 and 2023 Kivalina data, respectively. This discrepancy appears to be related to incorrectly applied time zone adjustments to the Kivalina data when downloading from the Alaska Water Level Watch portal. After lag-adjustment, the average difference between readings was  $-0.163$  m, with a root mean square error (RMSE) of  $\pm 0.187$  m. We next performed a linear regression on these data (fig. C1), calculating a slope (scale-factor) of 0.974 and an intercept (vertical offset) of 0.165 m, resulting in an  $R^2$  of 0.877 and residual RMSE of  $\pm 0.092$  m.
