**RI** bureau of mines  
report of investigations **7392**

**SPRAY-APPLIED POLYURETHANE  
FOAM TO INSULATE HEATED ROOMS  
EXCAVATED IN PERMAFROST**

June 1970

By K. Robert Dorman and Aldon E. Gooch

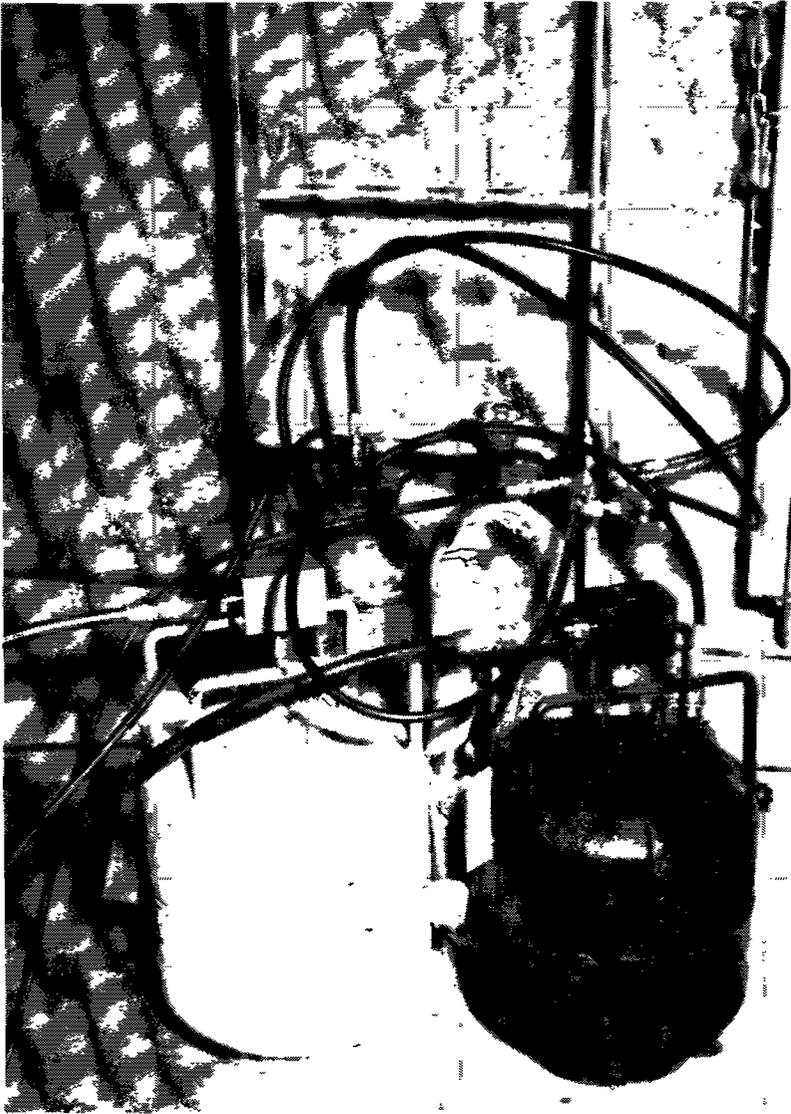
FIGURE 1. - Autofroth-I System.

Two types of rigid urethane-foam systems were employed in laboratory testing, the Olin Mathieson Chemical Corporation's Autofroth-I system<sup>3</sup> (fig. 1) and the Mine Safety Appliances Company's (MSA) Rigiseal system (fig. 2).

The Autofroth-I system employs four material components: resin, catalyst, flushing agent, and nitrogen. Each component in an individual cylinder is fed to the gun through a network of hoses. Nitrogen supplies the driving force required for application. The correct ratio of resin to catalyst is automatically controlled by a preset, metering controller valve located in the gun. The Autofroth-I gun discharges from 30 to 80 percent preexpanded froth foam, dependent upon operating conditions.

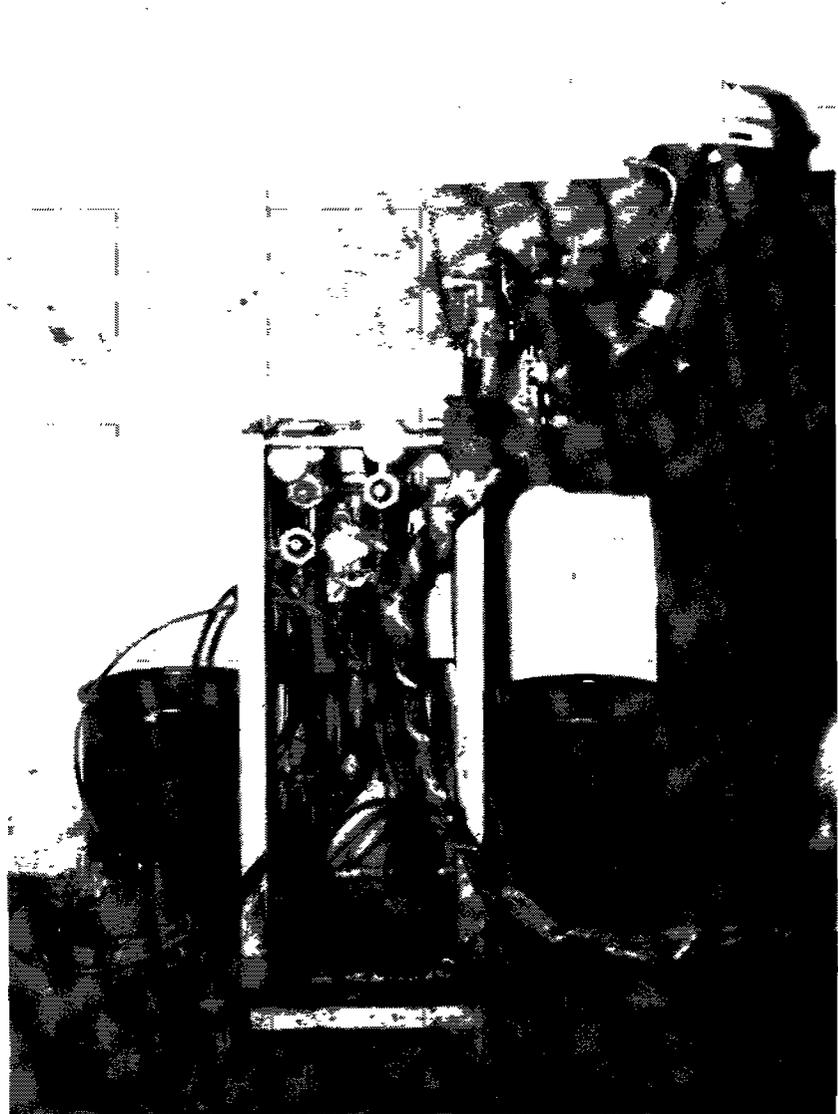
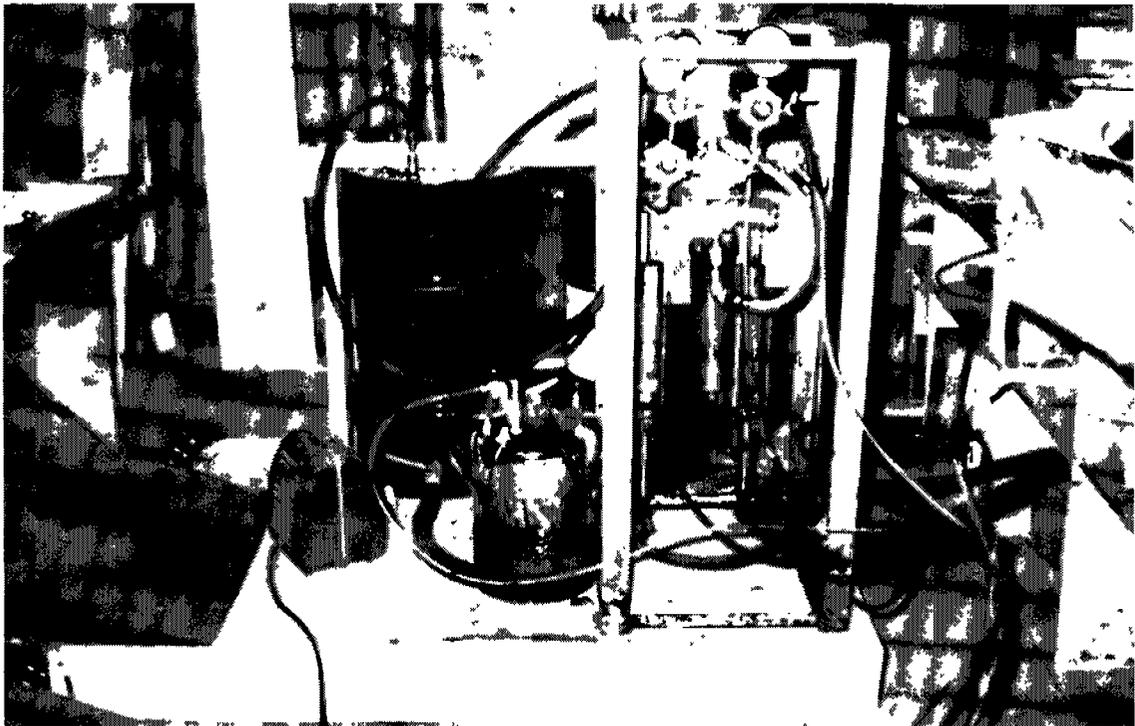
FIGURE 2. - Rigiseal System. A, Operator in lab.

FIGURE 2. - Rigiseal System. *B*, On sled at Fox, Alaska, installation.

The MSA Rigiseal system uses three components: resin, catalyst, and flushing agent. Compressed-air operated, the system requires a supply of air at 30 cfm and 70 psi minimum. The machine consists mainly of supply hoses, a pressure tank for flushing agent, a hand-held gun, and a two-piston pump that pumps the resin and catalyst from the drums to the gun. A correct ratio of the two components is maintained automatically by the relative sizes of the two pistons. In addition to driving the materials pump, the compressed air runs a small mixing motor located in the gun, supplies positive pressure to the flushing agent, and blows the froth onto the surface being foamed.

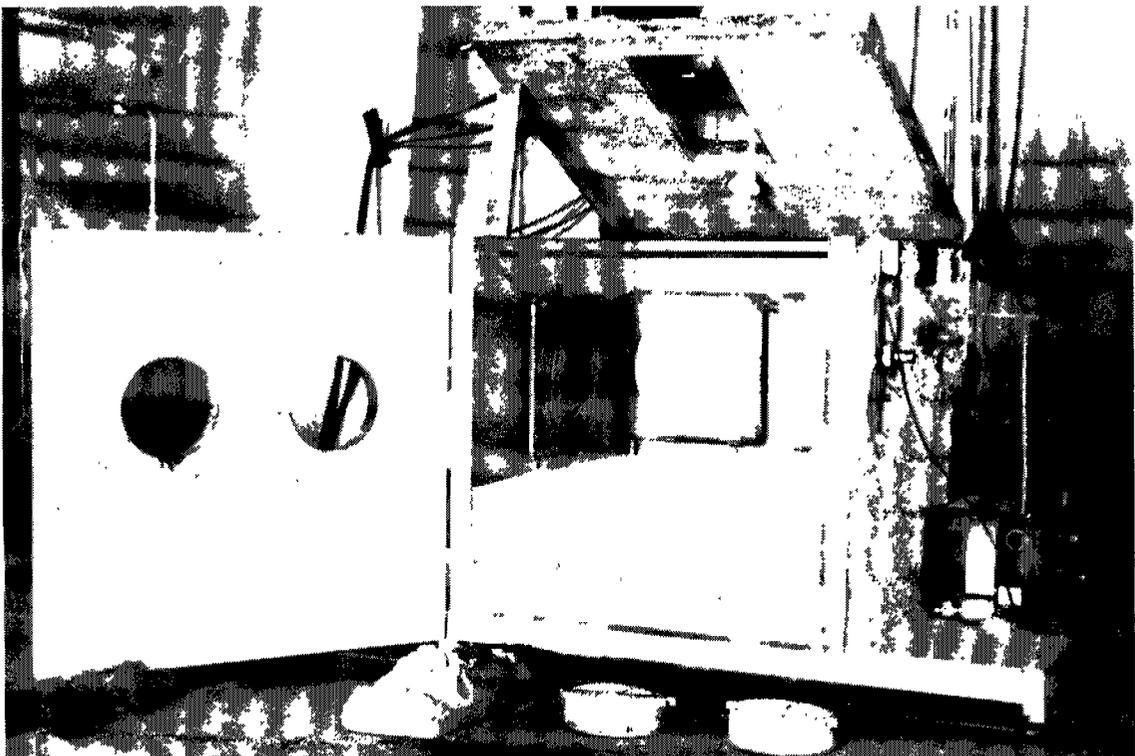
FIGURE 3. - Cold-Environment Box.

The environmental test chamber, fabricated at SMRL, is a 4-foot-square wooden box, 4 feet in height, equipped with the cooling coils, compressor, and motor from a surplus ice cream freezer (fig. 3). The exterior was foamed with a 3-inch minimum thickness of Autofroth-I rigid polyurethane. Personnel wore vapor-type respirators to protect themselves from the toxic isocyanate vapors.

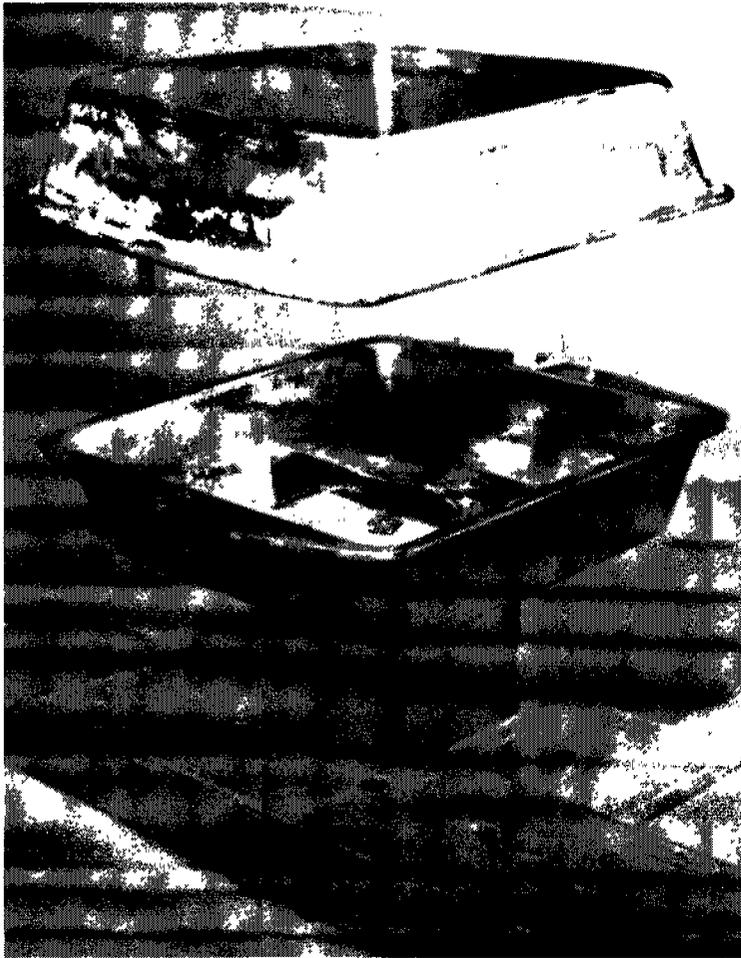
FIGURE 4. - Sample Pans and Hold-Down Device.

Miscellaneous equipment included a 200-pound-capacity pull-type scale, 2- by 2-inch pull plates made of punched steel plate, 8- by 8-inch aluminum sample pans, and a short length of 4-inch channel iron used as a hold-down device during pull testing (fig. 4). The bottom pan, serving as the container for the frozen sample, was bolted to a 36- by 36-inch plywood base in the cold box prior to foaming and to the channel iron for pull testing. The upper pan, from which the bottom had been removed, was placed over the lower pan in an inverted position; they thus served as an open mold for the foam covering.

The 8- by 8-inch aluminum pans, 2 inches in depth, were filled with materials containing varying amounts of water, bolted to a plywood base, and placed in the environmental cold box. Three samples were made of each combination. Table 2 provides a description of the combinations used to simulate permafrost materials. The same combinations were used for testing with the Rigiseal foam as were employed with the Autofroth-I, with one exception: fine mill tailings were used in place of eolian silt for Rigiseal testing. Prior to foaming, the upper pans were wiped with vaseline, inverted, and bolted to the sample pans.

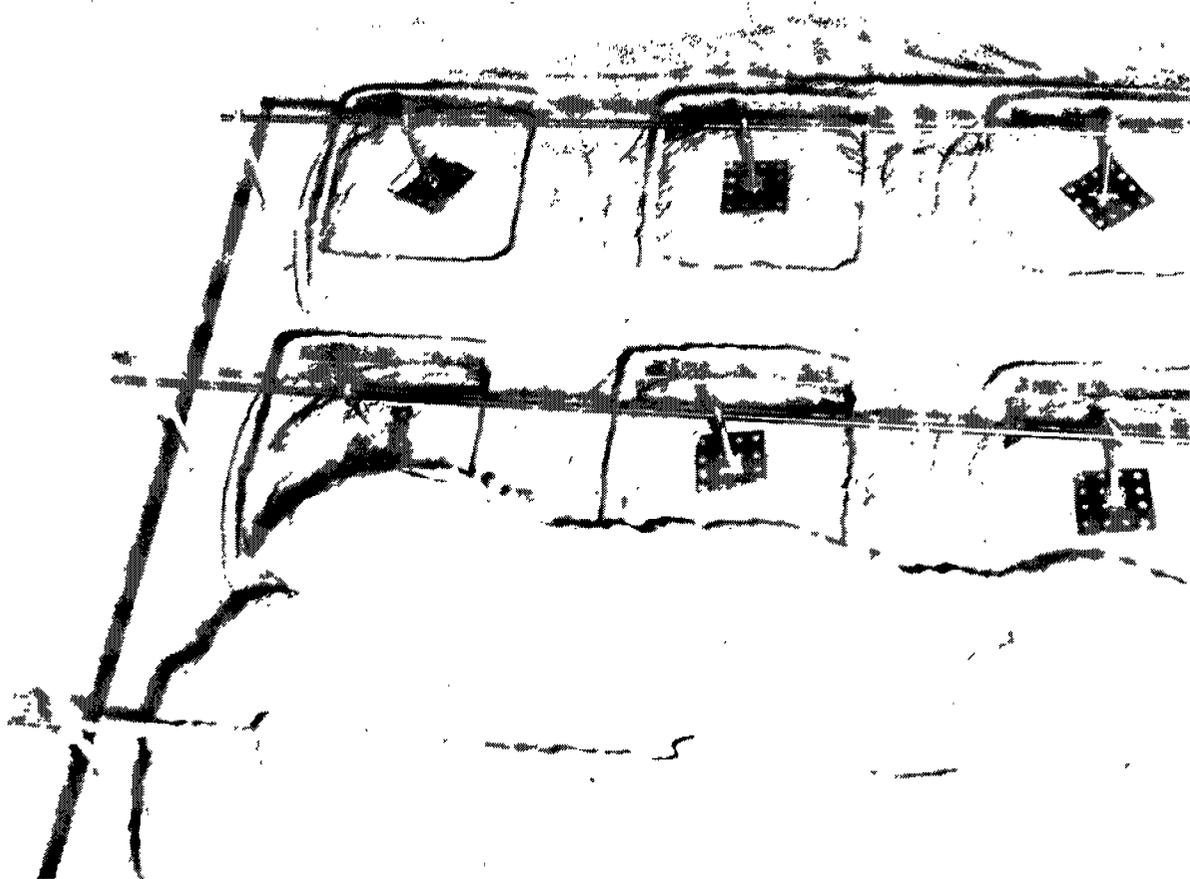
FIGURE 5. - Pull Plates in Position.

Testing procedure was as follows: A test sample was unbolted from the plywood base and freed from the surrounding foam layer by careful cutting of the insulation around the periphery of the pan. The inverted upper pan was next removed. Then the sample was removed from the cold box, bolted to the web of a 4-inch channel iron, and pull tested as illustrated in figure 6. A steadily increasing pull was applied perpendicular to the frozen surface until failure occurred, or until the 200-pound capacity of the scale was reached.

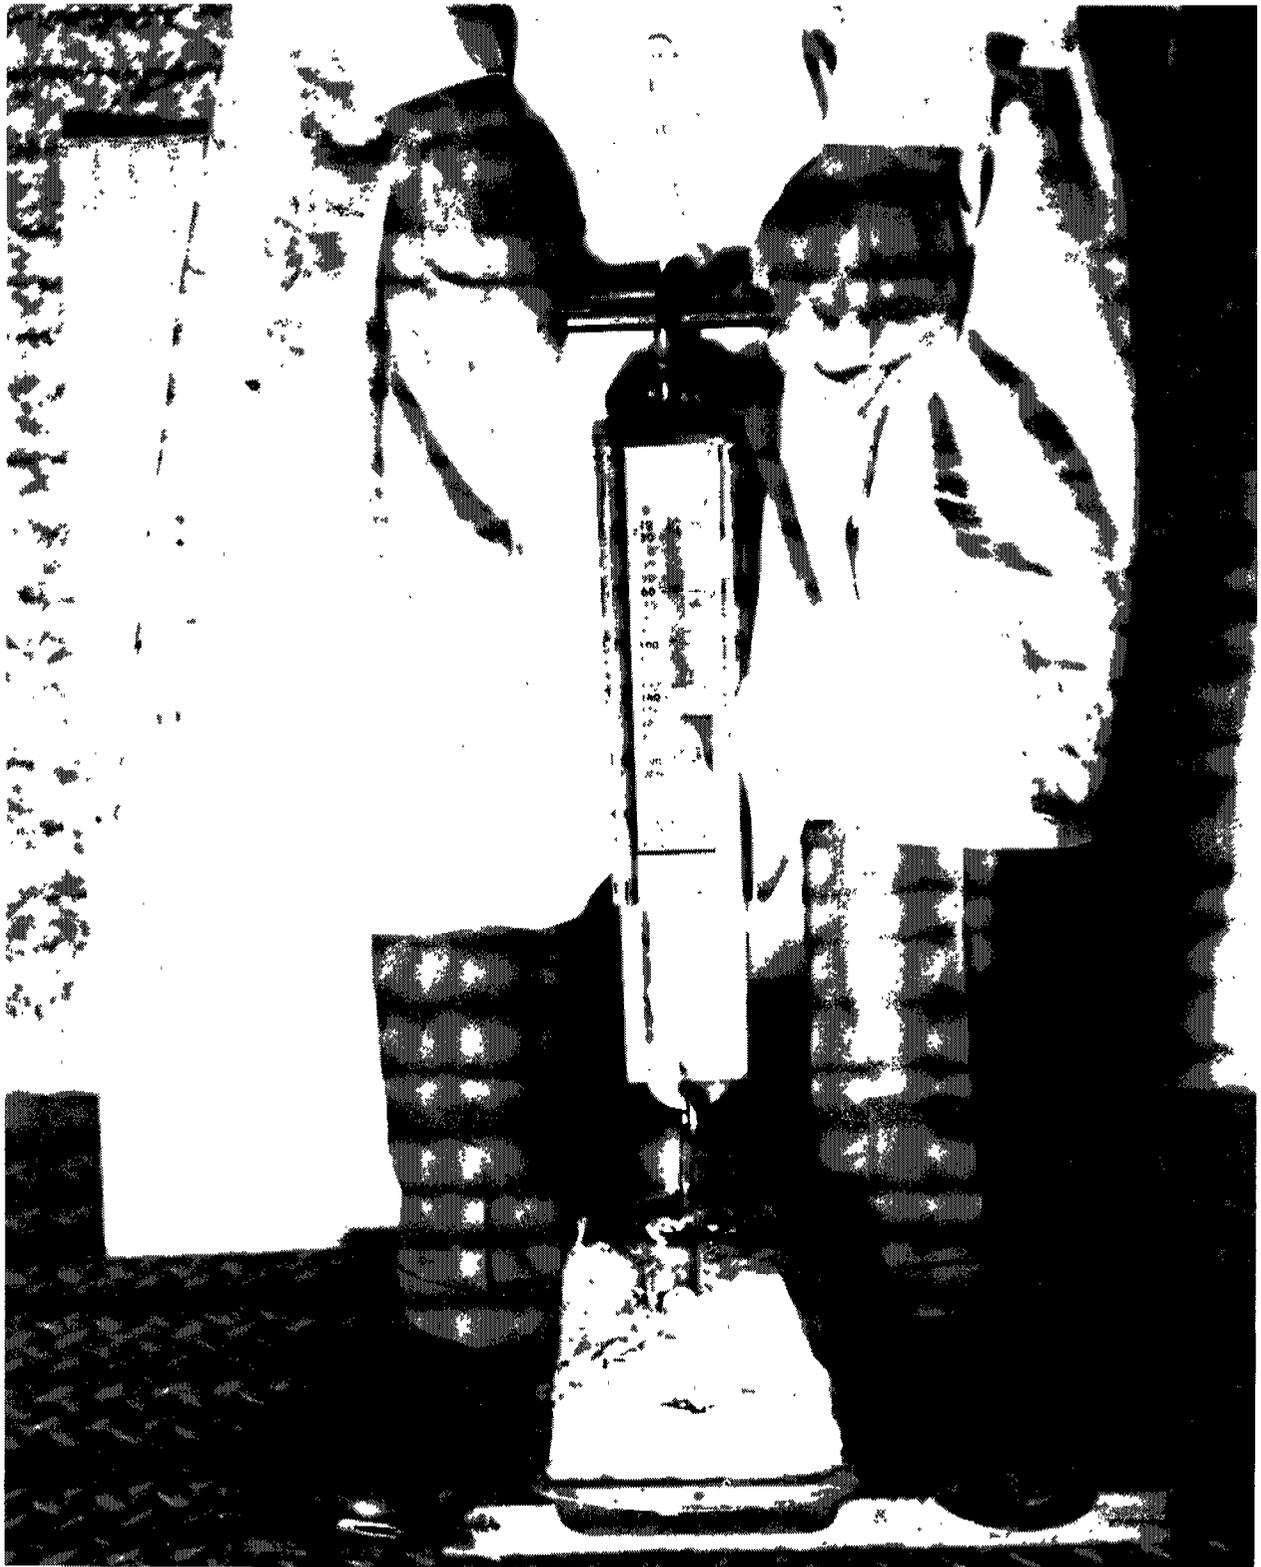
FIGURE 6. - Testing Adhesion Between Foam and Frozen Material.

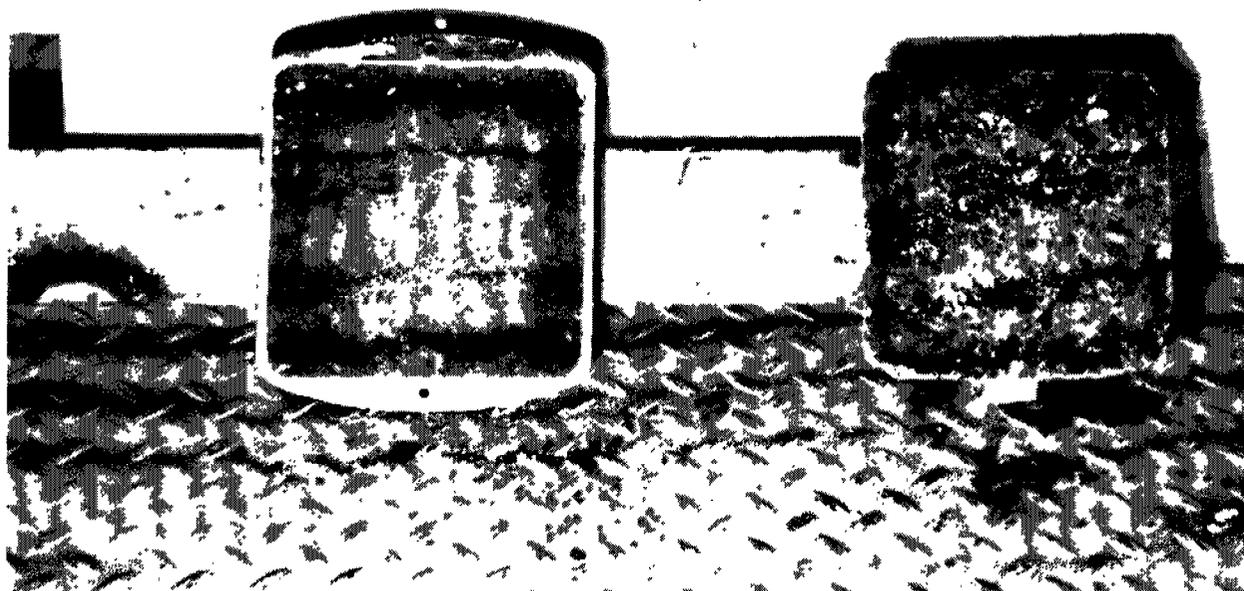
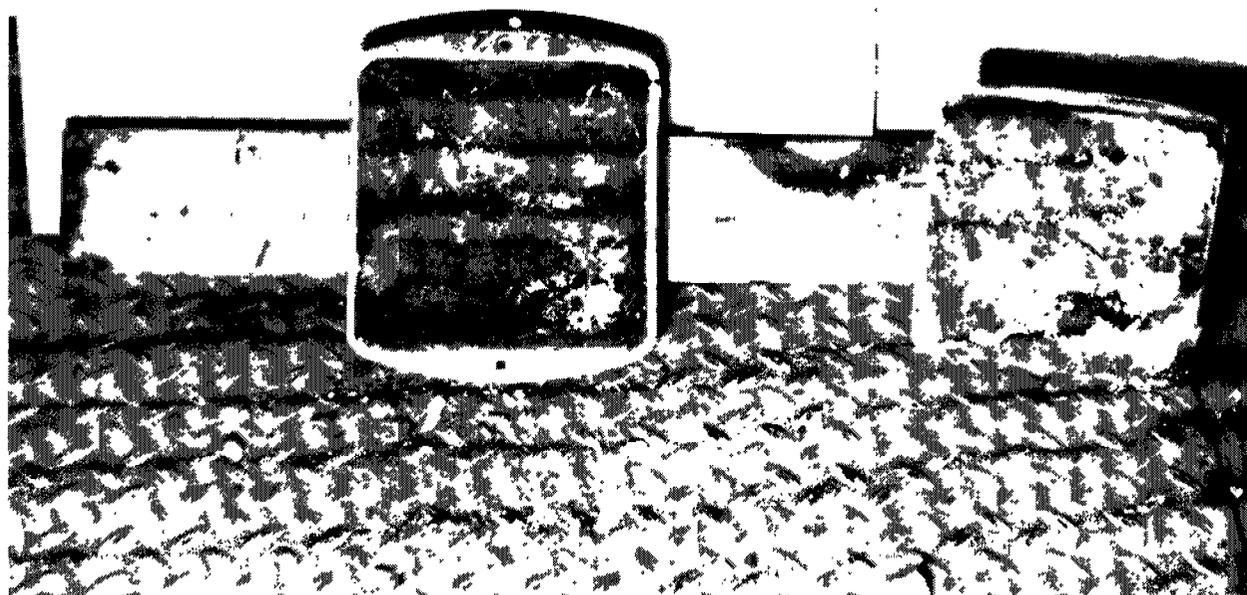
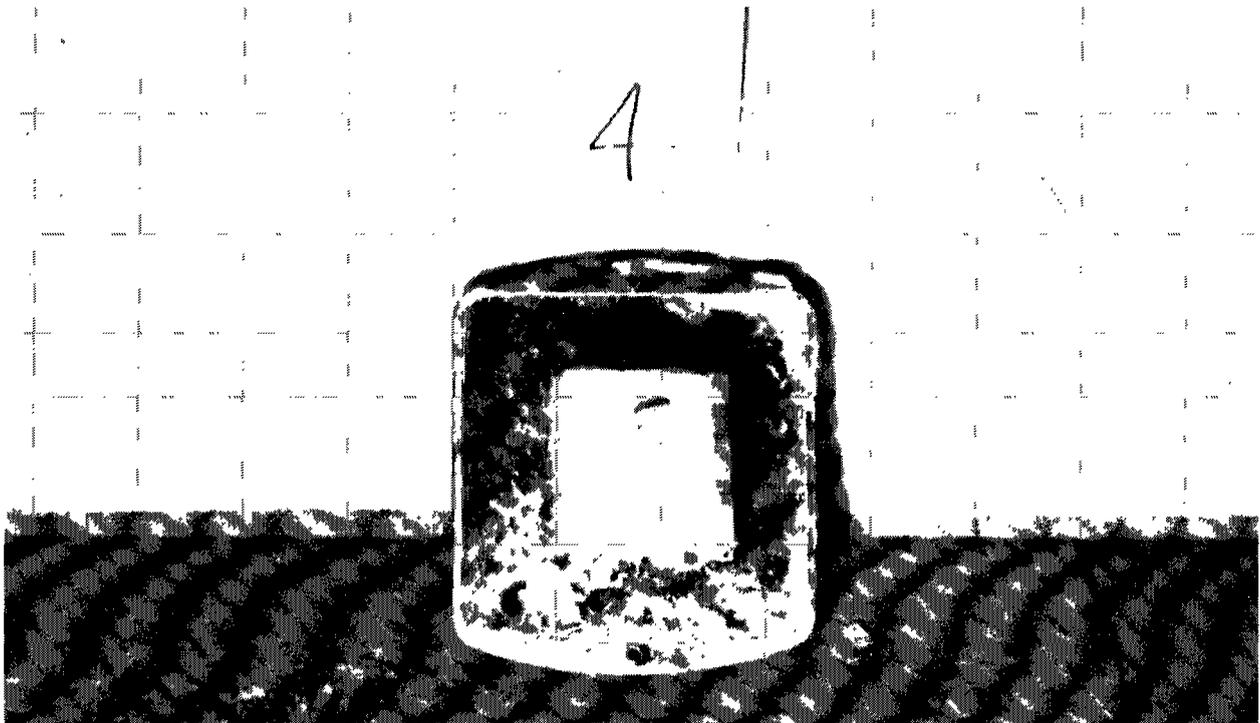
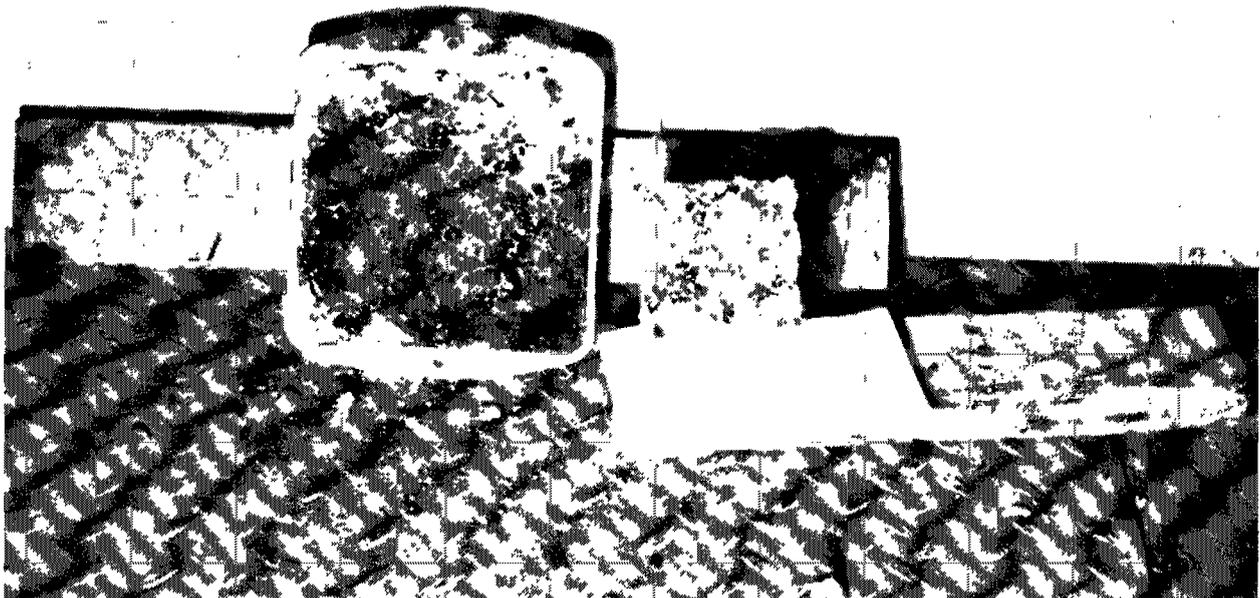
FIGURE 7. - Bond Between Foam and Frozen Material. *A*, Sample 2 after pull test.

FIGURE 7. - Bond Between Foam and Frozen Material. *B*, Sample 7 after pull test.

FIGURE 7. - Bond Between Foam and Frozen Material. *C*, Sample 4 trimmed to 16 square inches.

FIGURE 7. - Bond Between Foam and Frozen Material. *D*, Sample 4 after pull test.

Pull-test results are given in table 2. Visual examination of samples 1, 2, and 3 revealed that the upper portion of the gravel-sand mixture had dried out before the sample became frozen. Consequently, parting occurred within the mixture rather than at the mixture-foam interface. The gravel and sand particles can be seen imbedded in the foam in figure 7A. A pull of 200 pounds was not sufficiently large to cause failure with any of the remaining nine gravel-sand samples. The foam layer on sample 4 subsequently was trimmed to 16 square inches (fig. 7C). A force of 163 pounds was required to pull this reduced section of foam from the frozen material (fig. 7D).

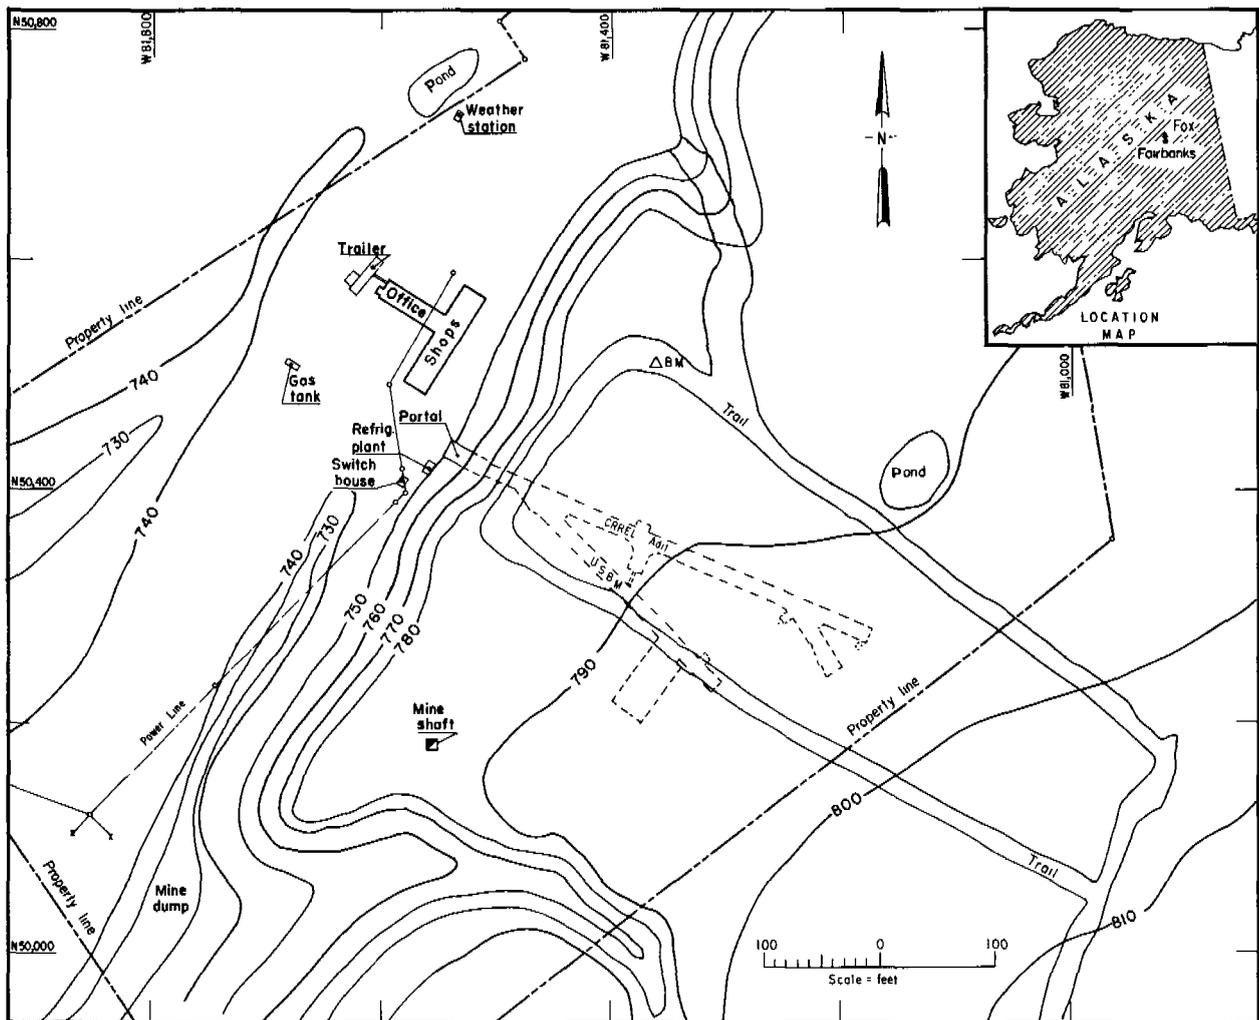
FIGURE 8. - Adit Site, Fox, Alaska.

The experimental adit at Fox, Alaska, approximately 10 miles north of Fairbanks (fig. 8), was driven in 1963 and enlarged in 1966 and 1967. Access to the site is provided by an asphalt-surfaced highway, connecting Fairbanks with Livengood to the north. The facility, which includes an office and shops, is the property of USACRREL. The adit (fig. 8), 360 feet in length, was excavated in perennially frozen silt (permafrost) in the toe of a bench

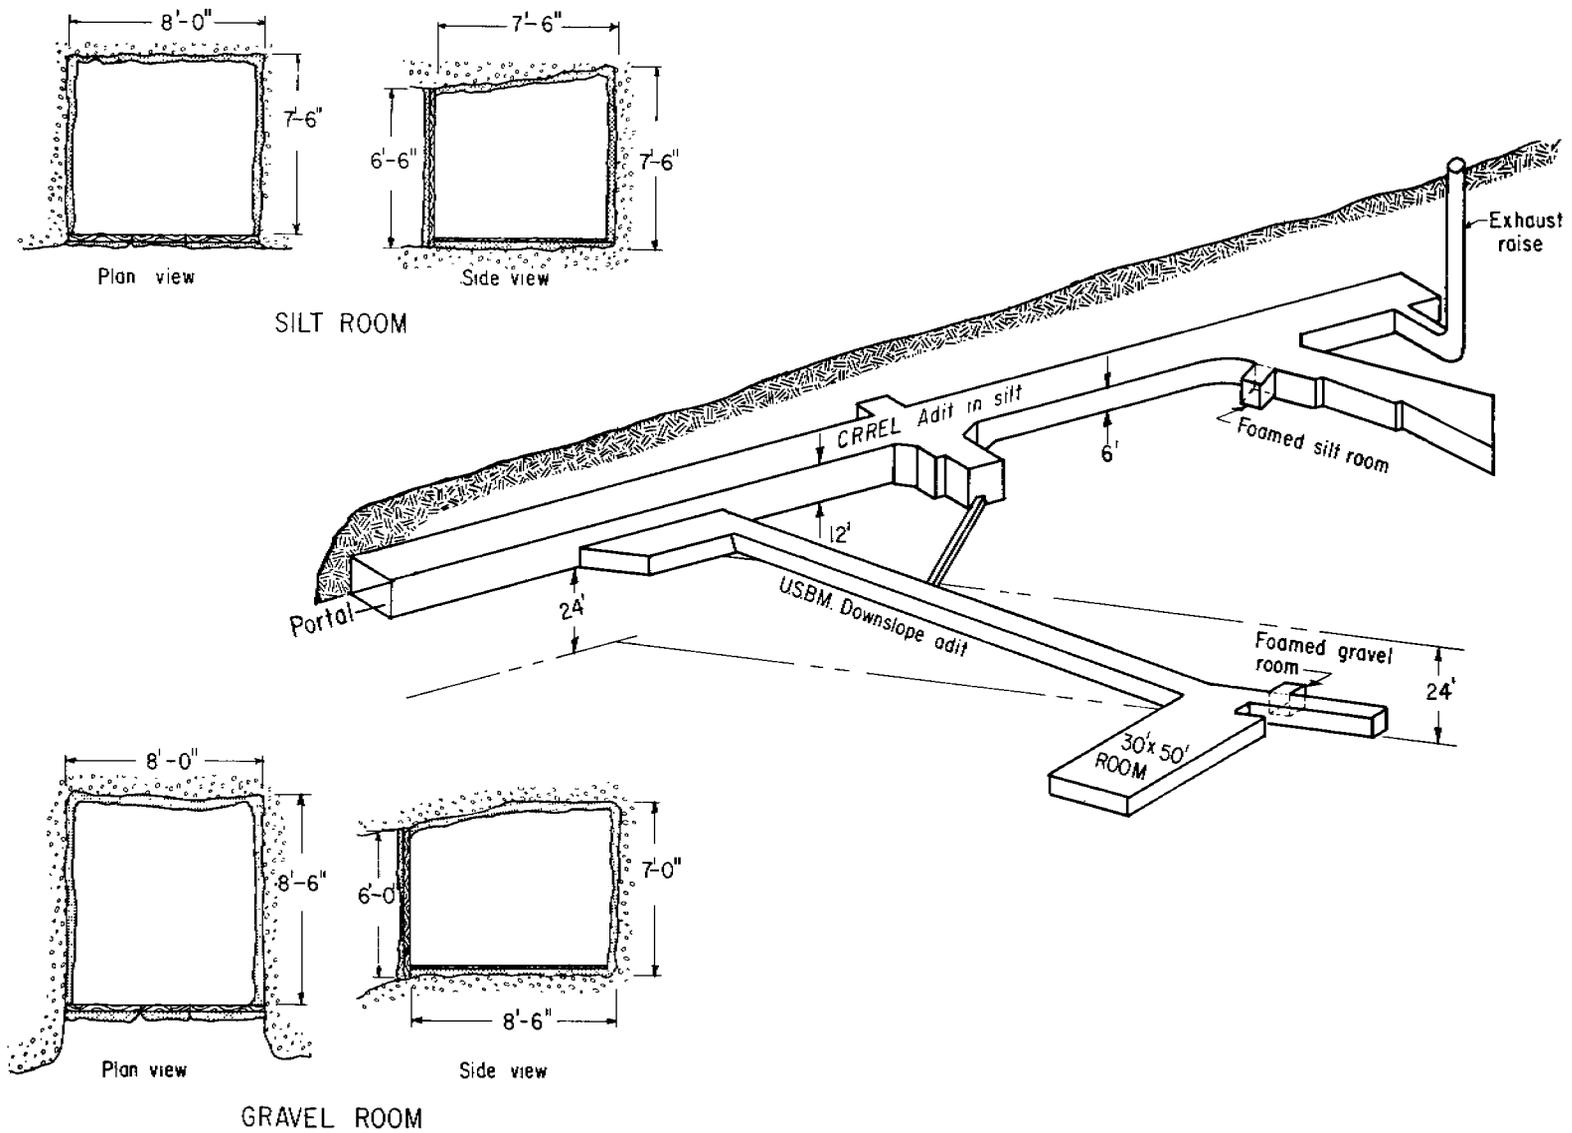
FIGURE 9. - Details of Adit.

left as the economic limit of earlier gold dredging. The small silt room later excavated and insulated by the Bureau is located near the far end of the adit. During the summer months, air within the adit is maintained at below freezing temperature by buried refrigerated pipes that surround the portal area and by fans which circulate the air through cooling coils located inside the adit. Also, the exhaust shaft is kept closed except in the winter.

So that the Bureau could conduct test work in the gravel horizon, Twin Cities Mining Research Center (TCMRC) personnel supervised the driving of an 8- by 15-foot winze on a 14- to 16-percent grade during the latter part of 1968 (fig. 9). The small gravel room insulated by SMRL personnel is situated near the bottom of this opening.

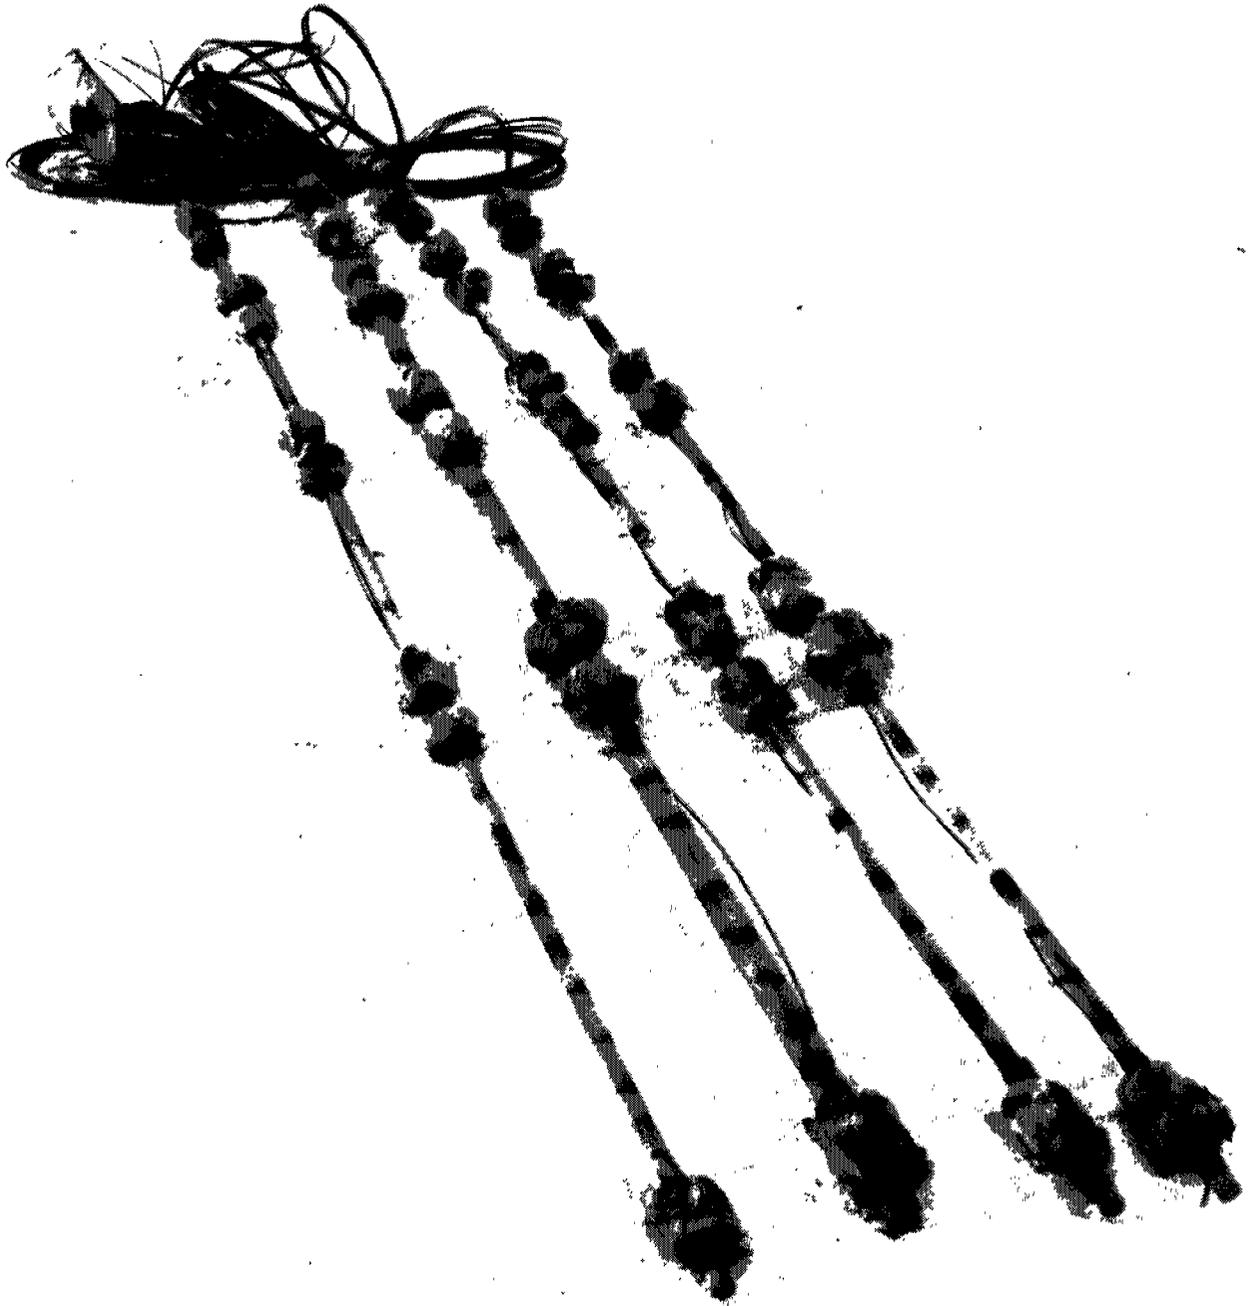
FIGURE 10. - Thermocouple Strings.

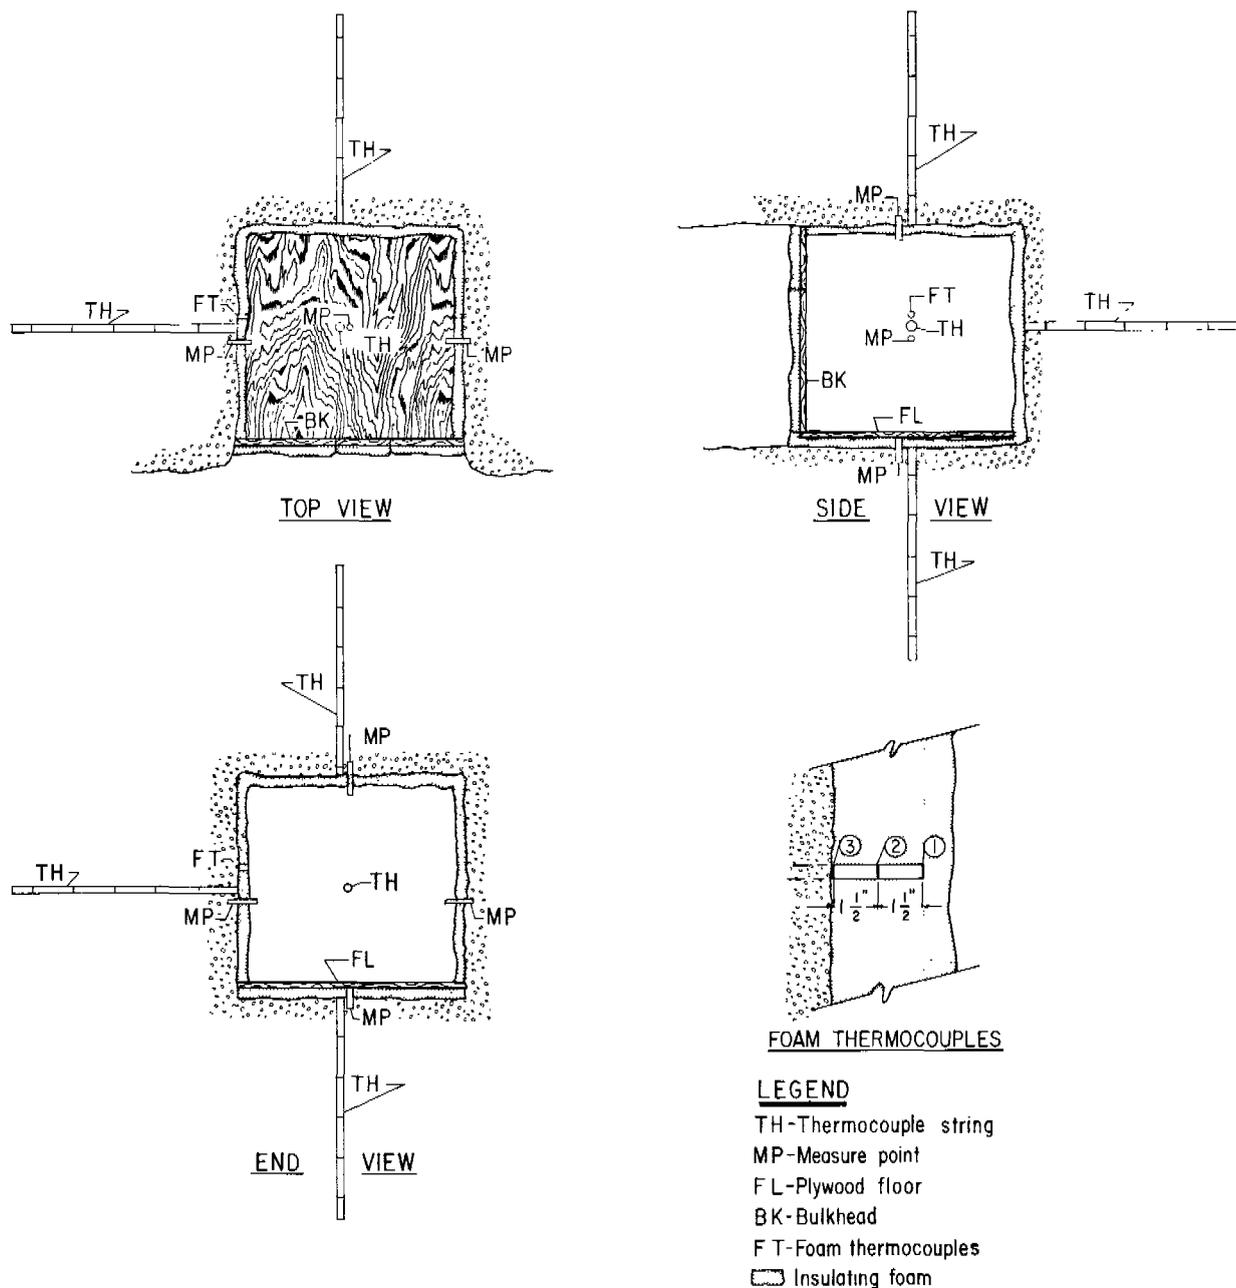
FIGURE 11. - Thermocouple and Closure-Point Location.

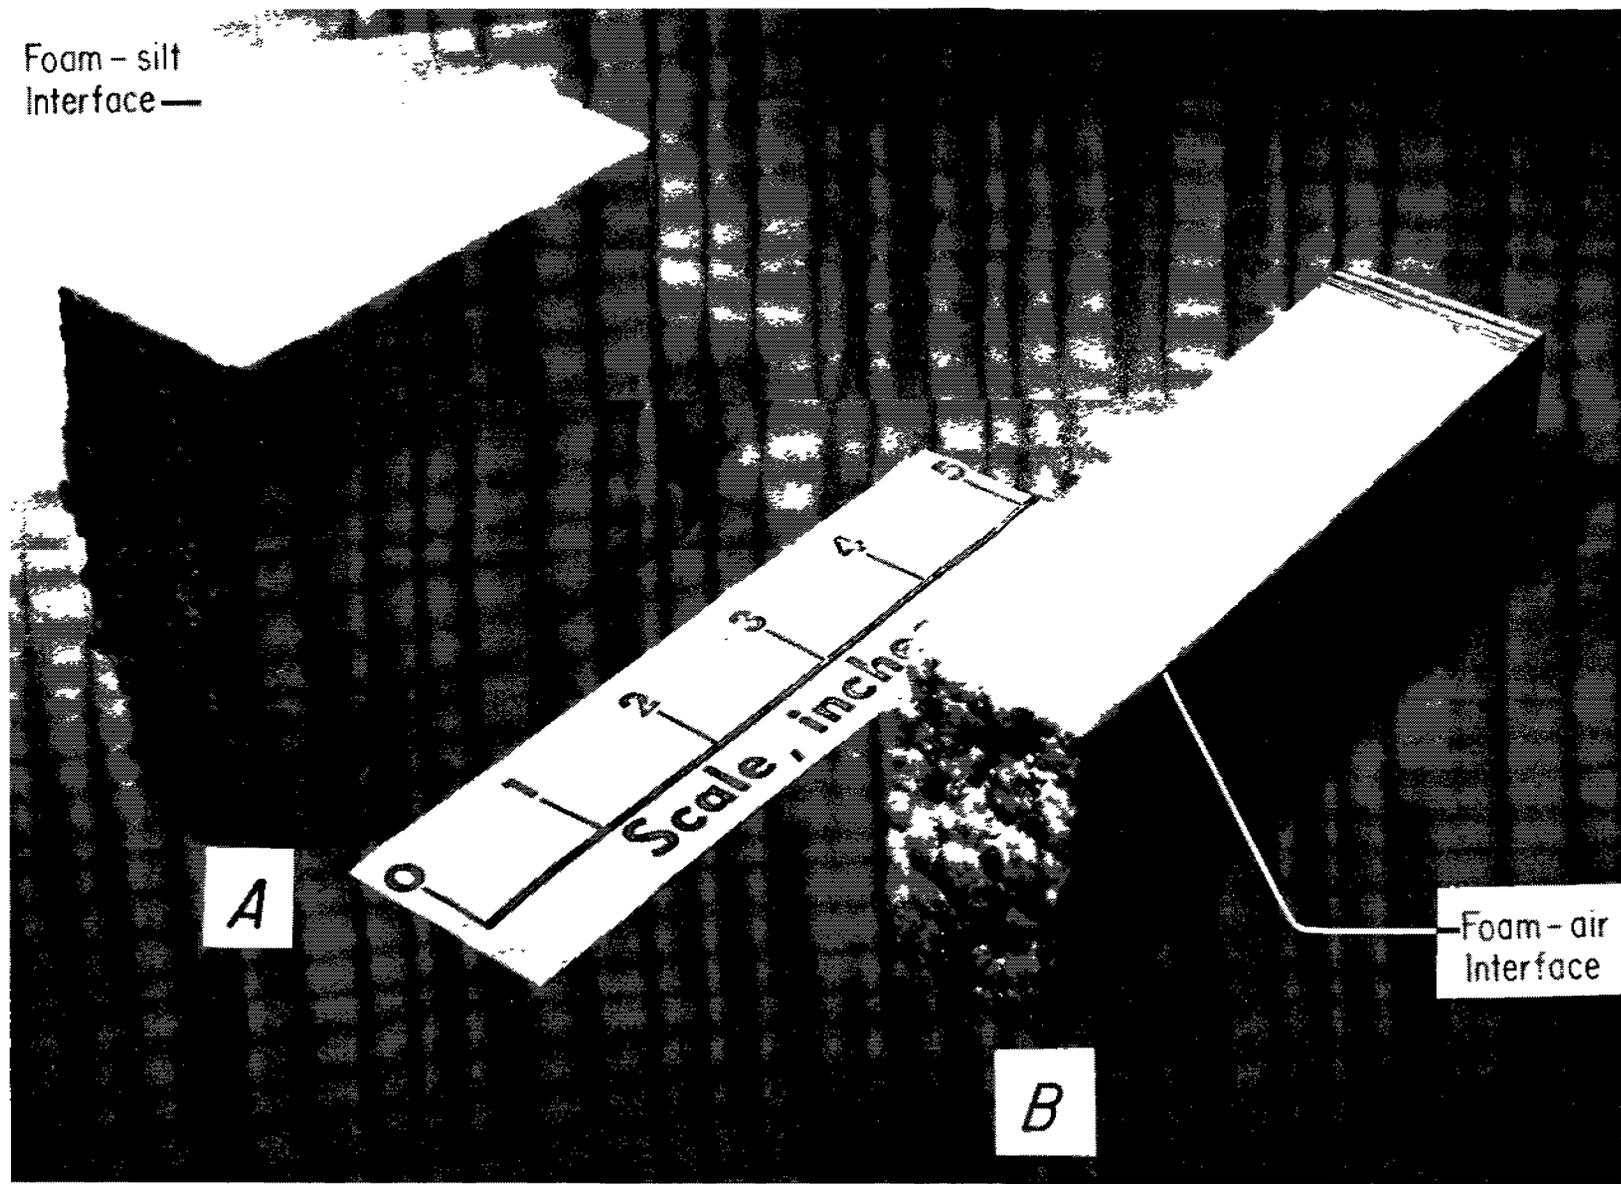
FIGURE 14. - Samples of Cured Foam. *A*, Sprayed on frozen silt; *B*, sprayed on bulkhead.

One observed property of the cured material could create difficulties with some types of applications. As the foam rises and hardens, considerable stresses evidently are produced within the material. When the material was being trimmed from around the door of the gravel room, a system of cracks, running to the extremities of the bulkhead, instantaneously developed radially from the point where the knife first penetrated the foam layer. The cracks later were filled with conventional rock-wool insulation. No cracking was observed, however, in the foam that was in contact with the frozen ground.

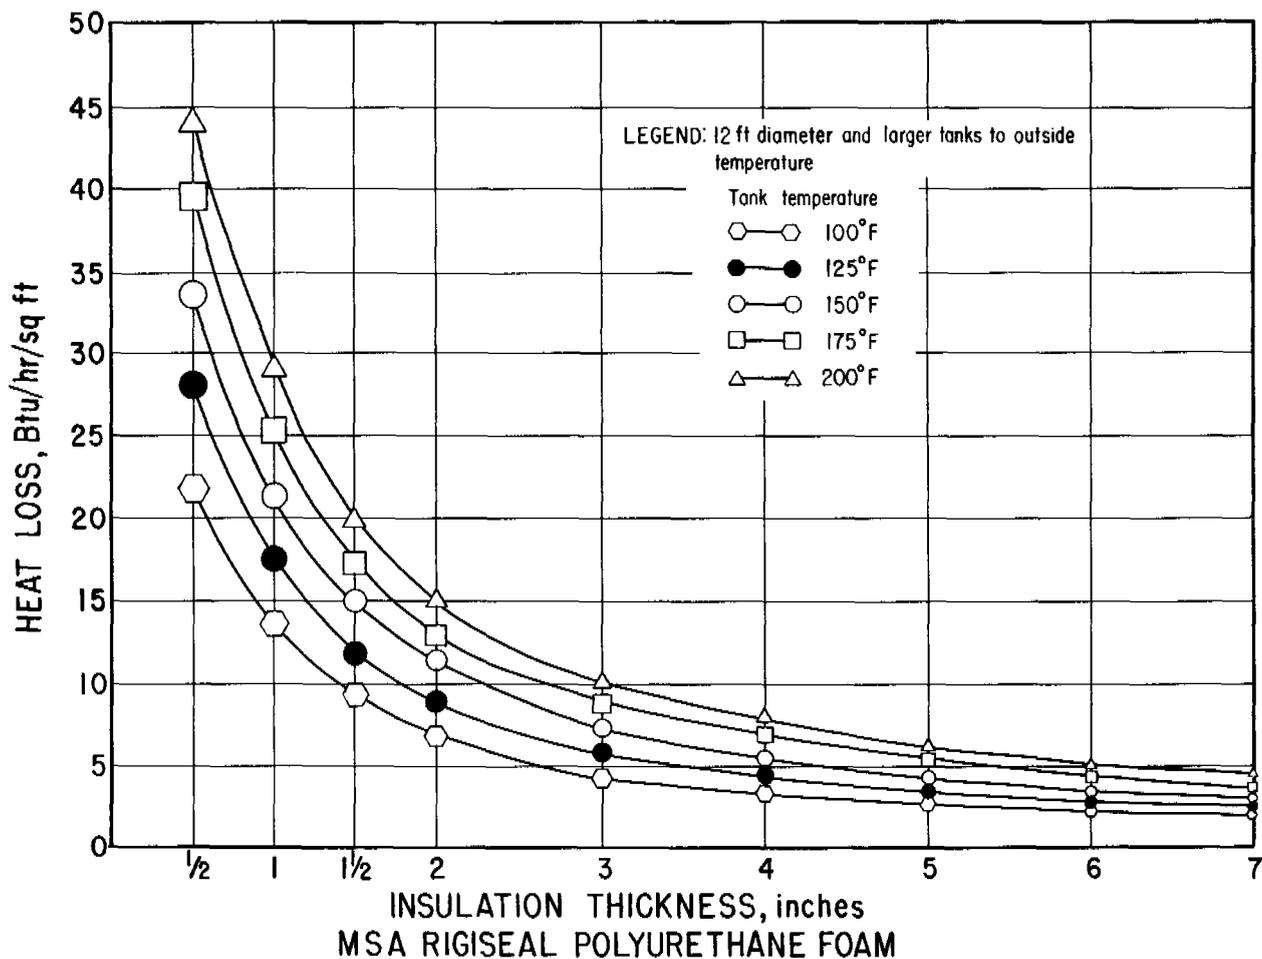
FIGURE 15. - Effect of Insulation Thickness on Heat Loss.  
(Courtesy, Mine Safety Appliances Company)
