**RI** bureau of mines  
report of investigations **7392**

**SPRAY-APPLIED POLYURETHANE  
FOAM TO INSULATE HEATED ROOMS  
EXCAVATED IN PERMAFROST**

June 1970

By K. Robert Dorman and Aldon E. Gooch

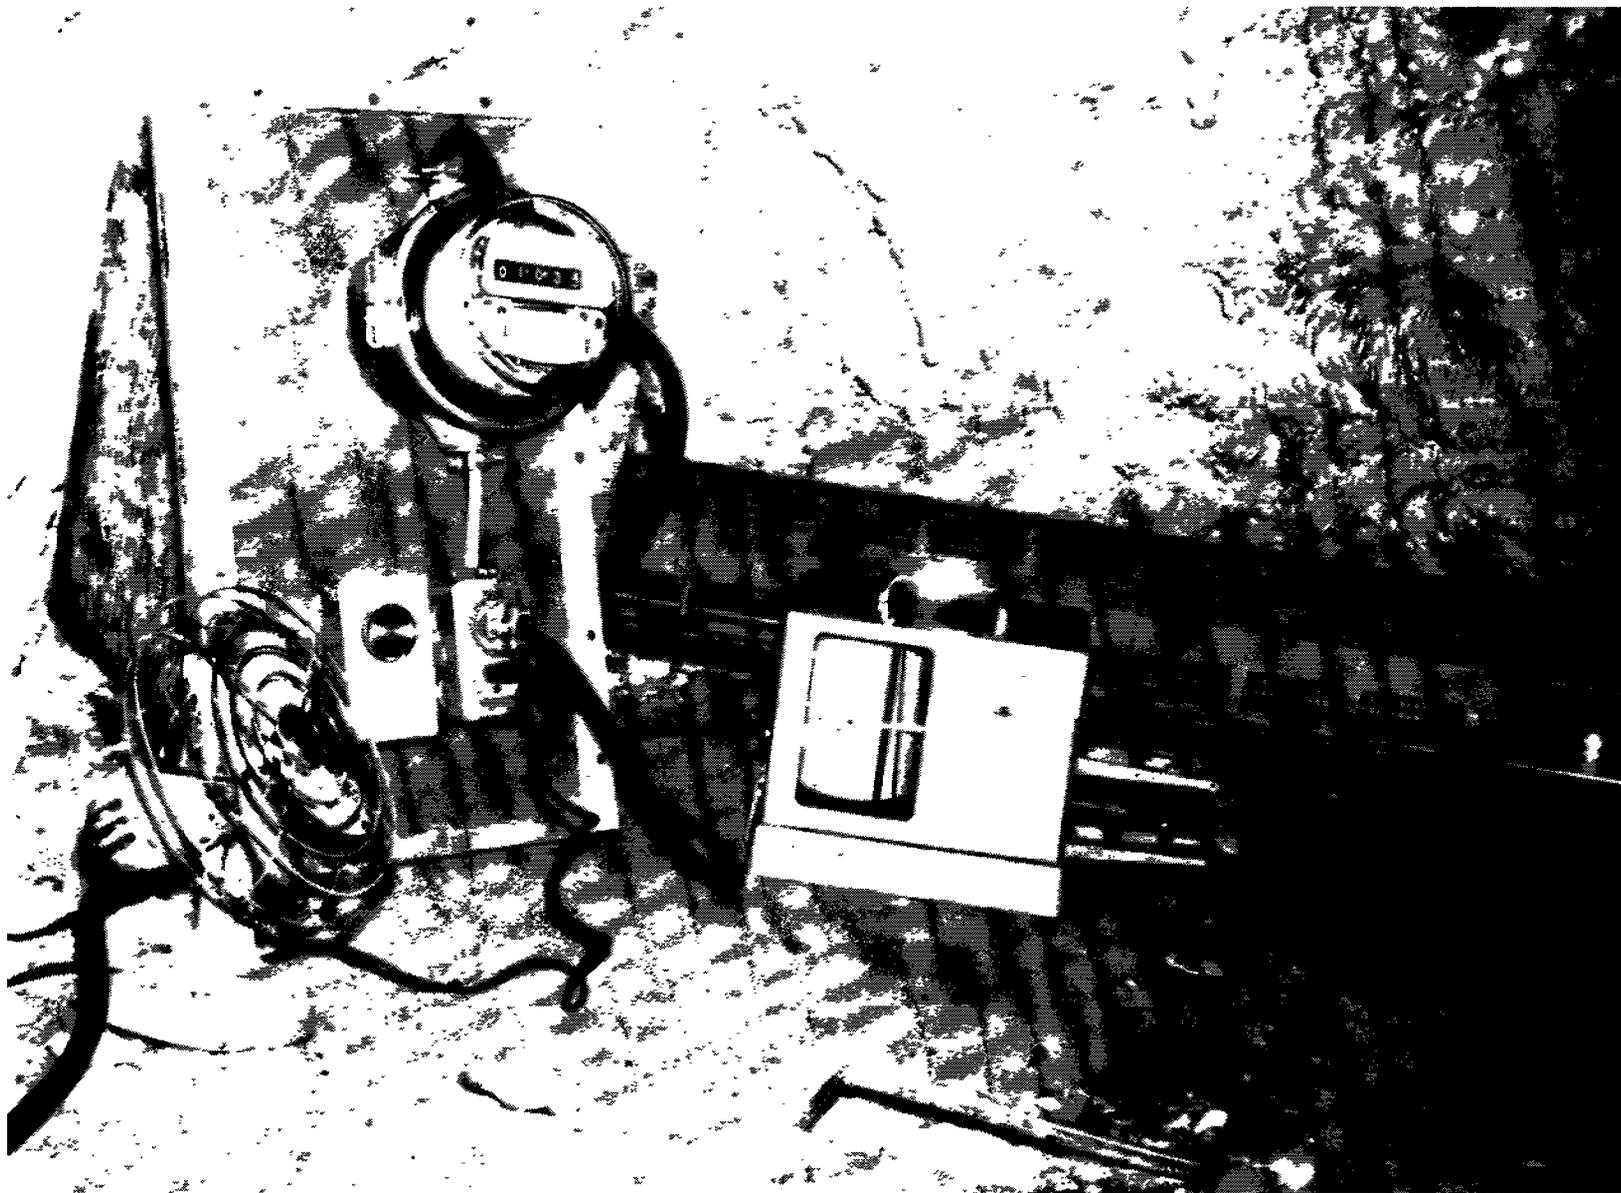
FIGURE 16. - Heating and Monitoring Equipment Inside Foamed Room.

After foaming was completed, each room was equipped with an electrical, thermostatically controlled strip heater and small table-type circulating fan. Temperature within a room was monitored continuously with a thermograph.

The day following application, the foam was cut and trimmed from around the doors. A strip heater, fan, watt-hour meter, and thermograph (fig. 16) were installed in each room, and initial temperature and closure readings were made. Heat was introduced in the silt room on January 27, 1969, and in the gravel room on February 20, 1969.

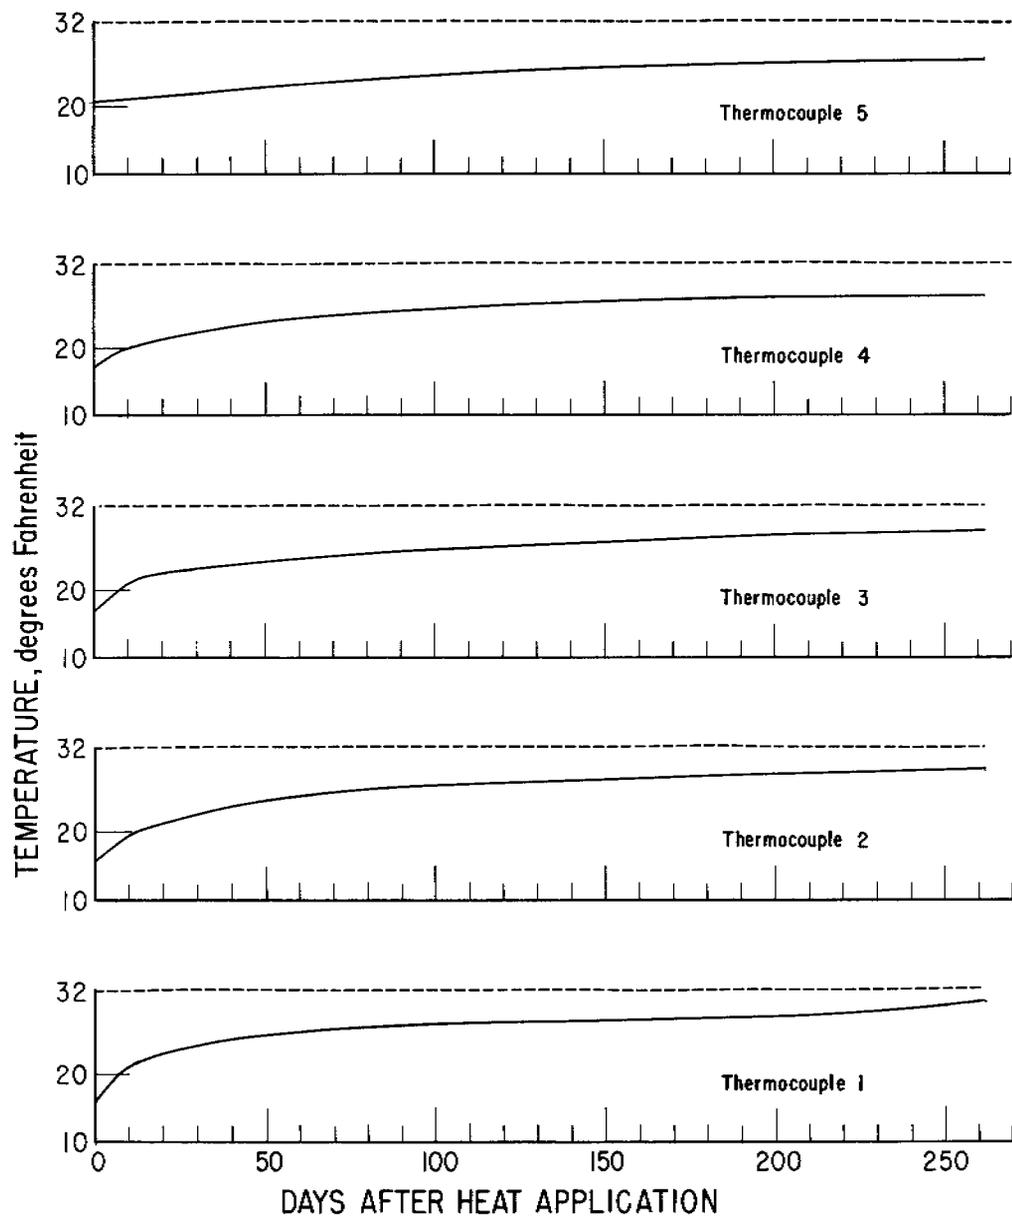
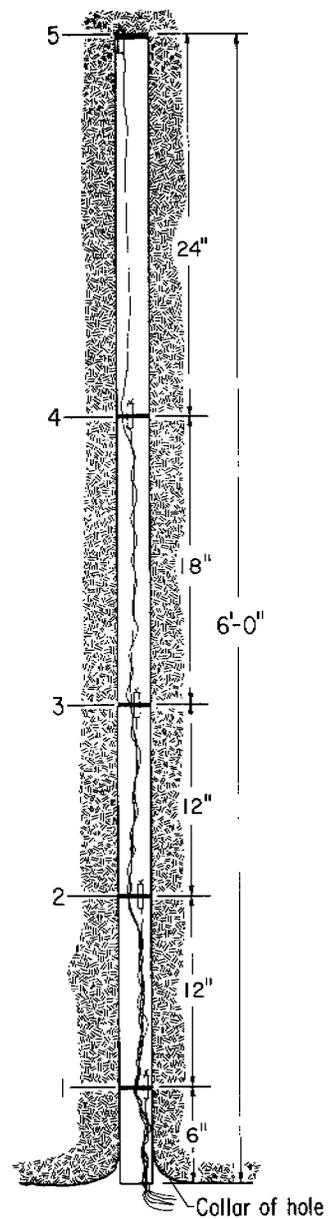
FIGURE 18. - Thermocouple Readings, Back of Silt Room.

Temperatures maintained in the silt and gravel rooms averaged  $57^{\circ}$  and  $51^{\circ}$  F, respectively. The transfer of heat across the insulating barrier and its migration into the frozen walls are shown by thermocouple readings in figures 18-27. A comparison of the graphs indicates that the walls of the silt room were colder than those of the gravel room at the time of insulation; the reason was that the silt room was excavated on December 4, 1968, the gravel room excavated on January 13, 1969, and the rooms were foamed on January 21, 1969. This difference in original temperatures is reflected in the greater rate of closure and total closure in the gravel room. Closures for the period between June 6, 1969 (the date the new invar measuring rod was first used), and September 23, 1969 (the day following discontinuation of heating in the gravel room), are presented in figure 28. The rate of horizontal closure increased in both rooms about the first of September. During the middle of August, vertical closure in the gravel room accelerated. It is not established whether vertical closure rate also increased in the silt room, for at this time vertical closure readings were discontinued in this room because the height had become too small to accommodate the measuring device.

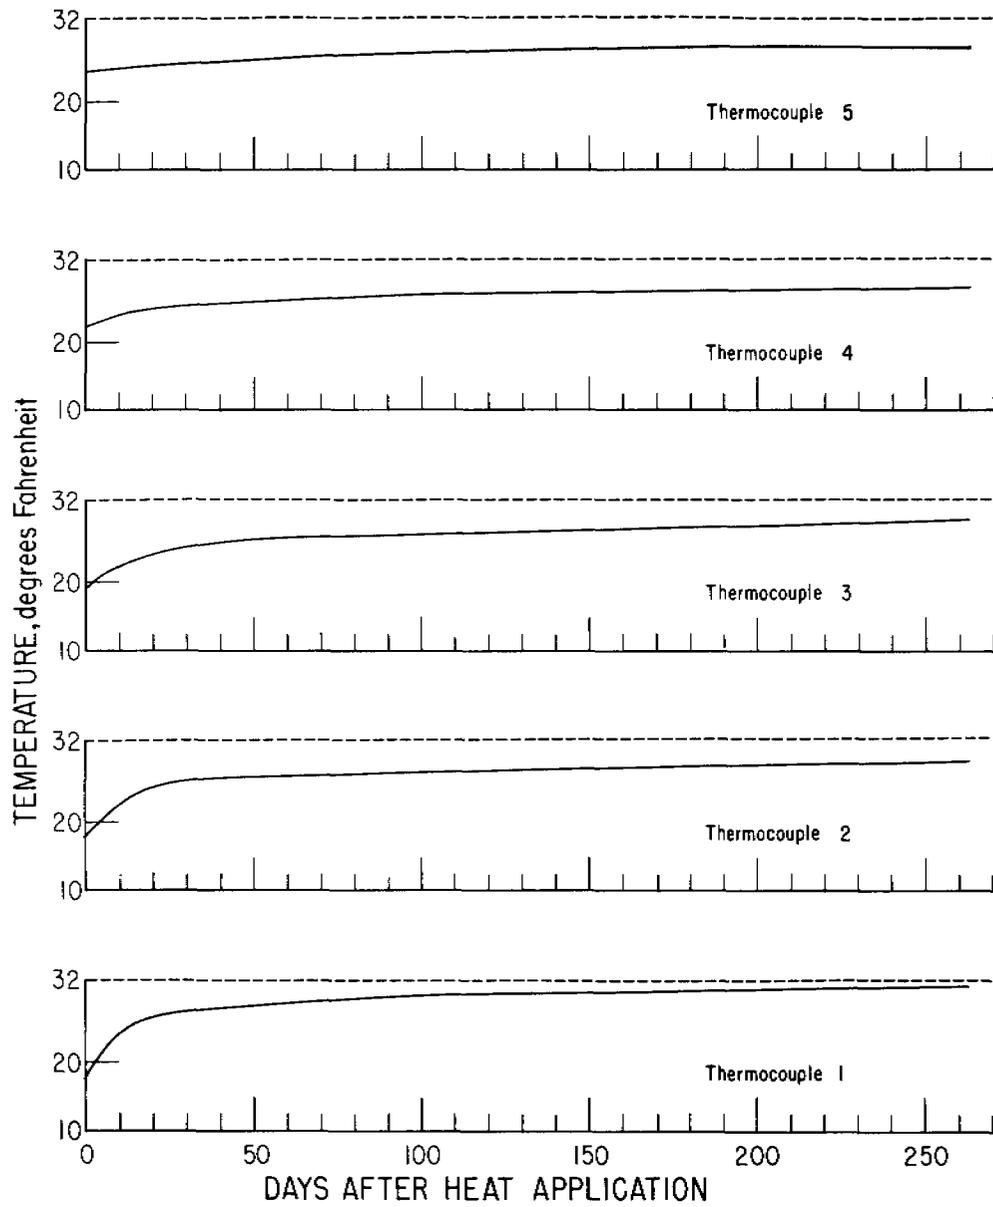
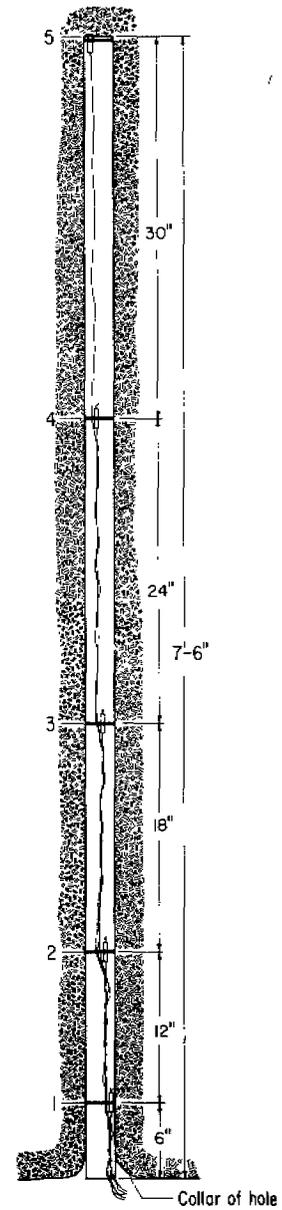
FIGURE 19. - Thermocouple Readings, End Wall of Silt Room.

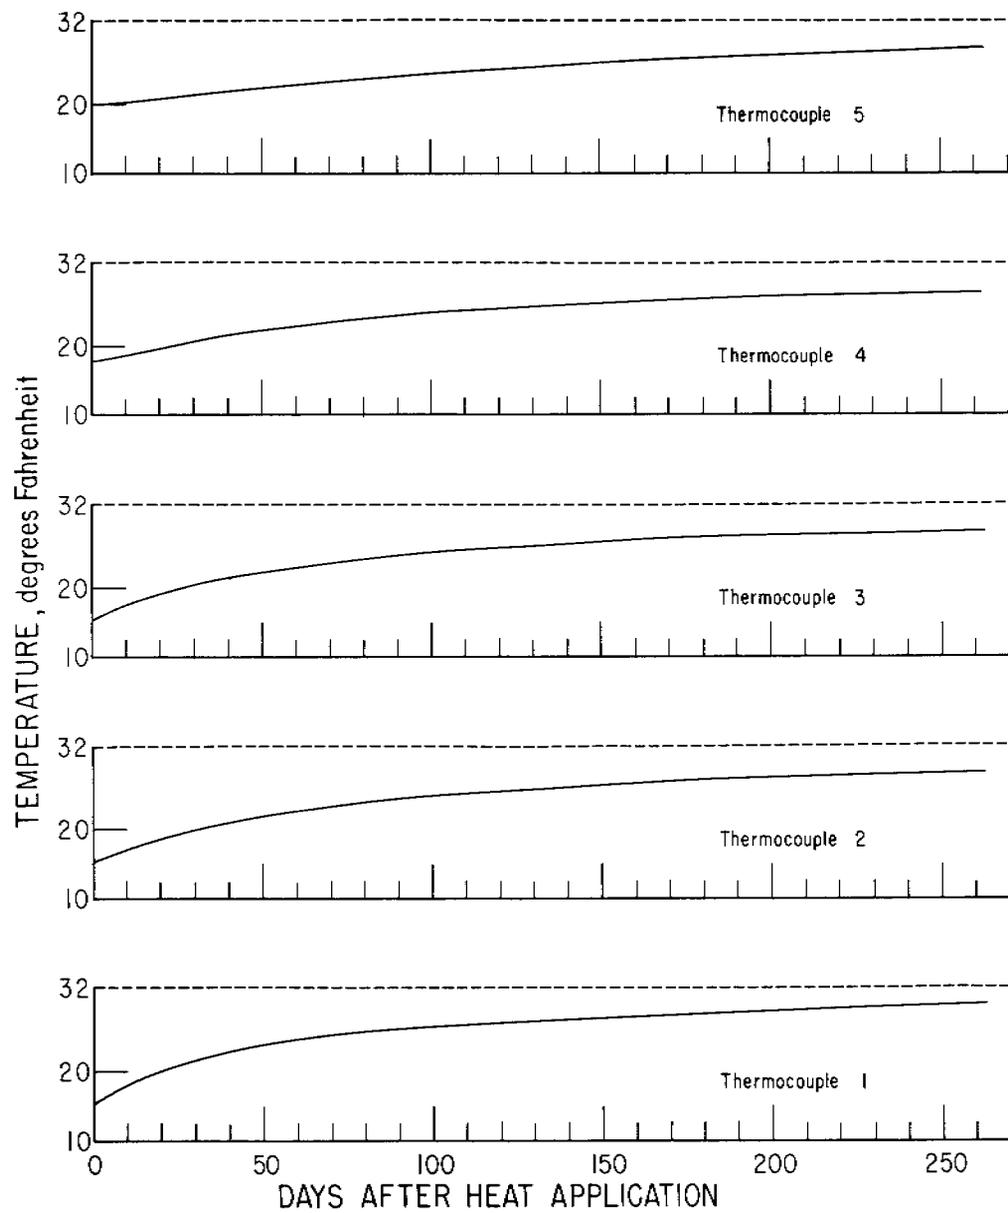
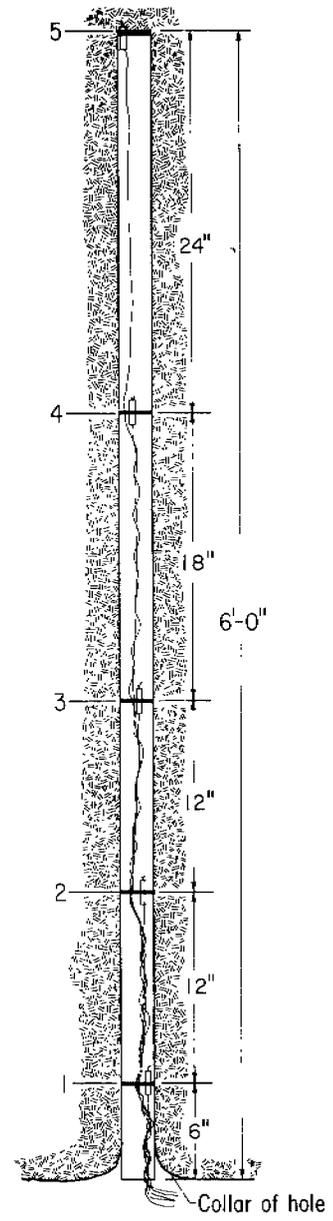
FIGURE 20. - Thermocouple Readings, Side Wall of Silt Room.

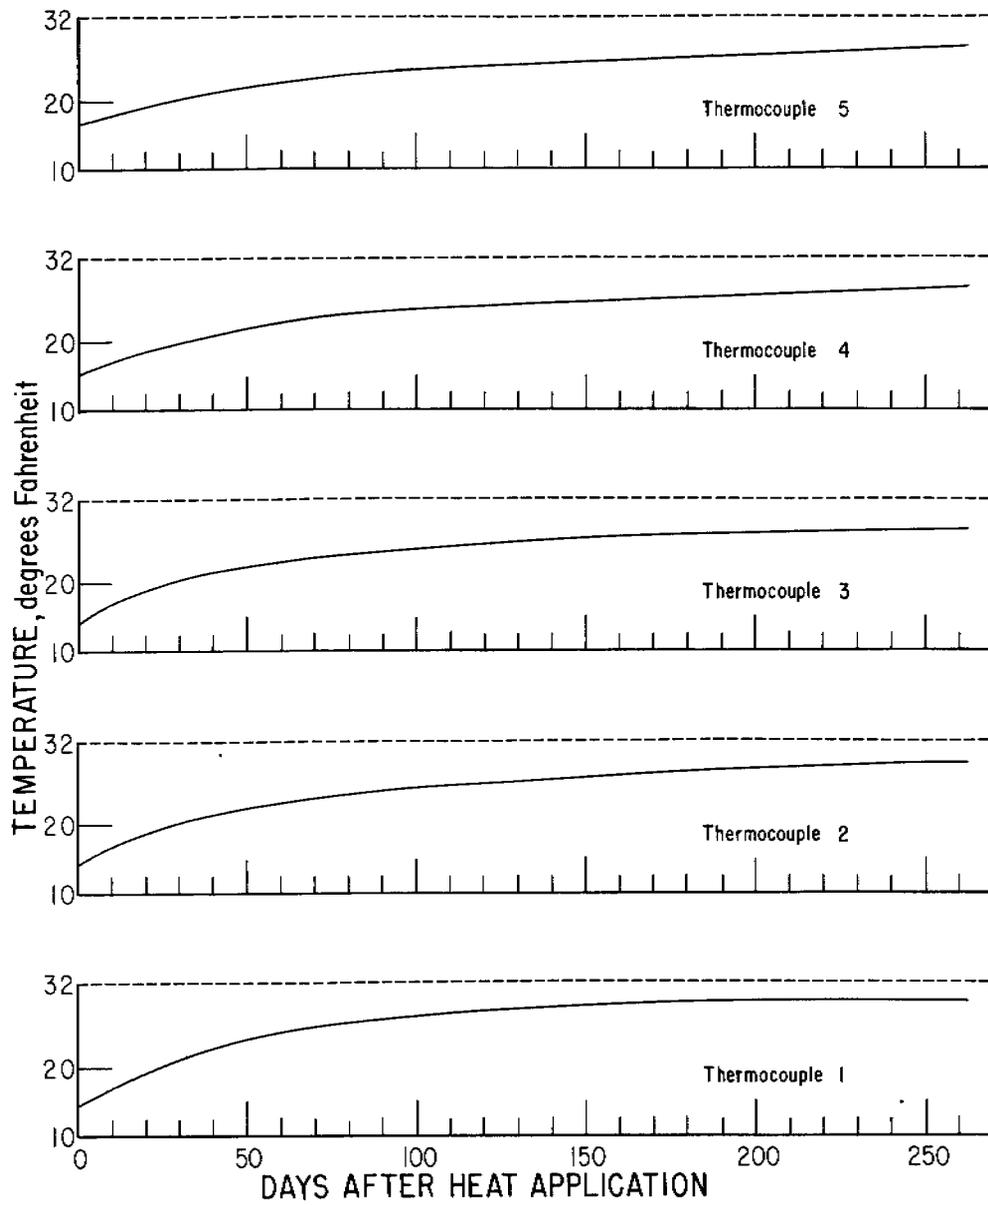
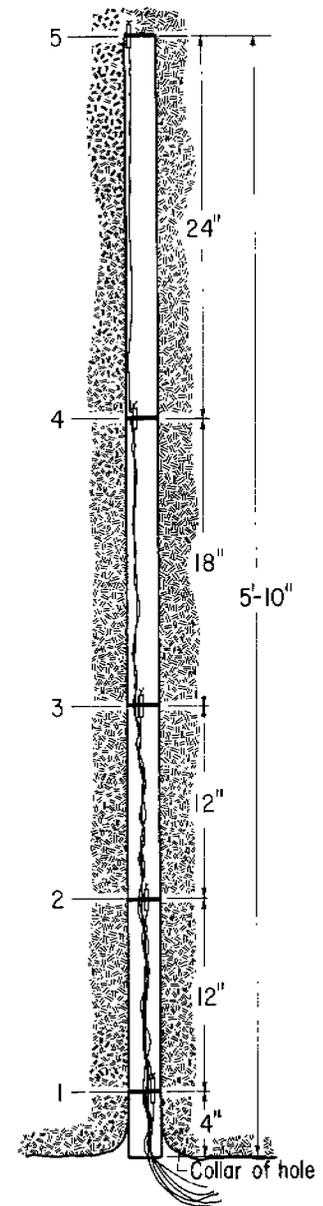
FIGURE 21. - Thermocouple Readings, Sill of Silt Room.

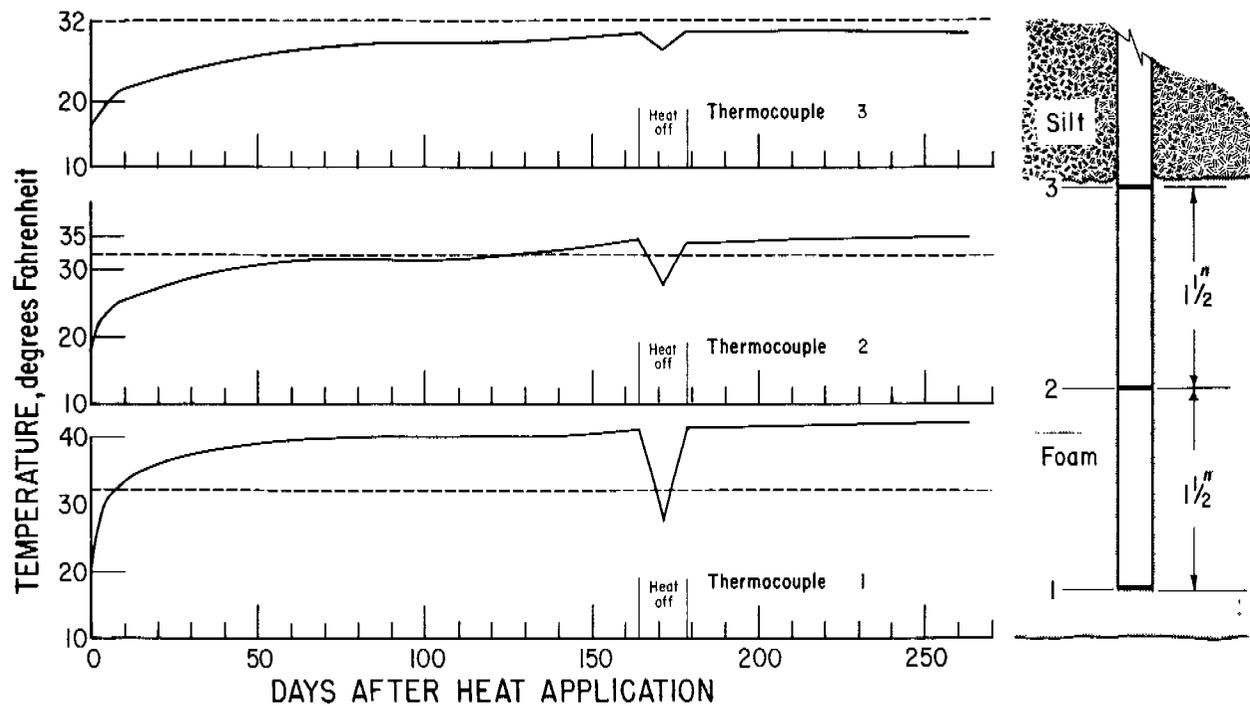
FIGURE 22. - Thermocouple Readings, Insulation in Silt Room.

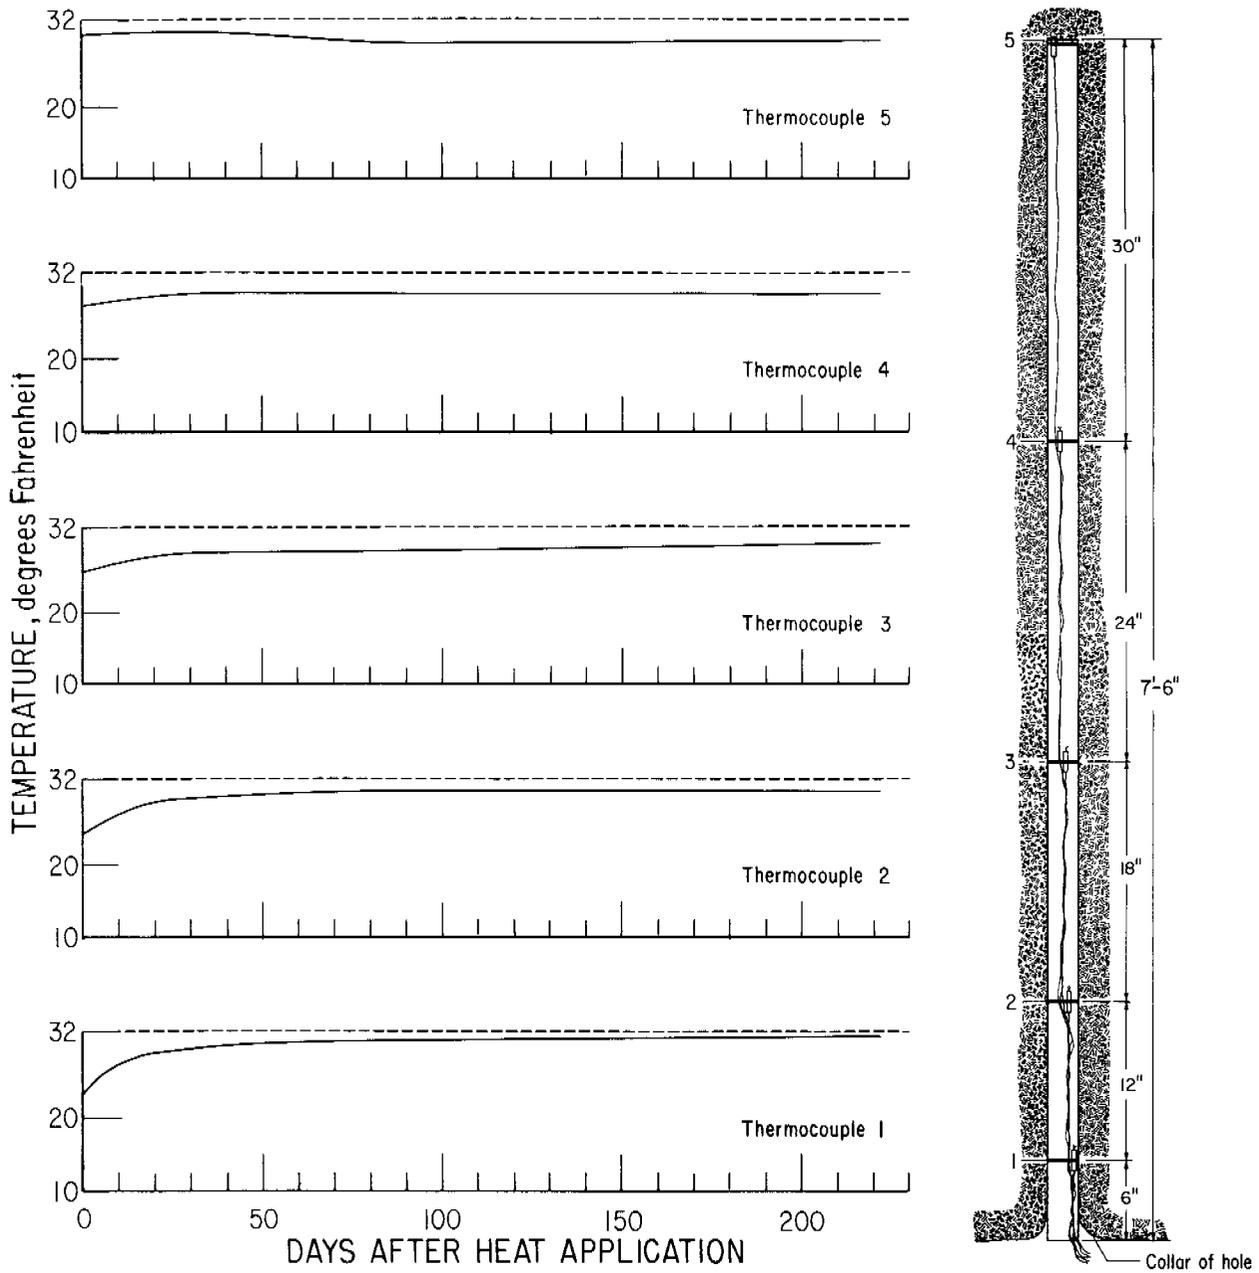
FIGURE 23. - Thermocouple Readings, Back of Gravel Room.

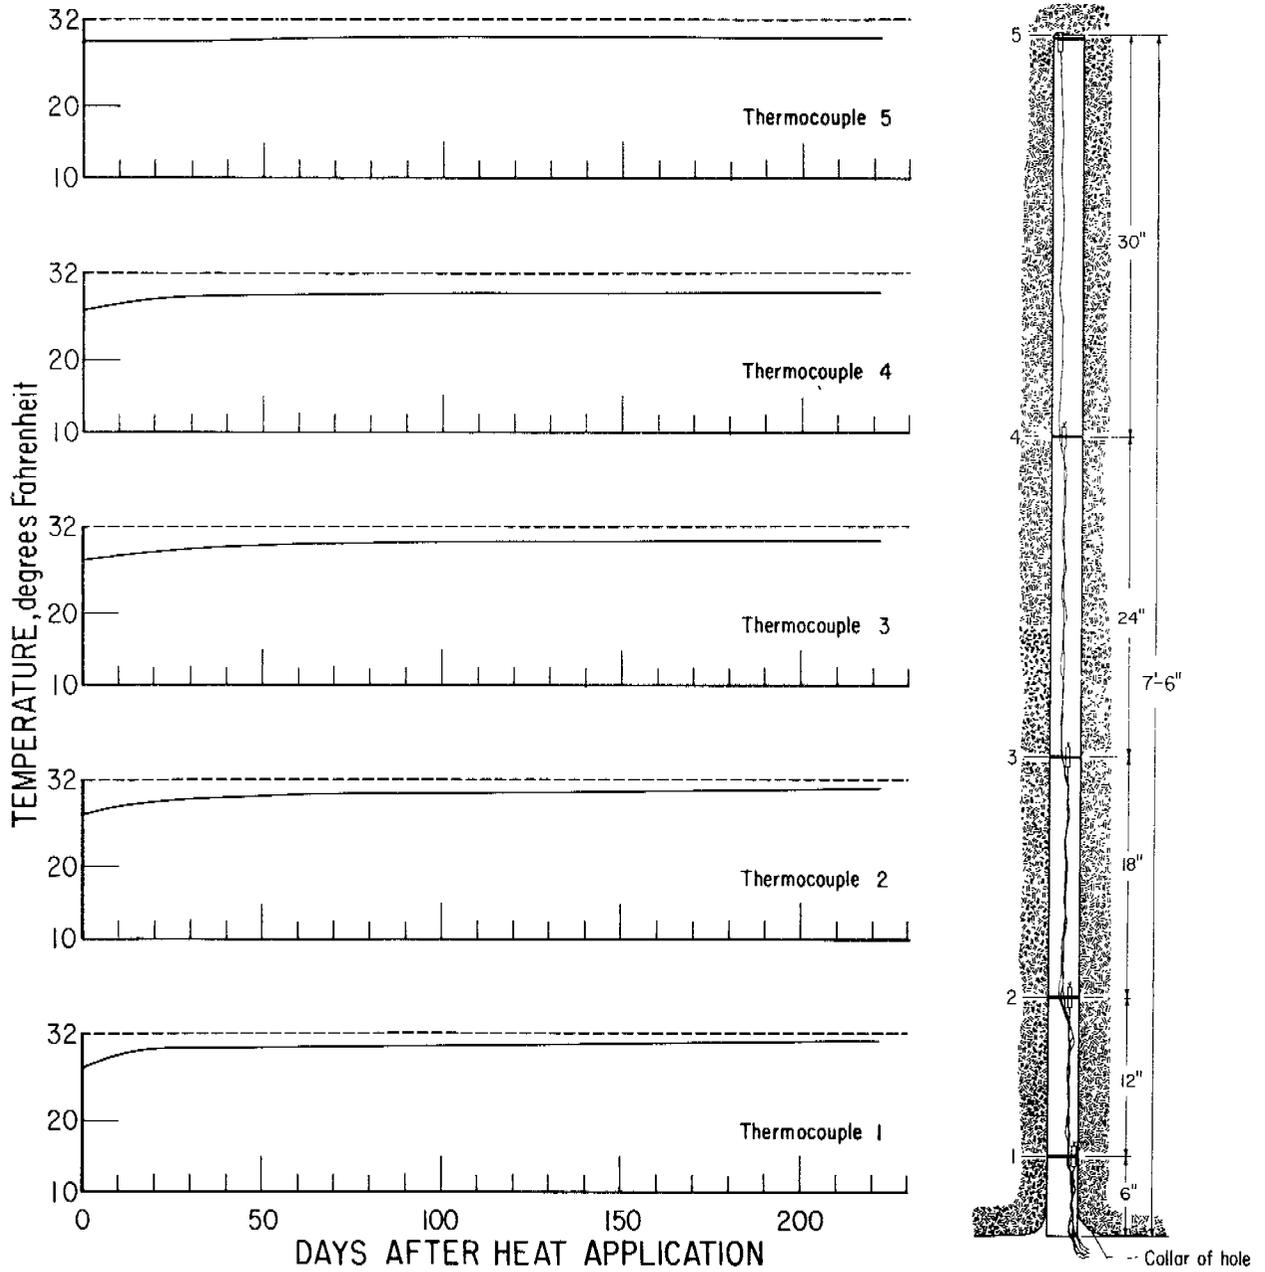
FIGURE 24. - Thermocouple Readings, End Wall of Gravel Room.

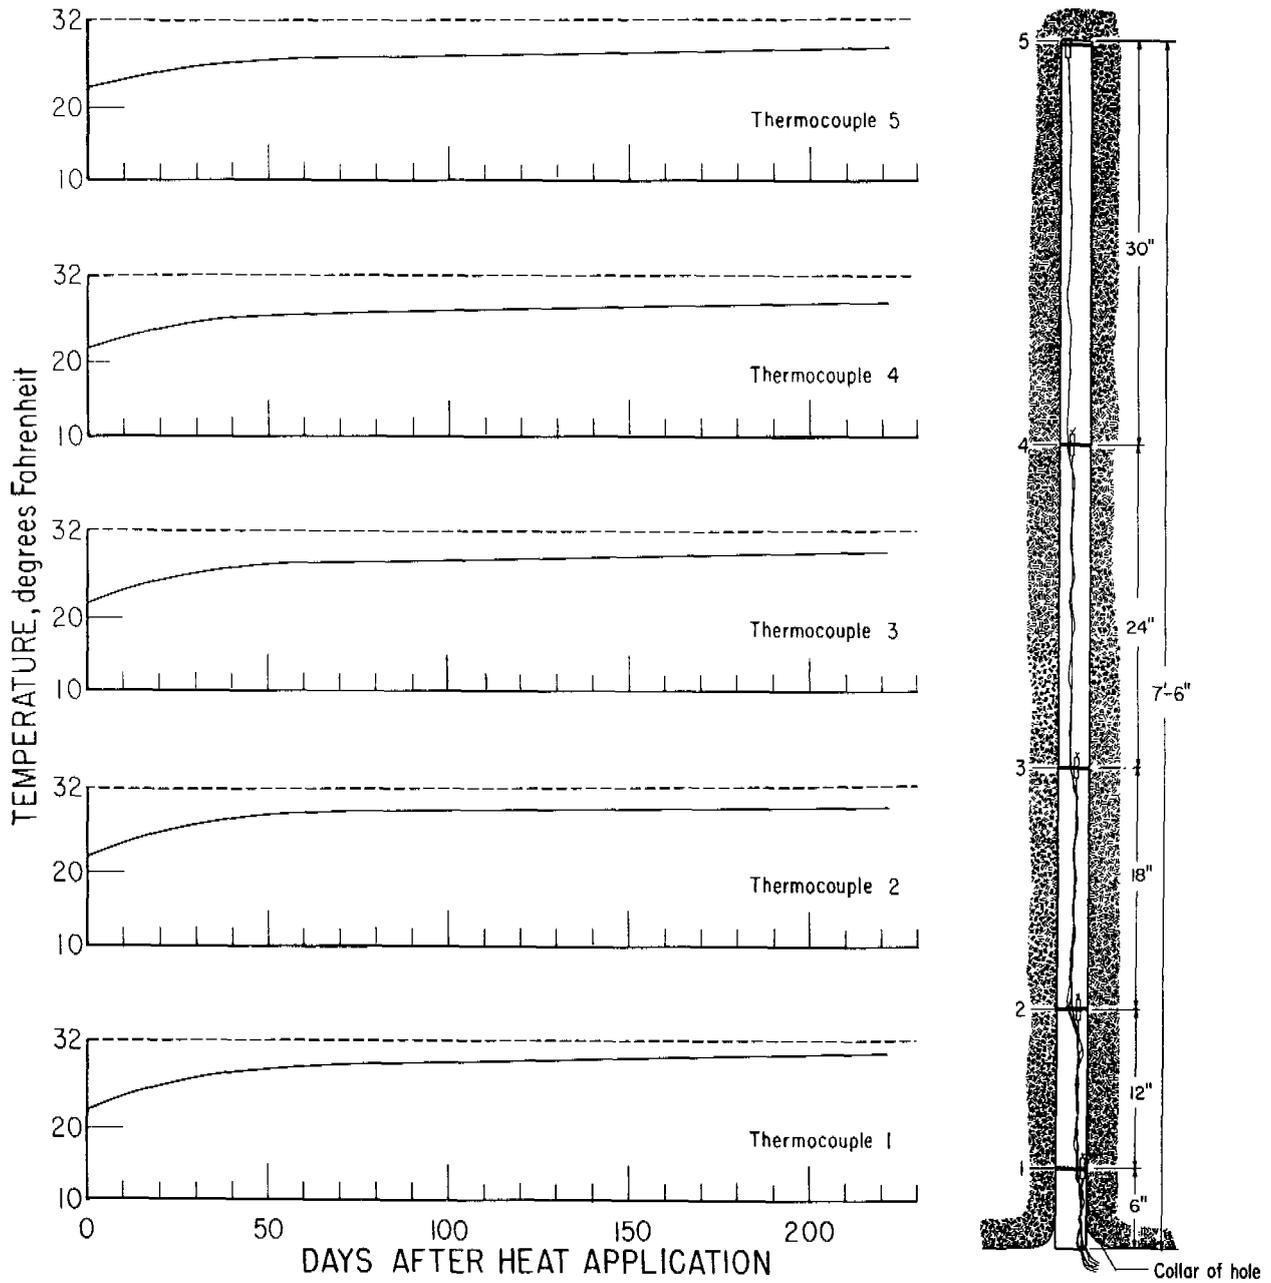
FIGURE 25. - Thermocouple Readings, Side Wall of Gravel Room.

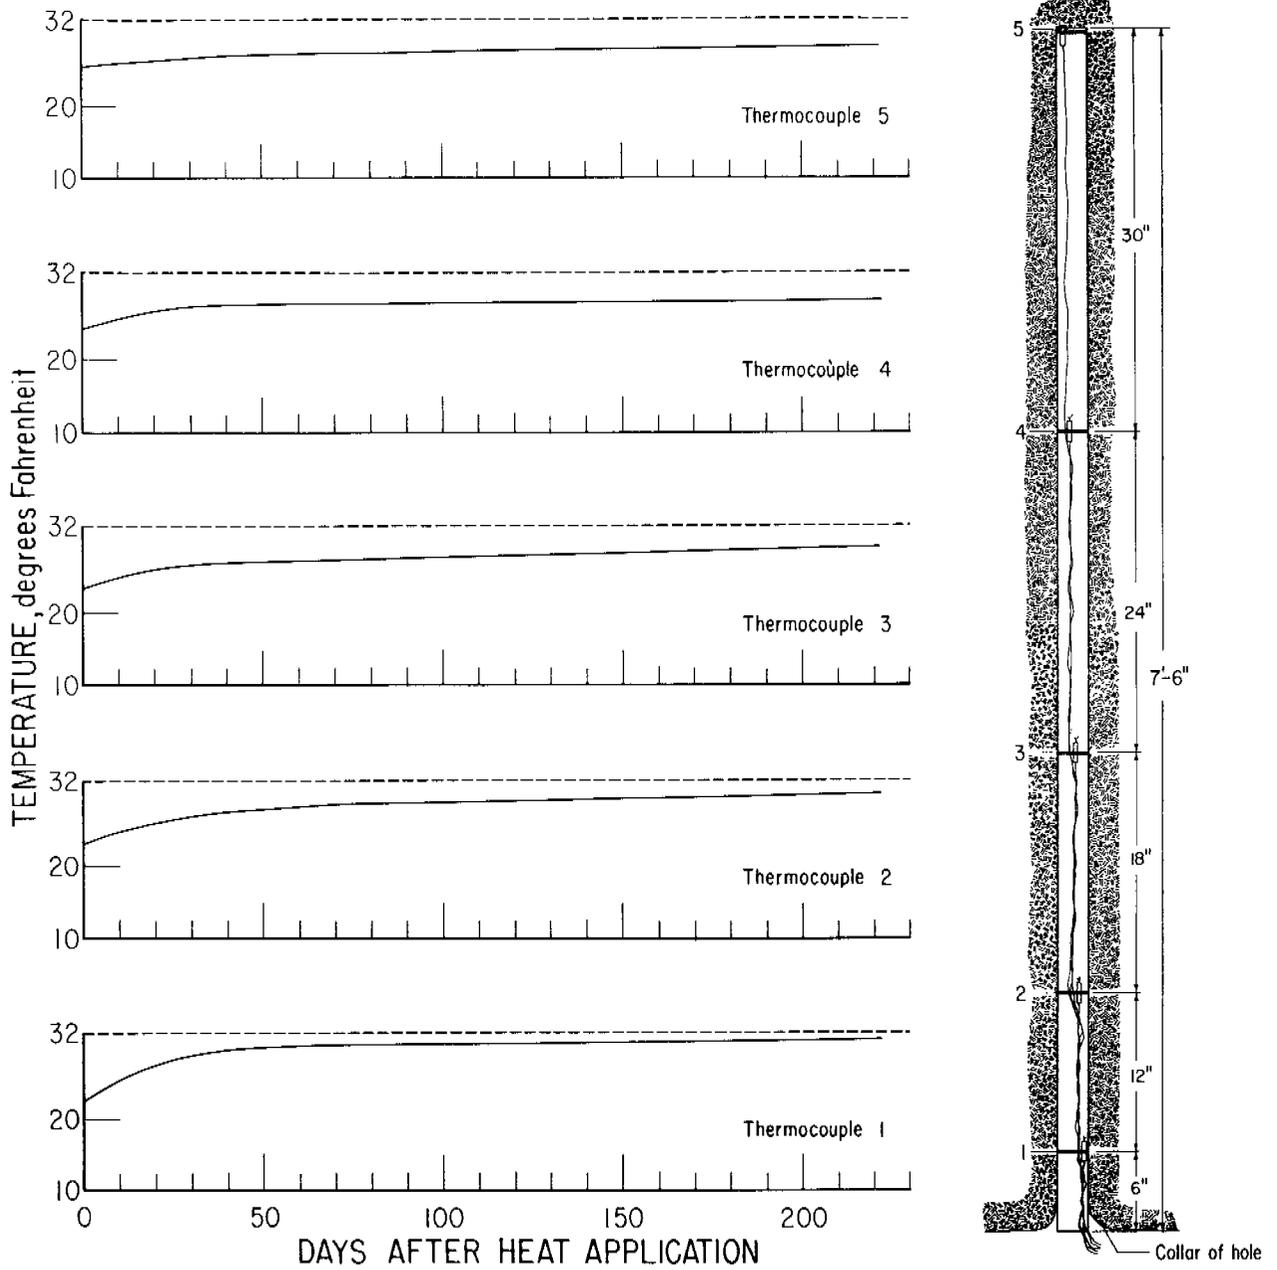
FIGURE 26. - Thermocouple Readings, Sill of Gravel Room.

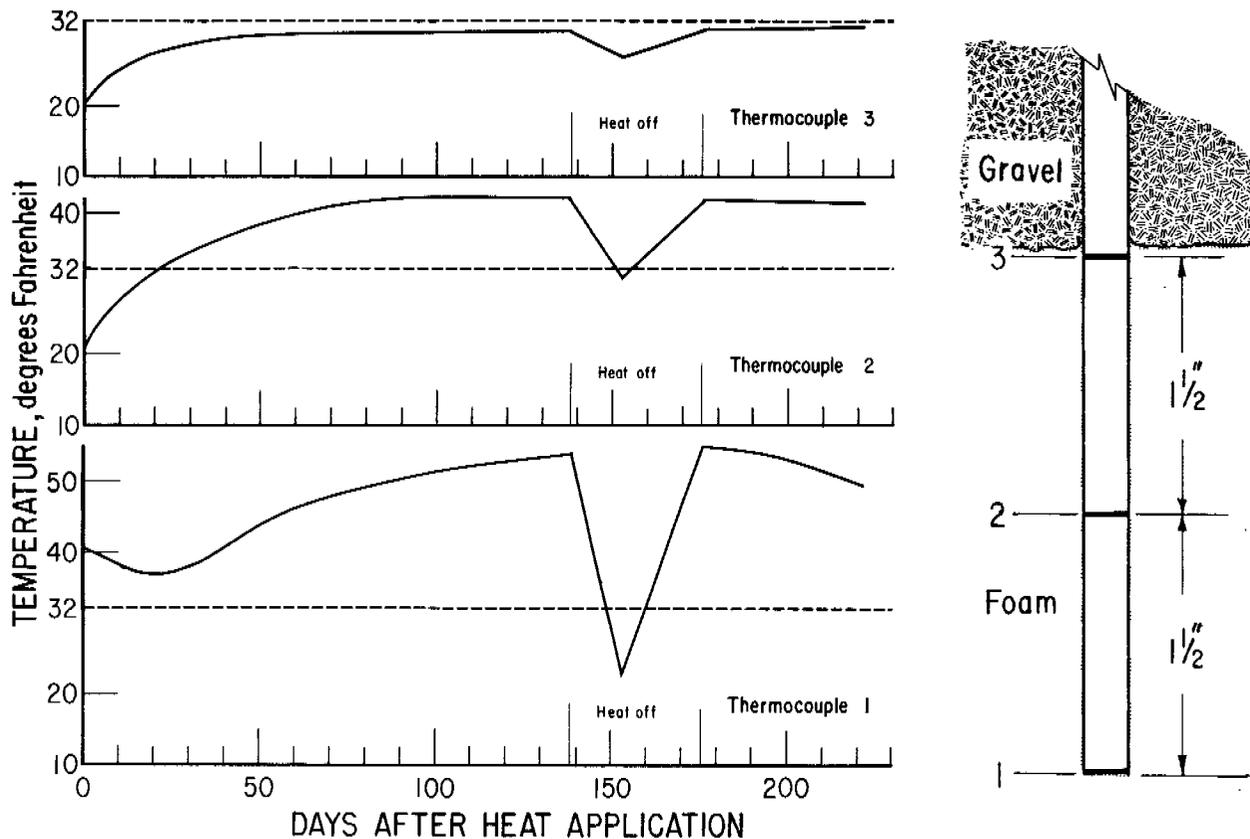
FIGURE 27. - Thermocouple Readings, Insulation in Gravel Room.

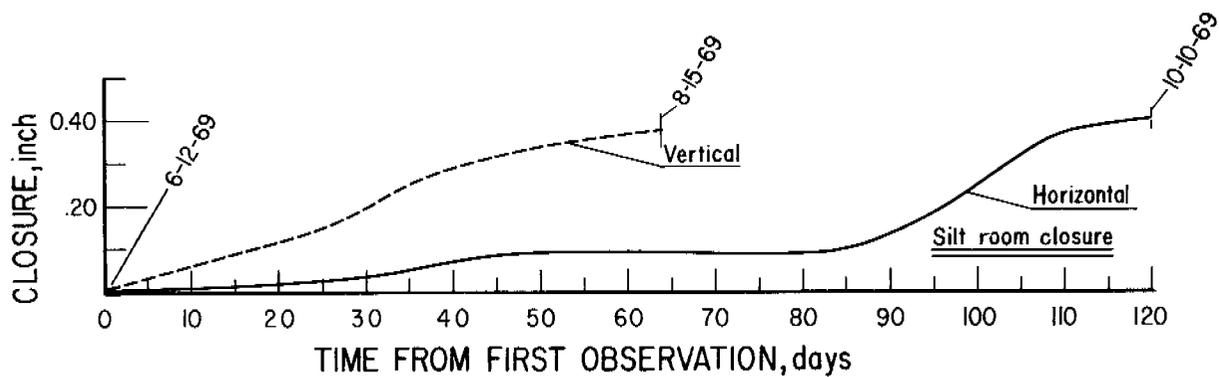
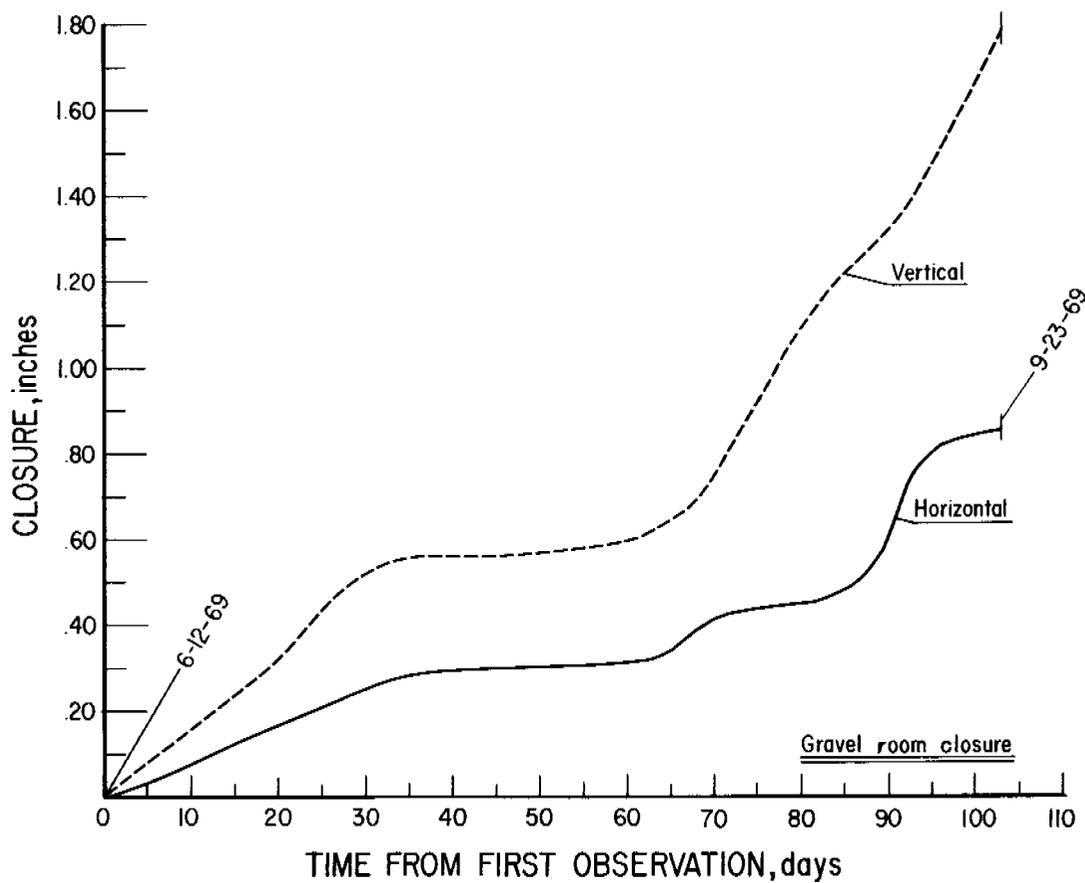
FIGURE 28. - Closure of Heated Insulated Rooms.

An analysis of temperature reading in the walls indicates no apparent reason for the increases in closure rates in either foamed room. On August 7, 1969, the room adjacent to the foamed gravel room (fig. 9) was bulkheaded to allow ambient-air temperature to rise from 25° (result of refrigeration) to 28° F. As a direct consequence of air-temperature rise, the larger room exhibited an increase in vertical closure rate beginning the middle of August. This acceleration of closure in the larger adjacent room undoubtedly affected the closure rate of the foamed gravel room. However, no explanation has been found for the increase in horizontal closure rates of both foamed rooms approximately 2 weeks later.

Total closures from February 12 to October 24, 1969, as measured by steel tape, are given in table 5. Vertical closure of the gravel room was 2.4 times that of the silt room. Horizontal closure was 5.9 times that of the silt room. At least part of this difference can be attributed to the fact that the walls of the silt room were colder than those of the gravel room at the time insulation was applied. This condition still existed when heating and monitoring were discontinued. Figure 29 shows the effect of temperature on the strain of a frozen Manchester fine sand which is under compressive loading. The graph was constructed mathematically, using data derived by Sayles (8). The values are based upon an assumed 200 feet of overburden, averaging 120 pcf, acting over a 6-month period. Though these strain values are based upon laboratory results of unconfined compression tests on sand, the effect of temperature upon roof or wall closure in the silt and gravel rooms would be similar. Other factors that probably contributed to the differences in closure were differences in insulation thickness and physical properties of the surrounding medium.

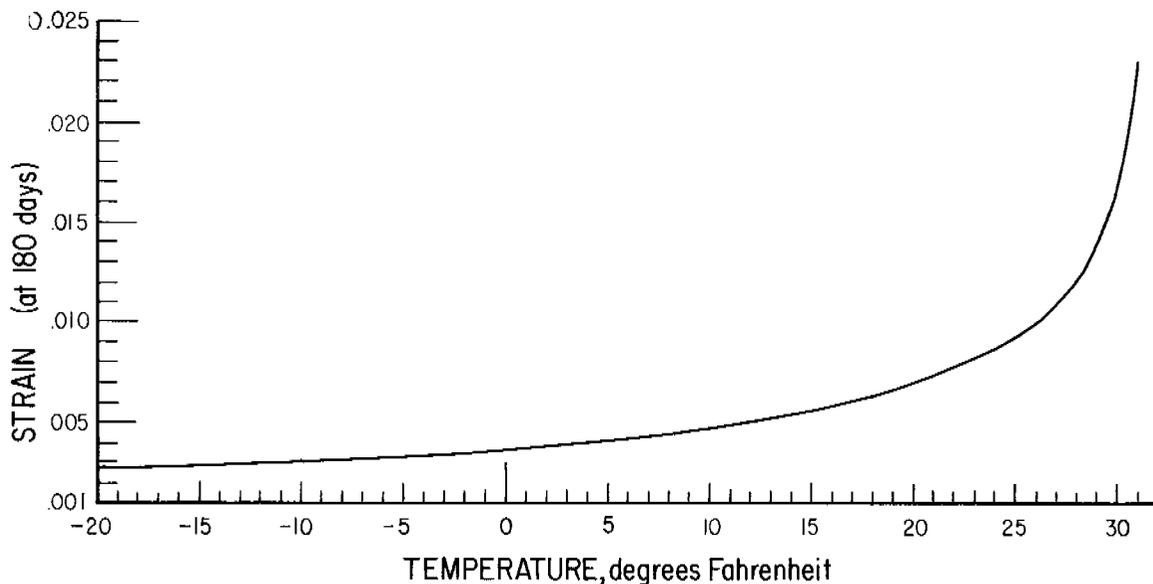
$$\epsilon = \left[ \frac{\sigma}{\sigma_{0i} (\theta + 1)^a} \right]^{1/k} \frac{t^\psi}{\psi} + \epsilon_0$$

Formula and constants from  
"Creep of Frozen Sands" by Sayles(8)

FIGURE 29. - Effect of Temperature on Strain of Frozen Sand.

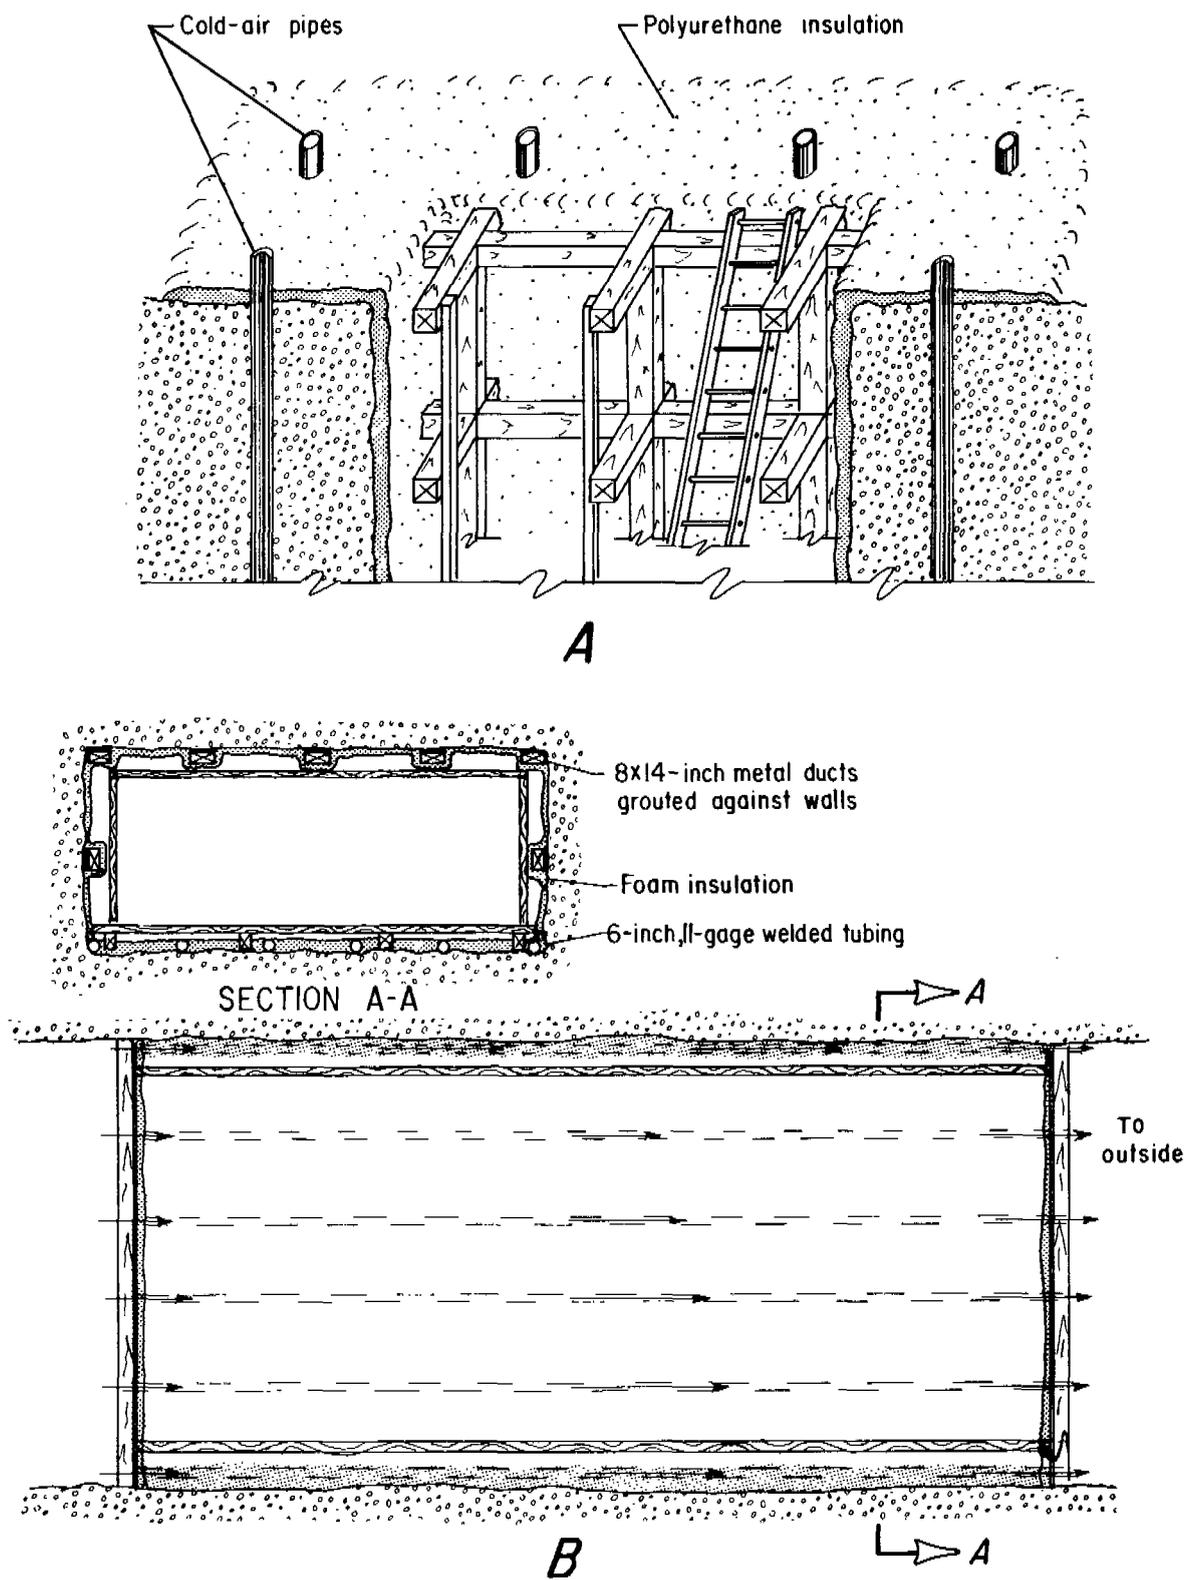
FIGURE 30. - Proposed Method of Maintaining Shaft or Heated Room in Permafrost.  
A, Shaft; B, heated room.

Obviously, it is desirable to exploit the extreme cold of winter whenever possible. A proposed method would utilize the winter cold to annually super-cool the zone surrounding an insulated opening in permafrost.

Rectangular ducts placed against the walls of the underground room afford passage for forced cold air during the winter months. The ducts are sealed during the summer.

In both schemes, the use of casing or ducts is necessary to prevent sublimation. Because creep cannot be entirely eliminated, soft squeeze blocking is required. With the scheme illustrated in figure 30, it should be possible to maintain a shaft or a heated room in permafrost for several years.
