PHOTOGRAPHS ILLUSTRATING THE VARIABILITY OF GLACIER DAMMED LAKES

GLACIER DAMMED LAKES AND OUTBURST FLOODS IN ALASKA

By
Austin Post and Lawrence R. Mayo
1971

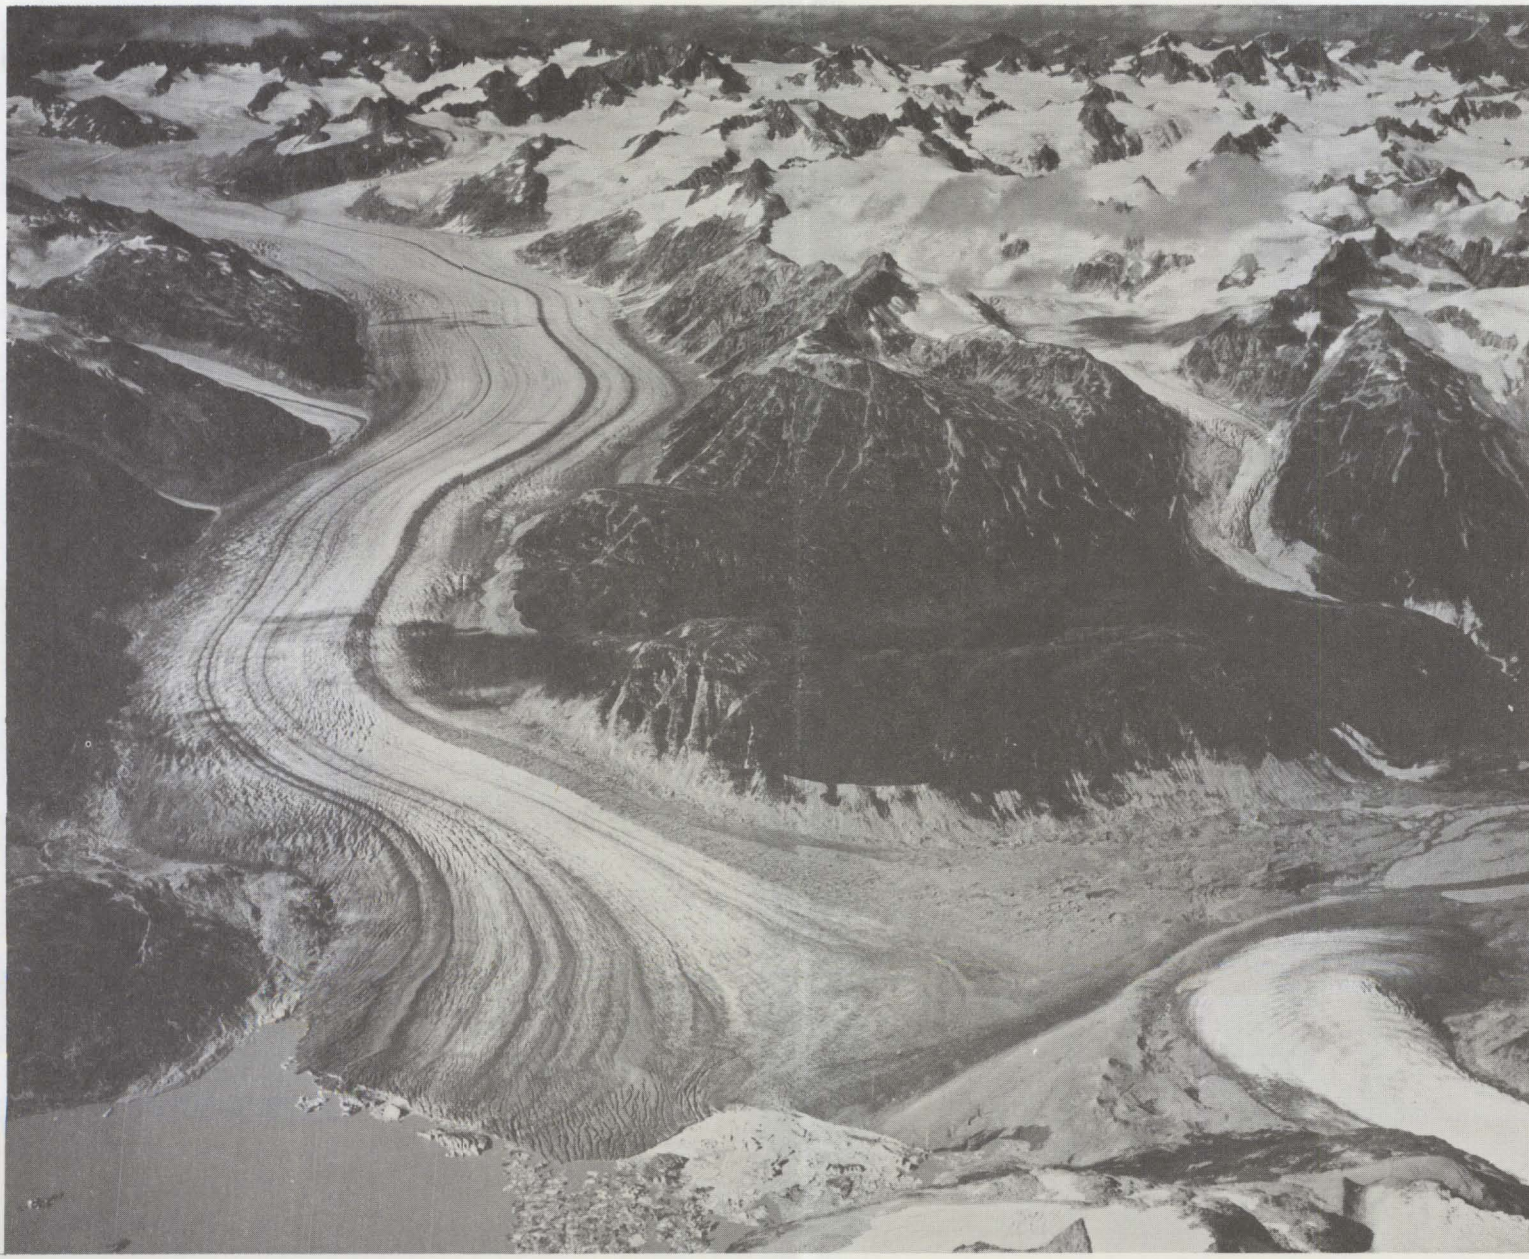
SUMMIT LAKE FILLED TO NEAR MAXIMUM LEVEL

SUMMIT LAKE (NO. 32) WHICH IS DAMMED BY AN UNNAMED GLACIER IN THE CHIGMIT MOUNTAINS. THIS PHOTOGRAPH, TAKEN IN AUGUST 1963, SHOWS THE LAKE NEAR ITS MAXIMUM LEVEL AND ICEBERGS ARE BEING DISCHARGED FROM THE GLACIER MARGIN.

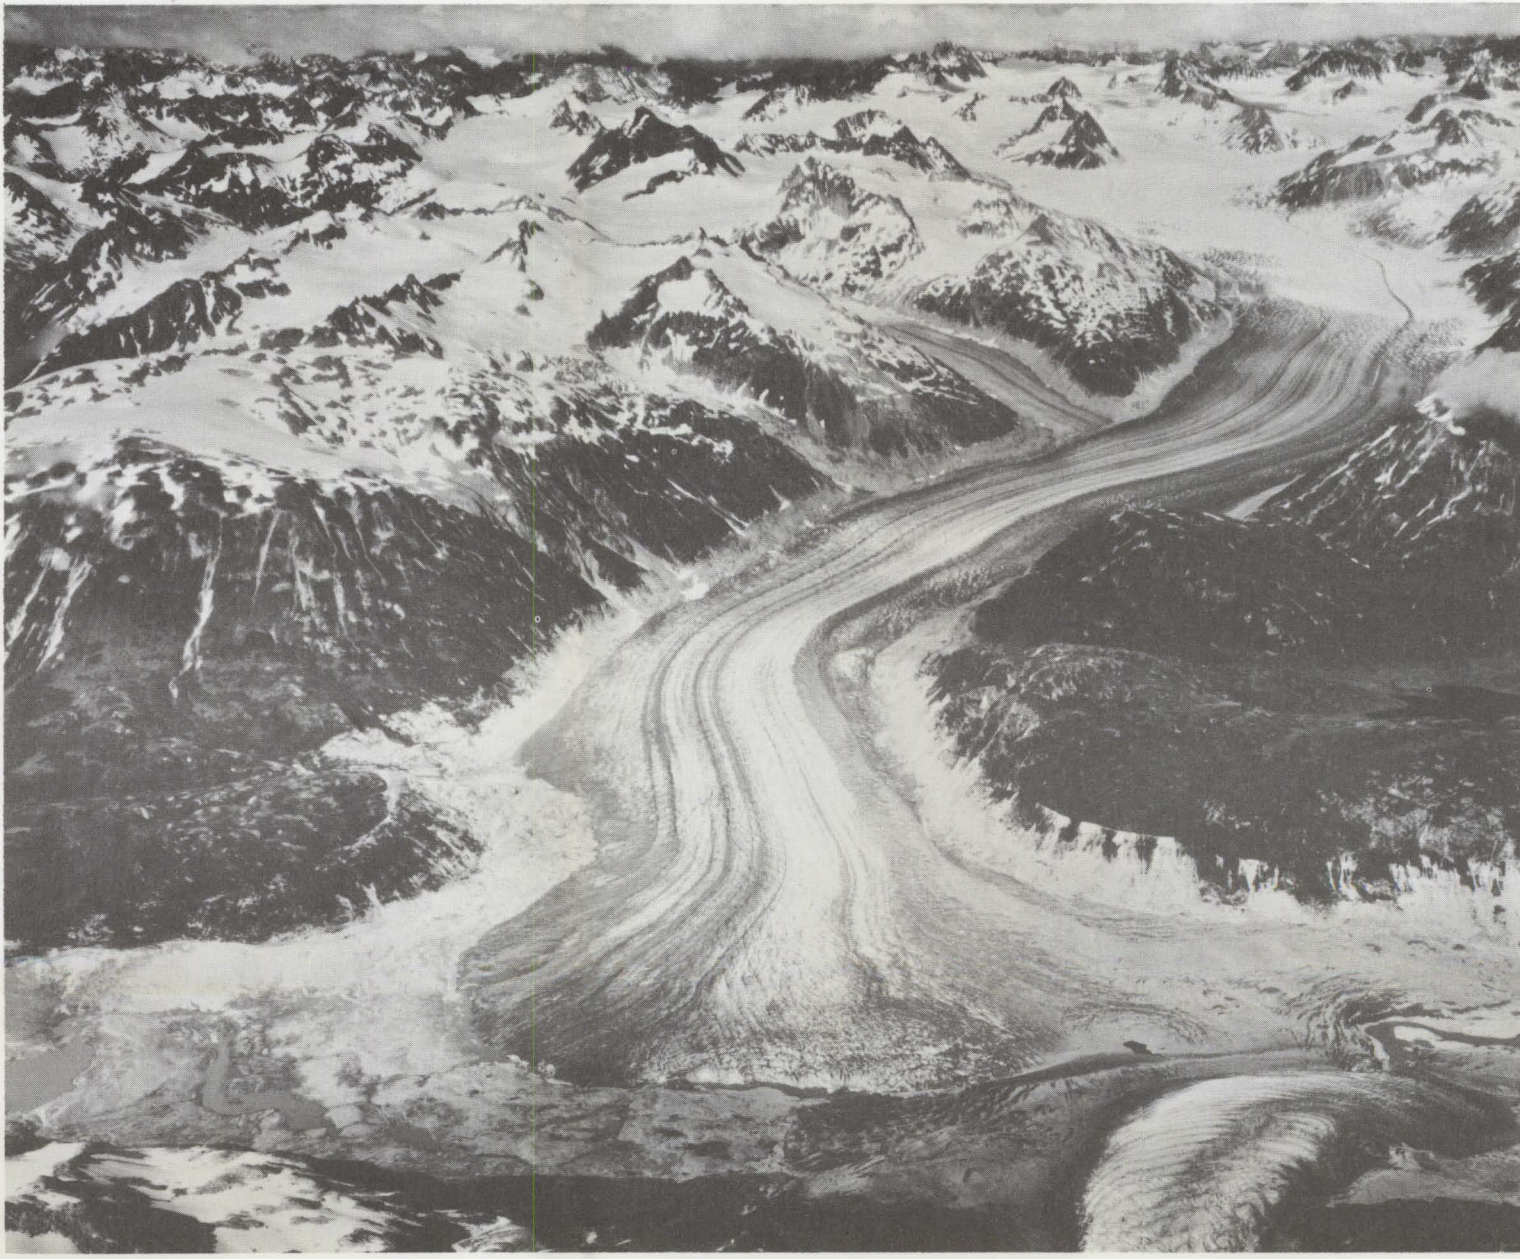
SUMMIT LAKE ALMOST COMPLETELY DRAINED

SUMMIT LAKE (NO. 32) PHOTOGRAPHED IN AUGUST 1970. THE LAKE HAS DRAINED THROUGH A SUBGLACIAL CHANNEL TO NORTH FORK BIG RIVER (RIGHT). THIS GLACIER HAS BEEN RETREATING FOR MANY YEARS. THE PRESENT ICE DAM WILL FAIL COMPLETELY IF RETREAT CONTINUES FOR A FEW MORE DECADES.

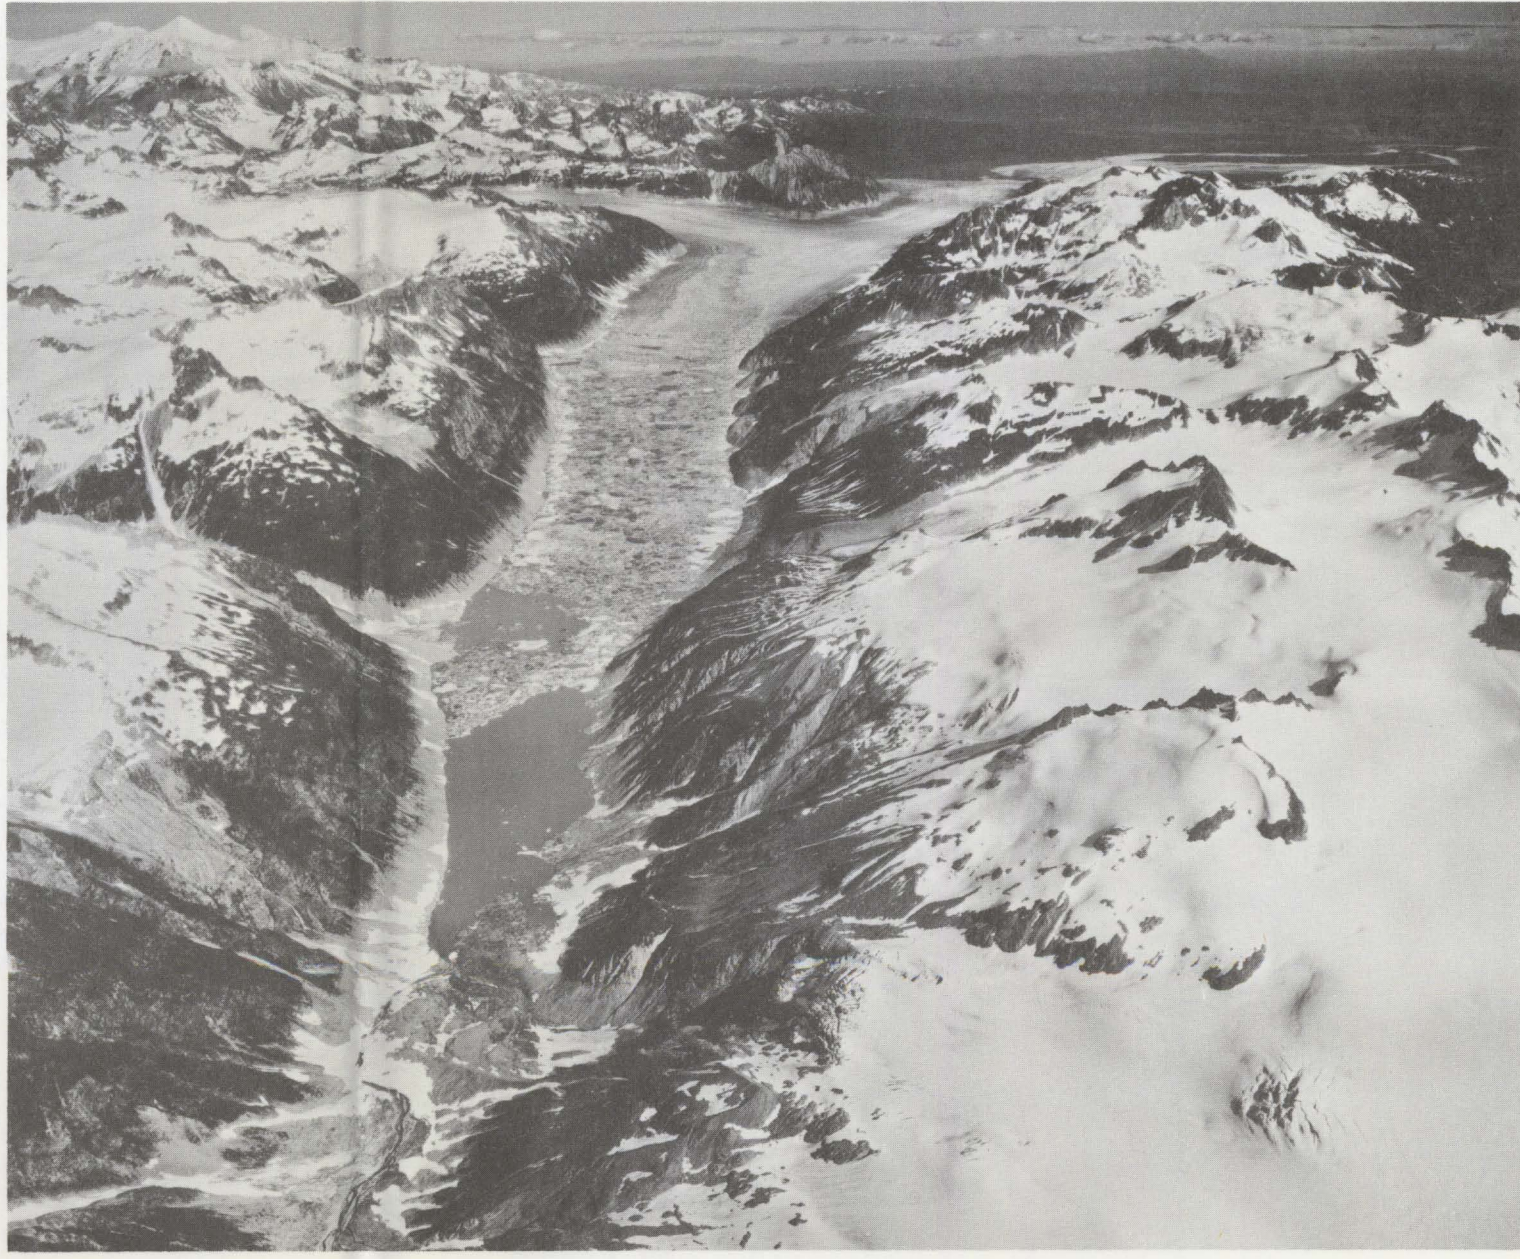
BLOCKADE LAKE IN THE PROCESS OF REFILLING

BLOCKADE LAKE (NO. 31) CHIGMIT MOUNTAINS. THIS LAKE IS IMPOUNDED BEHIND A MASSIVE ICE DAM 15.2 KILOMETERS (9.5 MILES) IN LENGTH FORMED WHERE BLOCKADE GLACIER LATERALLY ENTERS A DEEP, NARROW VALLEY AT THE FAR END OF THE LAKE. ALTHOUGH THE MAJOR FLOW OF ICE IS TO THE EASTERN TERMINUS, A PORTION OF THE ICE FLOWS TOWARD THE LAKE TERMINATING IN AN ICE CLIFF FROM WHICH LARGE ICEBERGS ARE DISCHARGED. THIS LAKE DOES NOT DUMP ANNUALLY BUT LARGE CHANGES IN SURFACE LEVEL INDICATE THAT THE ICE DAM FAILS EVERY FEW YEARS CAUSING MAJOR FLOODS ON MCARTHUR RIVER.

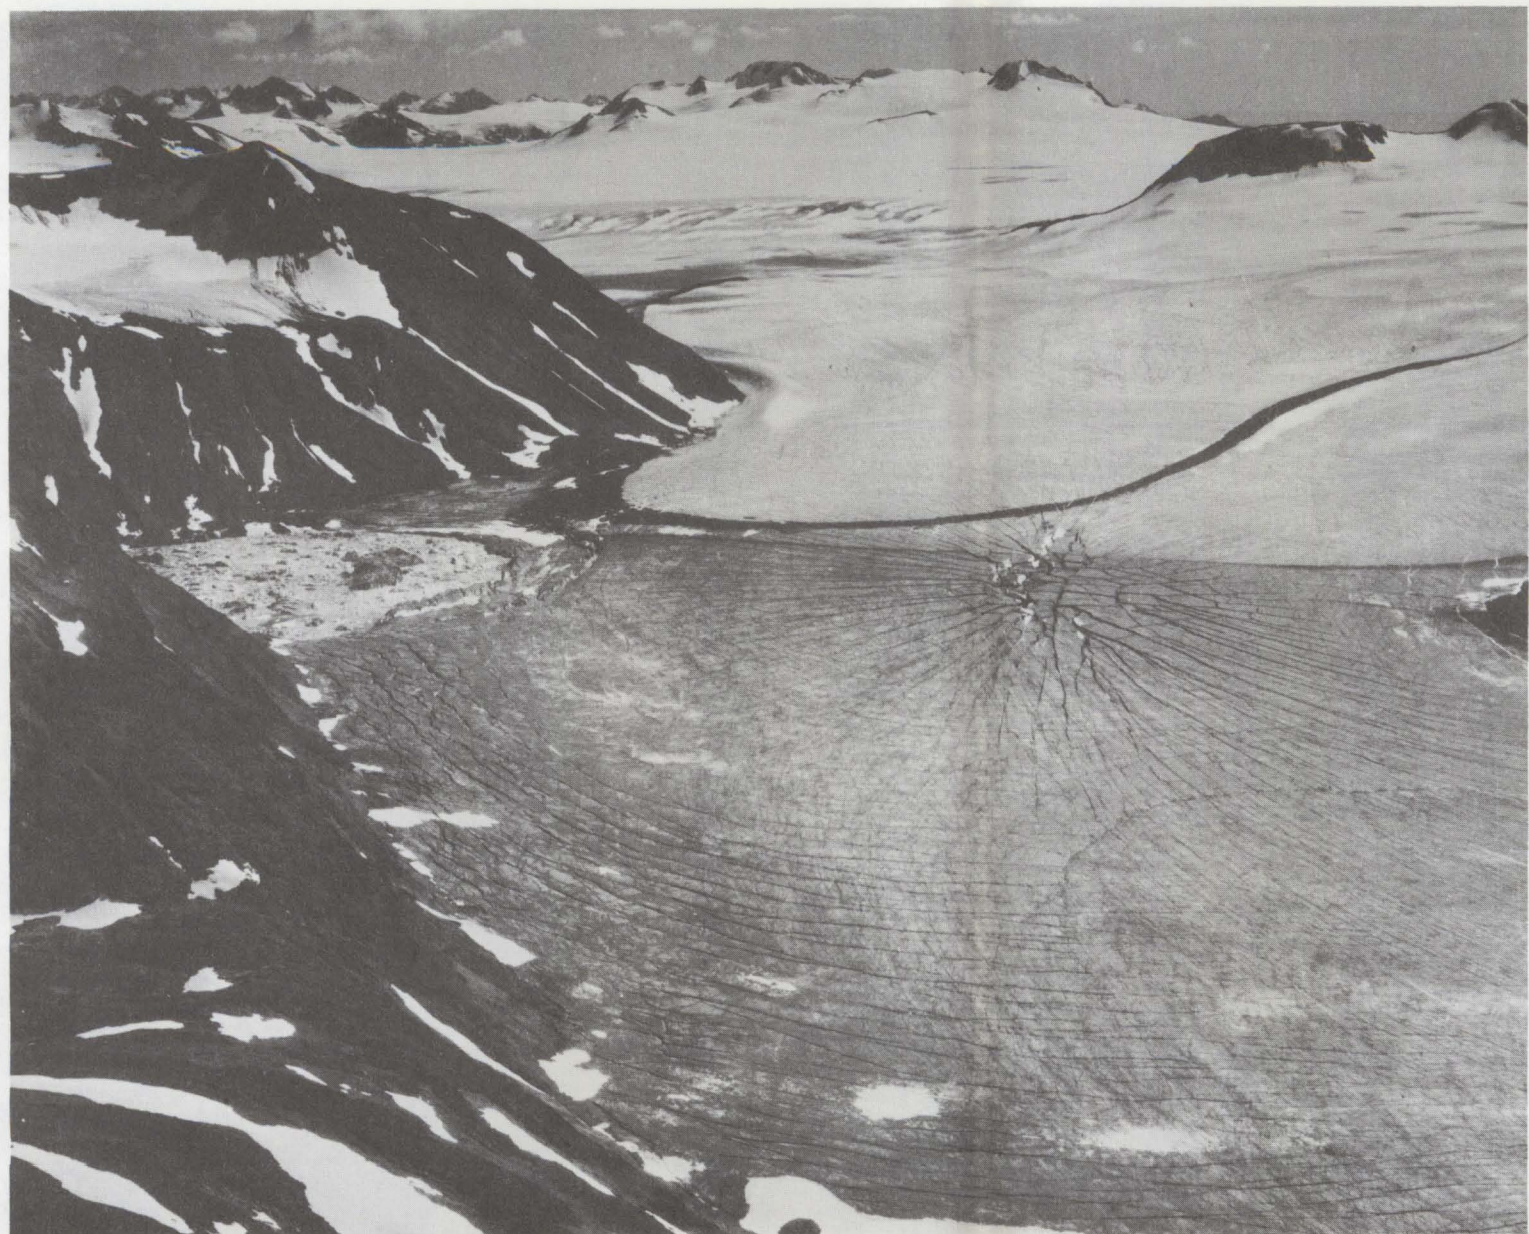
SKILAK GLACIER—SHOWING LATERAL AND SUBGLACIAL LAKES

THIS ICE DAMMED LAKE (NO. 27) IS LOCATED IN AN EMBAYMENT BETWEEN SKILAK GLACIER AND AN UNNAMED GLACIER IN THE KENAI MOUNTAINS. AN EXPOSED LAKE CAN BE SEEN ON THE LEFT. THE RADIAL PATTERN OF CREVASSES IN THE CENTER OF THE GLACIER SUGGESTS THAT THIS ICE IS RAISED AND LOWERED BY ALTERNATE FILLING AND DRAINING OF A SUBGLACIAL LAKE. WATER FROM THIS LAKE CREATED A DEVASTATING FLOOD IN THE KENAI RIVER VALLEY IN JANUARY 1969.

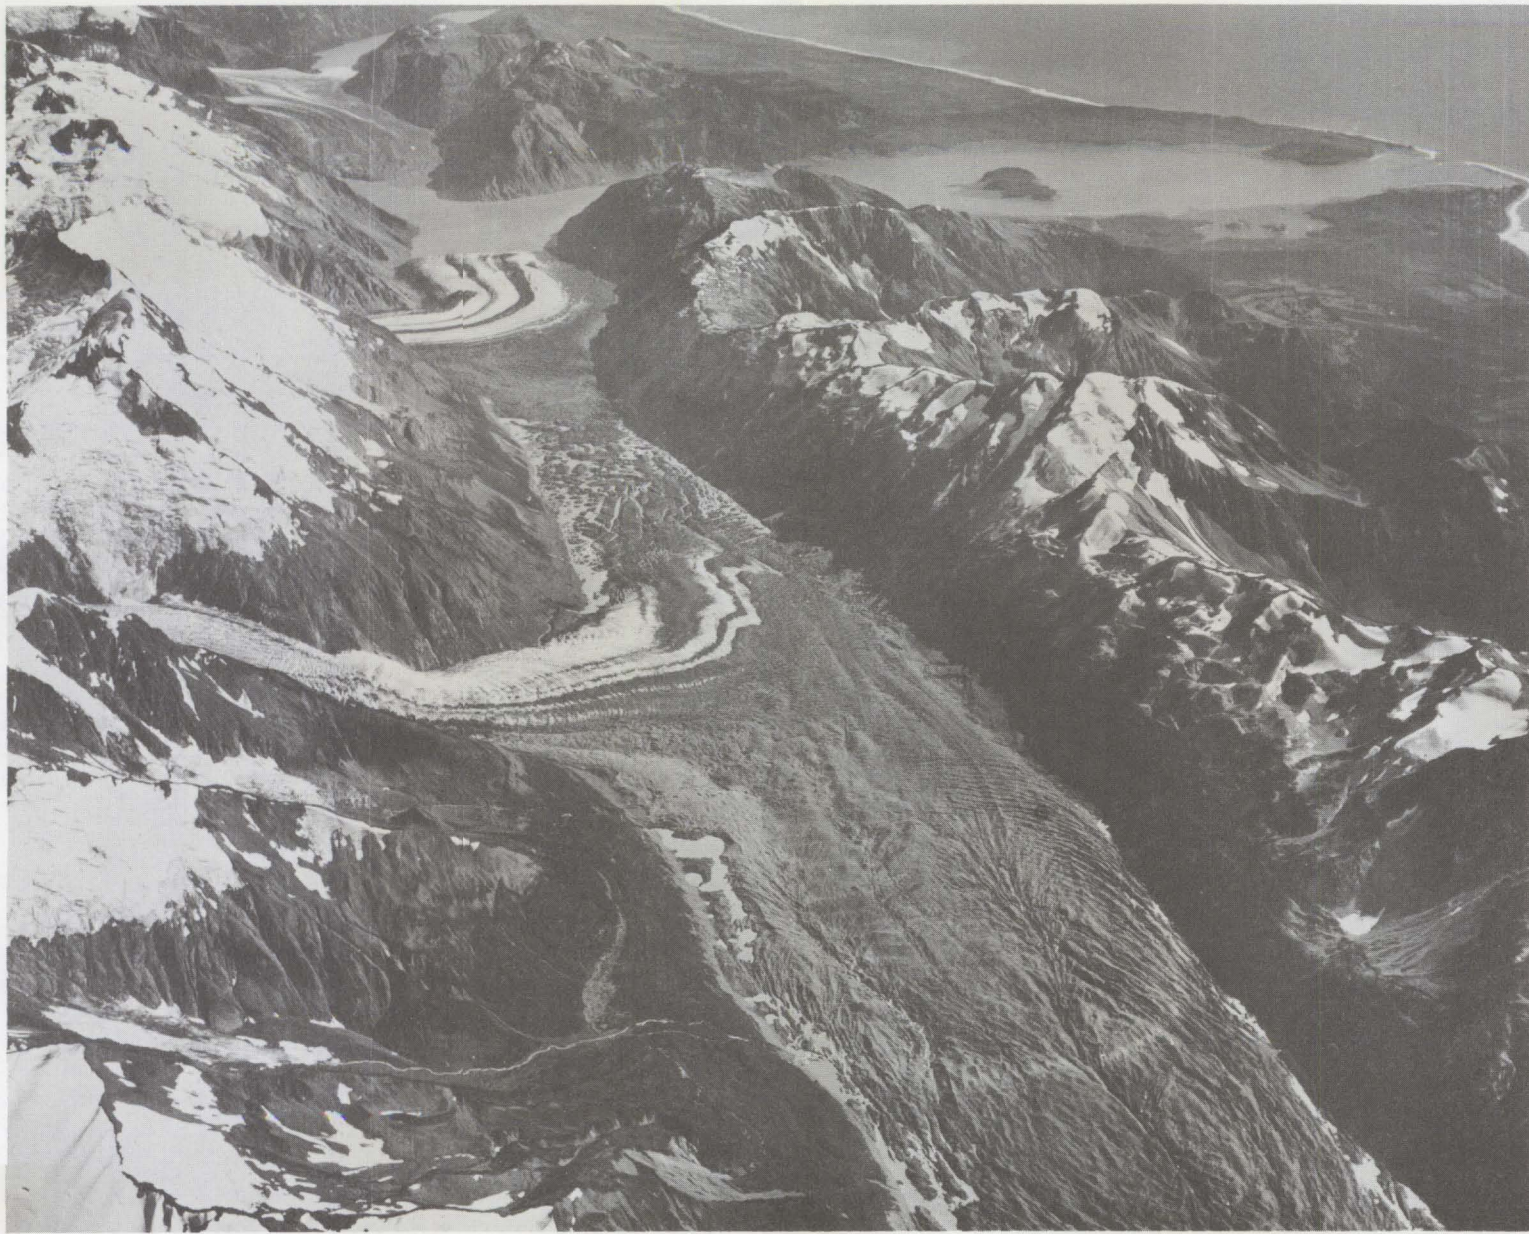
DESOLATION VALLEY—FORMATION AND EVOLUTION OF TWO LAKES

TWO LARGE ICE DAMMED LAKES ARE IN THE PROCESS OF FORMATION IN DESOLATION VALLEY, FAIRWEATHER RANGE. IN THE FOREGROUND IS DEBRIS COVERED ICE WITH SEVERAL LARGE LONGITUDINAL AND CONCENTRIC CREVASSES WHICH ARE ATTRIBUTED TO RAISING AND LOWERING OF THE ICE DUE TO FLOATING. WATER IS VISIBLE ALONG THE MARGINS AND IN THE LARGER CREVASSES. BETWEEN DESOLATION AND LUTIVA GLACIERS (UPPER CENTER) THE ICE HAS RECENTLY BROKEN UP AND A LARGE LAKE (NO. 9) IS NOW CLEARLY VISIBLE. THE LAKE PARTIALLY DRAINS SUBGLACIALLY AT INTERVALS TO LUTIVA BAY (MIDDLE DISTANCE). THE RECENT FORMATION OF THESE LAKES IS DUE TO THINNING OF THE GLACIERS OCCUPYING THE VALLEY.

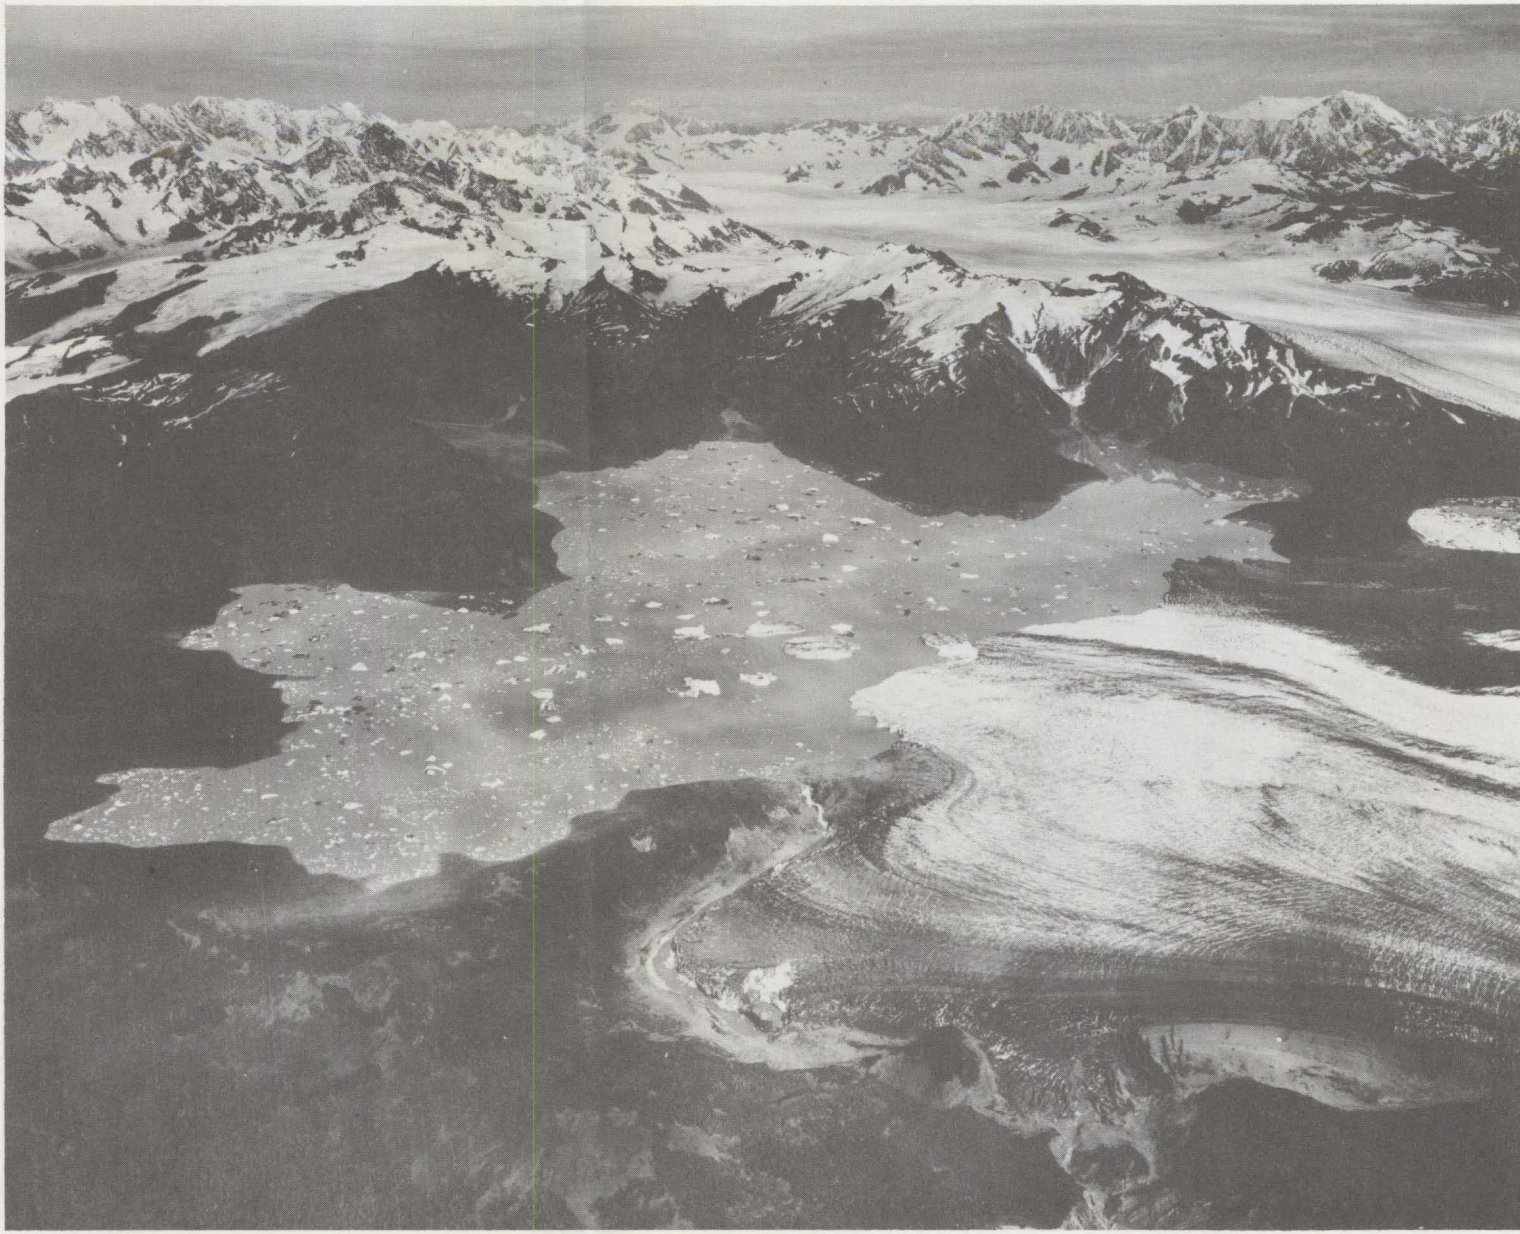
BERG LAKE—A RECENTLY DEVELOPED HAZARDOUS SITUATION

BERG LAKE (NO. 14) NEAR KATALLA. RETREAT OF AN ARM OF BERING GLACIER WHICH IN 1905 FILLED MOST OF THIS LARGE EMBAYMENT HAS JOINED FIVE SEPARATE LAKES THAT OCCUPIED INDIVIDUAL BAYS OF THE PRESENT LAKE. LOWERING OF THE ICE DAM IF CONTINUED WILL ALMOST CERTAINLY LEAD TO THE RELEASE OF IMMENSE FLOODS IN THE NEAR FUTURE. THE BERING RIVER FLOOD PLAIN AND AREA SURROUNDING BERING LAKE ARE ENDANGERED BY THIS INCREASINGLY CRITICAL SITUATION.

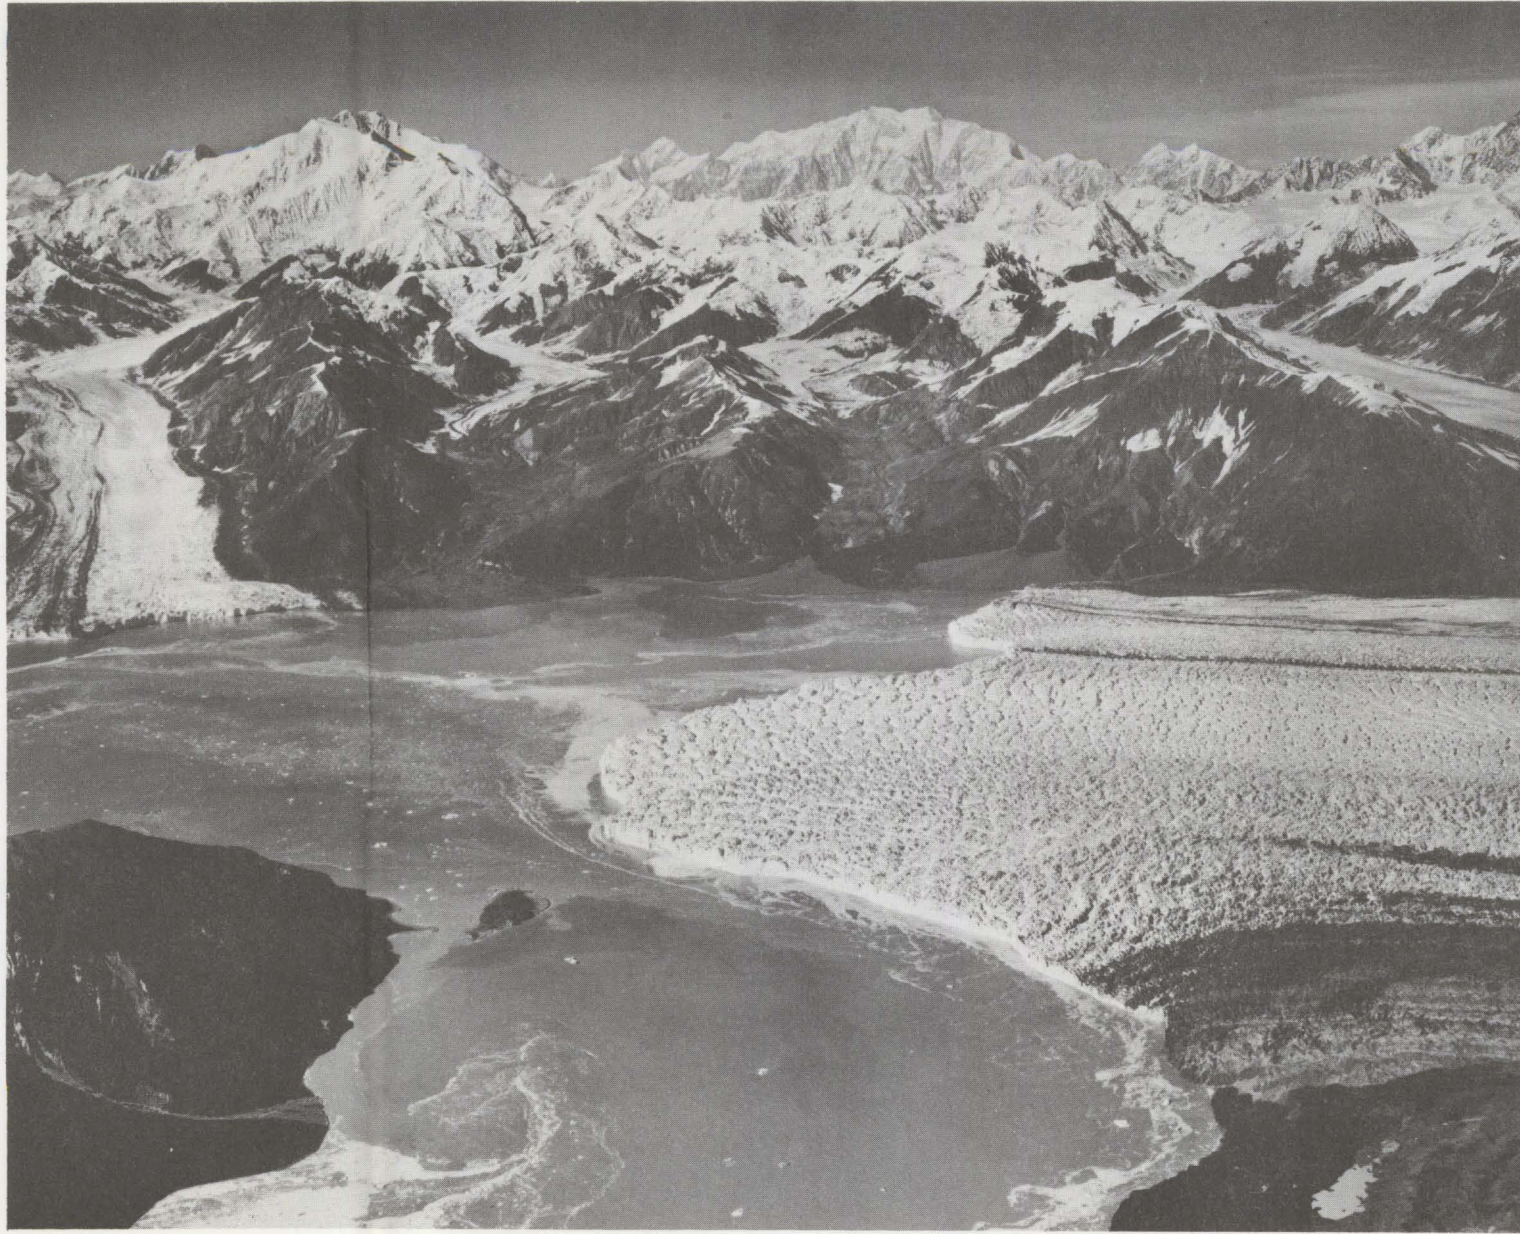
RUSSELL FIORD—SITE OF A LARGE POTENTIAL LAKE

DISENCHANTMENT BAY AND RUSSELL FIORD (NO. 13) NEAR YAKUTAT. THE MASSIVE HUBBARD GLACIER, DRAINING AN AREA OF APPROXIMATELY 4,000 SQUARE KILOMETERS (1,550 SQUARE MILES) DISCHARGES INNUMERABLE ICEBERGS INTO THE BAY FROM AN ICE CLIFF NEARLY 100 METERS (300 FEET) HIGH AND 10 KILOMETERS (6 MILES) LONG. THE GLACIER HAS BEEN SLOWLY ADVANCING SINCE IT WAS MAPPED IN 1895. IF THE ADVANCE CONTINUES AT THE SAME RATE, IN A FEW DECADES THE GLACIER WILL CLOSE OFF RUSSELL FIORD (FORGROUND), TURNING THIS ARM OF THE SEA INTO A LAKE 230 SQUARE KILOMETERS (90 SQUARE MILES) IN AREA.

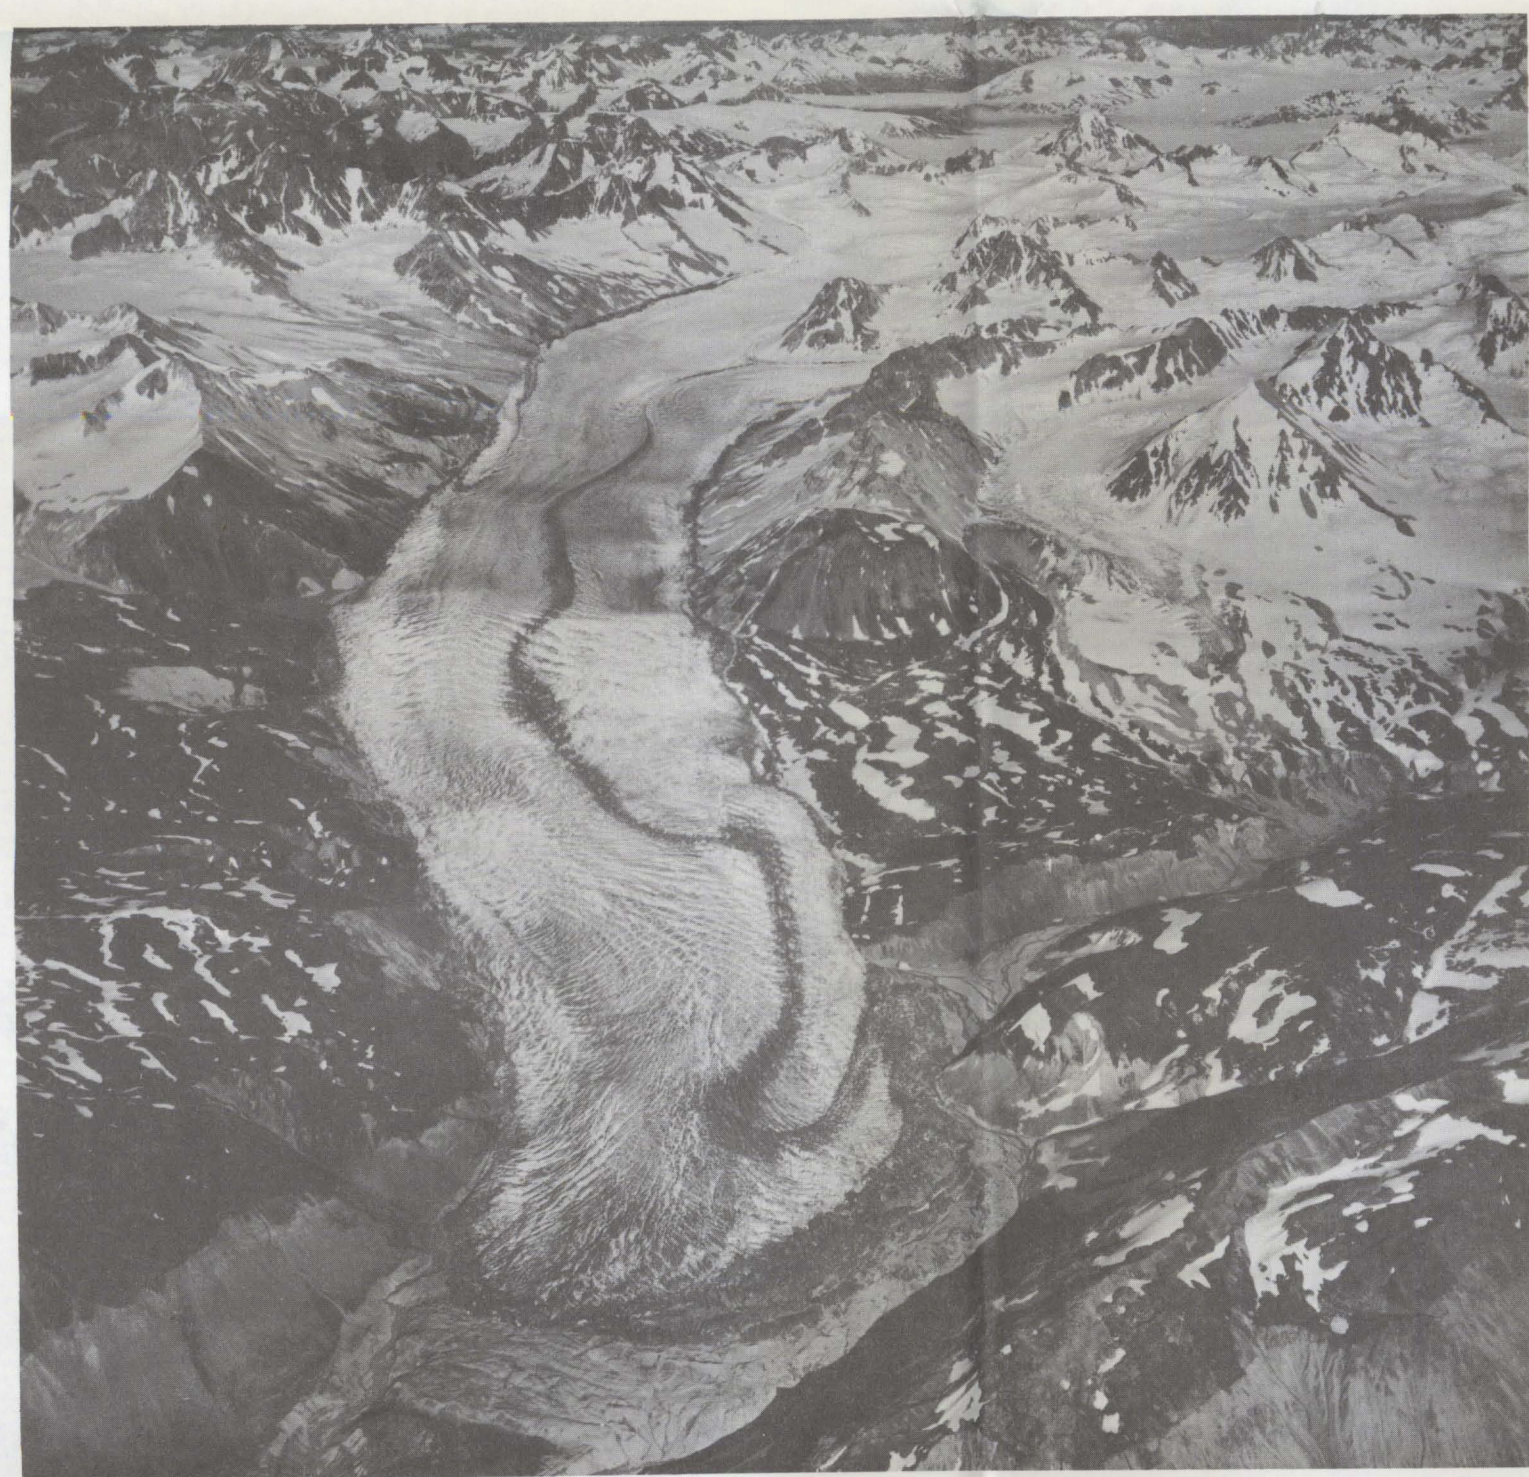
TIKKE GLACIER AT BEGINNING OF SURGE

TIKKE GLACIER, LOCATED IN CANADA NORTH OF GLACIER BAY, IS SUBJECT TO PERIODIC SURGES IN WHICH THE ICE SUDDENLY ADVANCES SEVERAL KILOMETERS AT APPROXIMATELY 20-YEAR INTERVALS. THIS VIEW OF THE GLACIER WAS TAKEN IN AUGUST 1965 WHEN A SURGE WAS MOVING RAPIDLY DOWN THE GLACIER. LATERAL VALLEYS TO THE RIGHT OF THE GLACIER DO NOT CONTAIN LAKES. FARTHER UP GLACIER ON THE LEFT SIDE THE FAST-MOVING ICE RECENTLY HAS DAMMED THE LATERAL STREAMS.

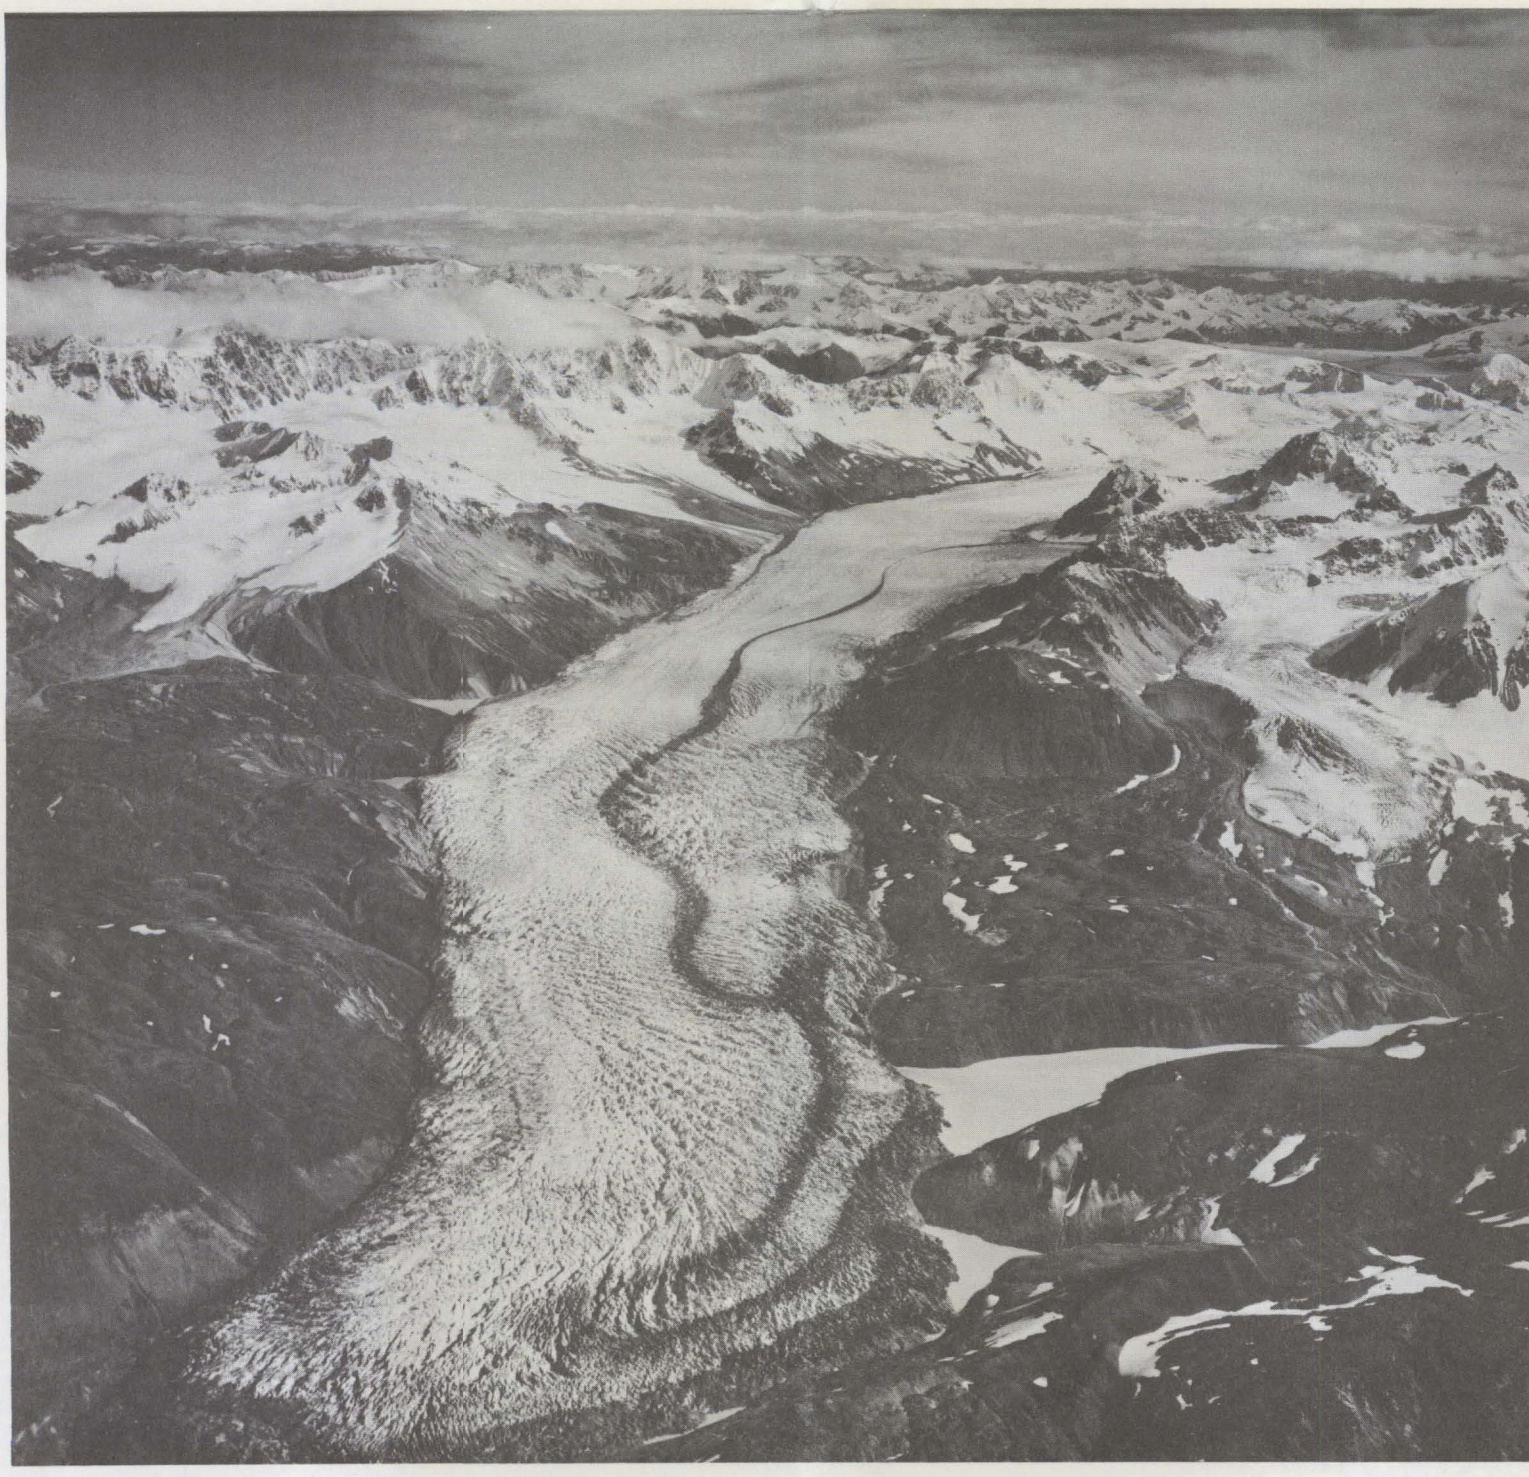
TIKKE GLACIER AFTER SURGE

TIKKE GLACIER IN AUGUST 1966, AFTER THE CULMINATION OF THE SURGE SHOWN IN PROGRESS IN THE VIEW TO THE LEFT. THE ADVANCING ICE HAS NOW FORMED DAMS BLOCKING BOTH SIDE VALLEYS ON THE RIGHT SIDE OF THE GLACIER. SINCE COMPLETING ITS RAPID MOVEMENT, THE GLACIER HAS RELEASED INTO NEAR STAGNATION. THE GLACIER DAMMED LAKES PROBABLY WILL FILL AND DUMP ANNUALLY UNTIL MELTING REMOVES THE ICE DAMS. TIKKE GLACIER IS ONLY ONE OF NEARLY 200 SURGING GLACIERS IN ALASKA AND ADJACENT CANADA WHICH CAN BE EXPECTED TO FORM HAZARDOUS LAKES PERIODICALLY.

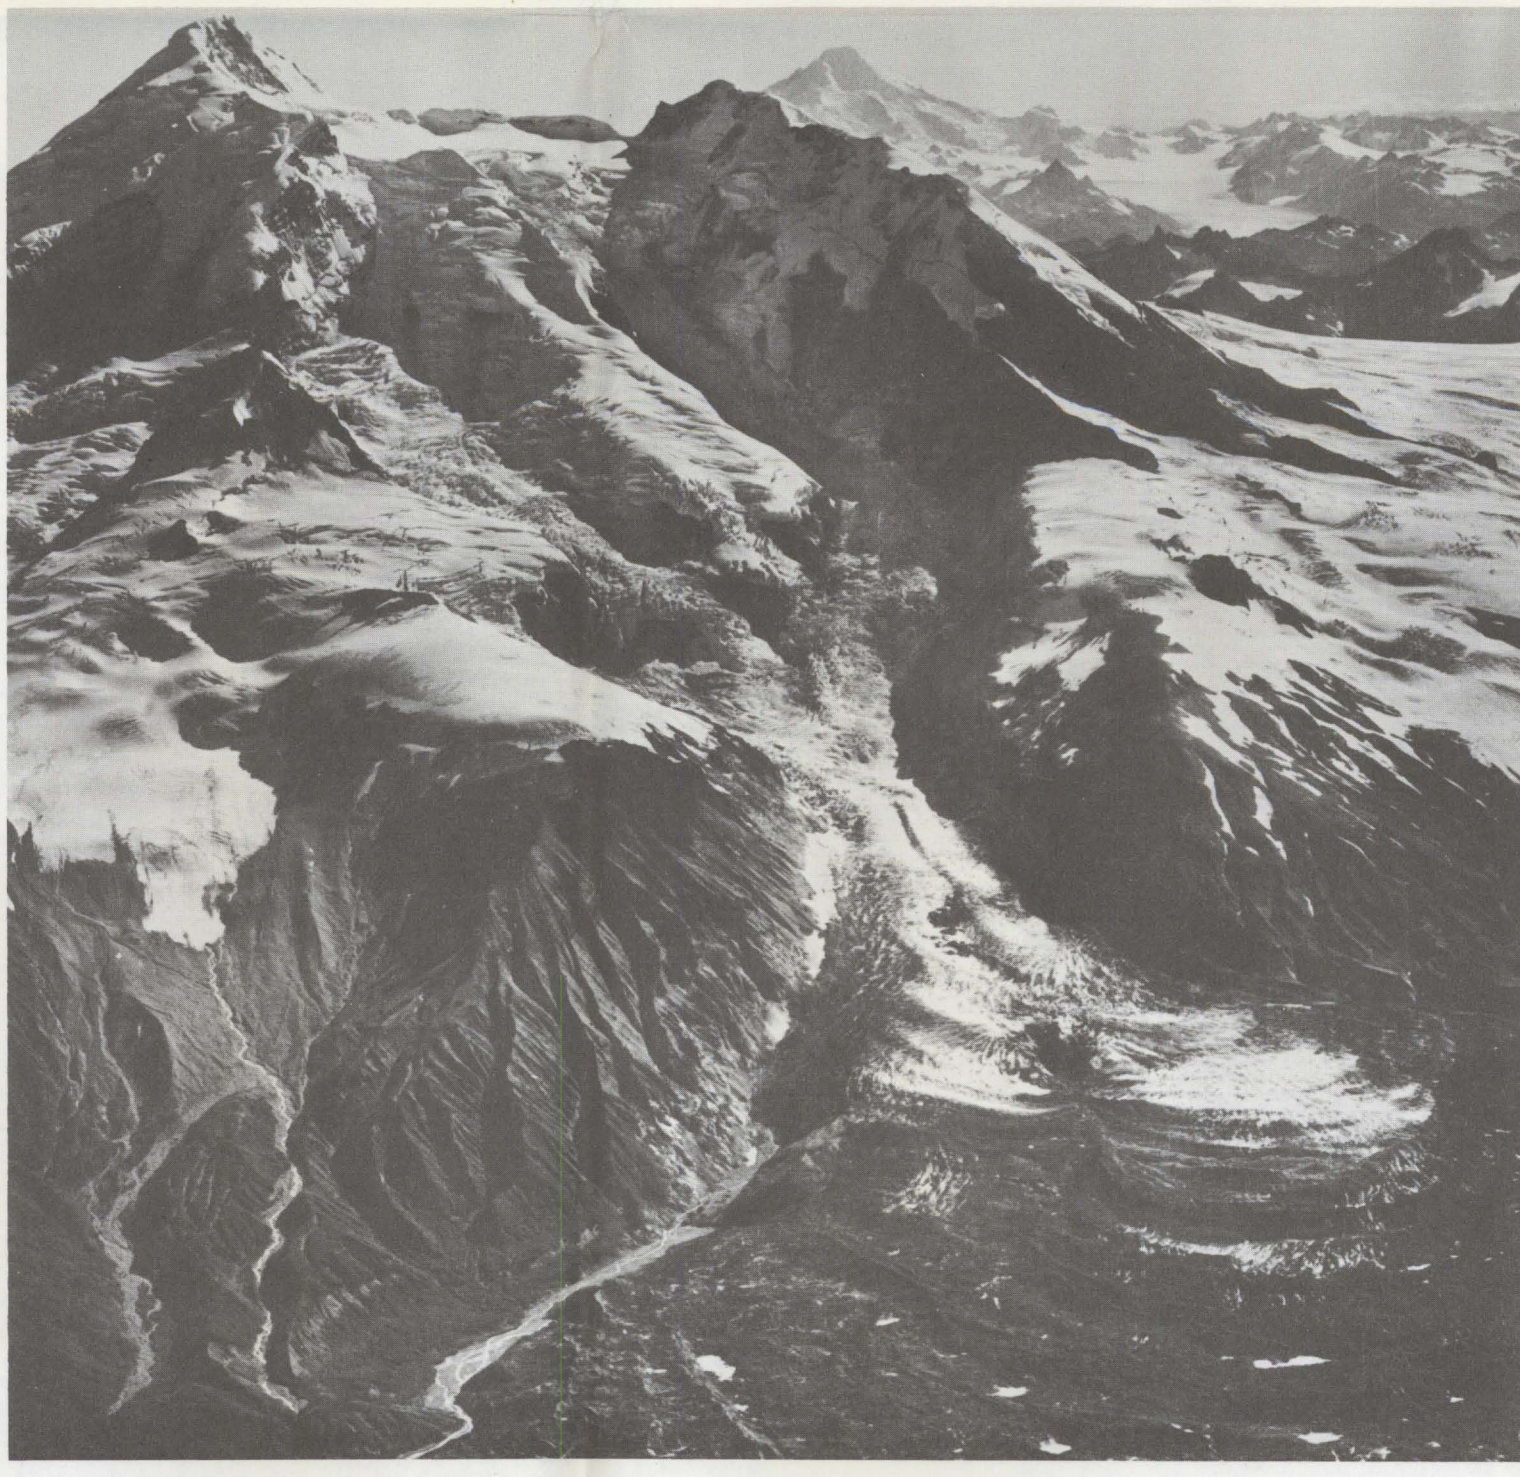
REDOUBT VOLCANO BEFORE 1966 ERUPTION

REDOUBT VOLCANO, CHIGMIT MOUNTAINS. PHOTOGRAPH AUGUST 1963 SHOWING CONDITIONS BEFORE THE ERUPTIONS BEGAN IN JANUARY 1966. THE LARGE UNNAMED GLACIER SHOWN HERE DESCENDS FROM THE SUMMIT CRATER. ALTHOUGH THE GLACIER IS LITTERED BY MUCH DEBRIS ON ITS LOWER REACHES, THE SPECTACULAR ICE CASCADES ON THE MOUNTAIN SLOPES ARE ALMOST DEBRIS FREE, INDICATING RECENT DECADES OF LITTLE VOLCANIC ACTIVITY.
