PHOTOGRAPHS ILLUSTRATING THE VARIABILITY OF GLACIER DAMMED LAKES

GLACIER DAMMED LAKES AND OUTBURST FLOODS IN ALASKA

By
Austin Post and Lawrence R. Mayo
1971

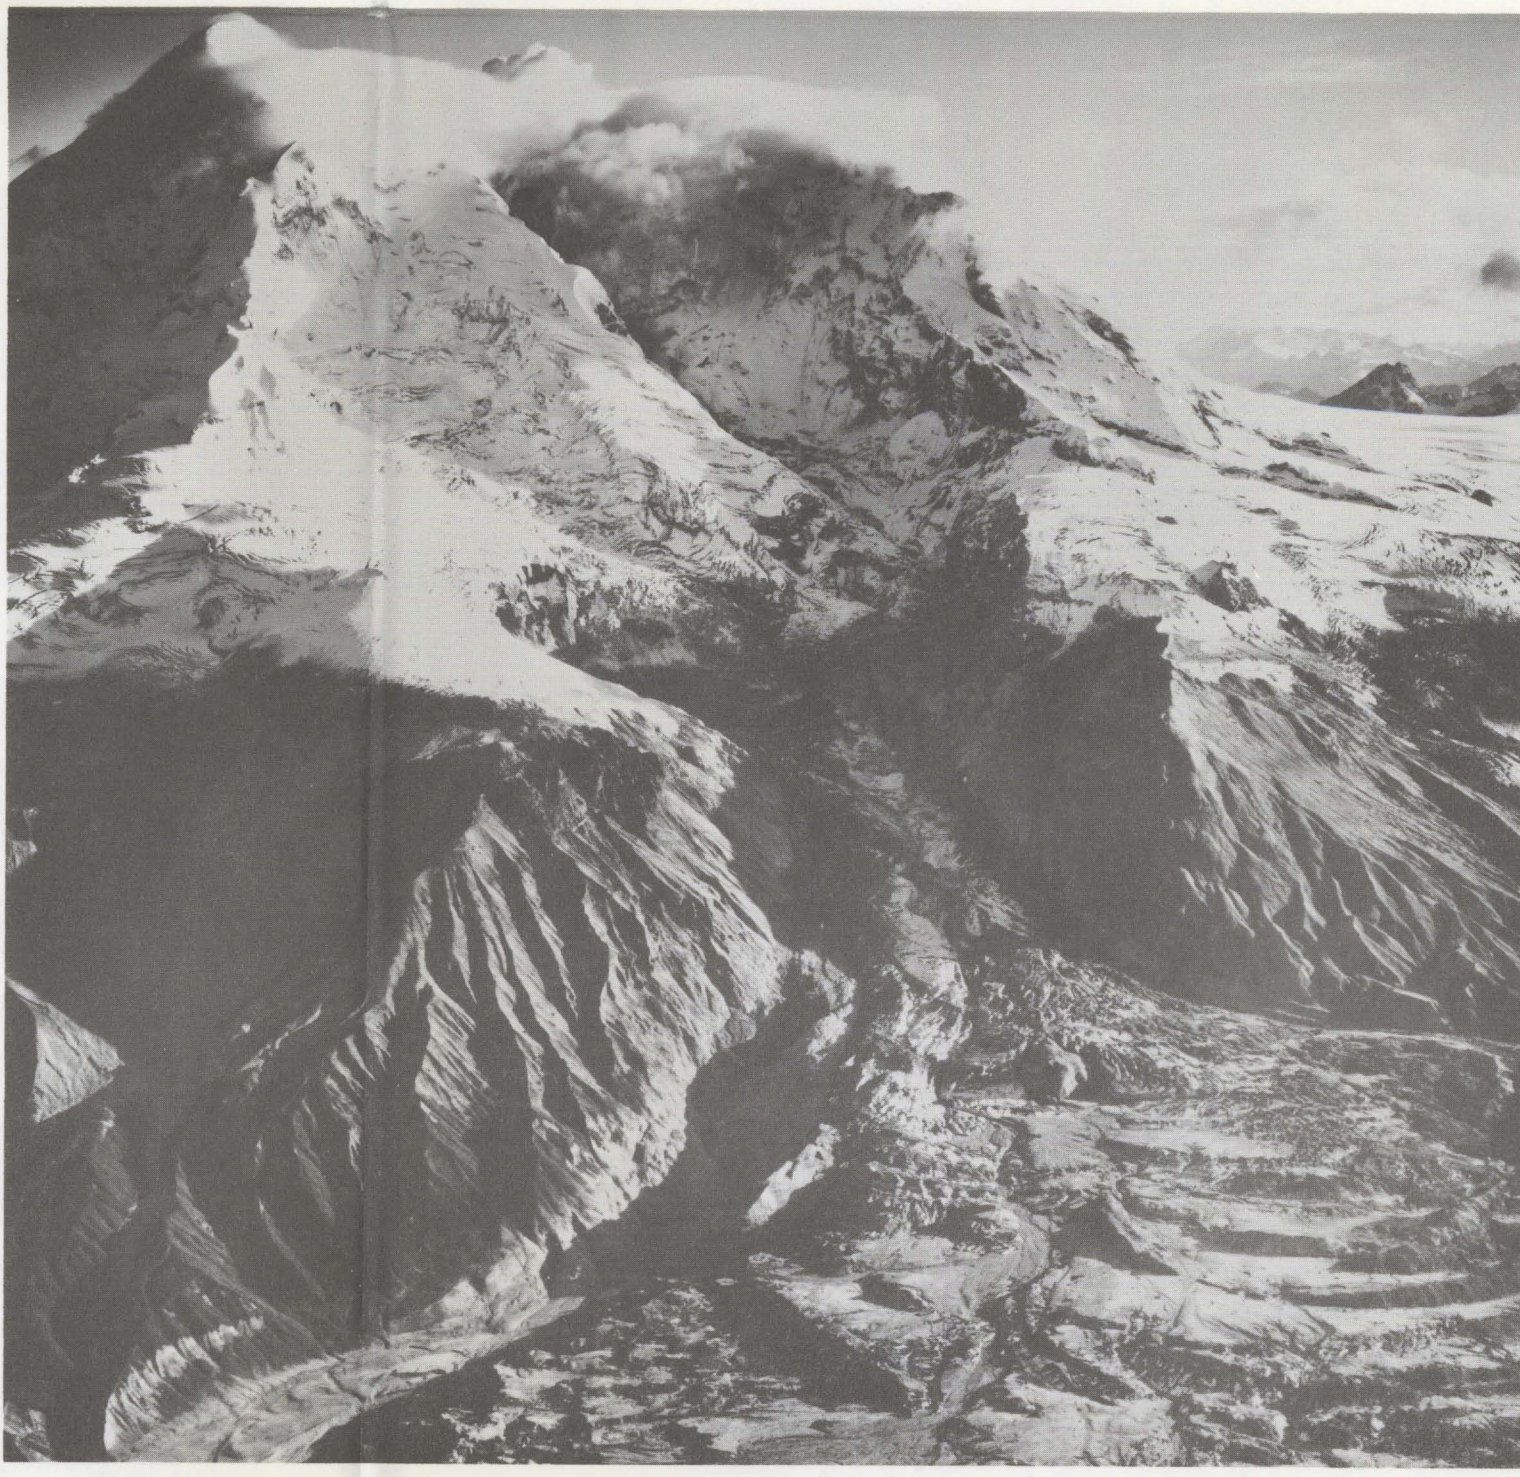
GLACIER ON REDOUBT VOLCANO AFTER ERUPTION

REDOUBT VOLCANO IN AUGUST 1966 SHOWING CHANGES IN THE GLACIER RESULTING FROM THE ERUPTIONS. STEAM CLOUDS FROM THE ACTIVE CRATER STILL OBSCURED THE SUMMIT OF THE MOUNTAIN. THE ICE CASCADES FLOWING FROM THE SUMMIT CRATER HAVE BEEN COMPLETELY DESTROYED AND A LARGE STREAM OF YELLOWISH, DEBRIS-LADEN WATER WAS RUSHING DOWN THE GORGE IN ITS PLACE. SERIAL OBSERVATIONS IN 1967 INDICATED LOWERING OF THE GLACIER SURFACE LEVEL IN THE CRATER WHICH SUGGESTS THAT ICE MELT DUE TO VOLCANIC HEAT WAS THE PRINCIPAL SOURCE OF THE FLOOD WATER. THE LOWER GLACIER IS ALMOST COMPLETELY BURIED BY DEBRIS DEPOSITED BY THE FLOOD WATERS.

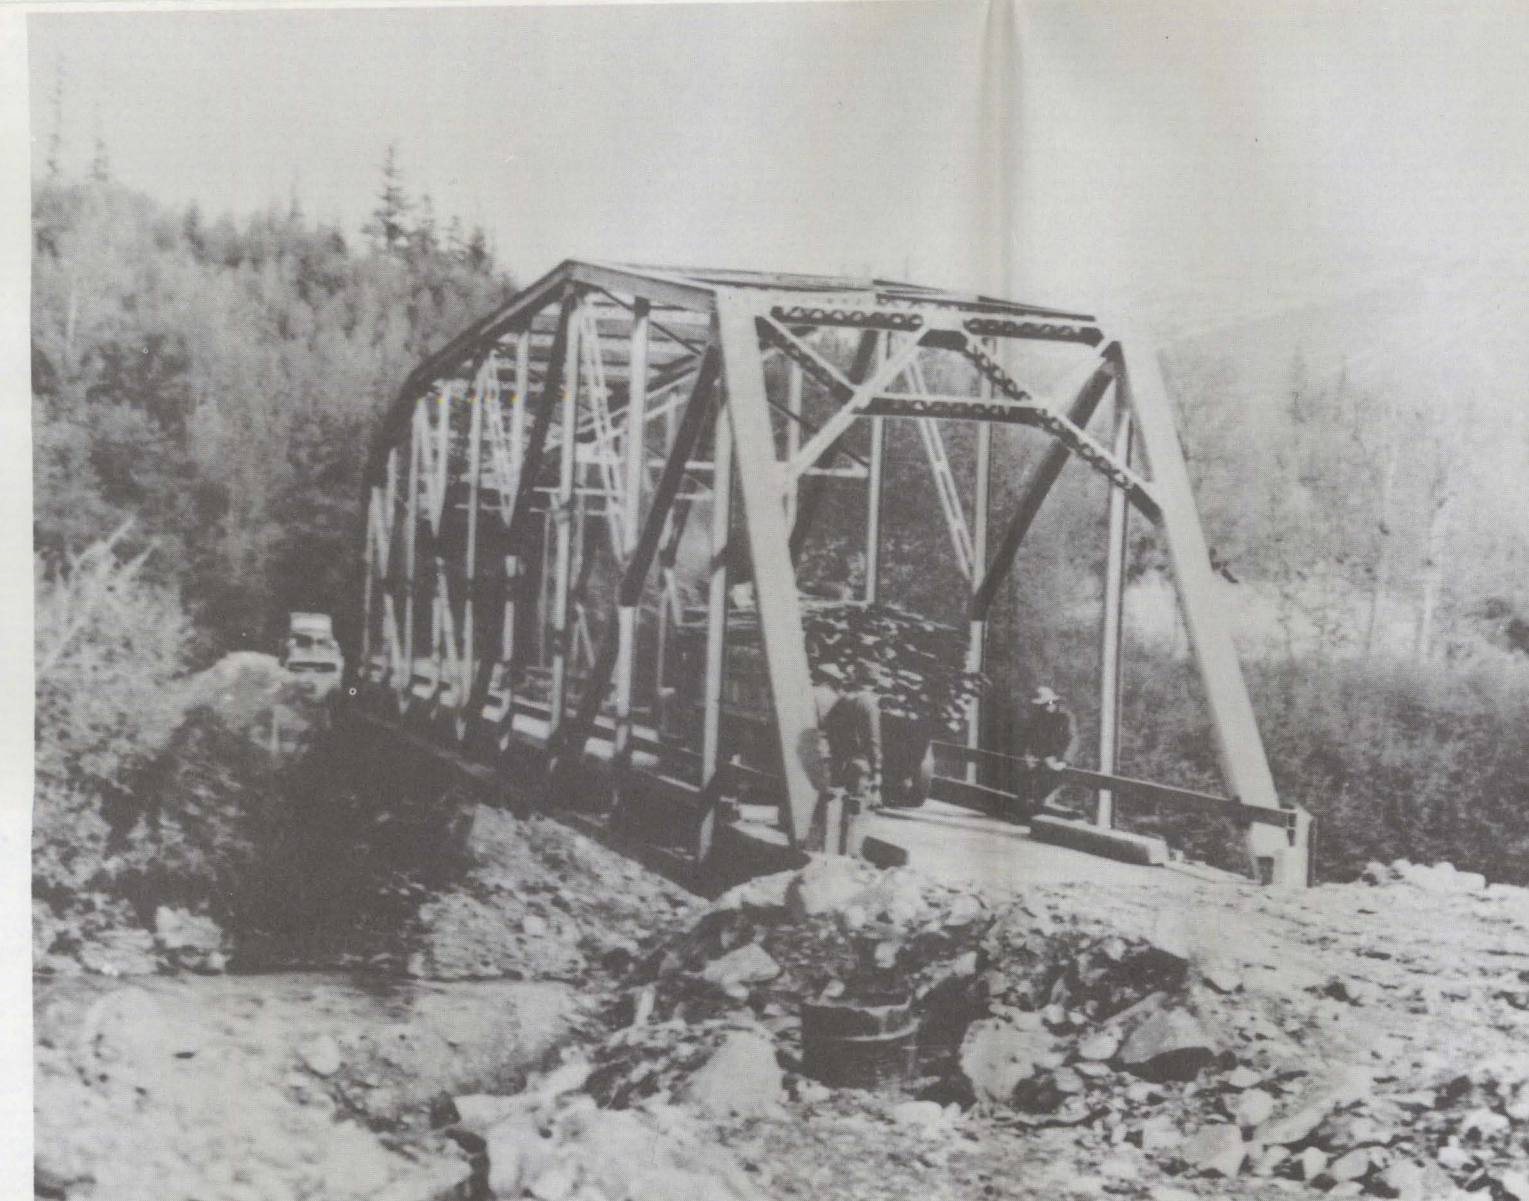
SHEEP CREEK

BRIDGE AT SHEEP CREEK, EAST OF VALDEZ ON THE RICHARDSON HIGHWAY. DENSE LOW WILLOW AND ALDER GROWING ON THE FLOOD PLAIN INDICATE SEVERAL YEARS WITHOUT FLOOD ACTIVITY. BUT ABSENCE OF LARGE TREES SUGGESTS THAT DAMAGING FLOODS HAD OCCURRED EARLIER. BRIDGE FORMS A CONSTRUCTION IN THE FLOOD PLAIN. ALASKA DEPARTMENT OF HIGHWAYS PHOTOGRAPH. DATE UNKNOWN.

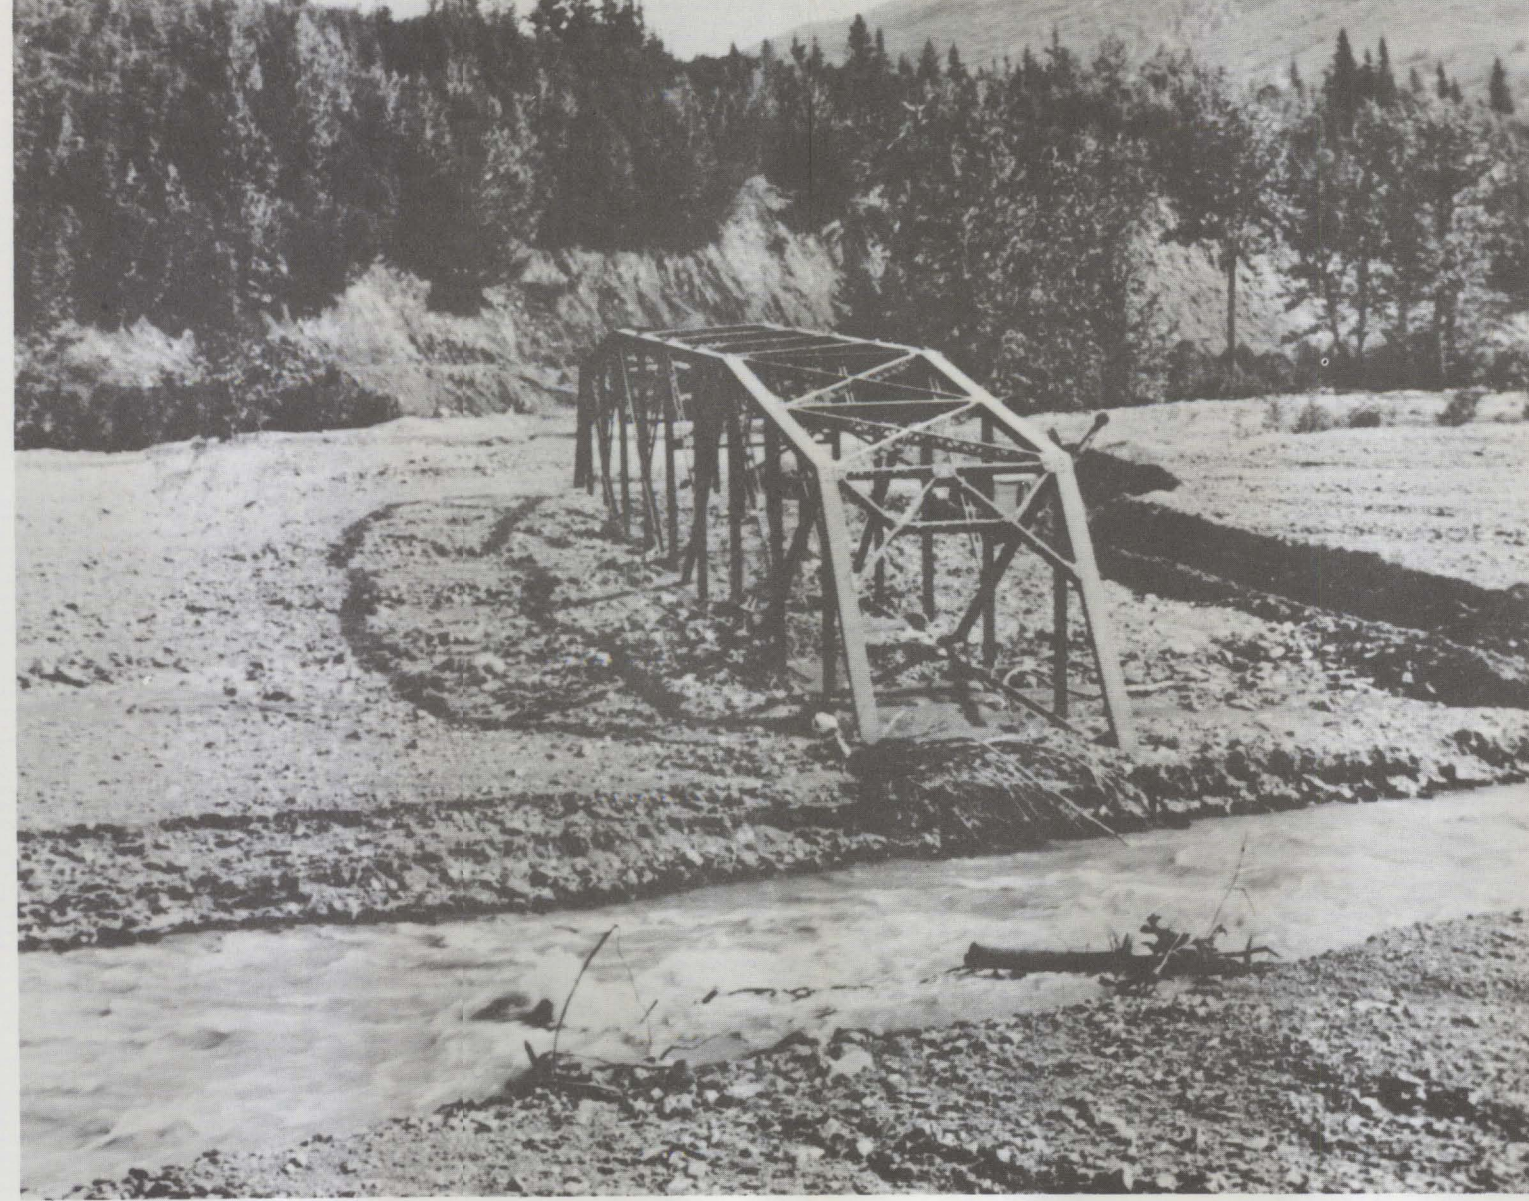
SAME BRIDGE AT SHEEP CREEK PARTIALLY BURIED BY DEBRIS RESULTING FROM A GLACIER OUTBURST FLOOD FROM A TINY GLACIER DAMMED LAKE (NO. 23). SEDIMENT BURIED MUCH OF THE WILLOW AND ALDER BRUSH, BUT AS THE FLOOD DID NOT CARRY AWAY THE COTTONWOOD TREES AT THE EDGE OF THE FLOOD PLAIN THIS FLOOD COULD NOT HAVE BEEN OF MUCH GREATER VOLUME THAN PREVIOUS FLOODS. APPROXIMATELY 7.5 METERS (25 FEET) DEPTH OF DEBRIS WAS DEPOSITED AT THE BRIDGE SITE. LARGE-SCALE EROSION UPSTREAM MUST HAVE TAKEN PLACE TO PROVIDE THE FILL MATERIAL. ALASKA DEPARTMENT OF HIGHWAYS PHOTOGRAPH. SEPTEMBER 1965.
