# HYDROLOGIC RECONNAISSANCE OF STREAMS AND SPRINGS IN EASTERN BROOKS RANGE, ALASKA — JULY 1972

UNITED STATES DEPARTMENT OF THE INTERIOR, GEOLOGICAL SURVEY  
Water Resources Division, Alaska District

J. M. Childers, C. E. Sloan, and J. P. Meckel

BASIC-DATA REPORT

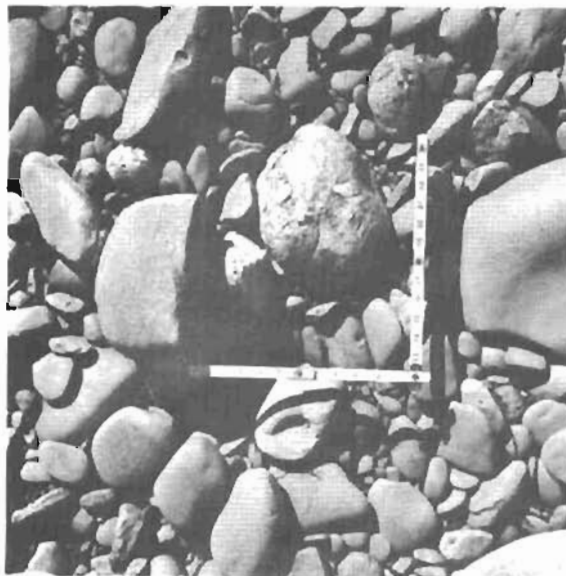
Figure 3.--Site 1, Kadleroshilik River.

Figures 3-13.--Photographs of sites. Upper photograph shows channel width in feet. Arrow indicates direction of flow. Lower photograph shows typical streambed material.

An oblique aerial photograph and a photograph of representative streambed material are given for each of the 11 stream study sites (figs. 3-13). The cross-section lines show the width dimensions in feet of the channel at bankfull stage and at the maximum evident flood.

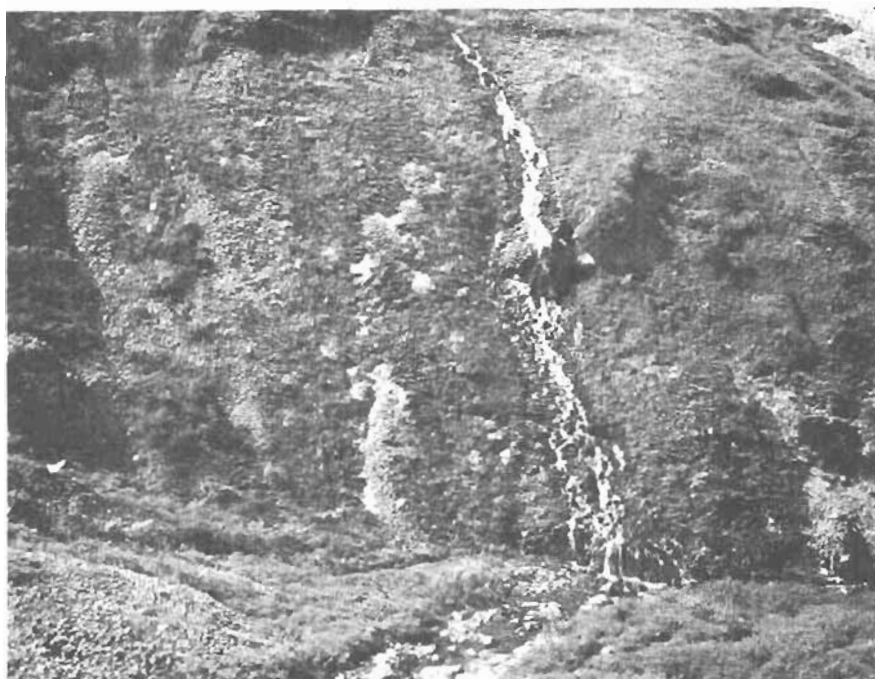
Figure 16.--Ivishak Hillside Spring (Site 5) discharging from limestone talus of the Lisburne Group.

Most of the springs discharge from limestone of the Lisburne Group or its associated alluvial deposits (figs. 15 and 16). The location of many of the springs is marked by verdant groves of cottonwoods (fig. 17), which are favored by the warm microclimate of the springs. The springs are also recognizable in summer because their perennial flow supports a rich green flora of grasses, mosses, and lichens.

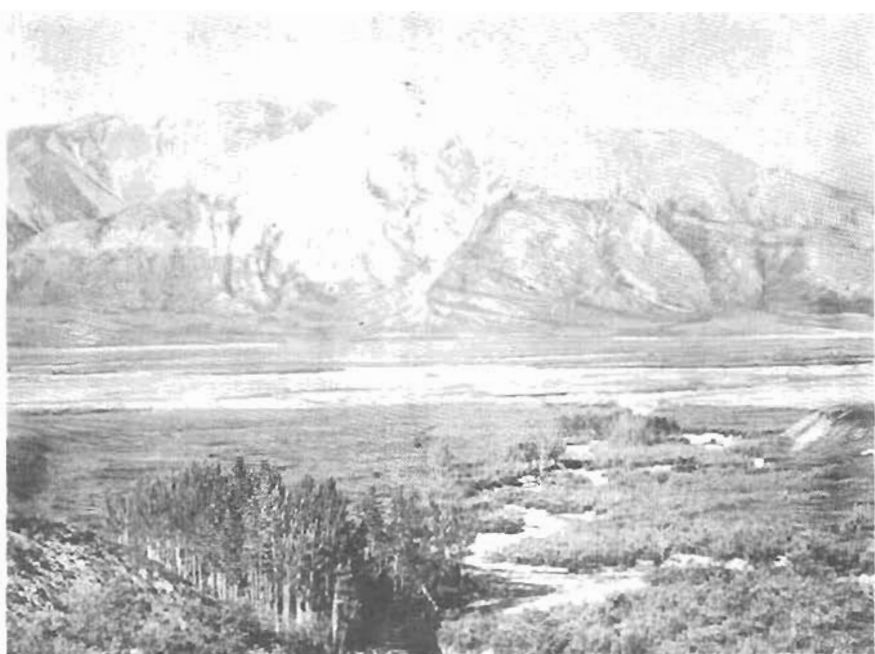
Figure 17.--Cottonwood trees at Ivishak Hillside Spring at edge of Ivishak valley.

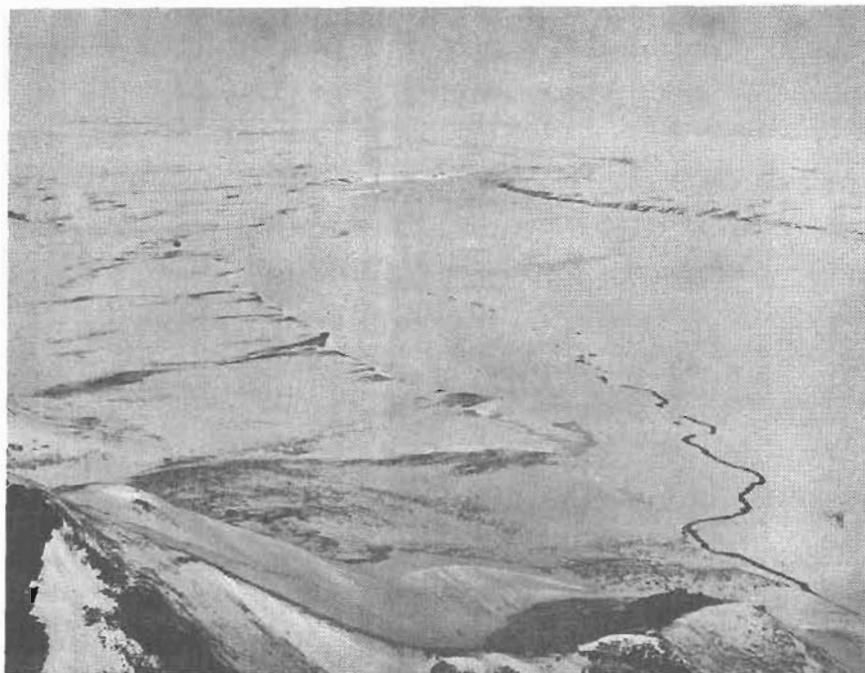
Figure 19.--Echooka River icing in May 1972.  
View downstream to north.

The most obvious manifestations of the springs are the large aufeis areas (icings) that they produce throughout the winter months, which are readily apparent from the air. Although all icings are not fed by springs, most icings are sustained by discharge of ground water. The larger, more spectacular, ones in the Brooks Range are clearly related to springs. Figure 18 shows the discharge zone of the spring on the west side of the Echooka River. Figure 19 is a general view of the icing produced by the spring and the extended open-water lead that exists downstream from the spring. The distance across the icing from bank to bank in the right foreground of the photograph is slightly over 2 miles. Figure 20 shows aufeis along an eroded channel in the Echooka River icing; the ice is about 16 feet thick. The layering in the ice is caused by successive overflows that froze on the surface of the icing field.
