UNITED STATES  
DEPARTMENT OF THE INTERIOR  
GEOLOGICAL SURVEY

CHANNEL EROSION SURVEYS ALONG TAPS ROUTE,  
ALASKA, 1976

**77-170**

OPEN-FILE REPORT  
(Basic Data)

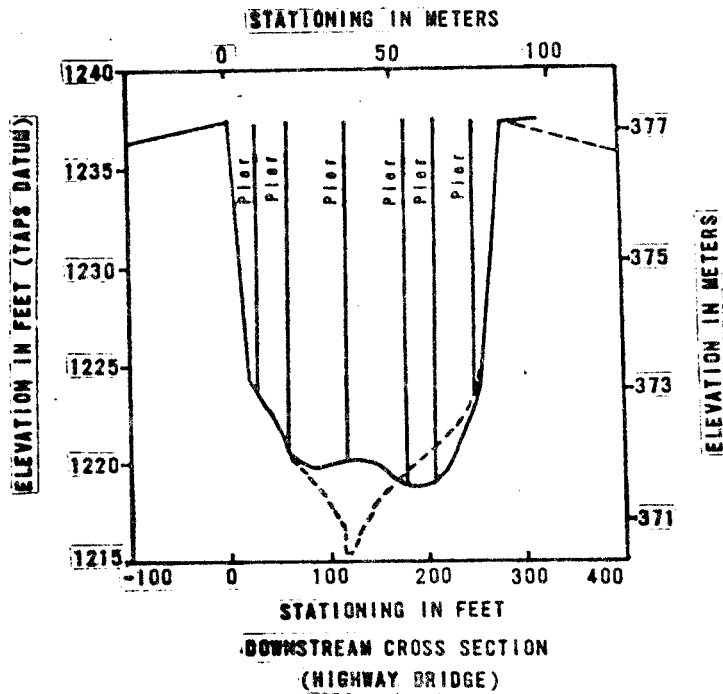
Figure 7.-- Cross sections of the Middle Fork Koyukuk River at Hammond River.

13                  The crossing site was resurveyed in July 1976. There was no  
14                  significant change in the upstream cross section. Figure 7 shows  
15                  the construction change in the centerline cross section and the  
16                  change in the downstream cross section. The floodway at the  
17                  pipeline crossing has been greatly constricted by the construction.  
18                  At the downstream section, the bed scour which took place during  
19                  the spring of 1975 has been reversed and the thalweg elevation  
20                  in this section is now 1 ft (0.3 m) higher than in 1971.  
21  
22  
23  
24  
25

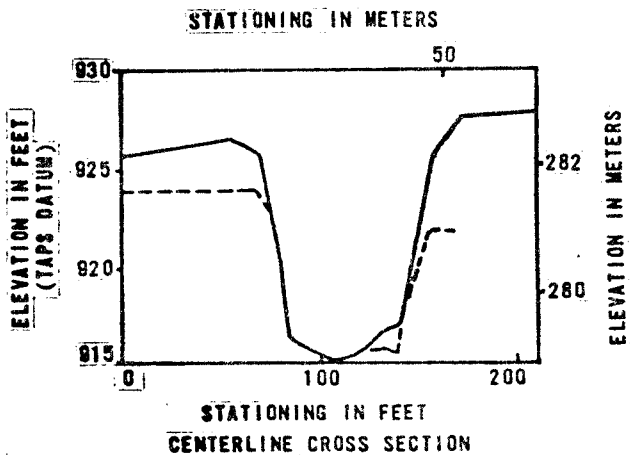
Figure 18.-- Cross sections of Prospect Creek near Prospect Creek Camp.

The crossing site was resurveyed in July 1976. No significant changes were found in the downstream cross section. Figure 18 shows the change at centerline section due to construction and the deepening of the upstream cross section.

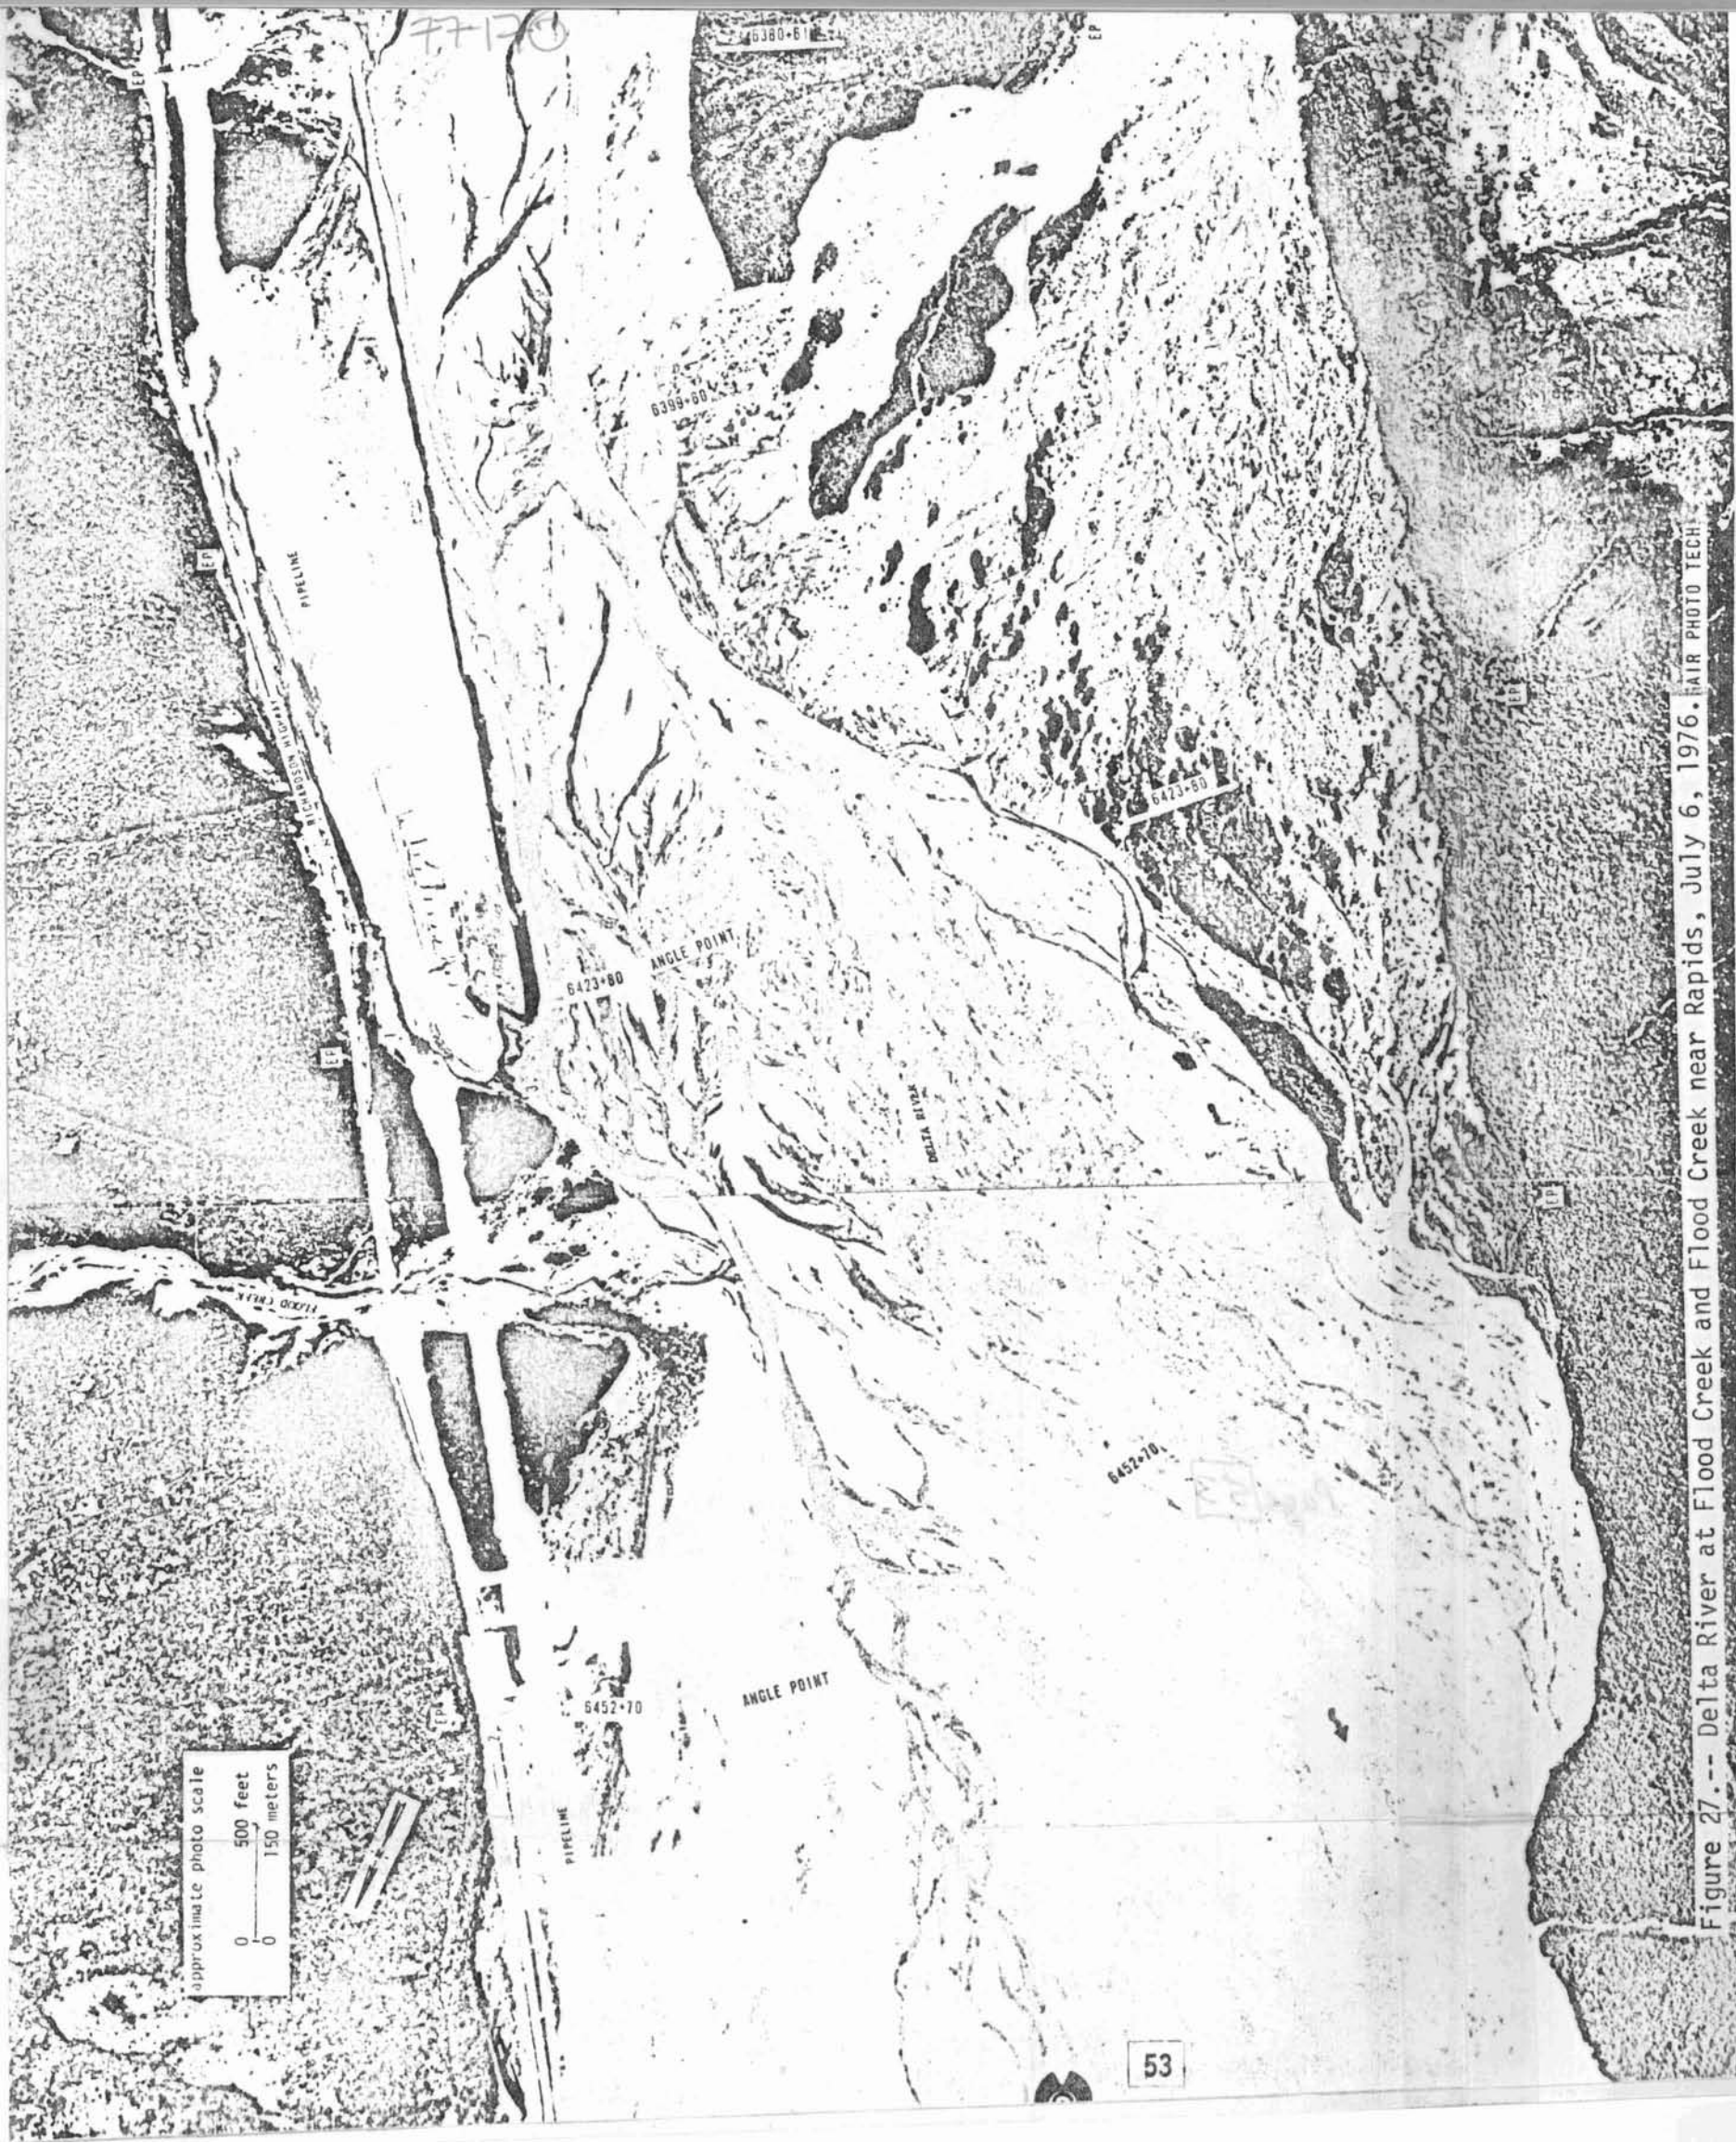
Figure 27.-- Delta River at Flood Creek and Flood Creek near Rapids, July 6, 1976. (AIR PHOTO TECH.)

1976 Surveillance.--Figure 27 shows the Flood Creek crossing on July 6, 1976. The pipe has been buried across the Flood Creek fan.

6 1976 Surveillance.--Figure 27 shows the Delta River at Flood Creek site  
7 on July 6, 1976. Lateral dikes have been built to protect the  
8 buried pipe between Michael and Flood Creeks. These dikes have  
9 forced the flow to the left side of the channel to some extent.

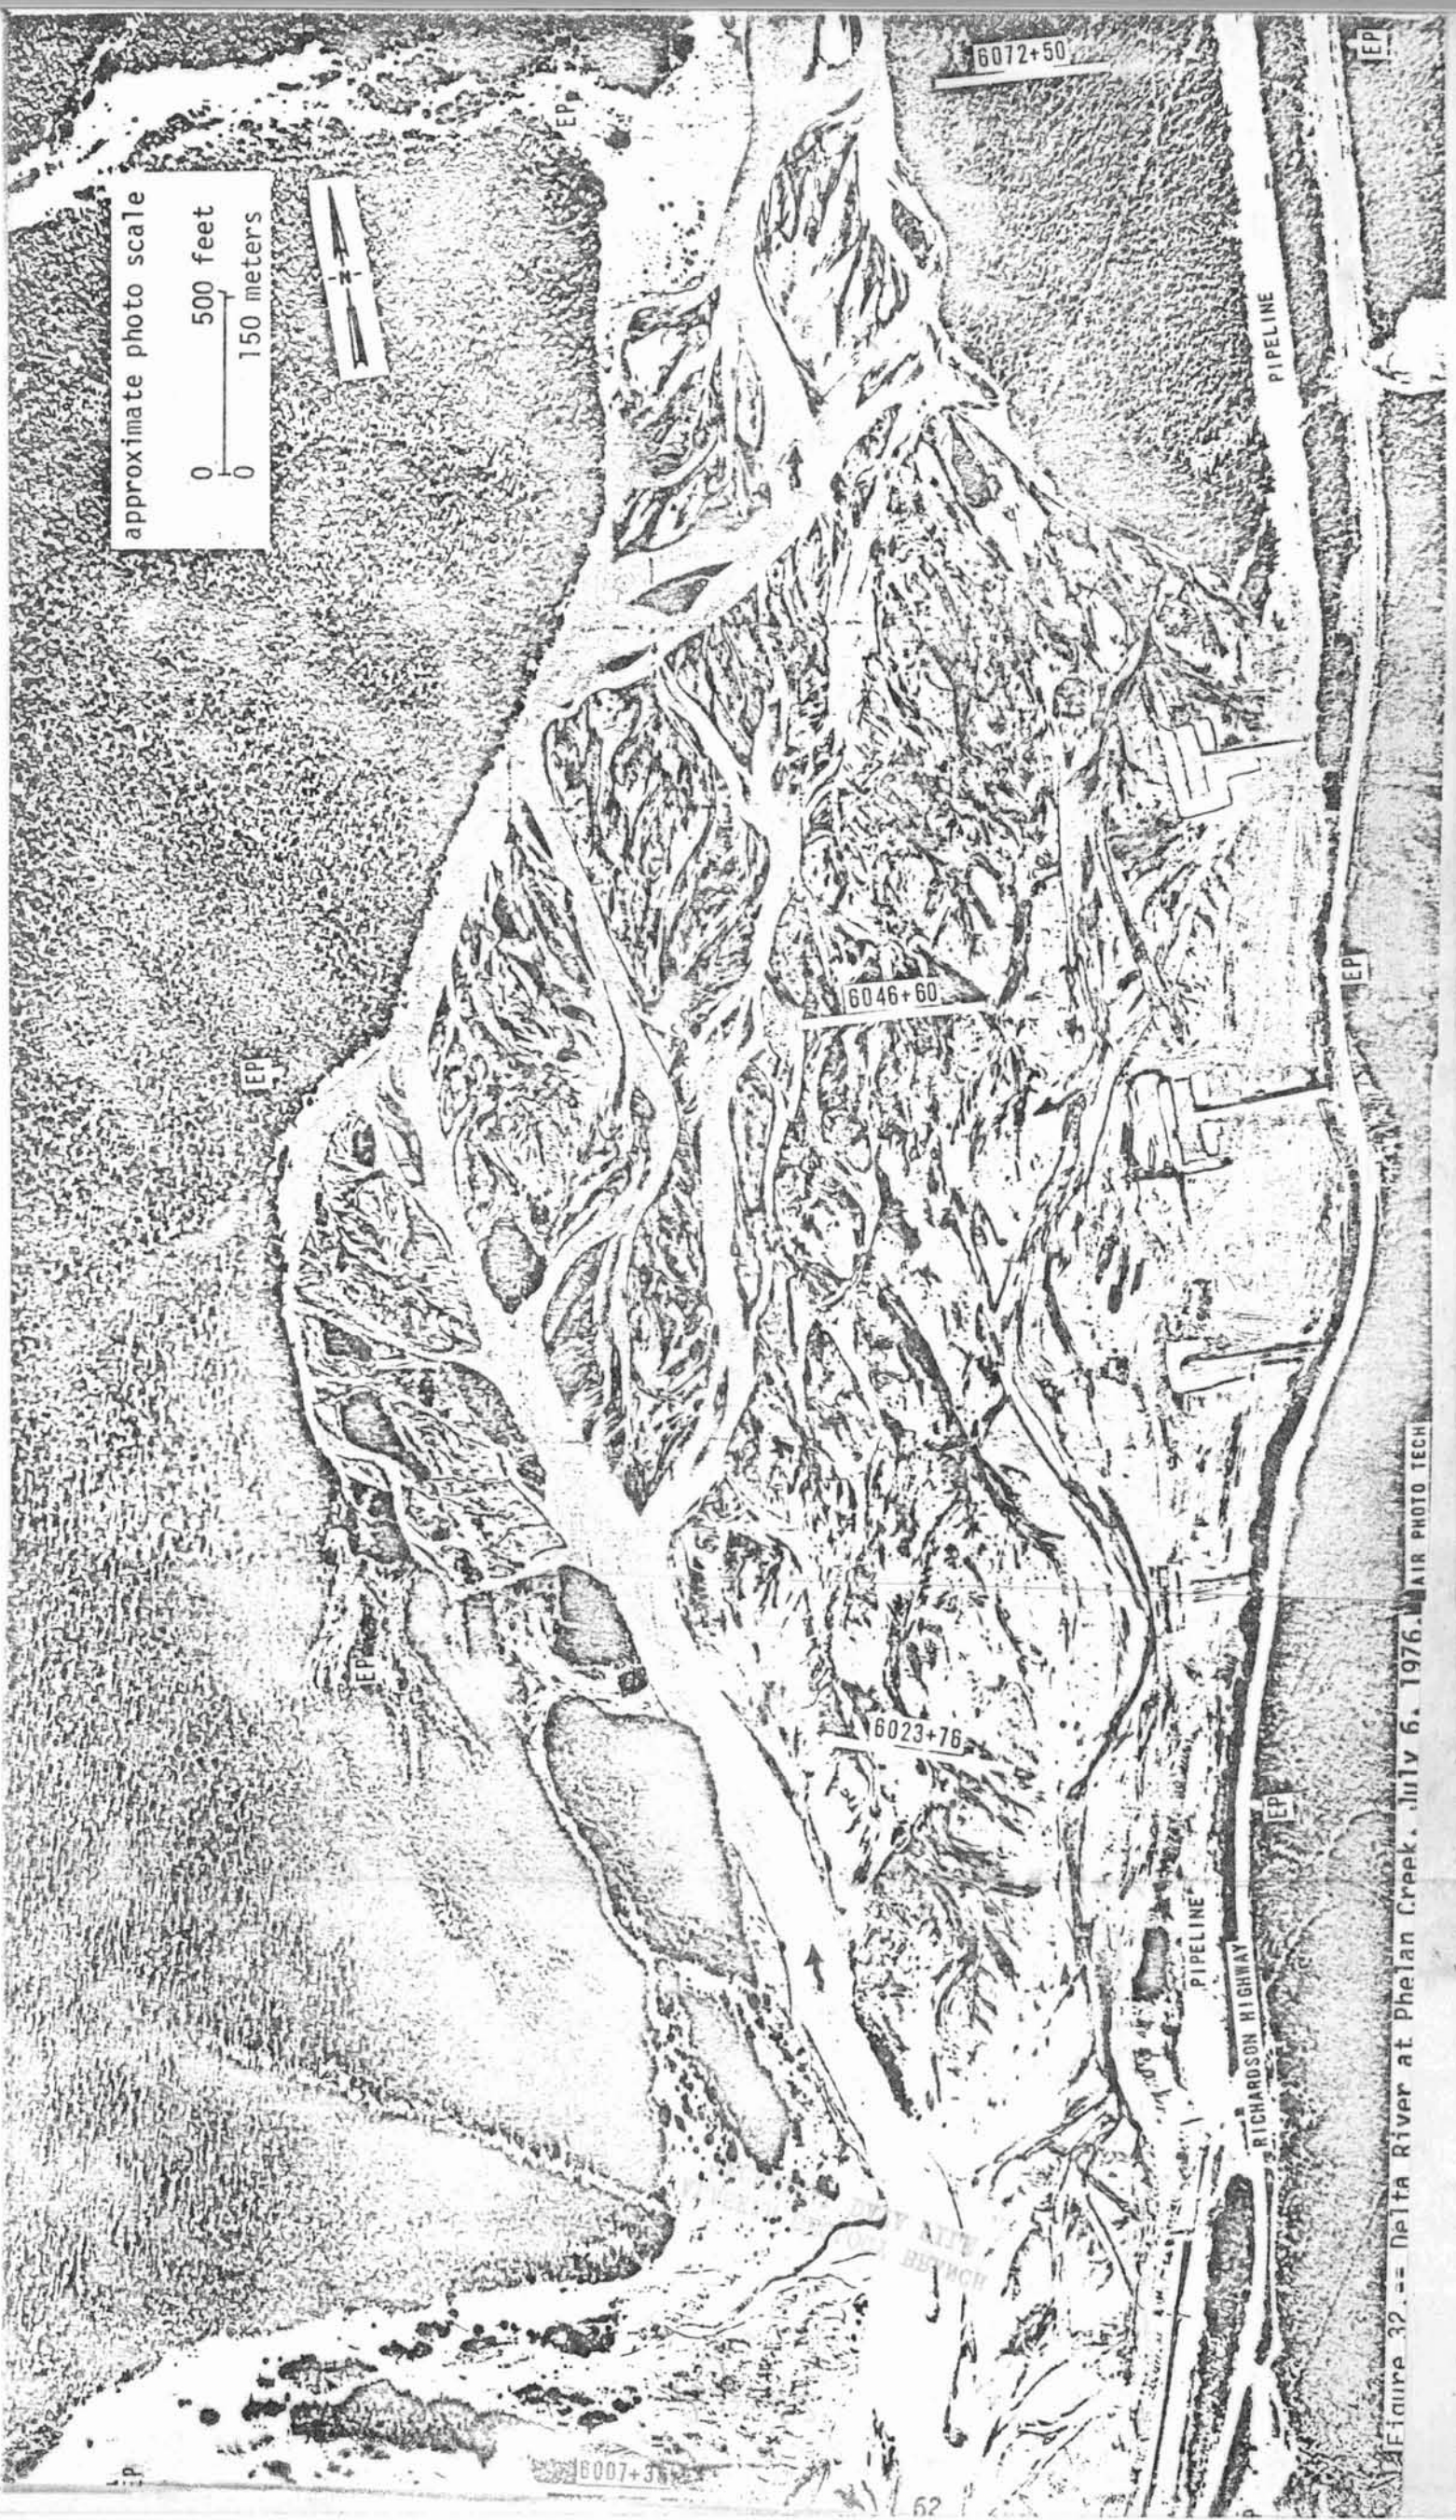
Figure 32 -- Nelta River at Phelan Creek, July 6, 1976. AIR PHOTO TECH

6 1976 Surveillance.--Figure 32 shows the Delta River at Phelan Creek site  
7 on July 6, 1976. The pipe has been buried along the right side of  
8 the flood plain and construction of protective spur dikes is in  
9 progress.

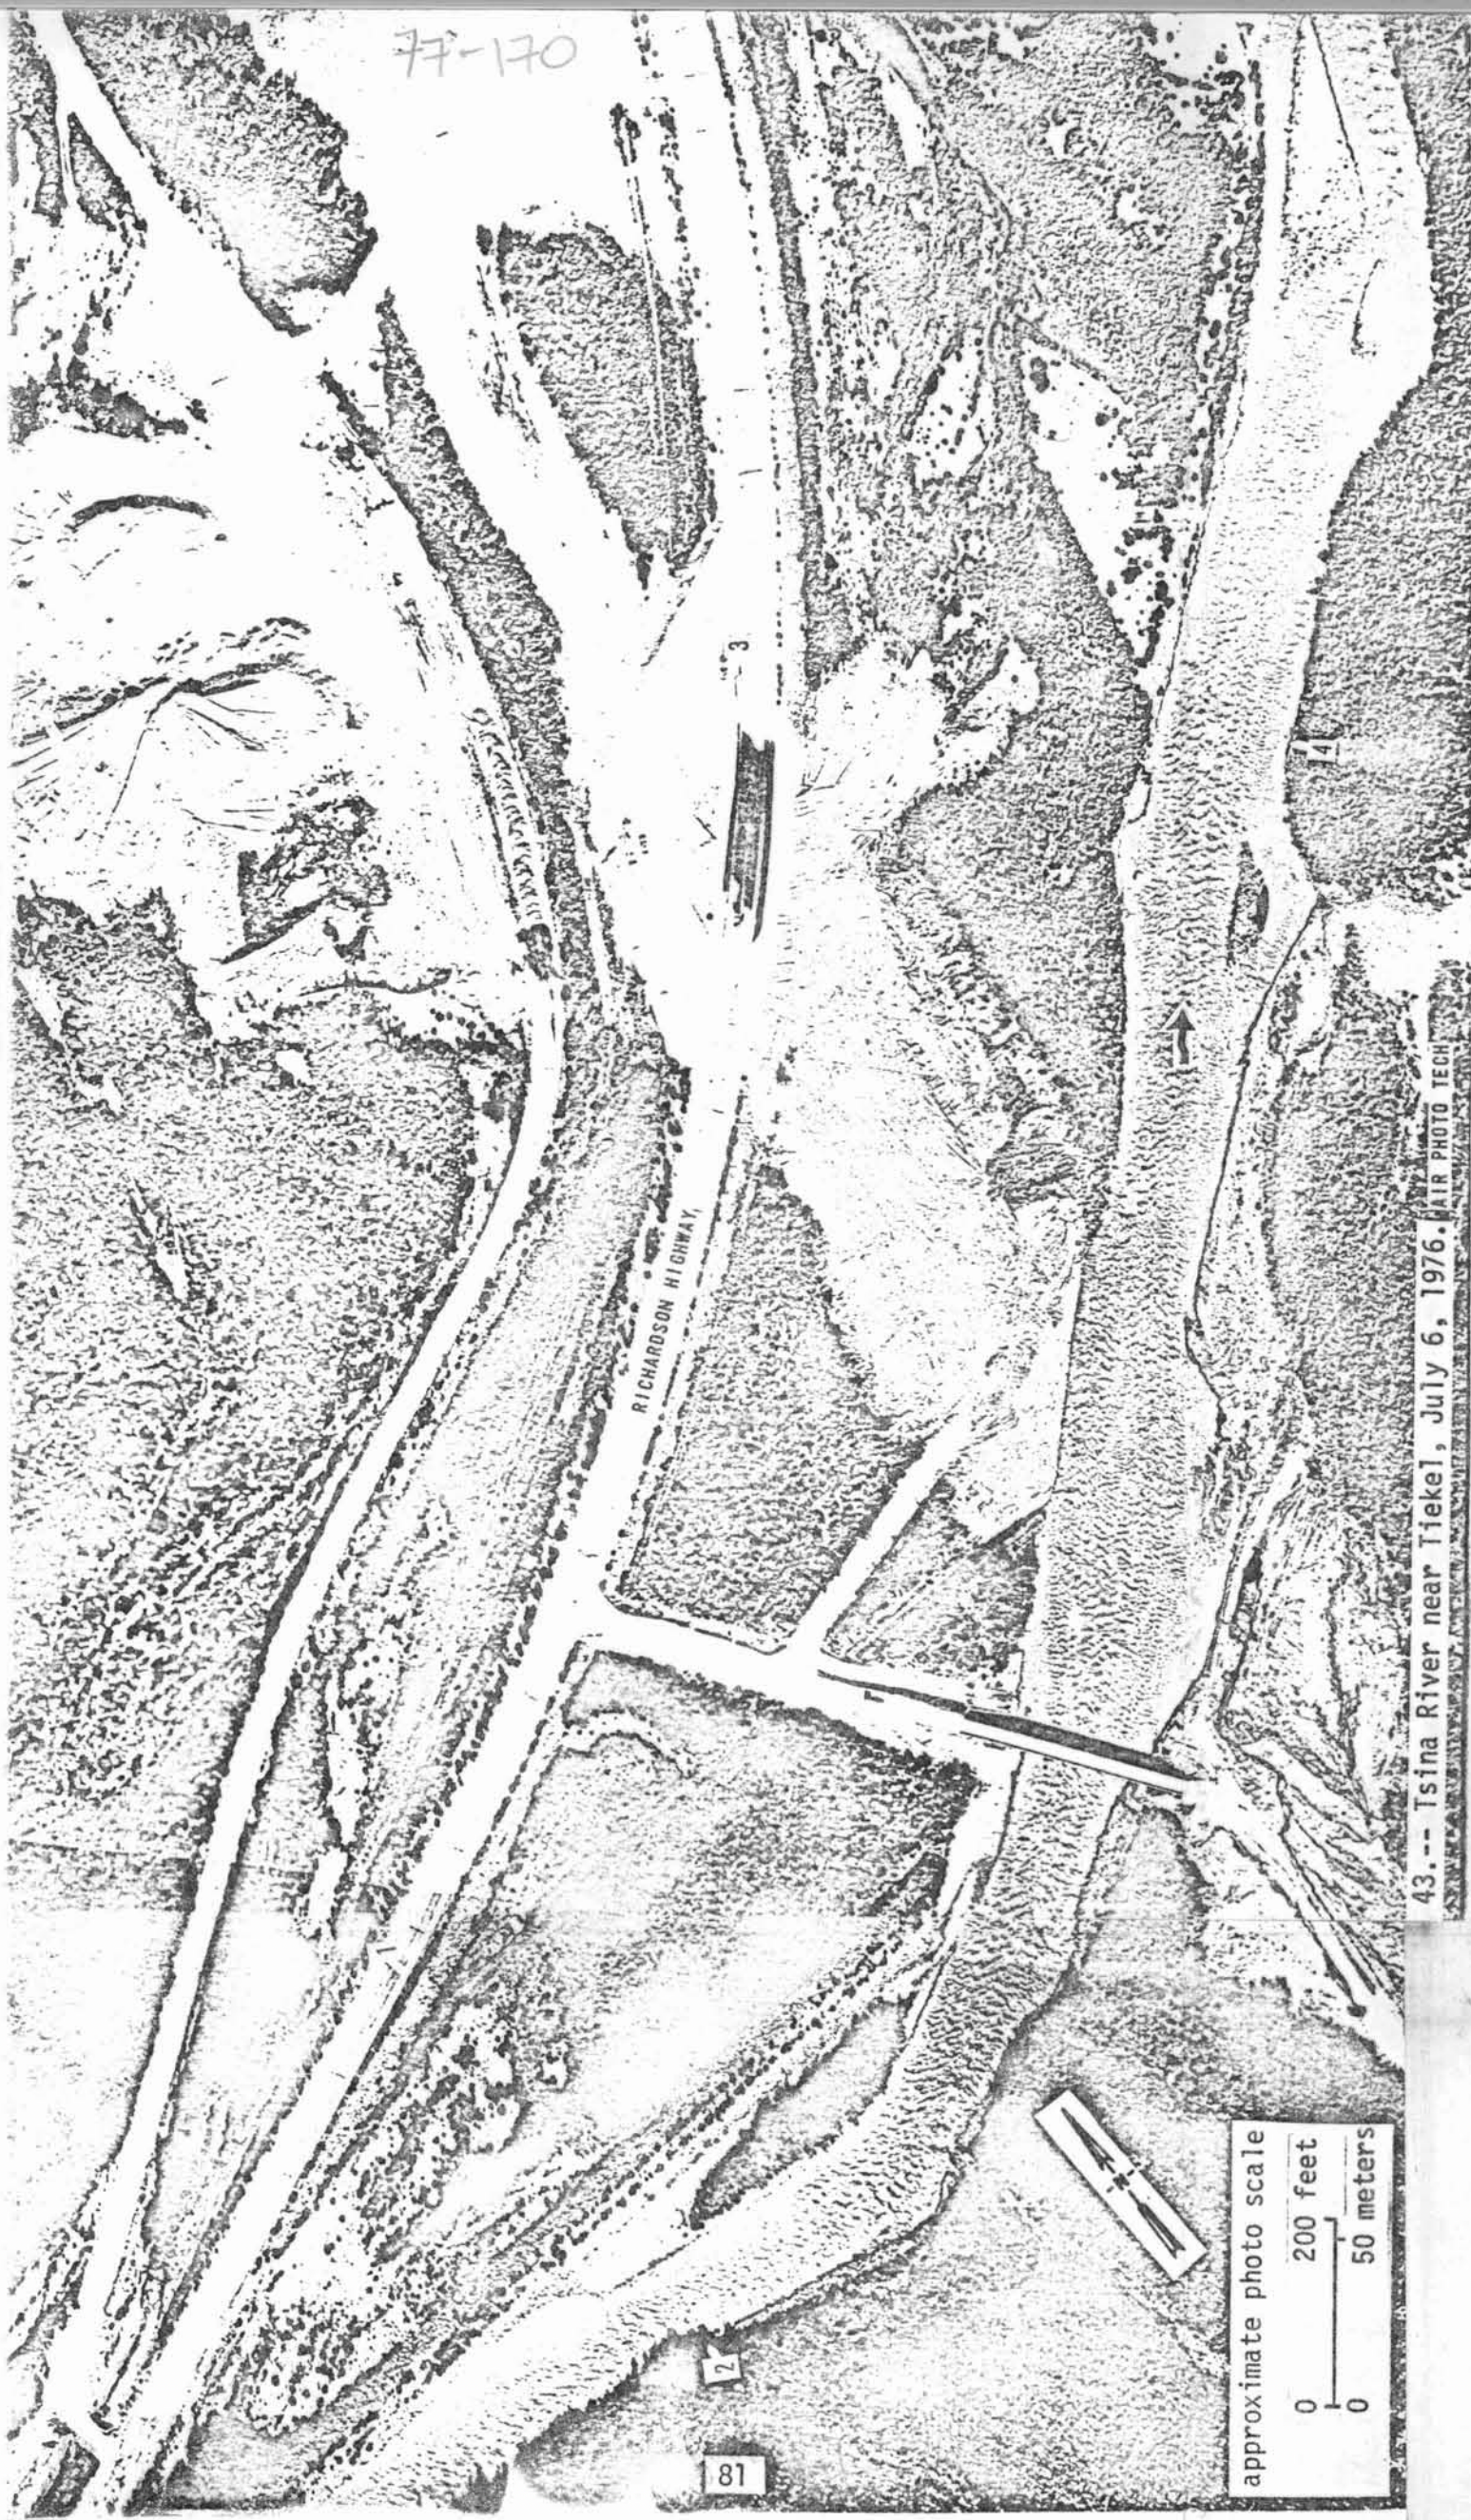
43.-- Tsina River near Tiekel, July 6, 1976. AIR PHOTO TECH

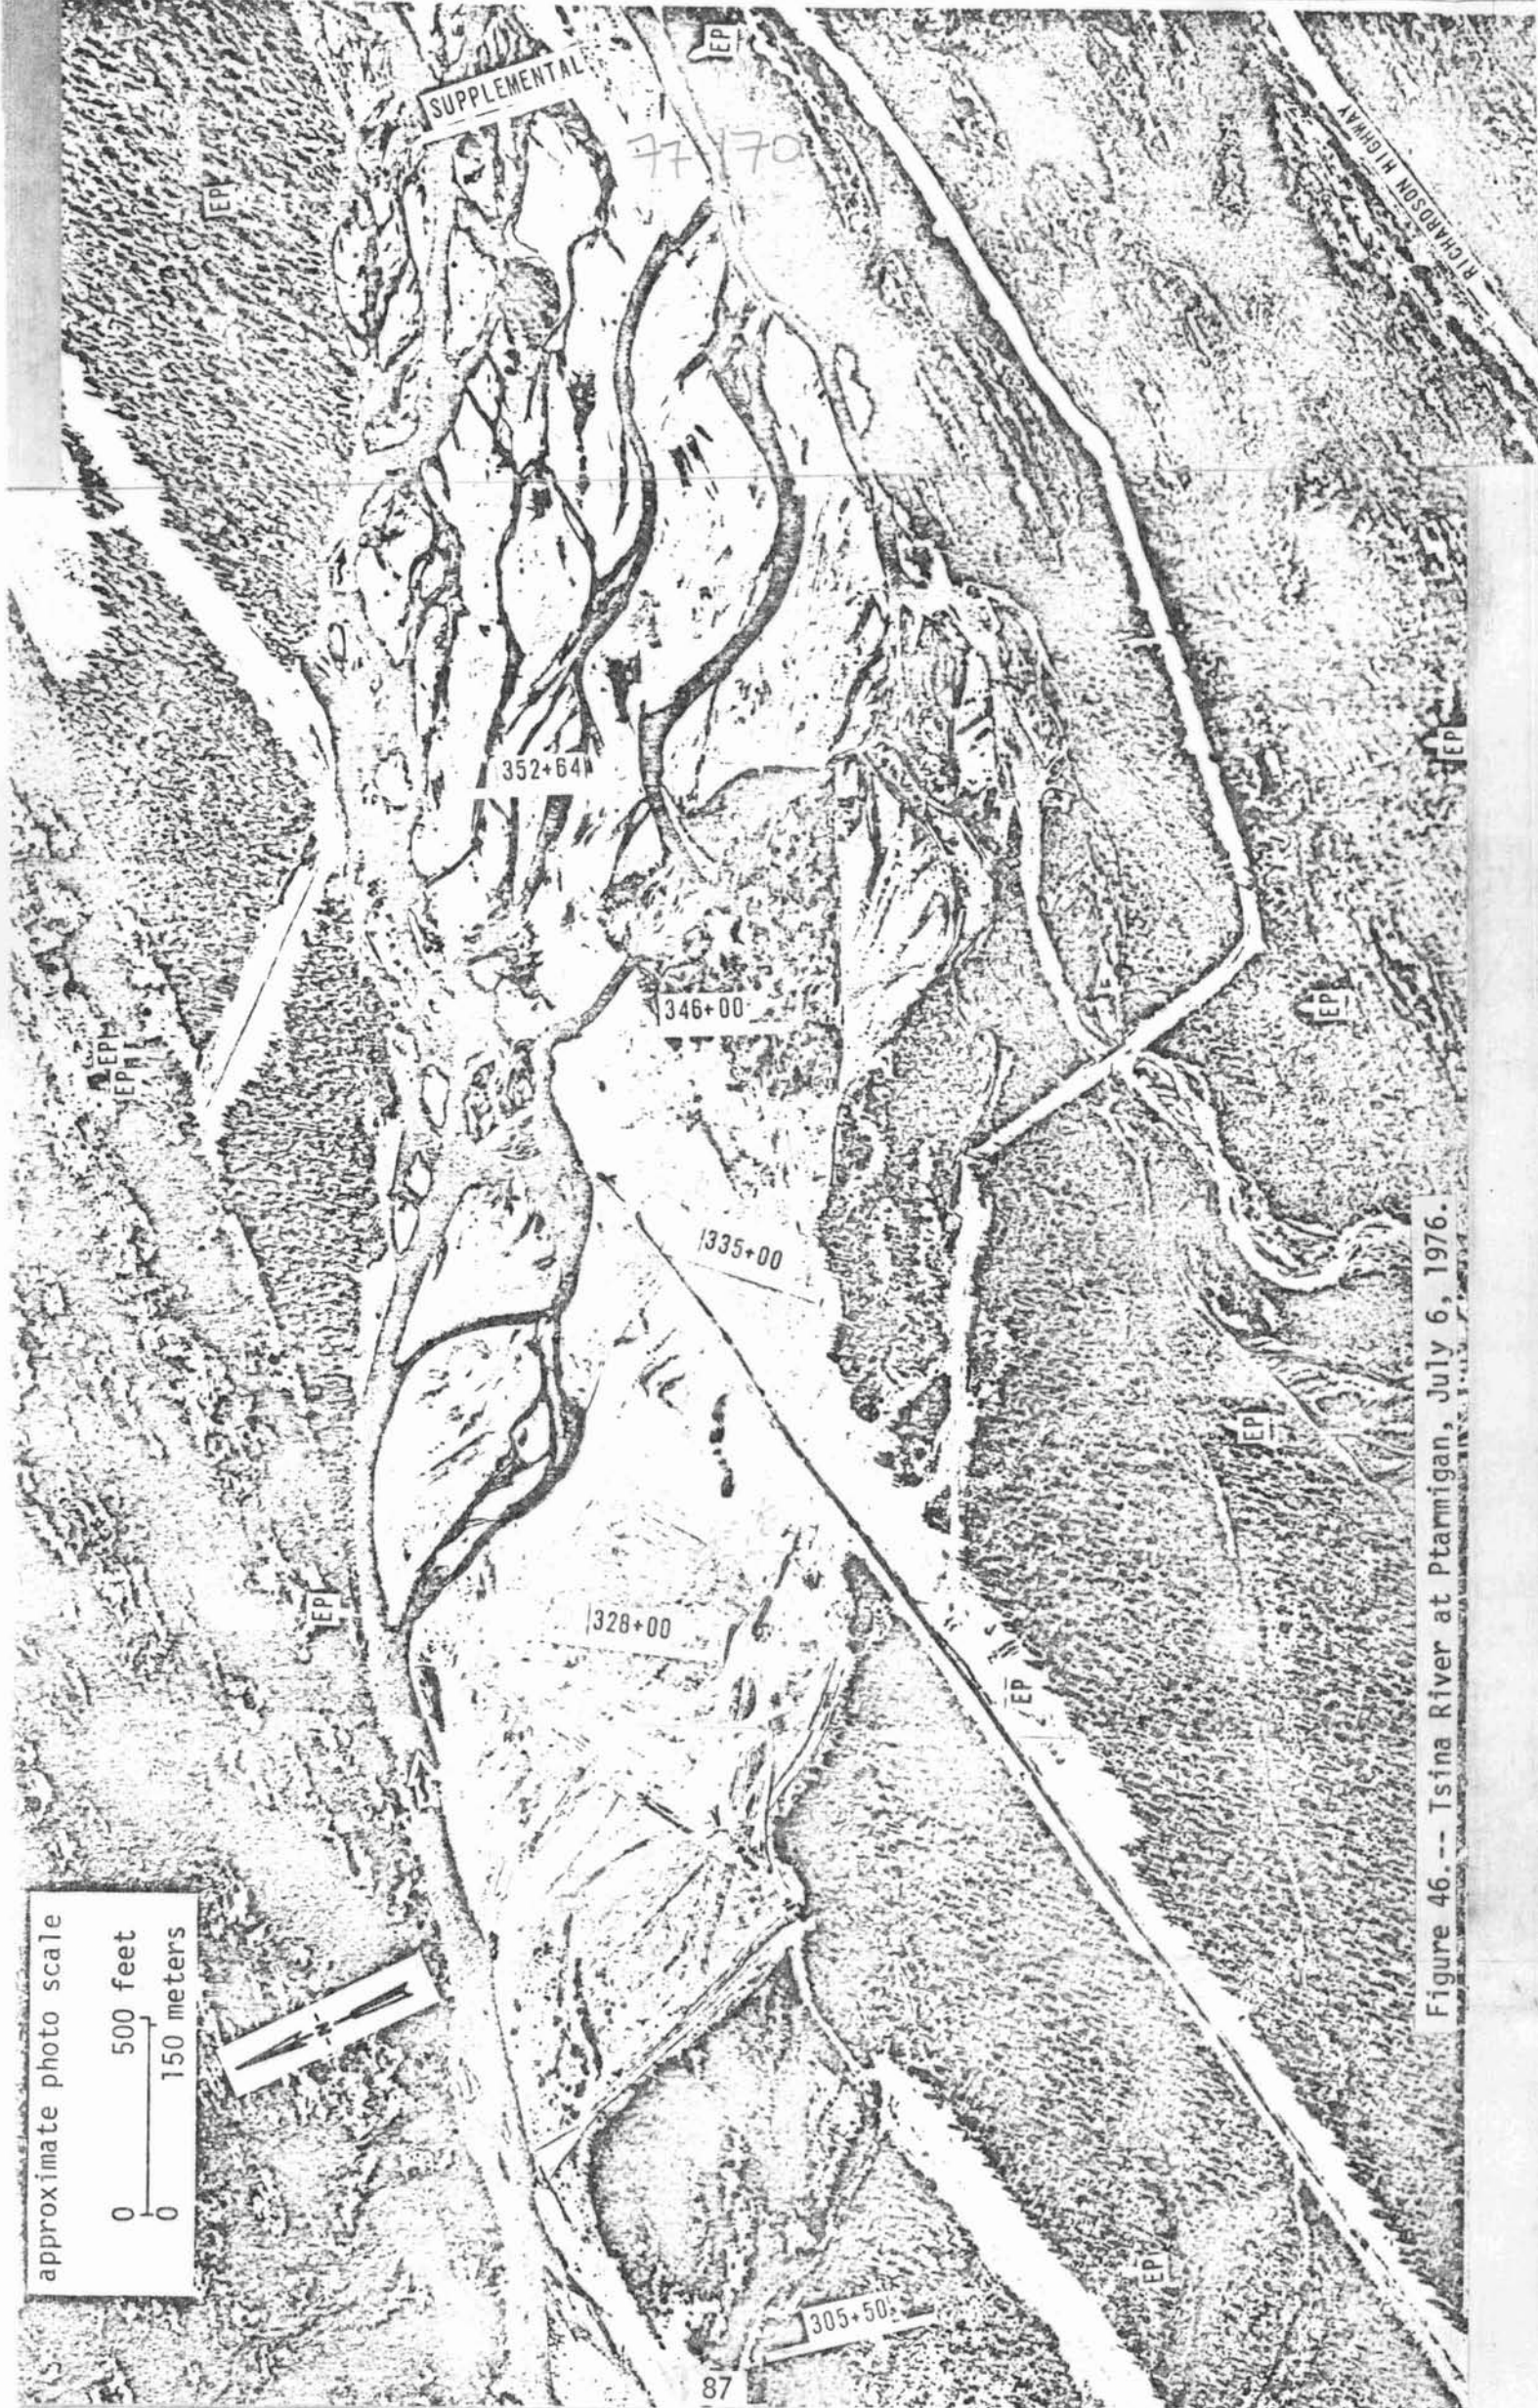
Figure 46. -- Tsina River at Ptarmigan, July 6, 1976.

6 1976 Surveillance.--Figure 46 shows the Tsina River at Ptarmigan  
7 crossing site on July 6, 1976. The pipe has been buried and  
8 there has been much stockpiling and movement of river-run gravel  
9 along the right side of the flood plain in the vicinity of the  
10- centerline. Dikes have been built upstream of the pipeline to  
11 protect the pipe. The dike on the left bank has been extended  
12 downstream of the centerline since the photo was taken, and heavy  
13 riprap has been dumped along the streamward face of the dike.

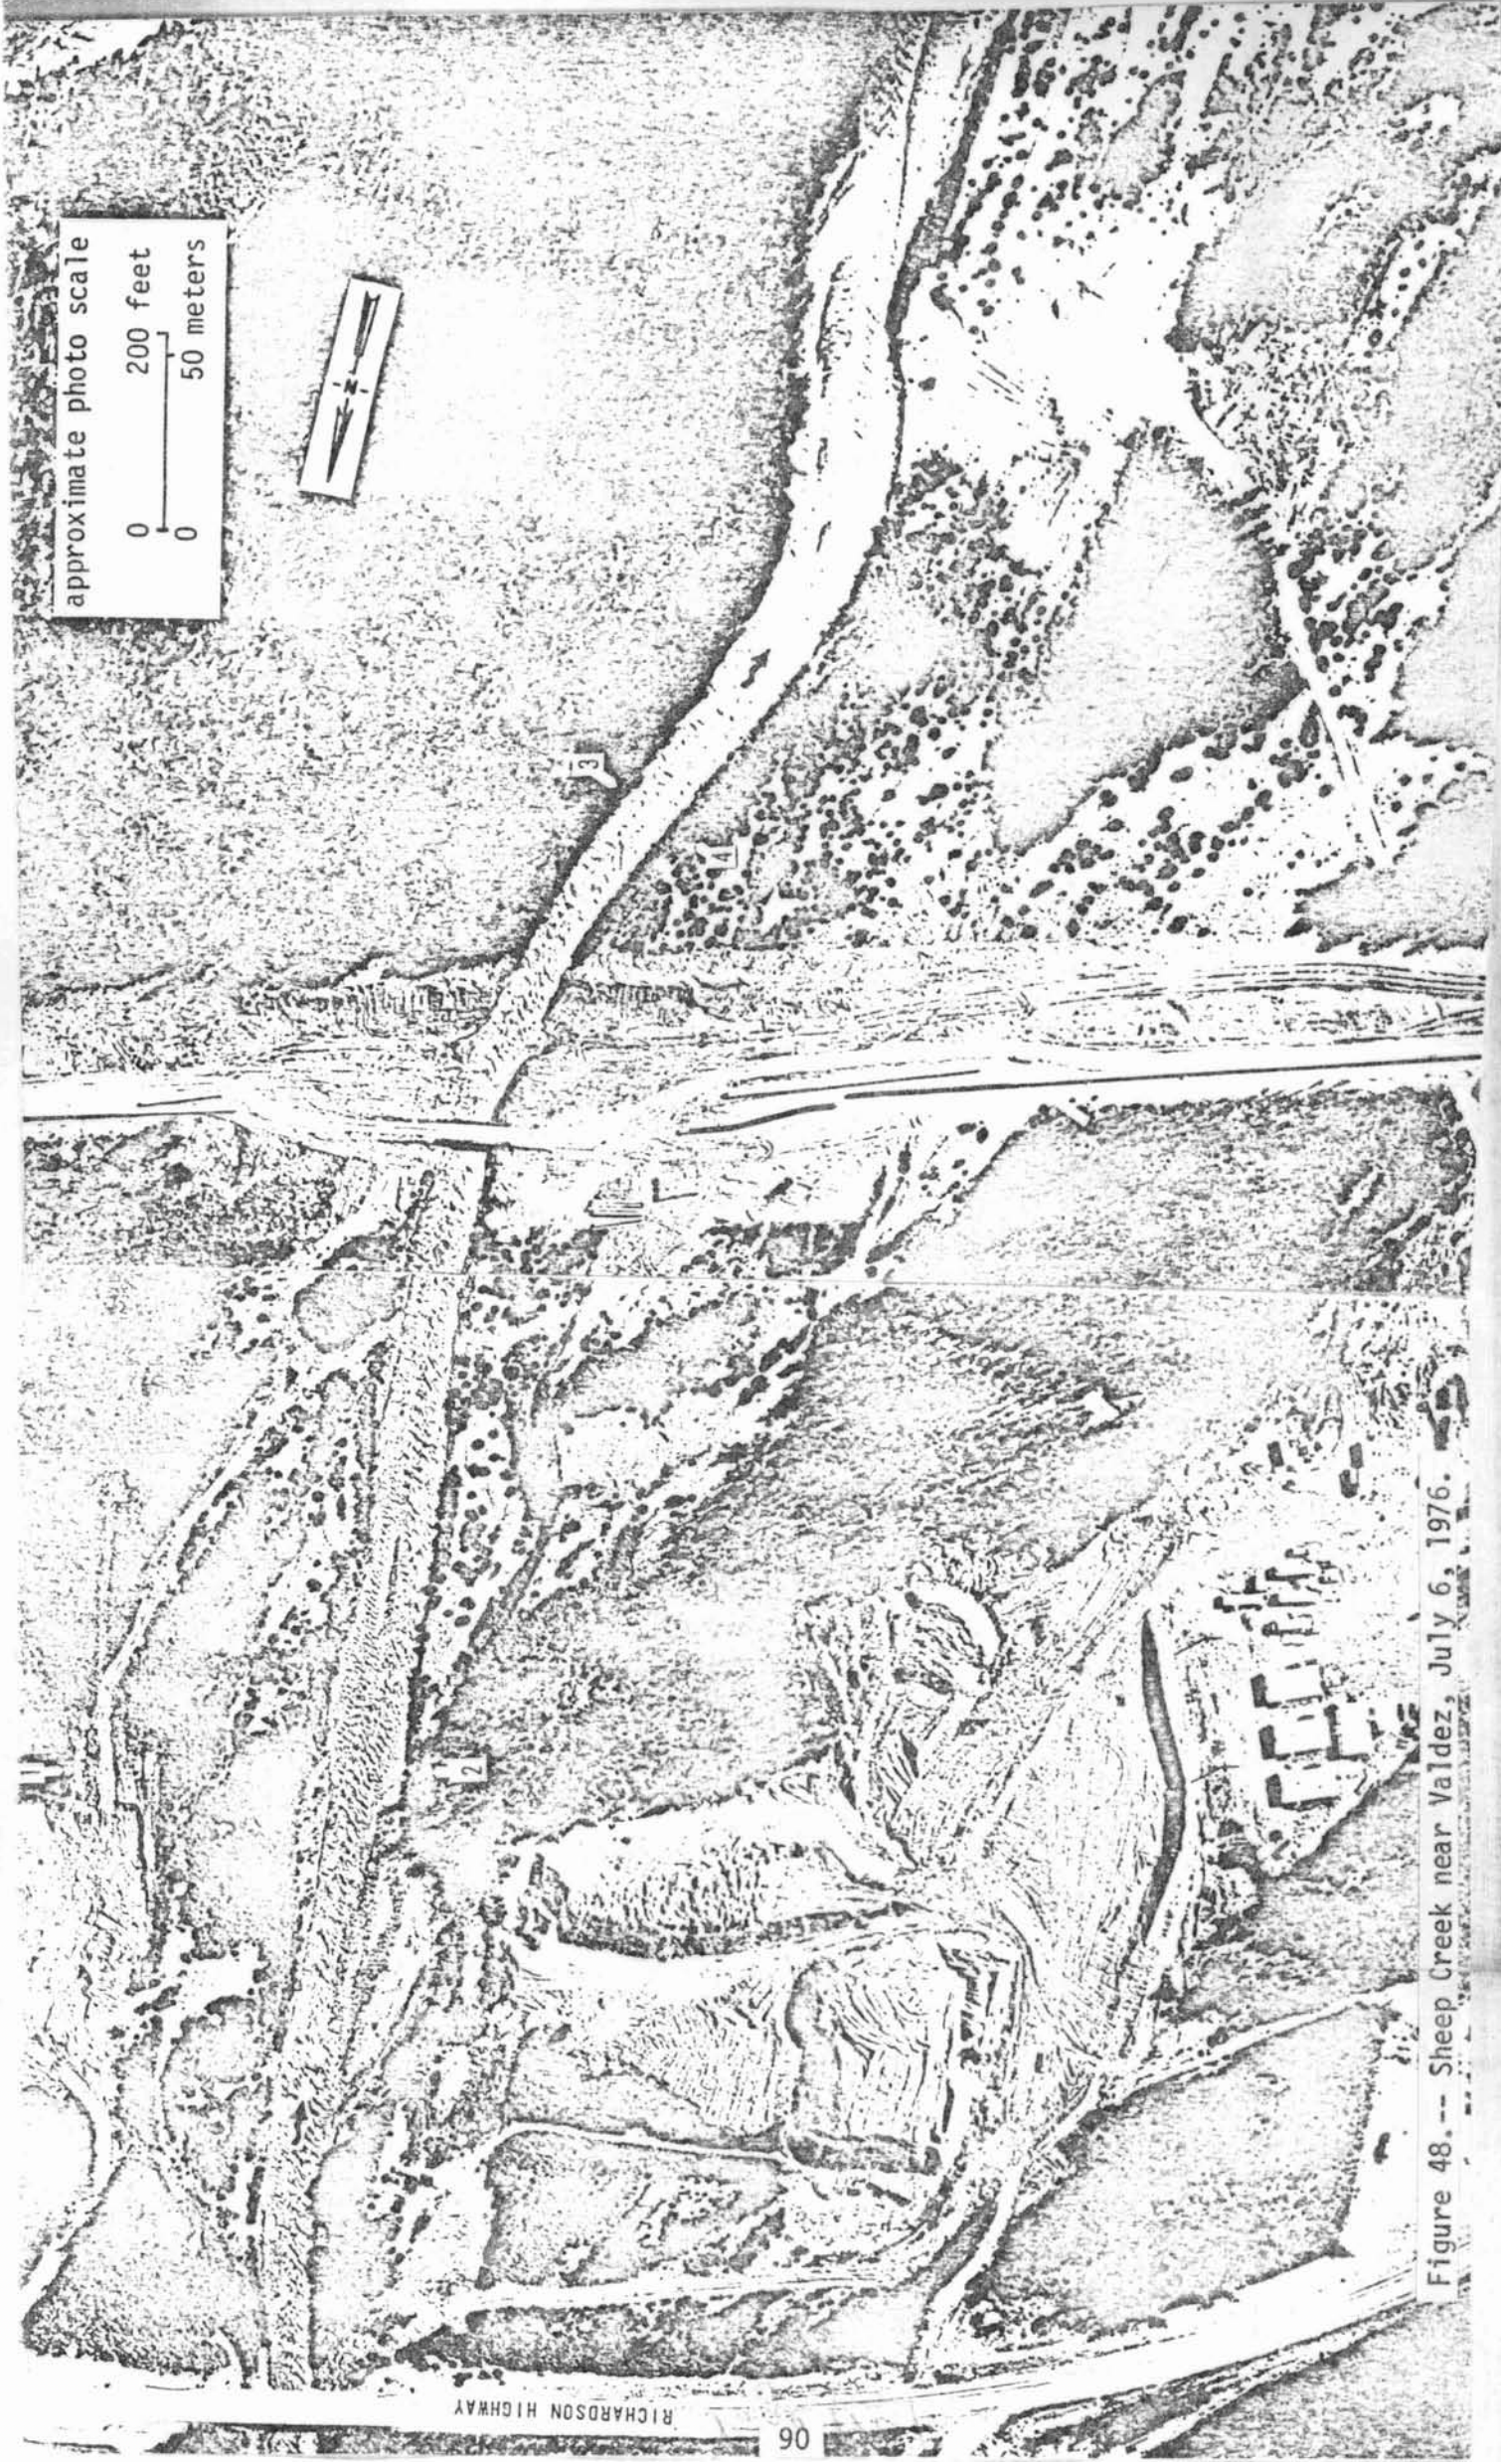
Figure 48. --- Sheep Creek near Valdez, July 6, 1976.

7 1976 Surveillance.--Figure 48 shows the Sheep Creek crossing site  
8 on July 6, 1976, during the construction of the buried crossing.
