DINKUM SANDS

U.S. Geological Survey  
OPEN-FILE REPORT  
80-360

## Dinkum Sands

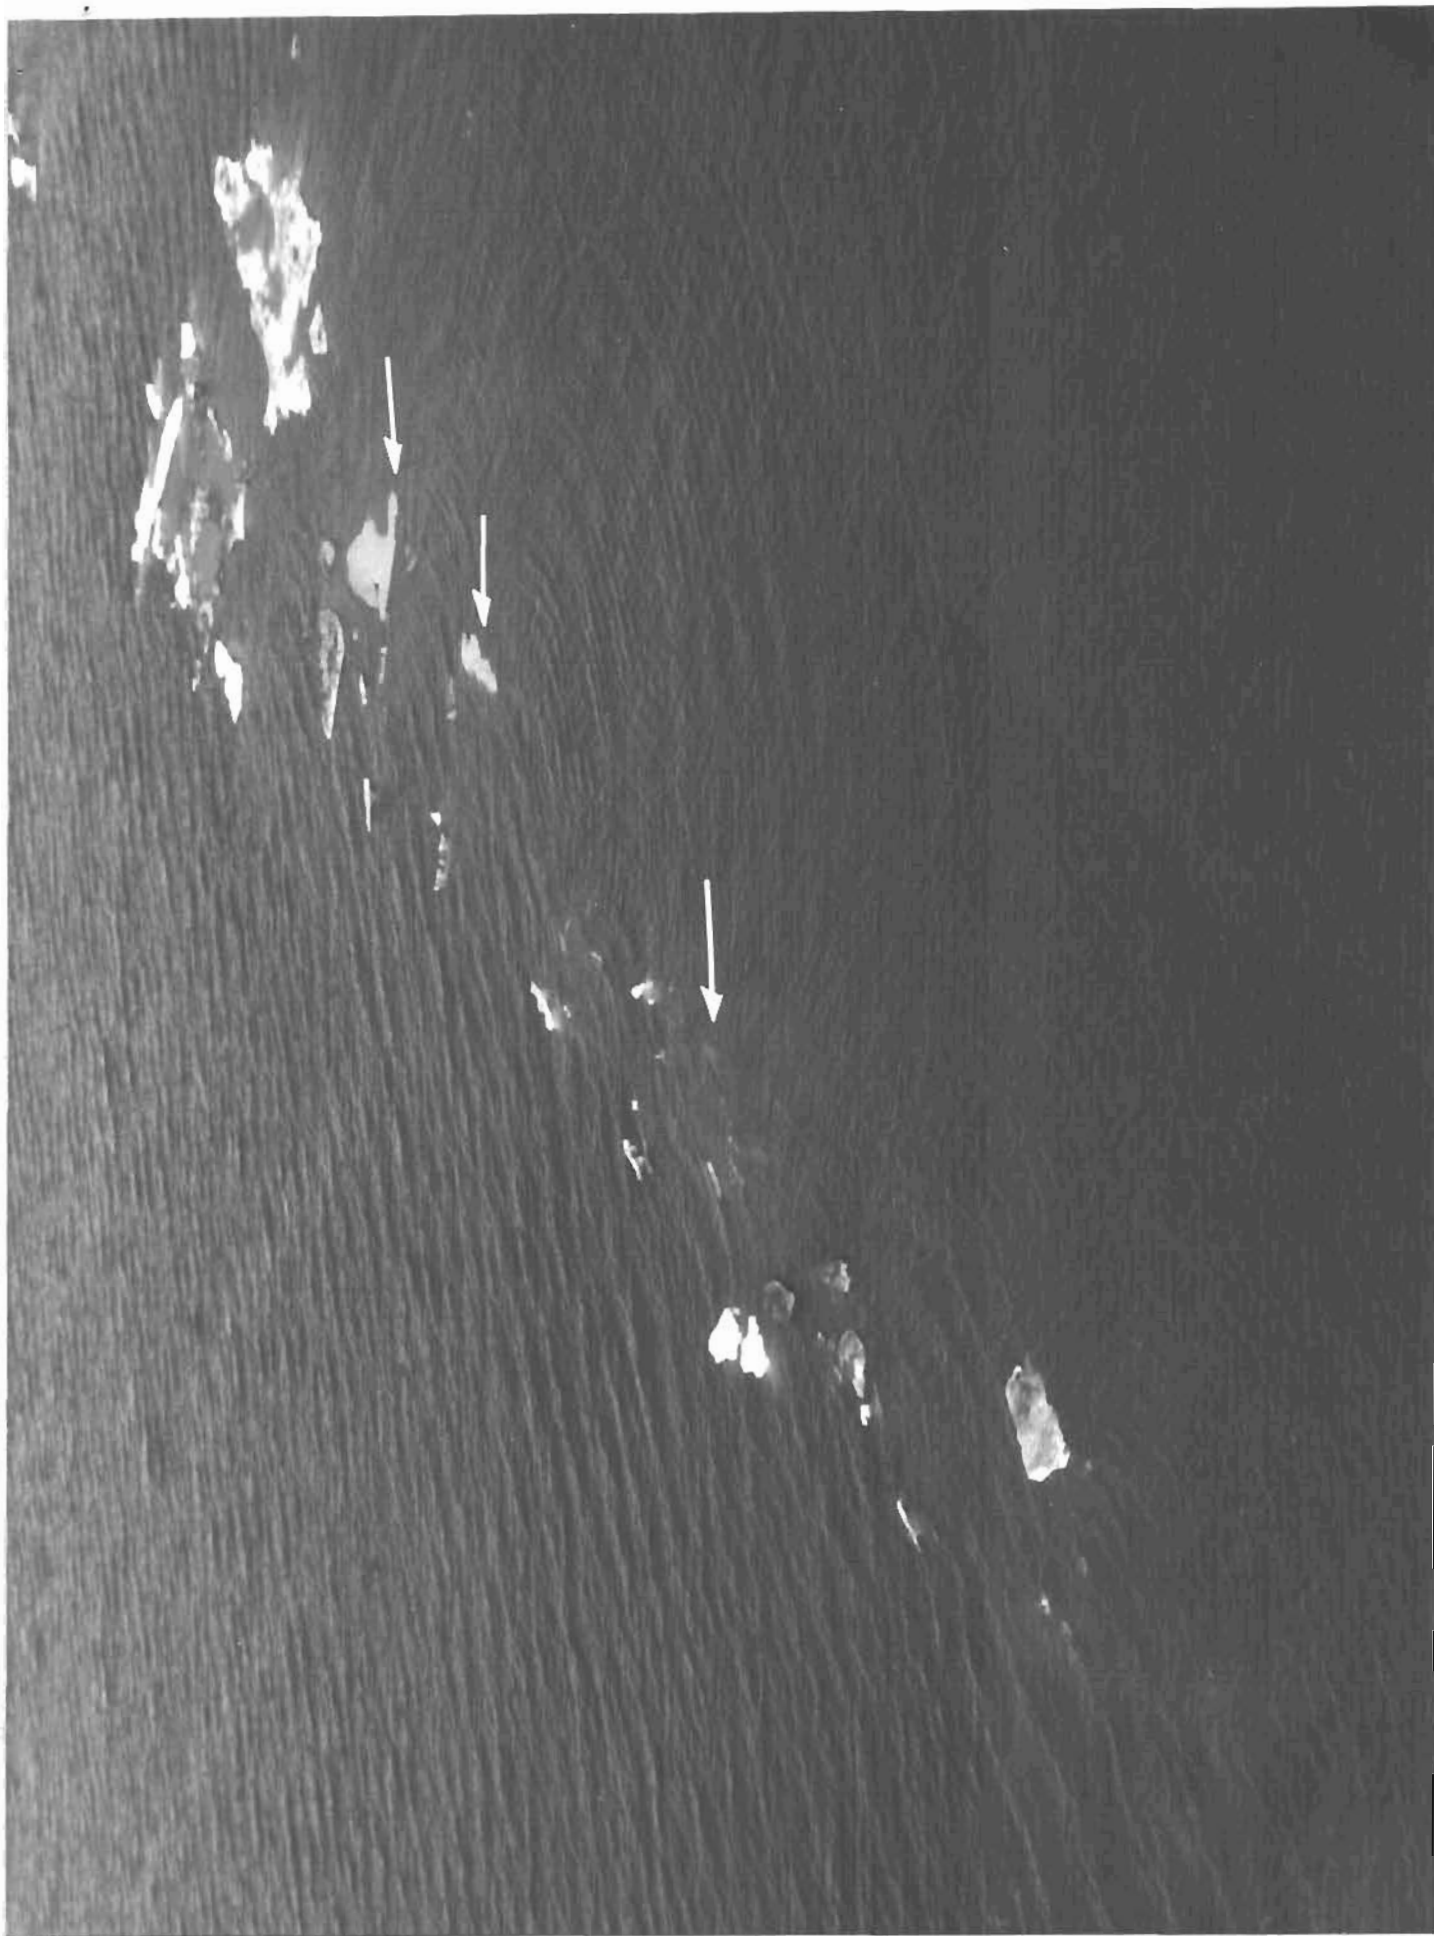
Figure 2. Aerial photograph of Dinkum Sands on July 15, 1979. The major gravel mounds above sea level are shown by white arrows. All other white objects are grounded ice.

Our first visit to Dinkum Sands on July 15, 1979 was prompted by reports that the State of Alaska had 'rediscovered the island.' The shoal, as seen from a helicopter on that date and photographed (Fig. 2) is studded by a series of isolated, small, irregular gravel mounds which break the sea surface. Many small grounded ice floes, remnants of ice piling on the shoal in the previous fall, form most of the light-colored, irregular surface features in the photograph. Submerged sea-ice kettles and ice gouges separate the line of gravel mounds.

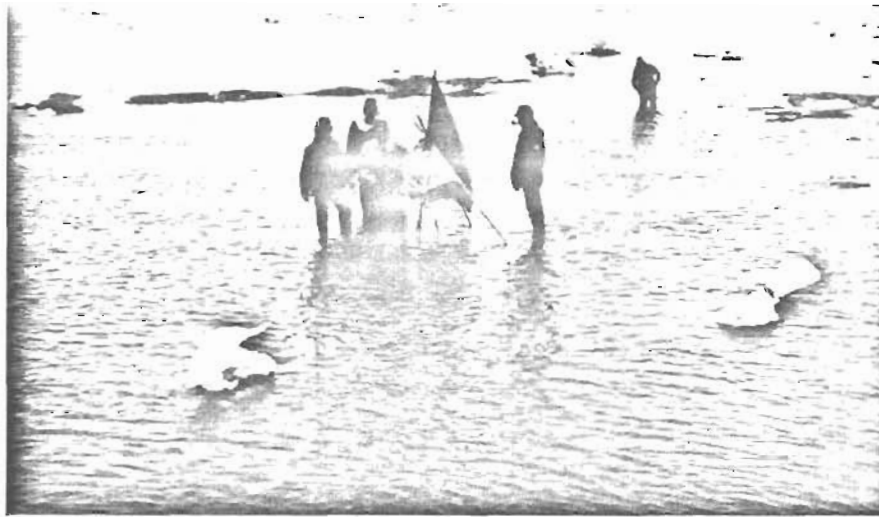
Figure 6. Dinkum Sands with the State of Alaska flag over the survey monument, during a visit by State and Federal officials on August 23, 1979. Minimum water depth was 20 cm.

On August 23 State and Federal Officials accompanied us on the R/V Karluk for a visit to Dinkum Sands where the State had placed a flag over a survey monument on the highest point (Fig. 6). The survey monument had been placed flush with the surface of the shoal on this spot. At the time of our visit the monument was beginning to protrude due to erosion of surface gravel. The shoal was submerged under 20 cm of water.
