THE ALASKA EARTHQUAKE, MARCH 27, 1964:
EFFECTS ON COMMUNITIES

Effects of the Earthquake of March 27, 1964 on Various Communities

GEOLOGICAL SURVEY PROFESSIONAL PAPER 542-G

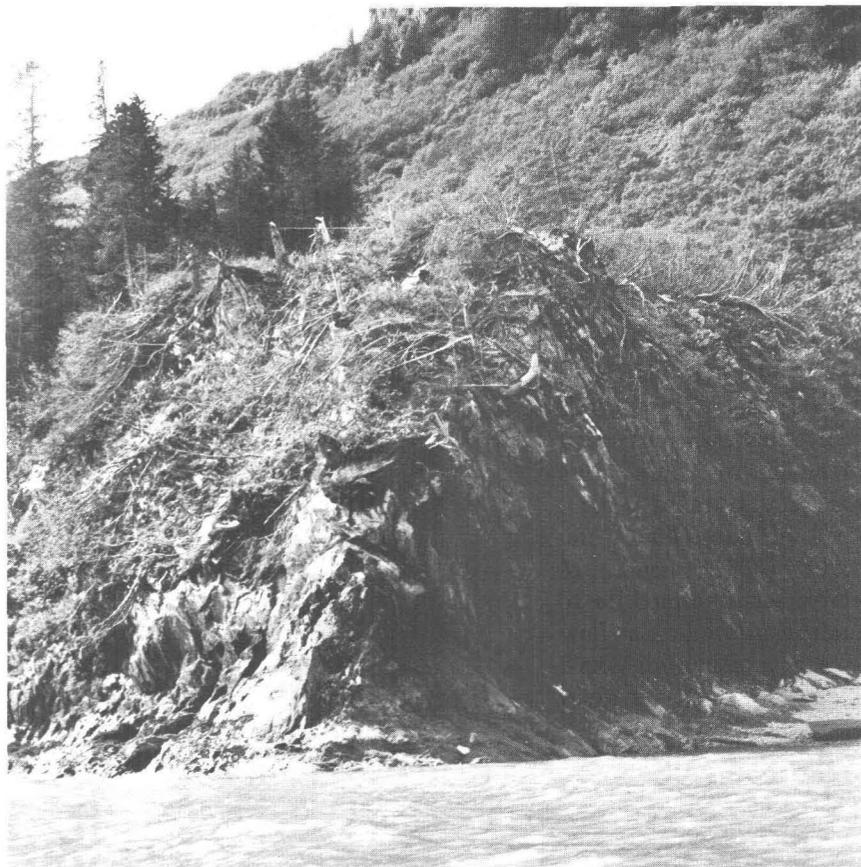
2.—Spur west of Shoup Bay in Port Valdez that was overtopped by a local wave traveling from right to left. Trees and branches are broken to an elevation of more than 100 feet above lower low water. Location shown in figure 1.

diameter spruce trees at elevations as high as 101 feet and deposited barnacle-covered boulders estimated to weigh 1,700 pounds 88 feet above the shoreline (figs. 2, 3, and 4). The waves that moved westward out of Port Valdez overtopped and destroyed the Valdez Narrows navigation light situated on top of a reinforced concrete pedestal 35 feet above lower low water (fig. 1).

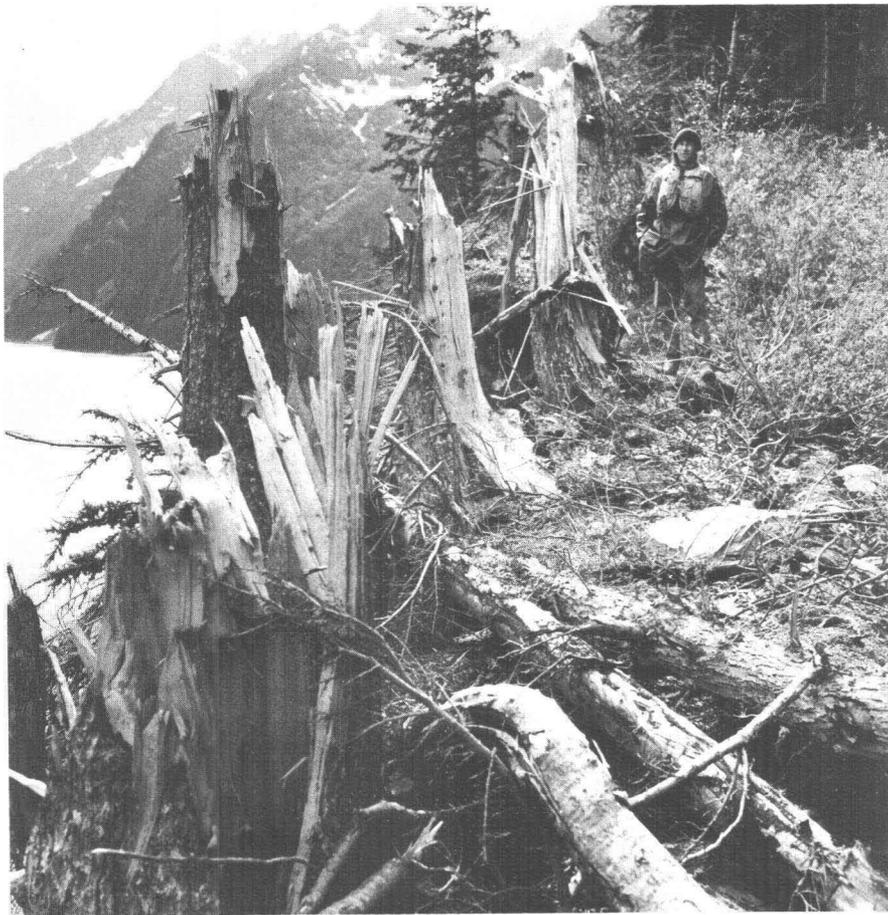
lowup studies (Plafker and Mayo, 1965, fig. 16) clearly indicates that the highest waves in western Port Valdez probably originated mainly at the sites of large submarine slides of segments of the Shoup Glacier end moraine that blocks the mouth of the bay (fig. 1). The moraine is a crescentic deposit of coarse unconsolidated glacial debris perched at the lip of a hanging valley whose floor is more than 500 feet above the bottom of Port Valdez. The damage distribution, submarine soundings, and changes in shoreline configuration indicate that the largest slides probably originated near the Cliff mine and at the west side of Shoup Bay near the points indicated by triangles on figure 1. Downslope movement of such masses triggered by the

high wave generated by submarine sliding at the head of the fiord 10 miles east of Shoup Bay is difficult to reconcile with the directions and relative heights of waves in western Port Valdez as indicated by the pattern of wave damage along the shoreline (fig. 1).

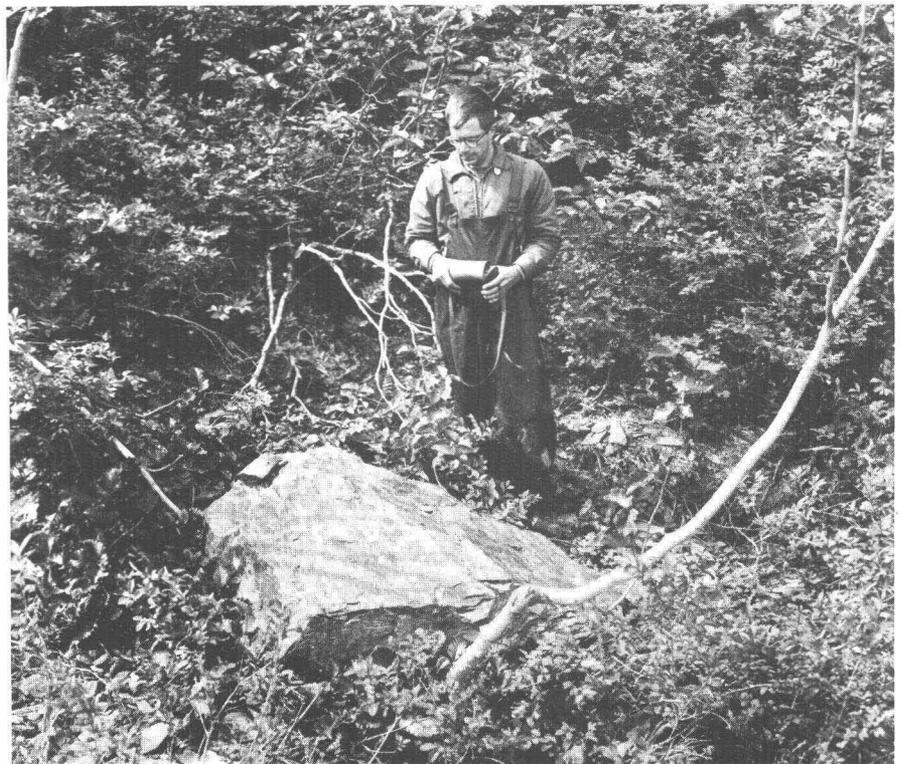
4 (right).—Boulder estimated to weigh 1,700 pounds thrown up 88 feet above the shoreline by a local wave at the place near Shoup Bay shown in figure 1.

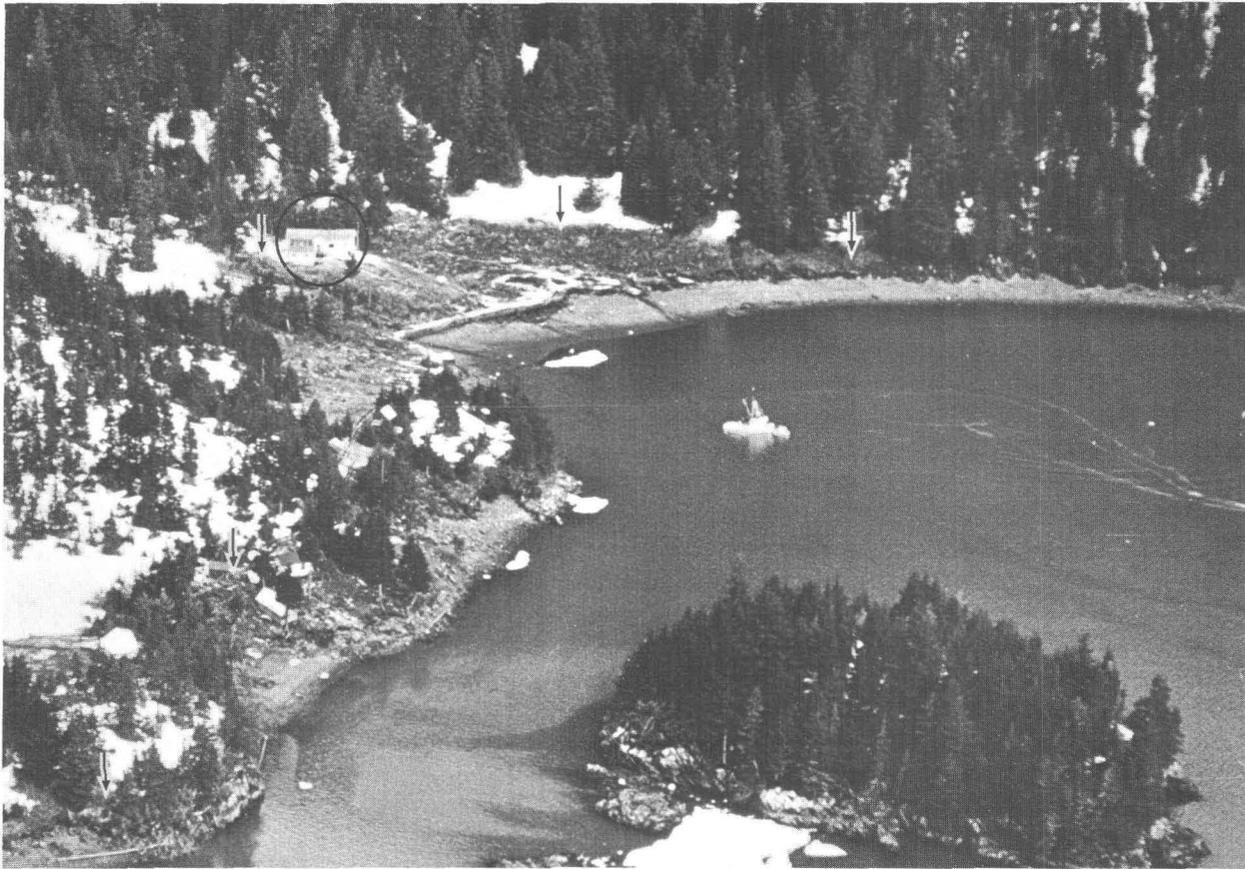
5.—Aerial view of the Chenega village site at the head of Chenega Cove. Lower limits of snow, as shown by arrows, indicate the approximate limits of wave runup; the schoolhouse is circled. Photograph taken March 29, 1964.

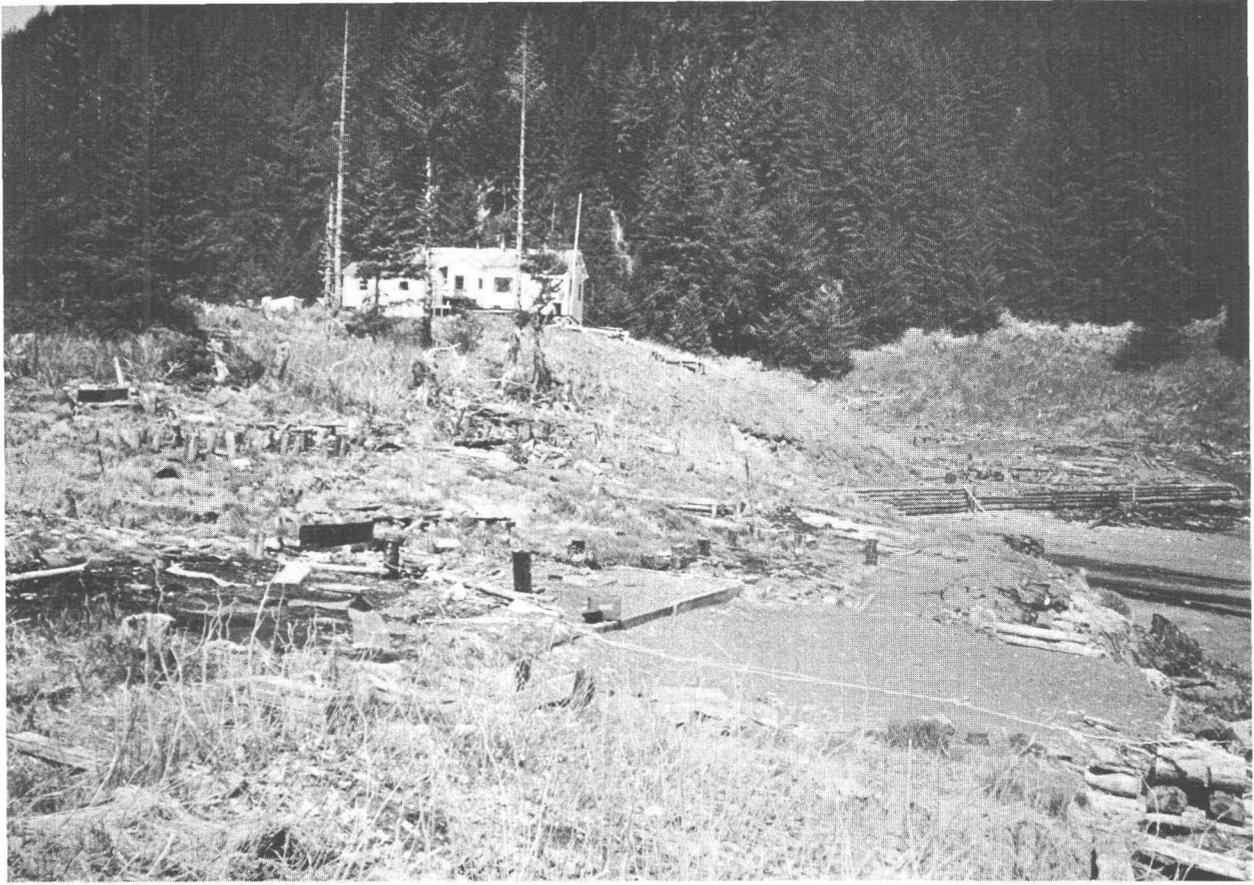
6.—Main part of the Chenega village site. Piling in ground marks the former locations of homes that were swept away by waves. Schoolhouse on high ground was undamaged.

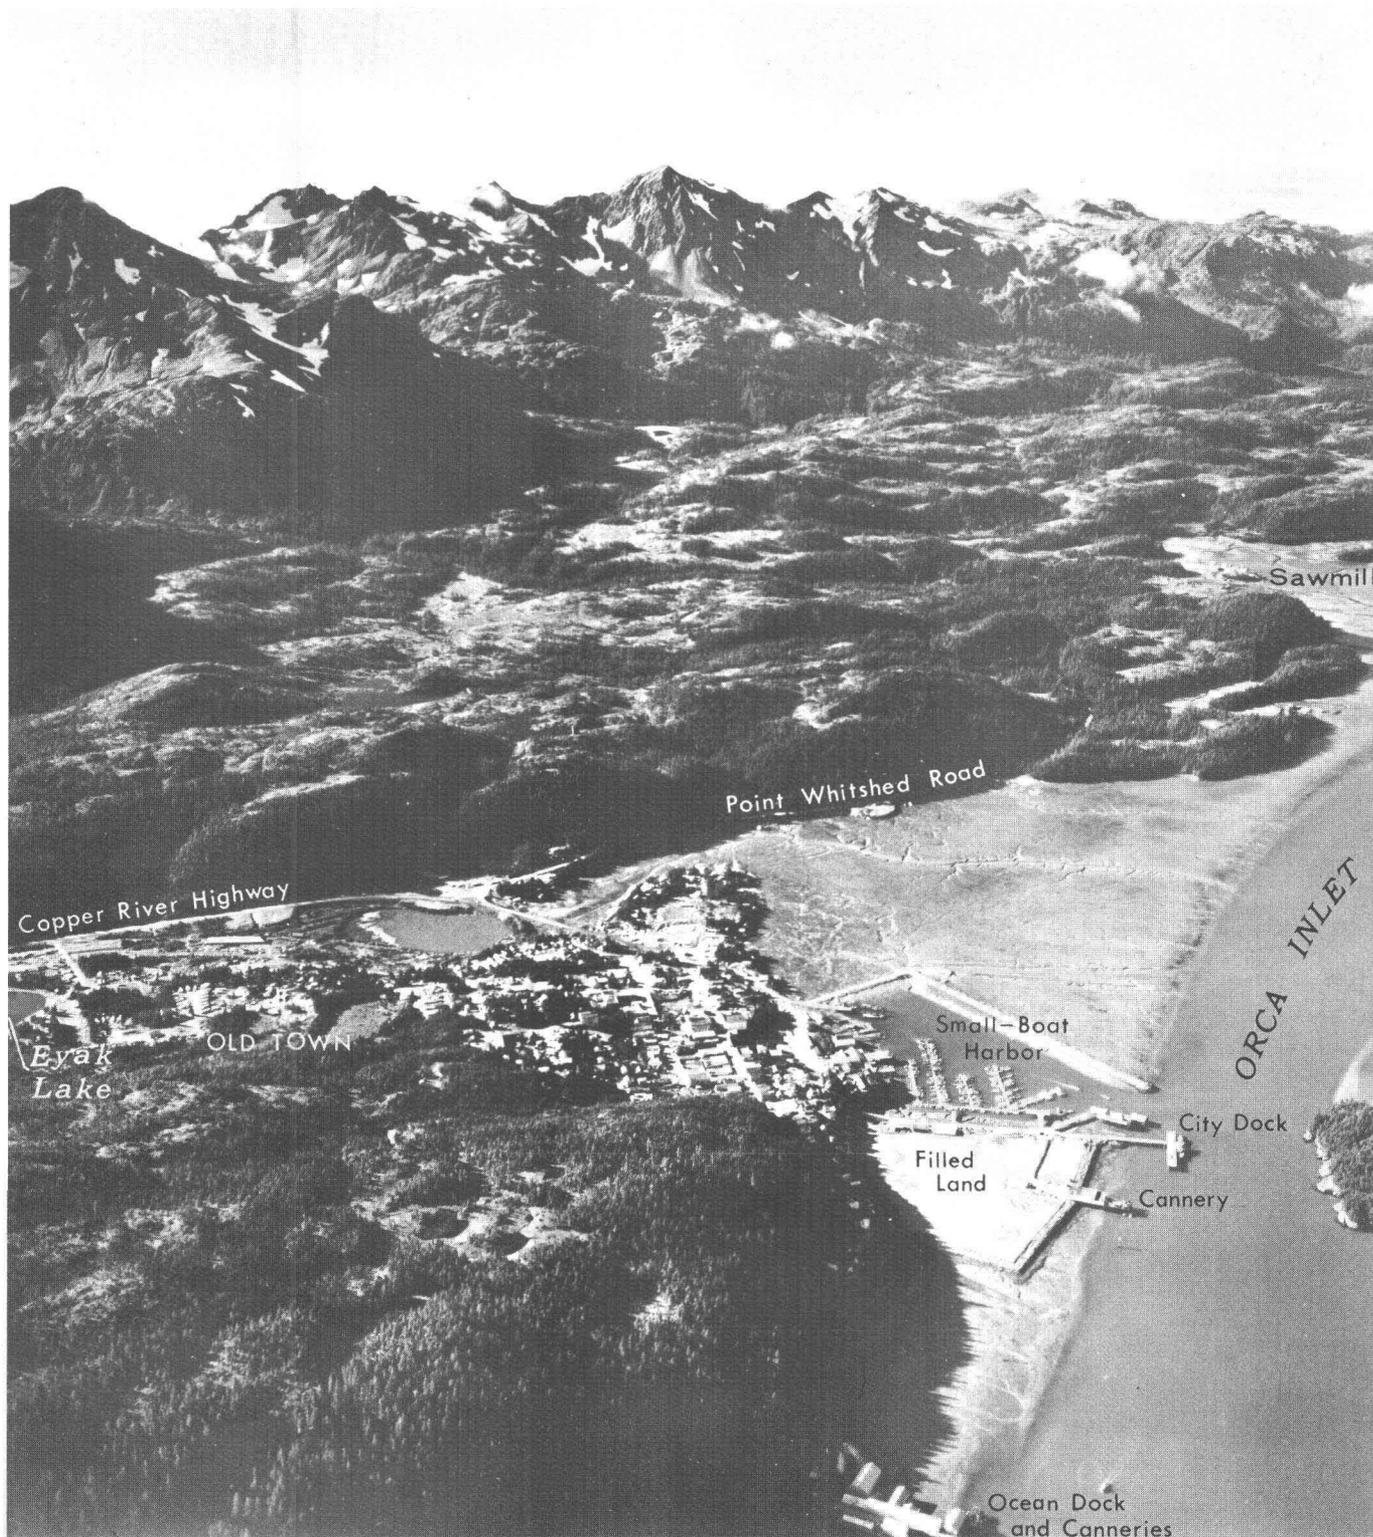
S.—Cordova, as it appeared in September 1966, with port facilities rebuilt to compensate for the 6-foot tectonic uplift of the shoreline. Looking south, with end of Eyak Lake and Copper River Highway in left center, and Cordova sawmill, destroyed by seismic sea waves, toward upper right. The white angular patch, lower right, is new land made from material dredged from the deepened and enlarged small-boat basin. Photograph by U.S. Army.

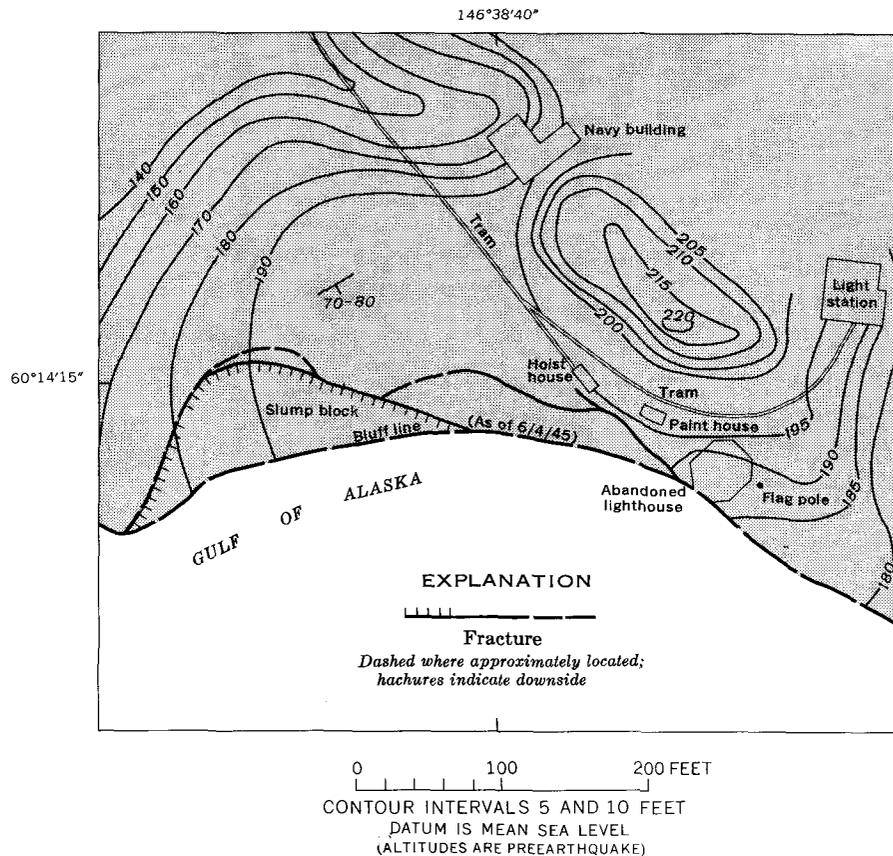
11.—Map of Cape Hinchinbrook Light Station. Present bluff is substantially north of that shown, because of erosion since 1945 when the base map was made. Bedrock is graywacke.

The topography and geology in the immediate vicinity of the station are shown in figure 11. The main building is on a gently undulating bench about 150 feet north of a near-vertical seacliff that is 180 to 190 feet high near the station but somewhat lower toward the west. Structures are built on well-indurated medium-grained blocky graywacke sand-

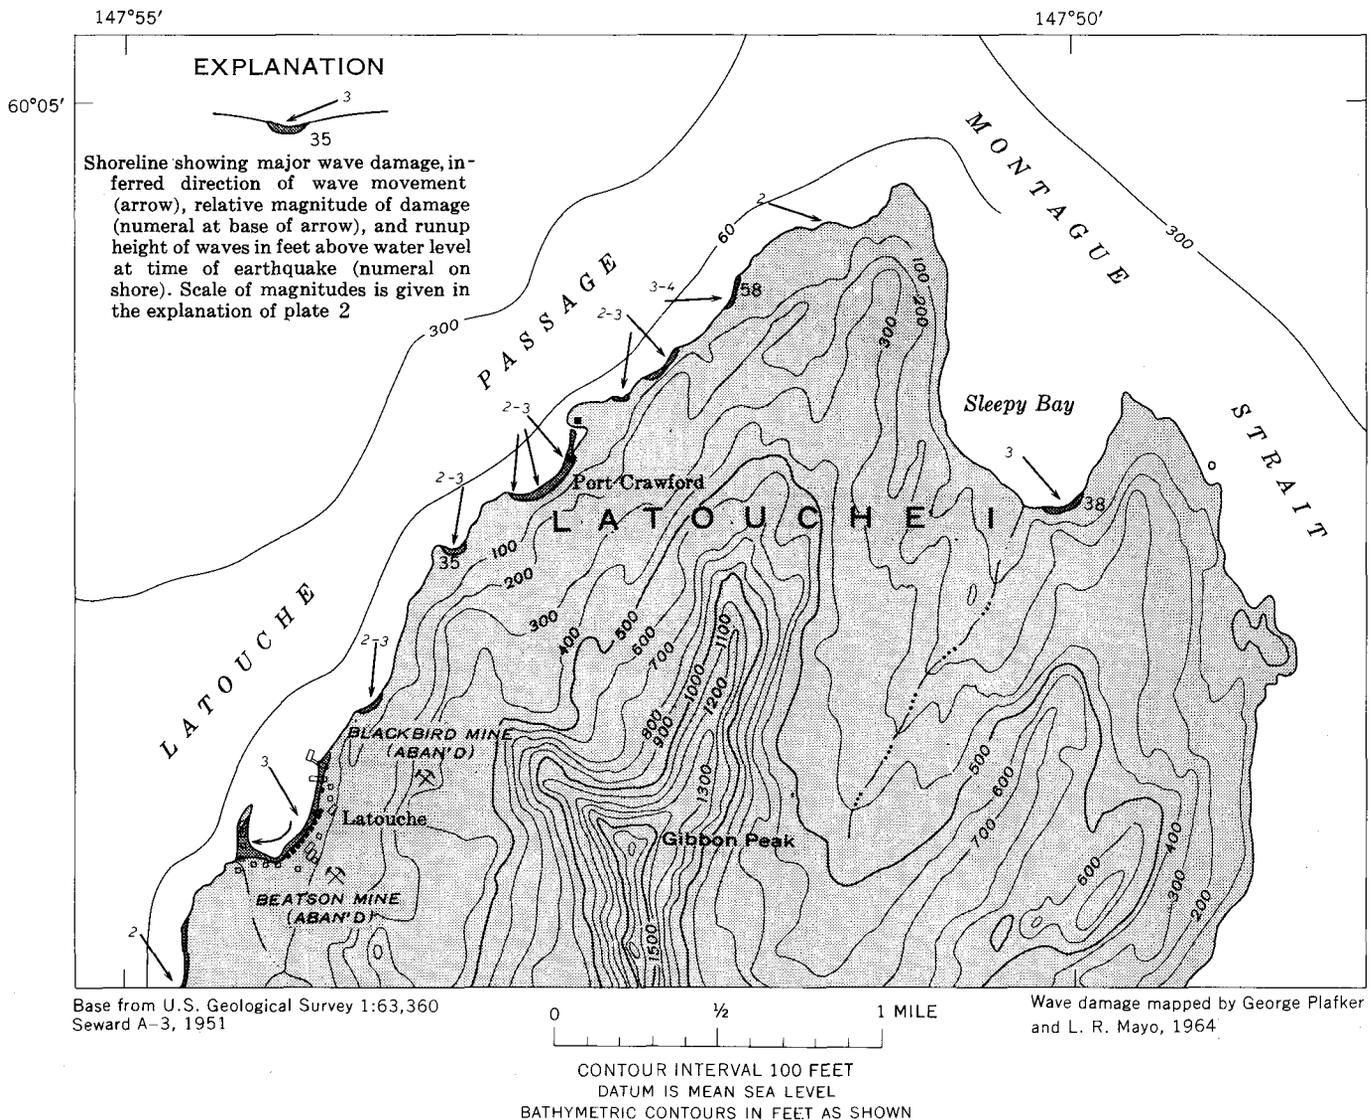
12.—Distribution and intensity of wave damage at Latouche and adjacent parts of northern Latouche Island.

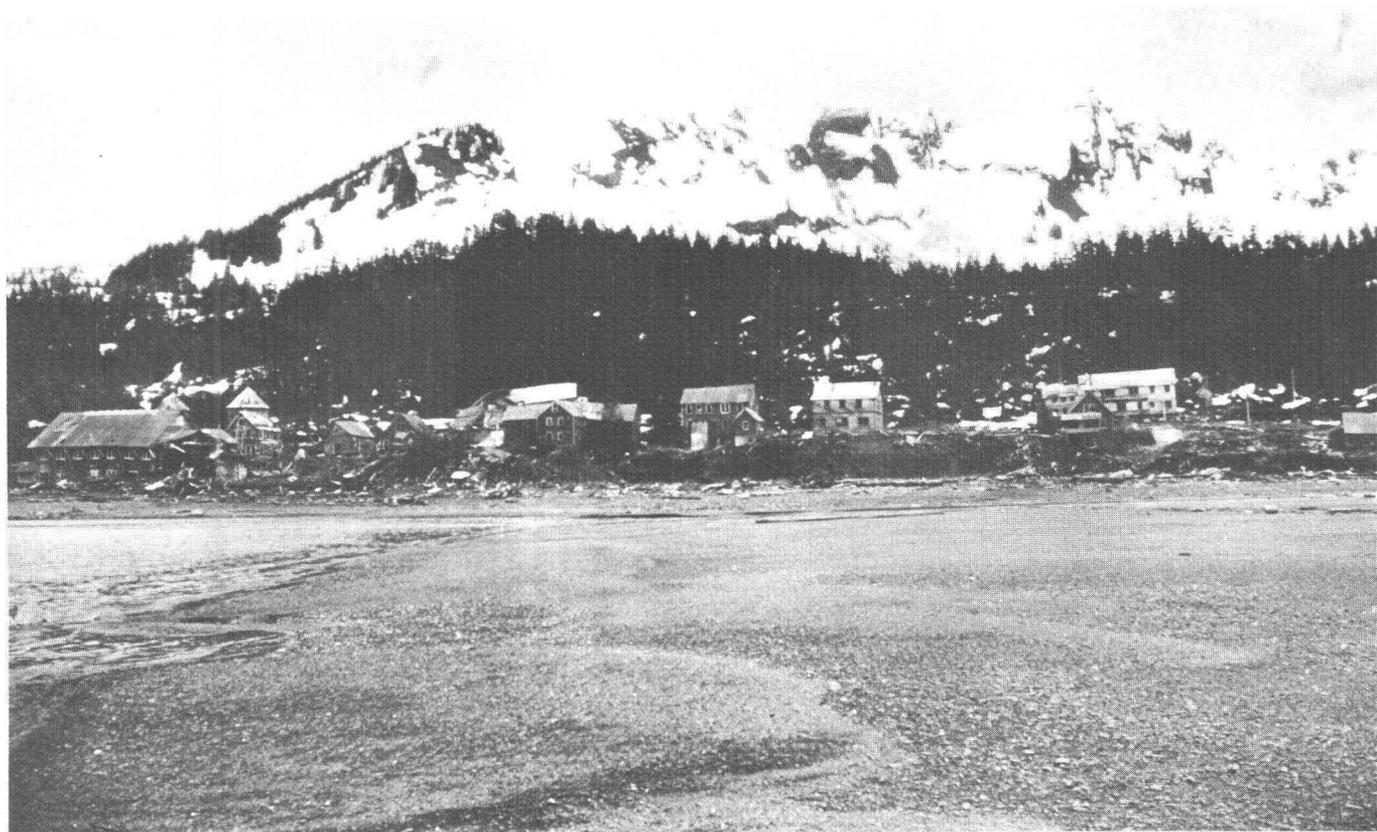
13.—Remains of buildings partially damaged by waves along part of Latouche waterfront. Docks, piers, and some buildings in this area were swept away. Approximately 11 feet of tectonic uplift has raised this former port above the reach of most tides.

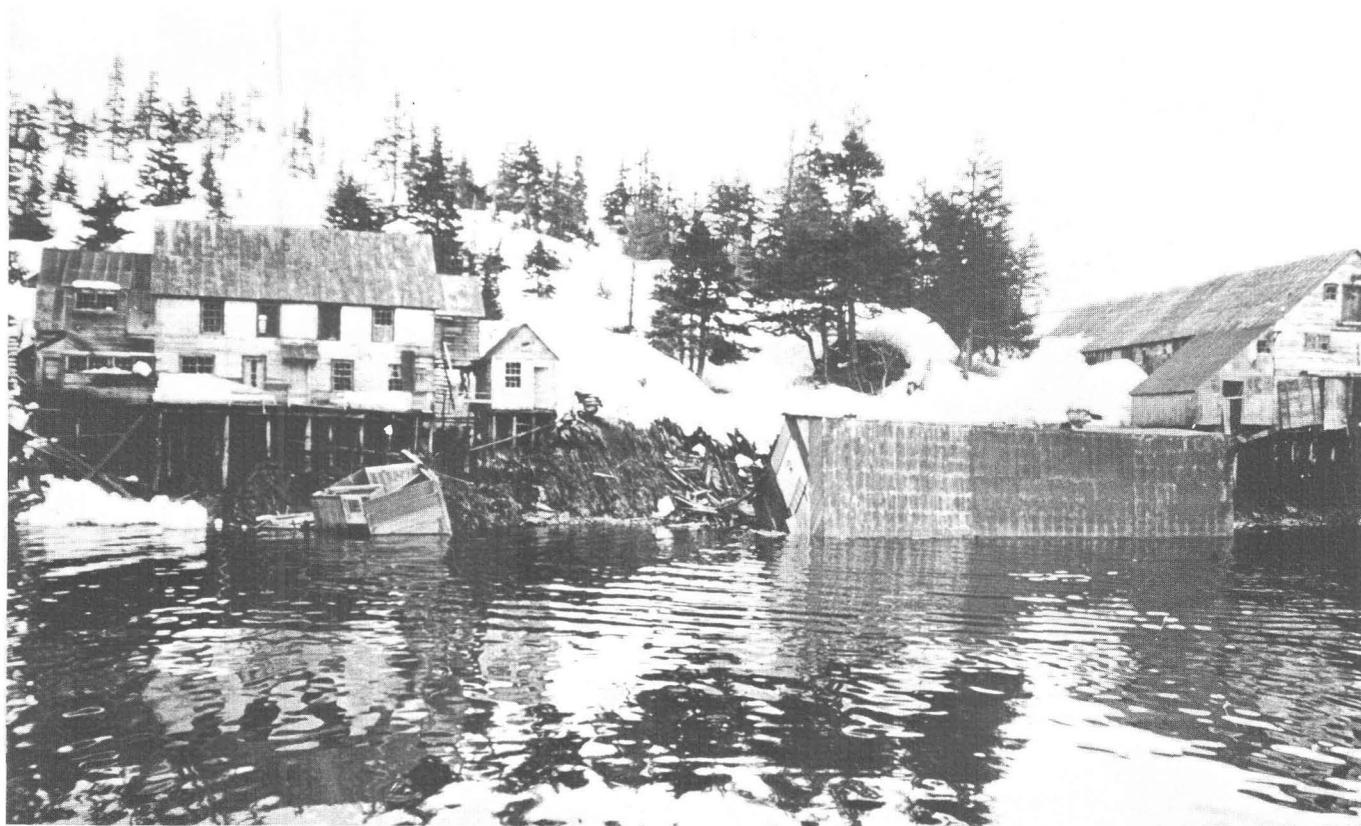
14.—Wave-damaged structures at Port Nellie Juan cannery. A wave, which ran up to the snow trimline along the shore, damaged these structures, washed away the dock, and presumably drowned the three resident caretakers of the cannery. Photograph taken April 4, 1964.

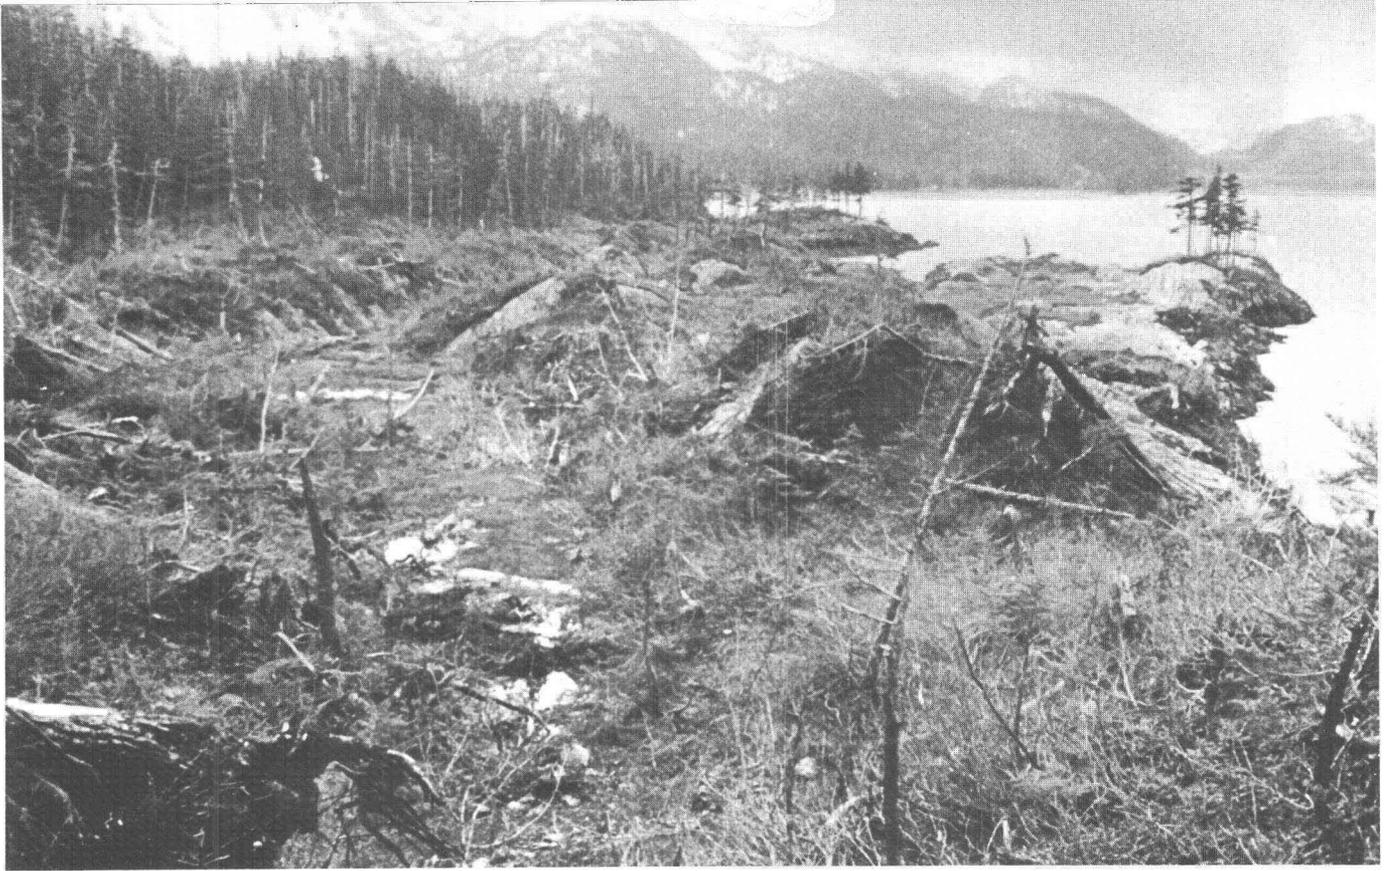
15.—Shore near the head of Kings Bay swept bare of timber to an altitude of 110 feet by slide-generated local waves. Bare areas of rock on the spur in the right middle distance were scoured clean of the soil and muskeg cover.

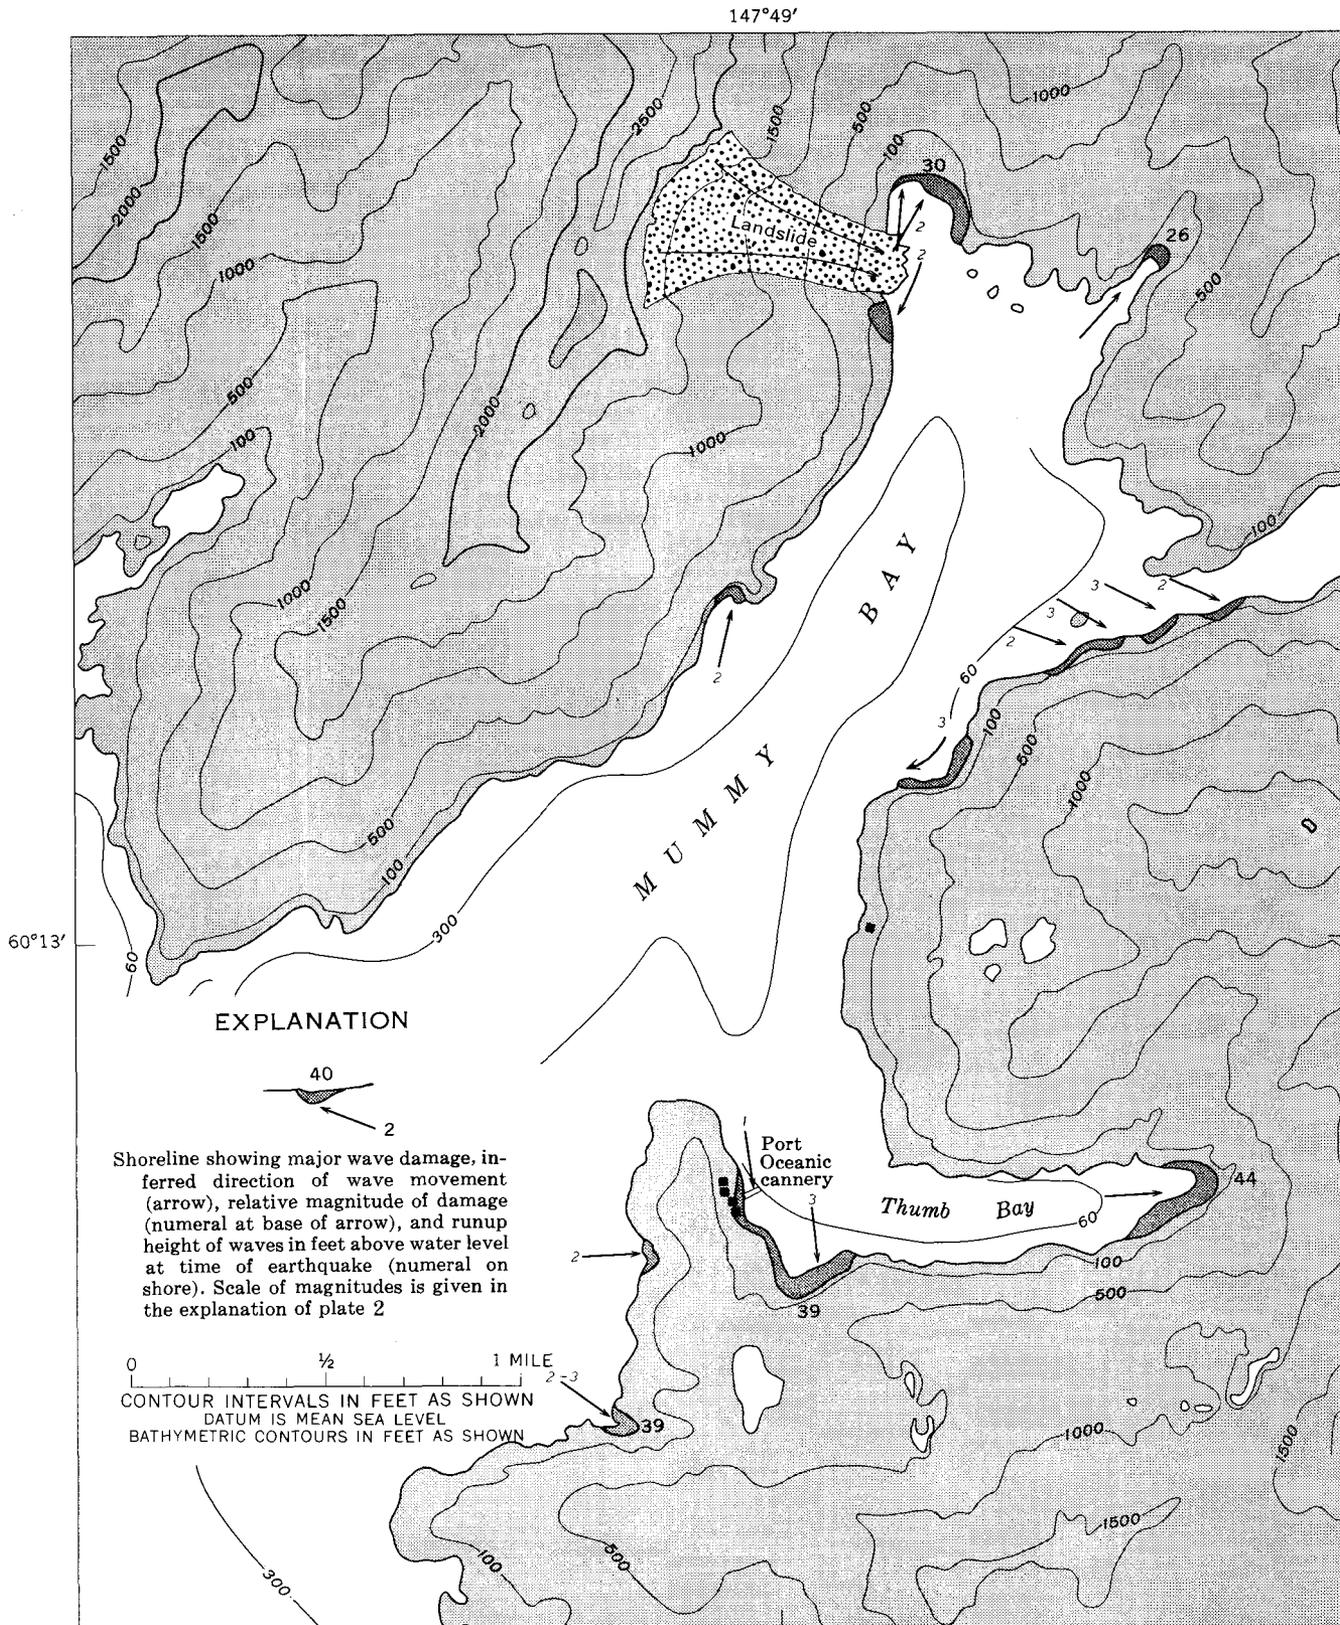
17.—Distribution and intensity of wave damage in the vicinity of Port Oceanic cannery at Thumb Bay, Knight Island.

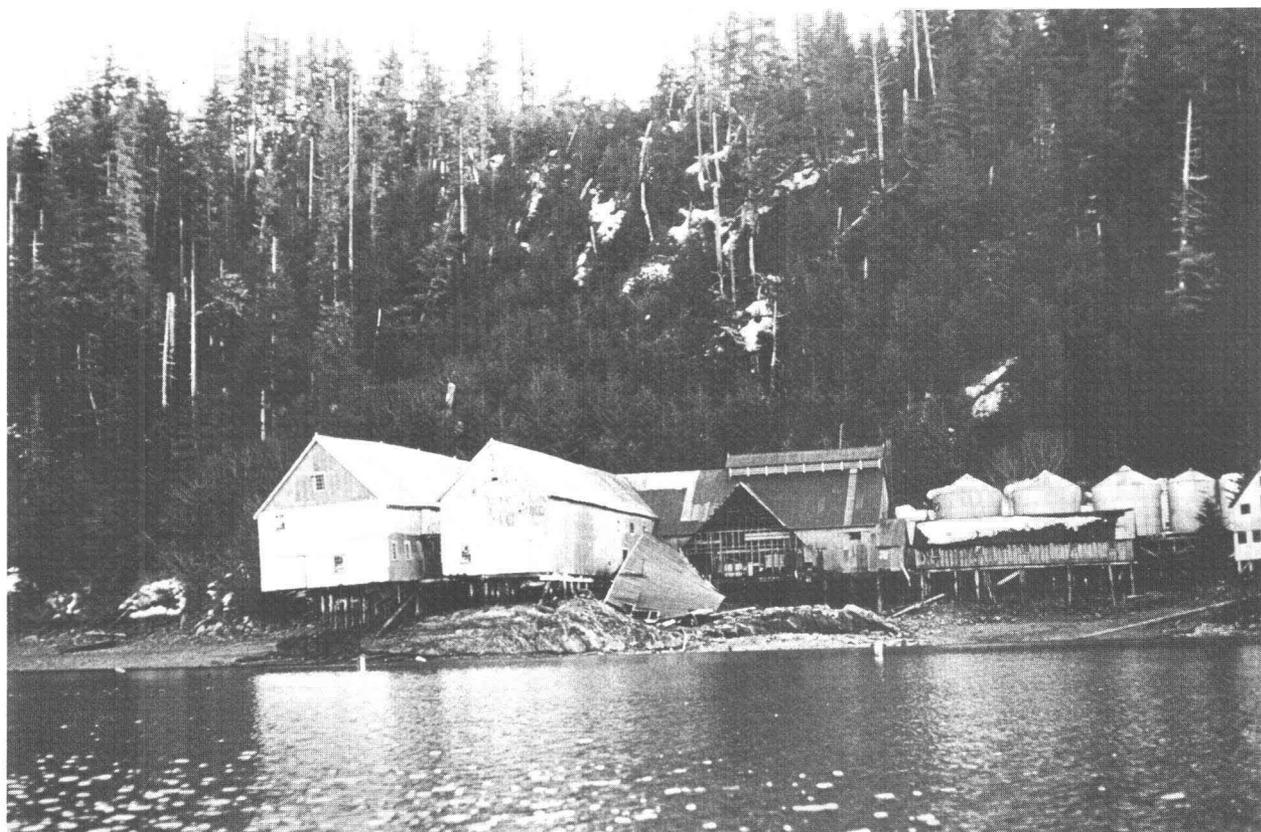
18.—Buildings at the Port Oceanic cannery damaged by a wave that struck within 2 to 3 minutes of the initial shock and had a crest height about even with the cannery floor level. Photograph taken April 4, 1964.

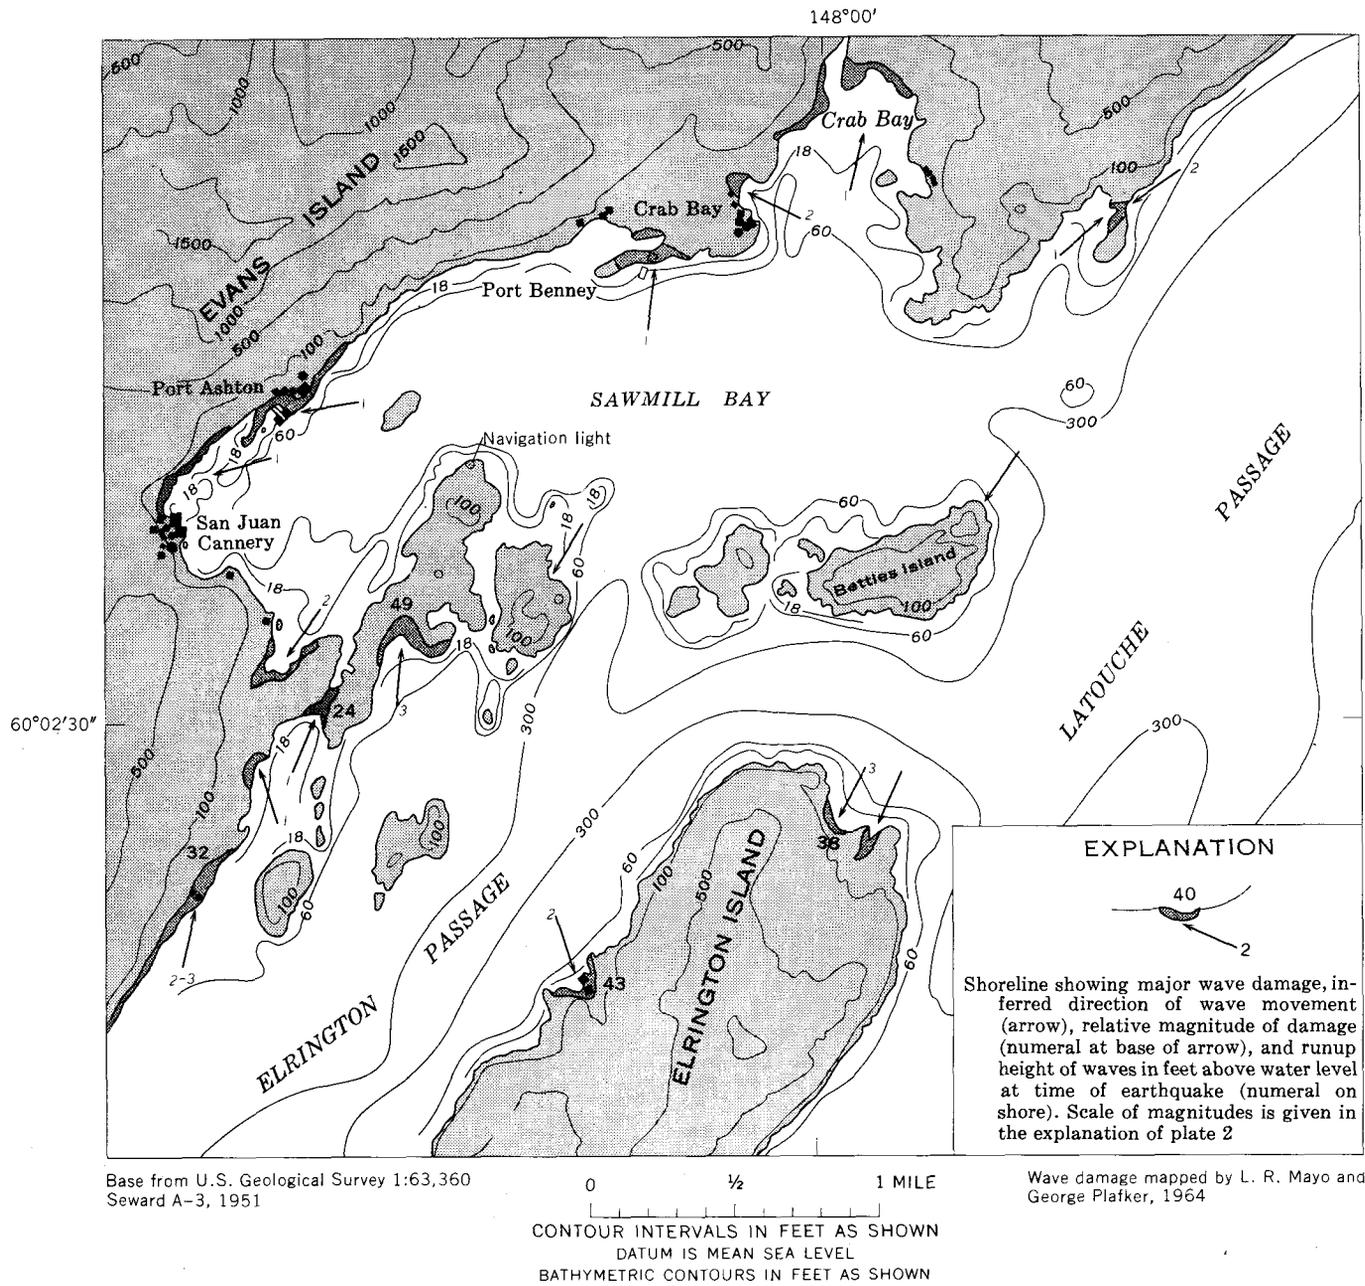
19.—Distribution and intensity of wave damage in Sawmill Bay and vicinity, Evans Island.

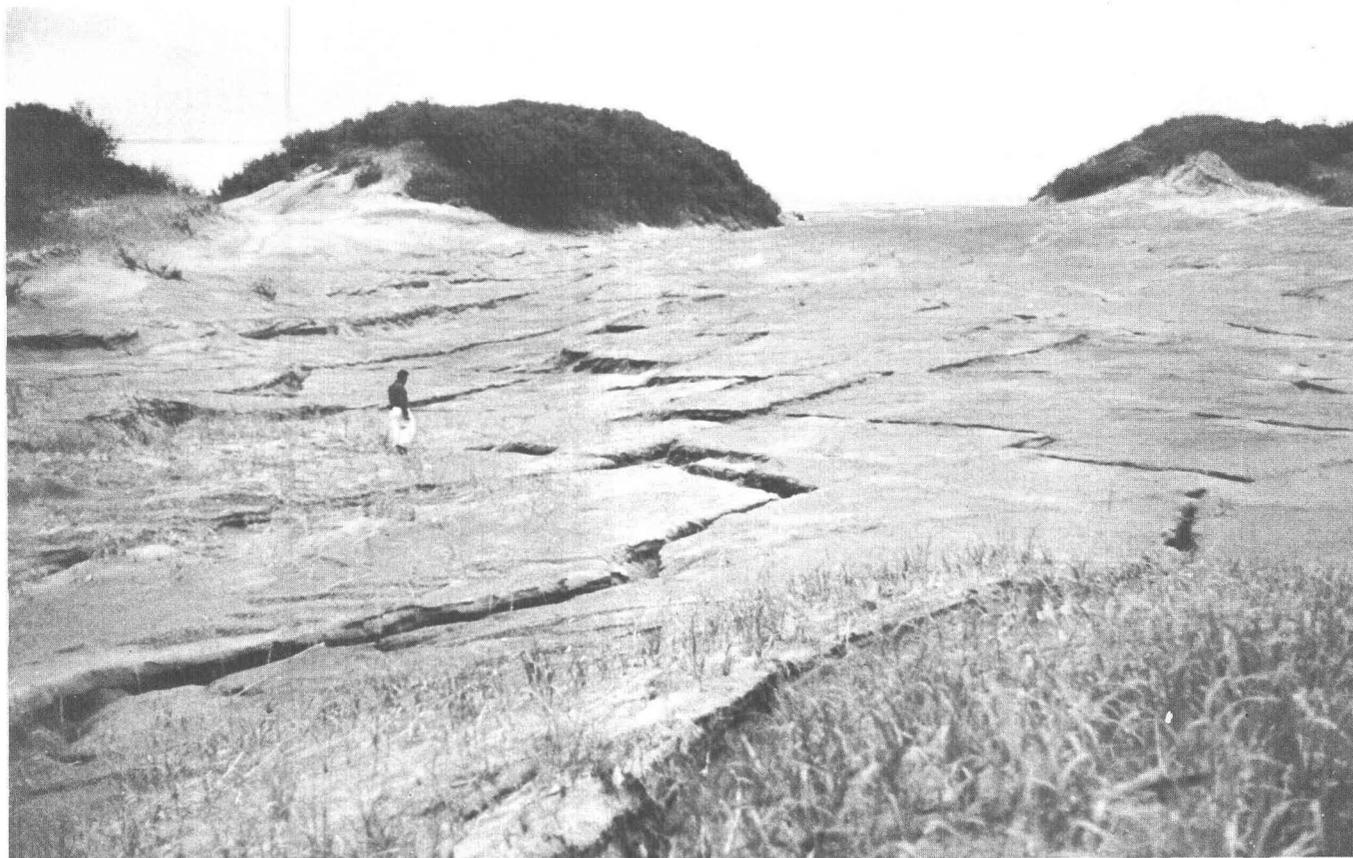
20.—Typical extensively fissured sand dune on the Copper River Delta.

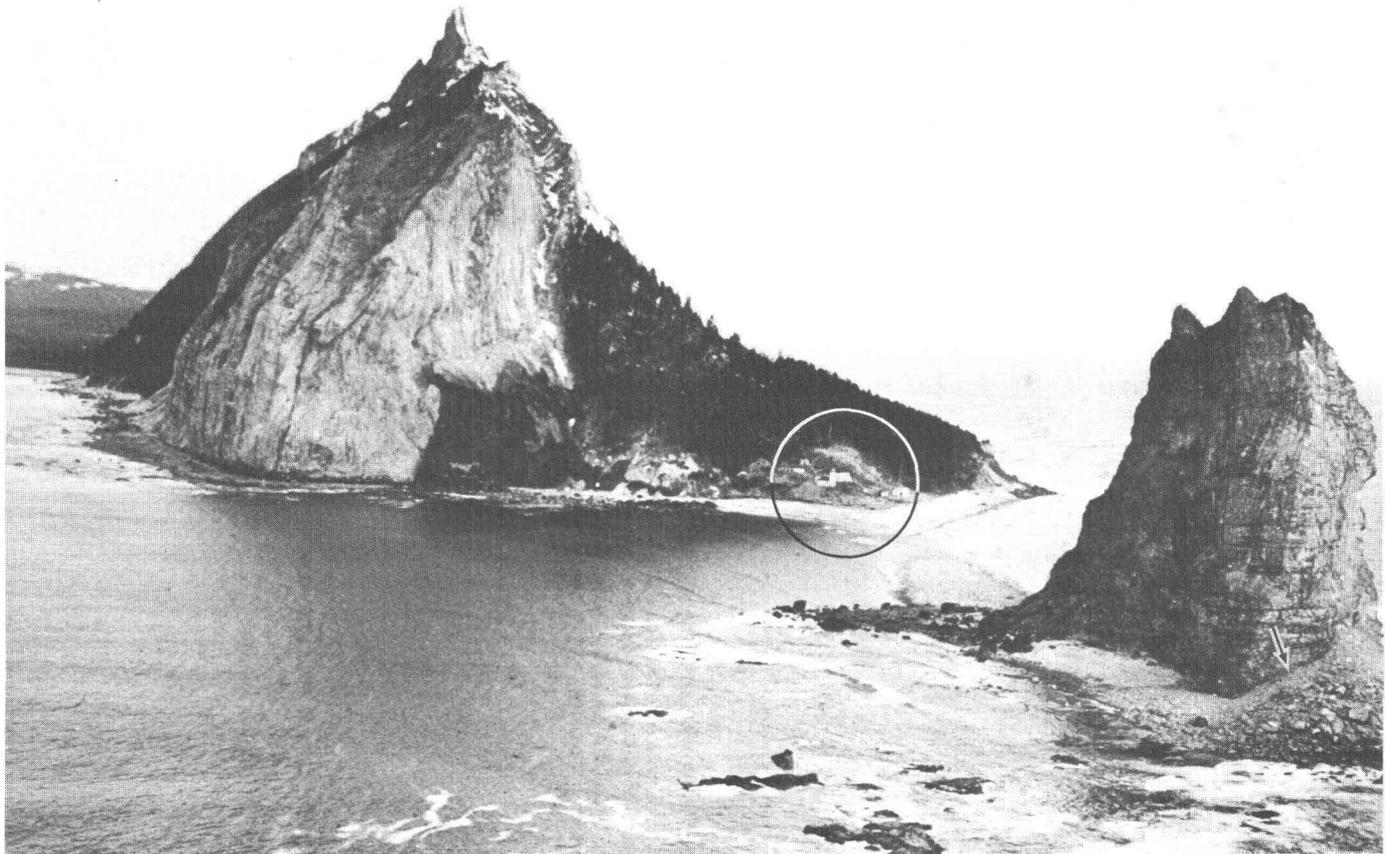
23.—Aerial view of Cape Saint Elias (left) and Pinnacle Rock (right) at the southwestern tip of Kayak Island. A portion of the earthquake-triggered rock fall from Pinnacle Rock is in the lower right corner (arrow); the Cape Saint Elias Coast Guard station is circled.

lions at the pinnacle had a leg broken by the falling rock. Later, as he was being carried back to the station by the other three crew members, a series of seismic sea waves that flooded over the low-lying gravel bar drowned the injured man and nearly drowned his companions. These waves reportedly struck at about 6:15 p.m., almost an hour after the start of the earthquake. The first wave, which reportedly came from the southeast, overtopped the tectonically elevated gravel bar to a depth of about 4 feet; it was immediately followed by a second and higher wave from the northwest that swept the men into the sea.

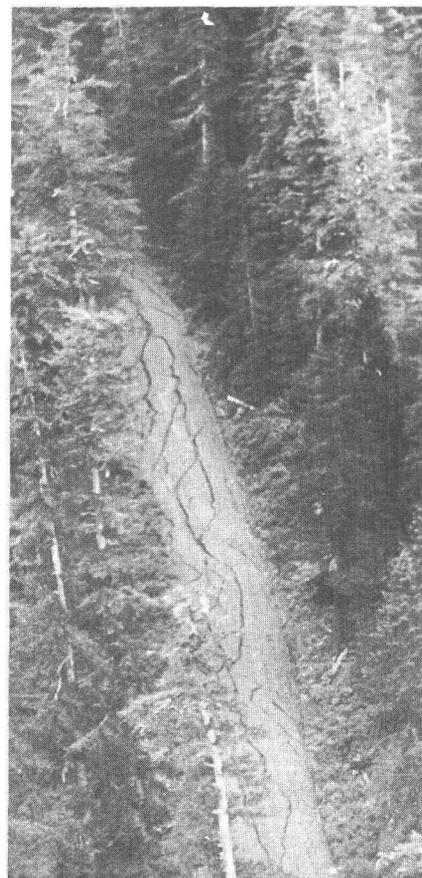
24.—Intensely fissured road at the crest of an elevated beach ridge west of Yakataga.

The main damage in the area consisted of extensive fissuring of abandoned oil-exploration access roads (fig. 24) and buckling of some bridges due to lateral movement of the banks inward toward the channels. Horizontal displacement across some fissures was as much as 10 feet, and pressure ridges formed from ½ to 8 feet high. Tarbelt observed that a 5/8-inch steel cable which had frozen into the ground surface was
