THE ALASKA EARTHQUAKE, MARCH 27, 1964:
EFFECTS ON COMMUNITIES

Effects of the Earthquake of March 27, 1964 on Various Communities

GEOLOGICAL SURVEY PROFESSIONAL PAPER 542-G

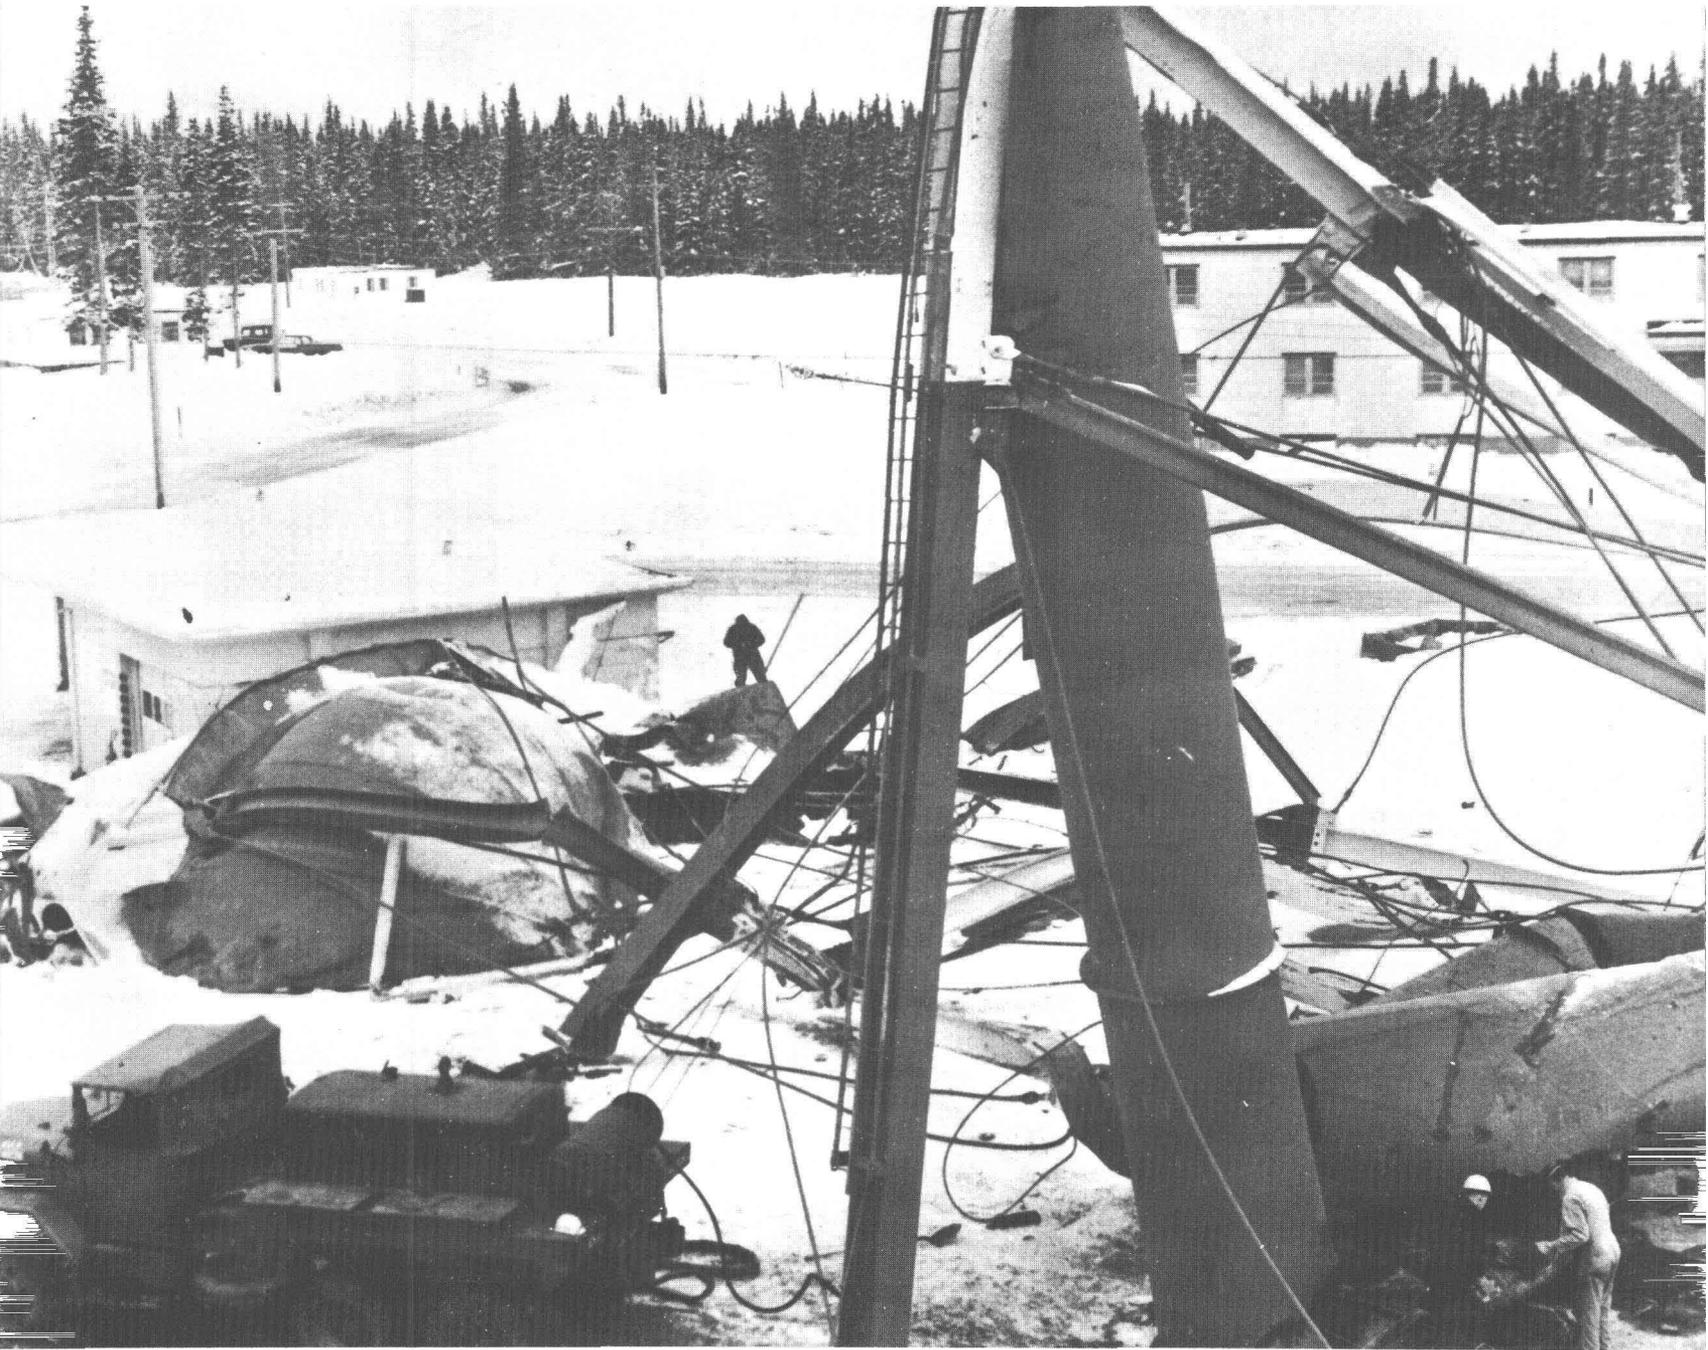
25.—View westward showing southwest half of collapsed water tower at Wildwood Station. Officers' club in background.
Photograph by U.S. Air Force.

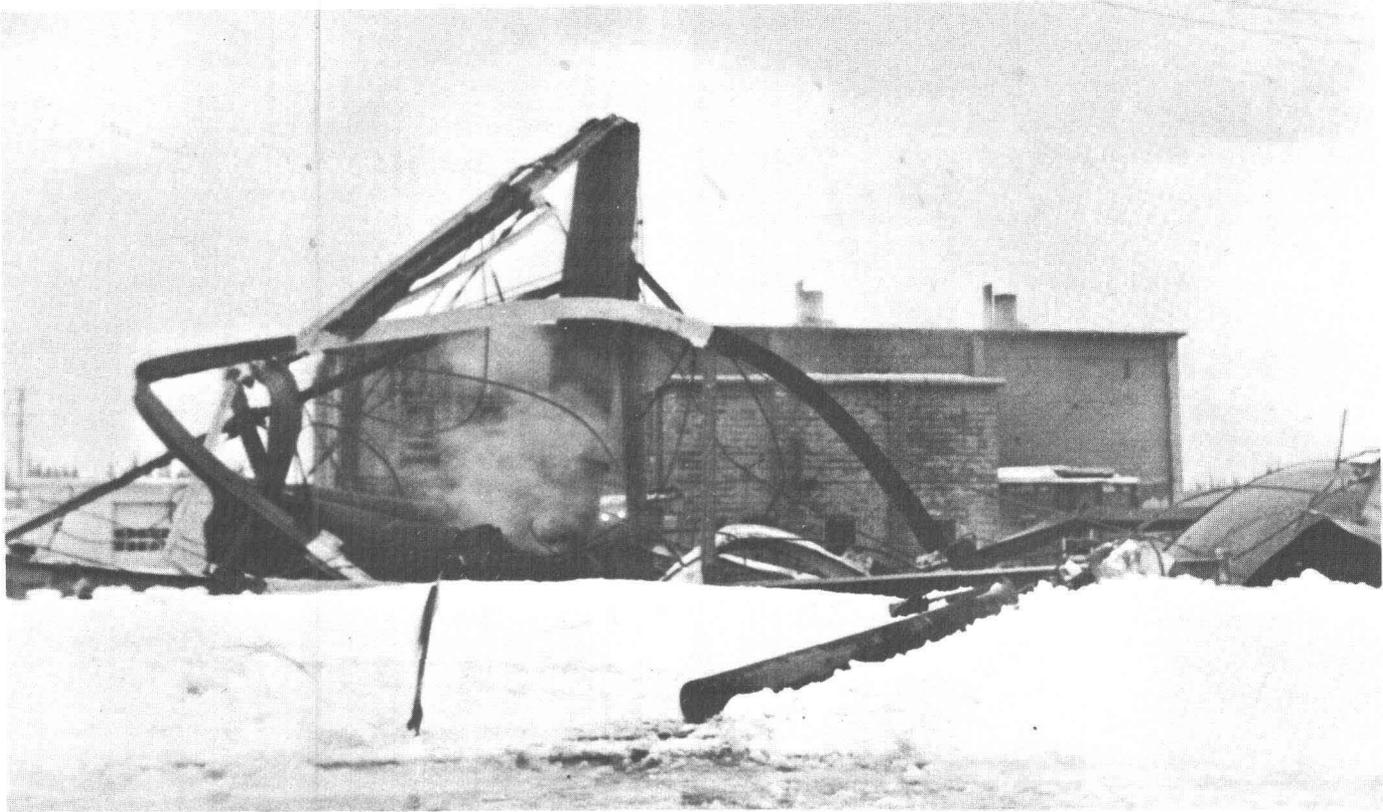
26.—Northeast half of collapsed water tower at Wildwood Station. Photograph by U.S. Air Force.

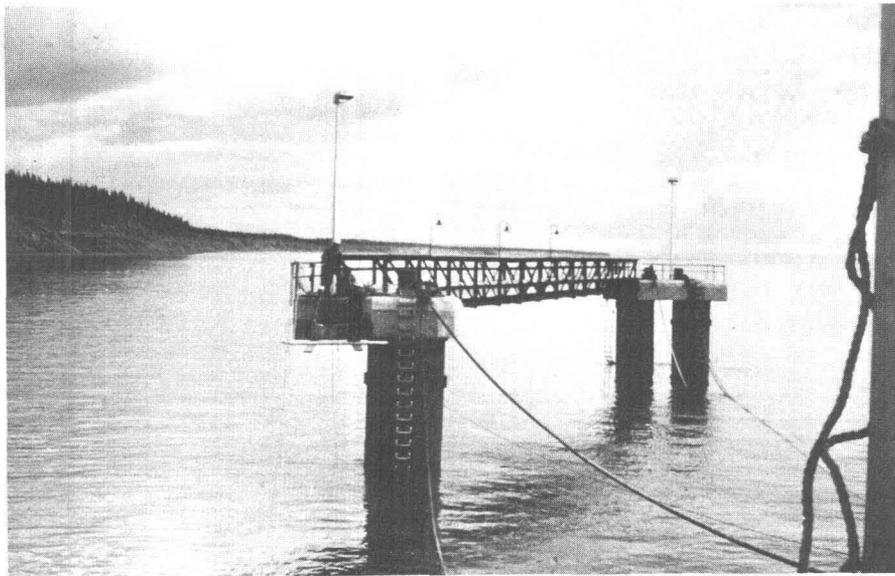
27.—Collapsed catwalk at Nikiski refining facility.

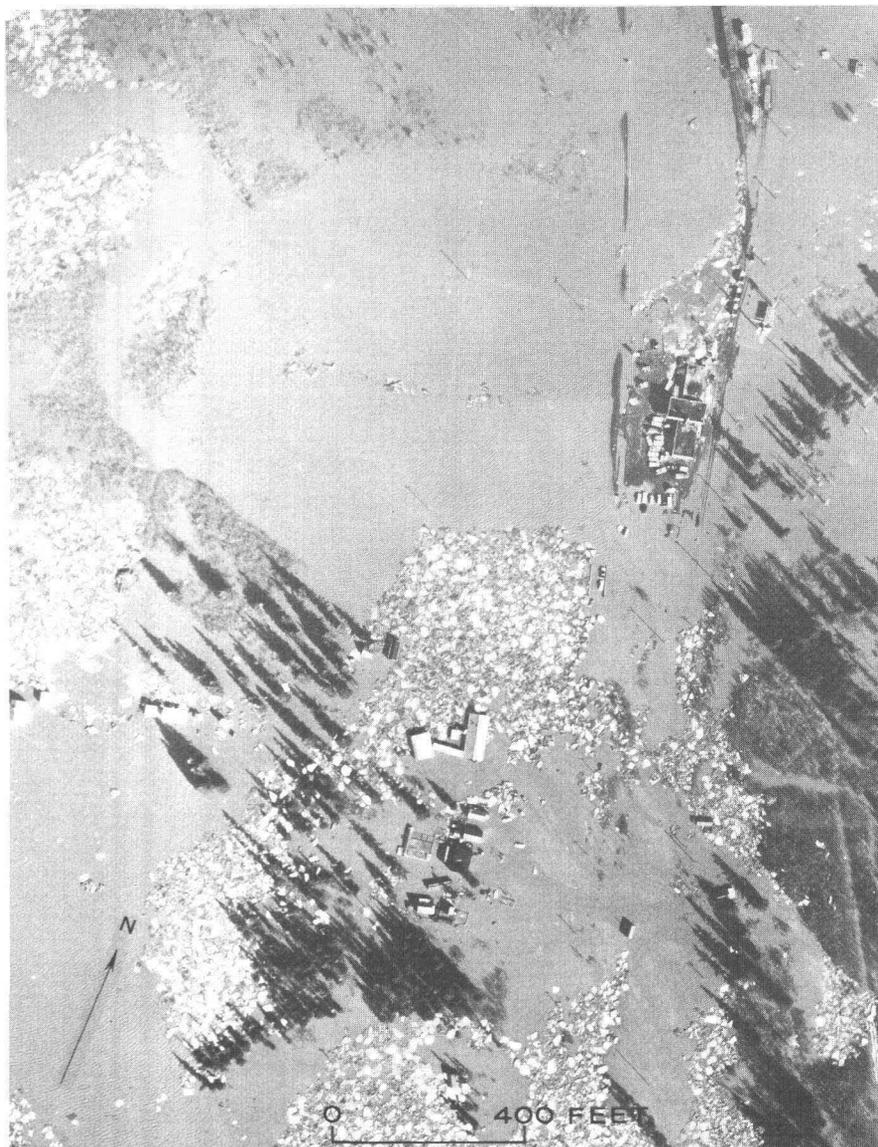
29.—Vertical aerial photograph of Portage area showing extent of inundation by high tides of April 14, 1964. Photograph by Air Photo Tech., Anchorage, Alaska.

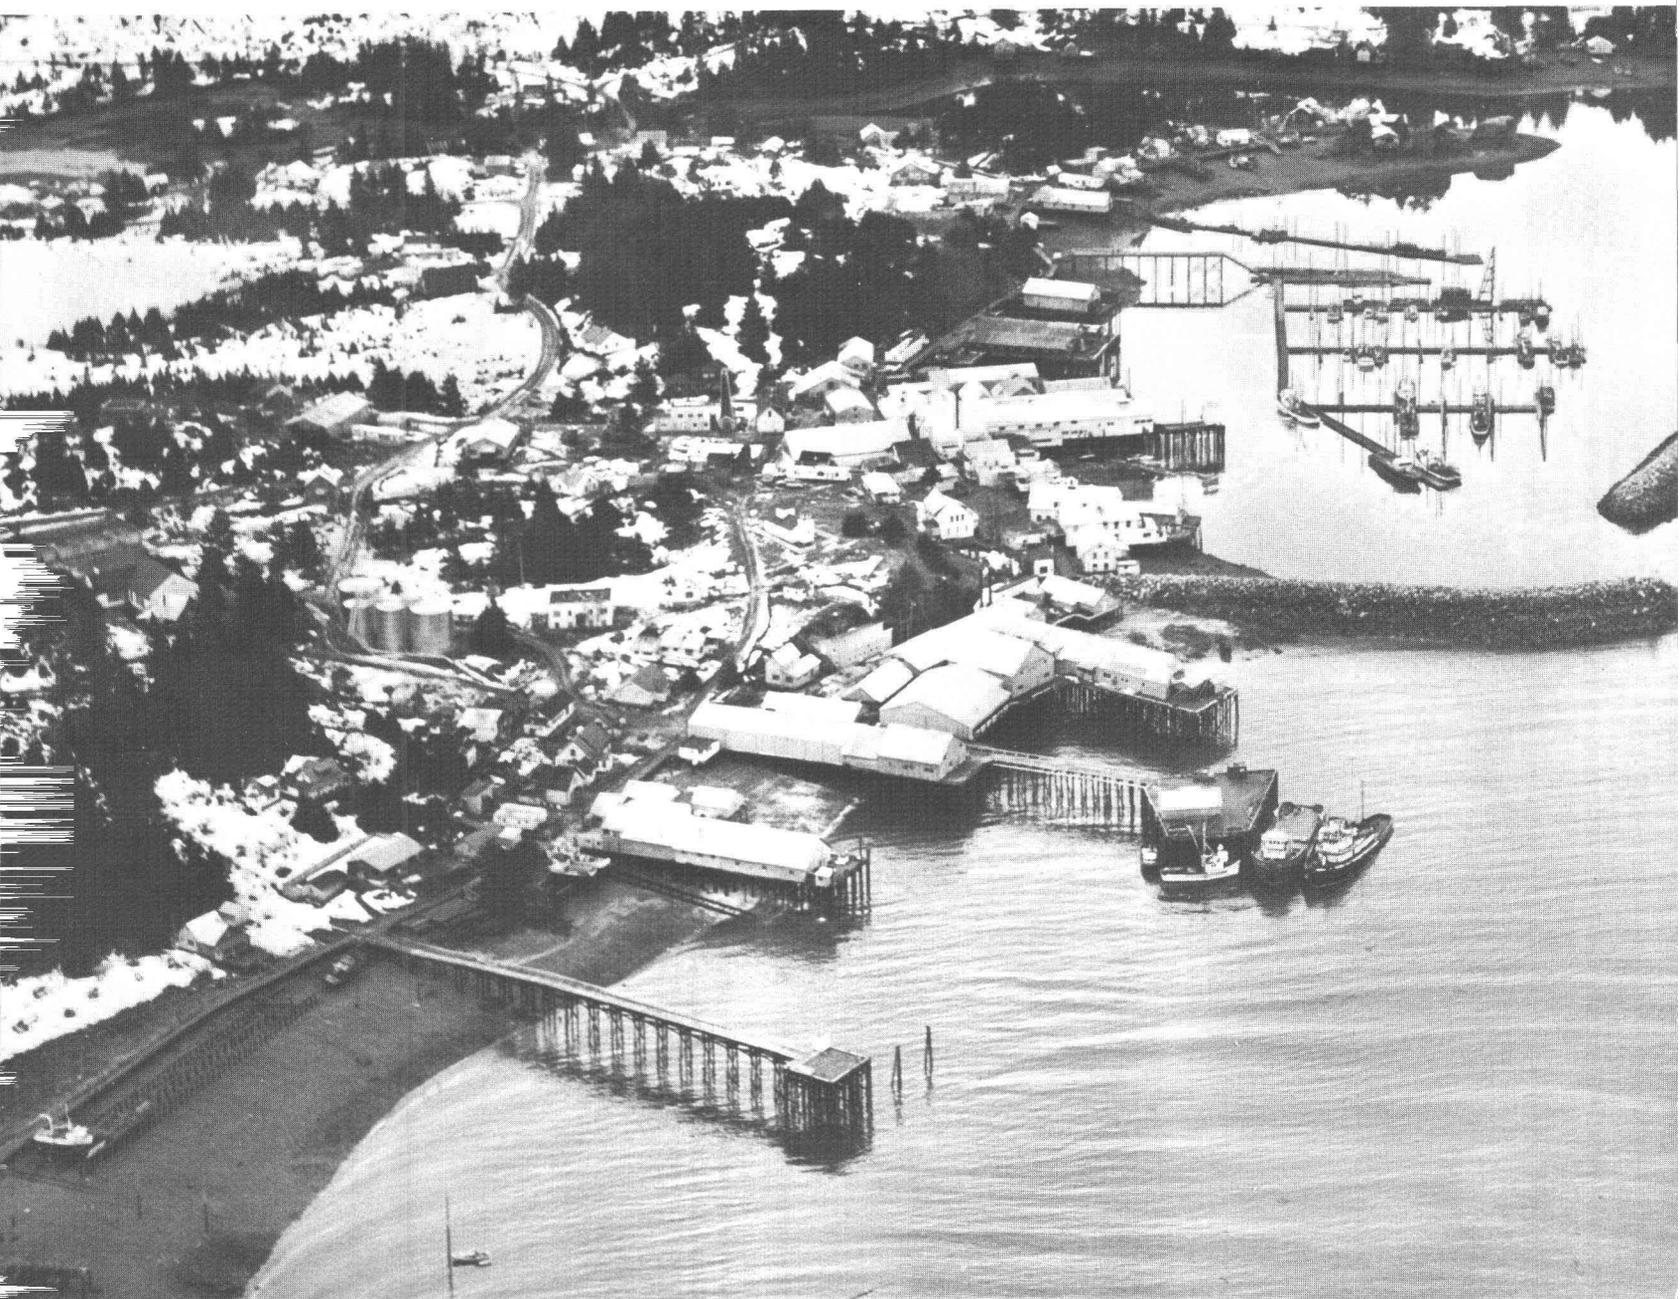
30.—Seldovia as it appeared in March 1965, with restored inner harbor facilities and breakwaters, piers, and docks raised to compensate for the 3½-foot tectonic subsidence. Photograph by U.S. Army.
