# The Alaska Earthquake March 27, 1964: Regional Effects

Effects of the  
Alaska Earthquake of  
March 27, 1964  
On Shore Processes and  
Beach Morphology

GEOLOGICAL SURVEY PROFESSIONAL PAPER 543-J

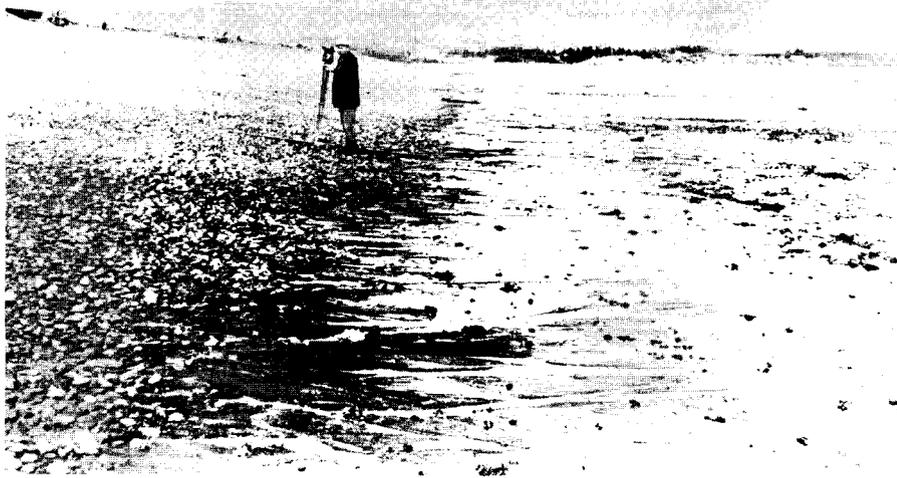
3.—Sharp break-in-slope between upper and lower beach faces extends from mid-foreground to midcenter of photograph, just to right of man. These features, here seen in Kachemak Bay at low tide, are common to many shingle beaches.

ent from 1:8 to 1:30 and are characterized by a break-in-slope 50–200 feet seaward of the high-water line. The break-in-slope marks the location where waves act longest at high tide (King, 1959). The beach face (fig. 2) shoreward of the break (termed the “upper beach face”) has a steeper gradient and coarser material than does the lower beach face. The break-in-slope shown in figure 3 is typical of those on many shingle beaches in Alaska.

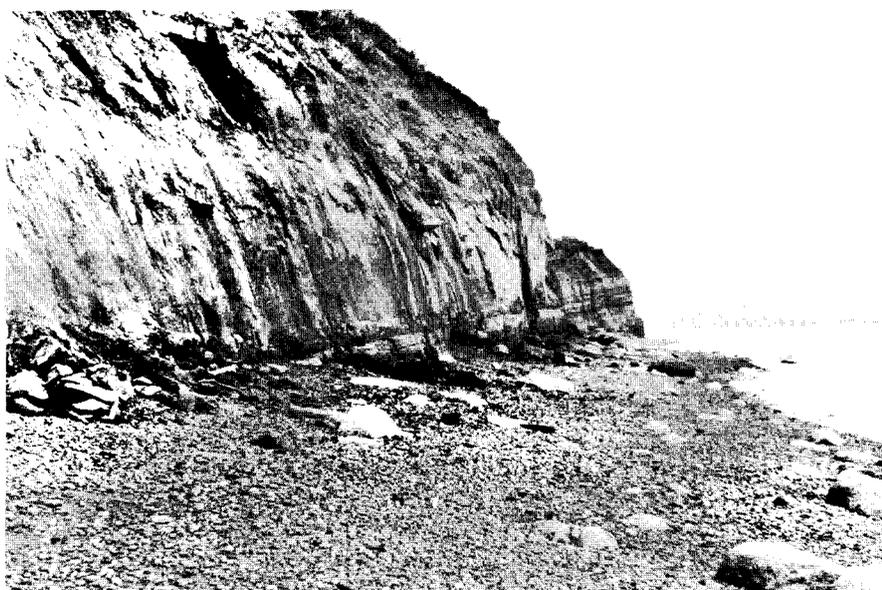
7.—Submergence caused the high-water line to shift to a higher elevation on this beach on the eastern shore of Cook Inlet. The establishment of a new high-water line caused undercutting and sloughing of bluffs. Note absence of beach ridges.

(fig. 7). Thus, the material, instead of accumulating higher on the beach (as it did along Homer Spit) was dissipated by wave action and was transported away from the site by the longshore drift. As the bluffs in such areas erode and recede, the beaches will eventually regain their preearthquake widths, and new beach ridges similar to those that existed before the earthquake should develop.

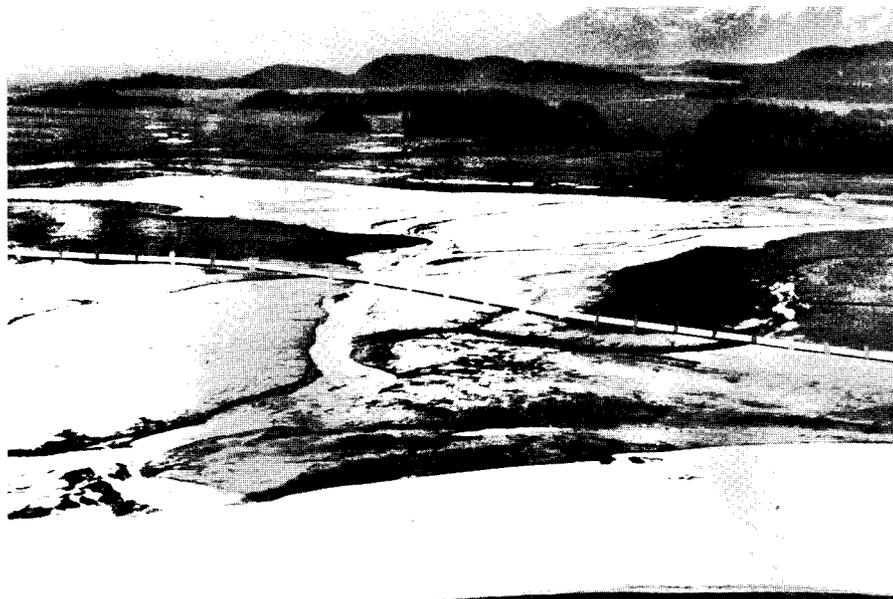
8.—Tectonic uplift created new lands permanently above high water, such as this area along the Copper River Delta. View at high tide, several months after the earthquake. The preearthquake high-water line is shown approximately by the dashed line. Photograph by U.S. Forest Service.

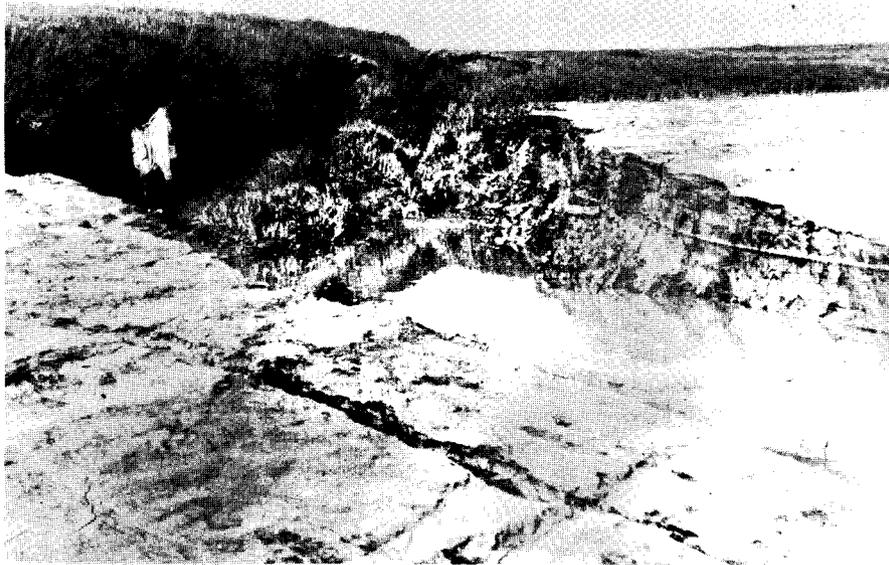
9.—Rapid gullying and sloughing caused by headward stream erosion along the uplifted coast on the Copper River Delta. Photograph by U.S. Forest Service.

Along appreciably uplifted shorelines composed of sand and silt, rapid gulying occurred at stream mouths (fig. 9). Along the Copper River Delta, an area of readily eroded sand and silt that was uplifted several feet, gulying commenced within hours after uplift (Reimnitz and Marshall, 1965). Rapid headward erosion produced small waterfalls 1-2 feet high.

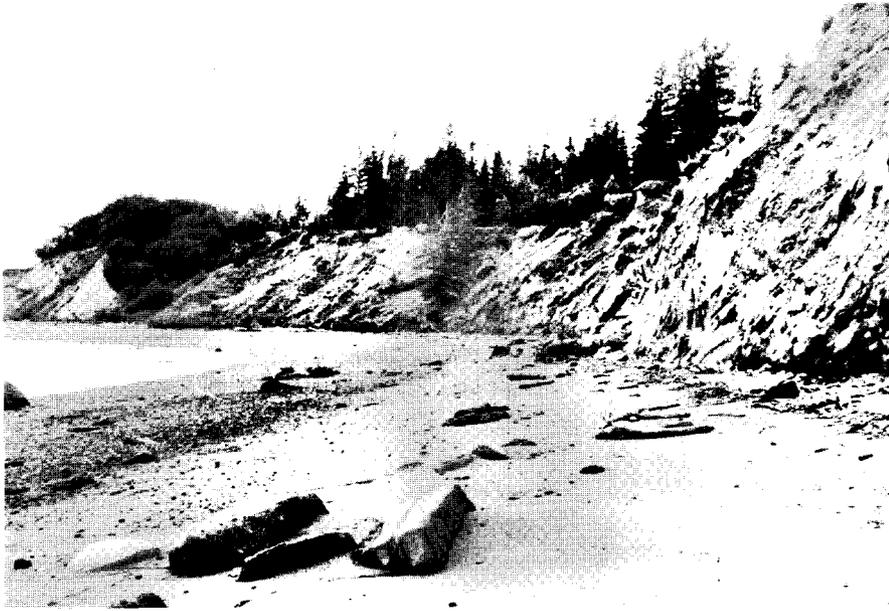
10.—Undercutting and sloughing of bluffs caused by tectonic subsidence, eastern shore of Cook Inlet. Driftwood along toe of bluff indicates the position of post-earthquake high-water line.

During the earthquake the shoreline subsided as much as 3½ feet along the southern section near Homer and as much as 1 foot near Point Possession at the mouth of Turnagain Arm. Prior to submergence the width of beach between the high-water line and the toe of the bluff was generally less than 100 feet, and in some areas less than 20 feet. Submergence decreased these widths and, after the earthquake, storm waves, particularly along the southern section, acted directly upon the toes of the bluffs. Many beach ridges that had previously protected the toes of the bluffs were exposed to waves of even, moderate height (fig. 10).

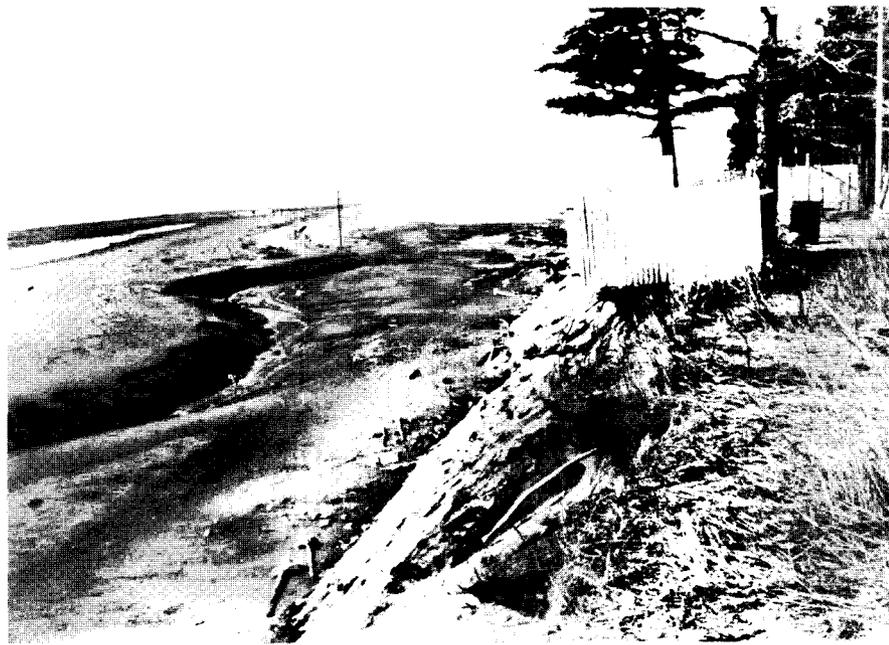
11.—Serious bluff erosion caused by subsidence along the waterfront of the town of Kenai. View looking northwestward, about 30 days after the earthquake.

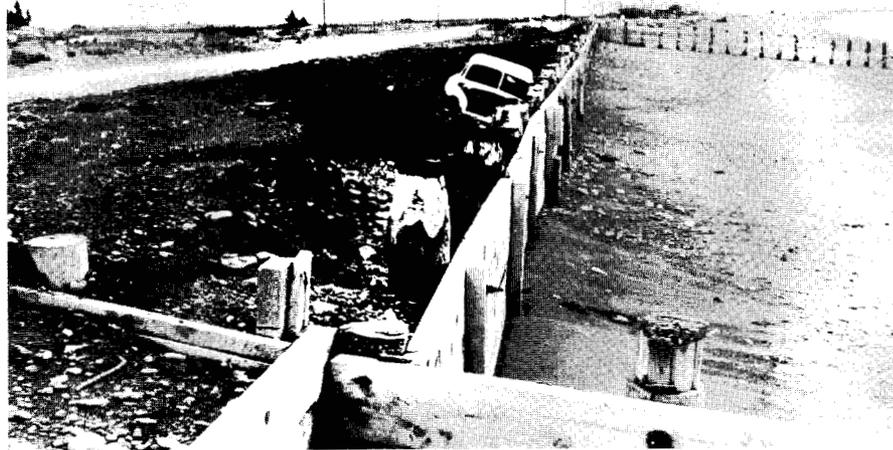
12.—Timber seawall and new groins along west side of Homer Spit as constructed 3½ months after earthquake-caused subsidence.

Except at Homer and a few small villages, no serious effort has been made to construct erosion-preventive works anywhere in the earthquake-affected area. Along the Cook Inlet side of Homer Spit, erosion on the lee side of the groin farthest downdrift became critical. Retreat of the beach was jeopardizing the spit highway. In July 1964, a seawall and two additional groins were constructed. Two hundred feet of the wall was constructed to a height of 1–2 feet above the high-water line, and one section was built 5 feet higher above the high-water line. Figure 12 shows the timber bulkhead and the additional groins a short time after construction. Figures 13 and 14 show the same area 6 and 16

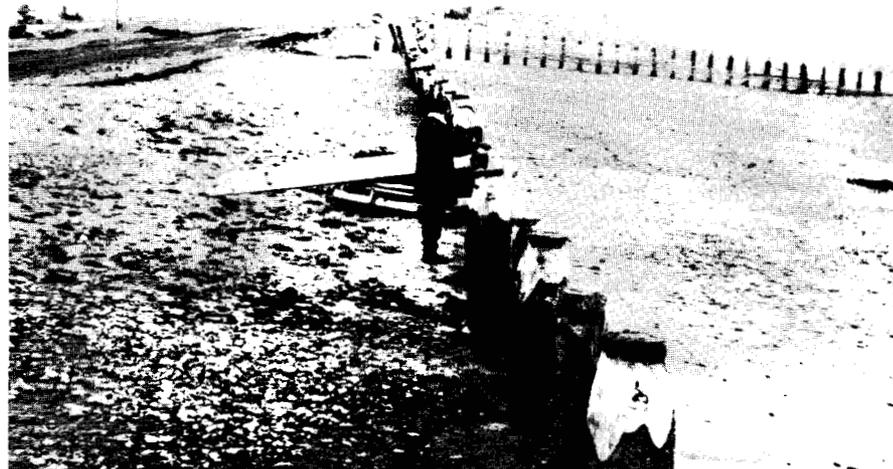
13.—Seawall shown in figure 12, approximately 6 months after construction.

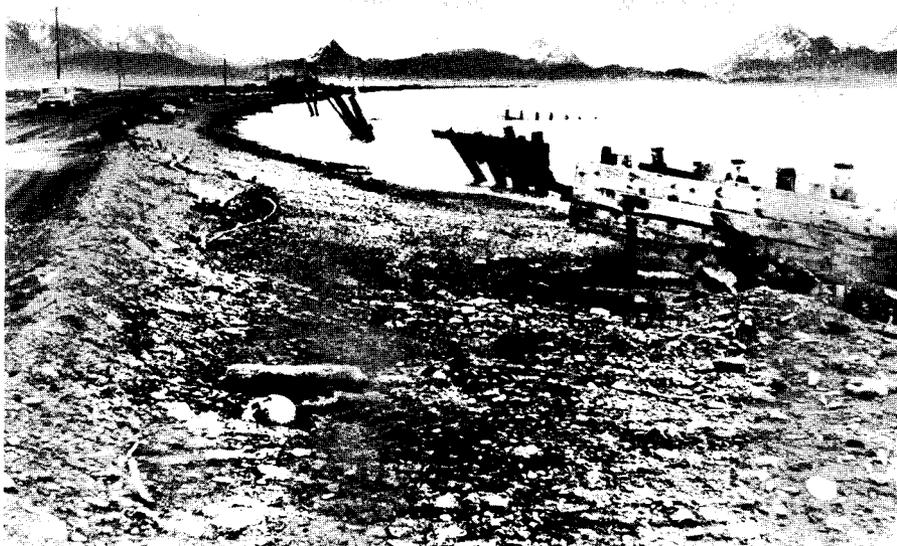
14.—Seawall shown in figure 12 some 16 months after construction. Note that the bulkhead and one of the groins were completely destroyed during this period owing to their excessive height.

months later, respectively. Sixteen months after construction, the high timber bulkhead between the fifth and sixth groin had been destroyed, as had the last groin (fig. 14). Similar high bulkheads were

constructed in other areas but most were destroyed within several months, or at most within a year, after the earthquake. Failure is attributed to the fact that the bulkheads were too high and were

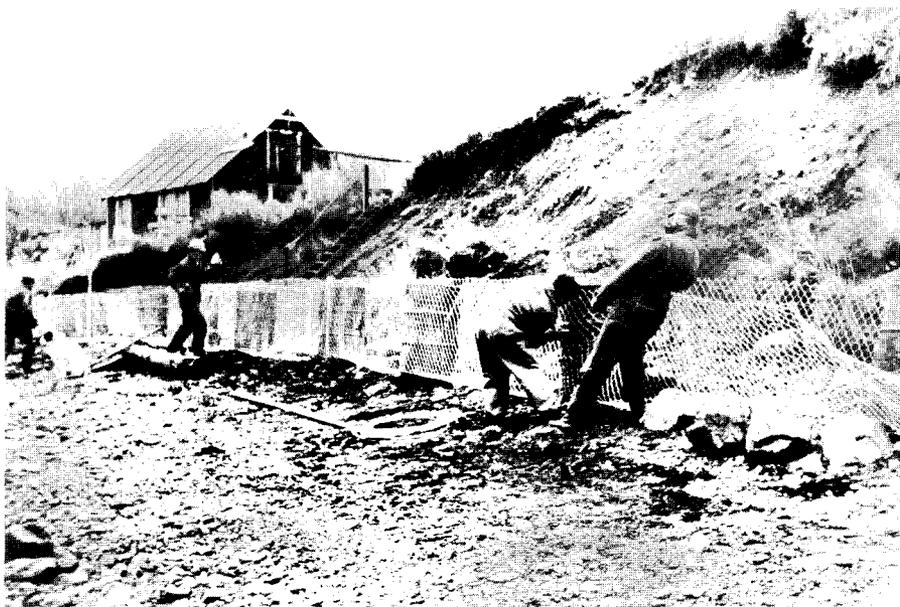
15.—Cobble-filled wire-mesh fence under construction at Larsen Bay, Kodiak Island, shortly after the earthquake and resultant subsidence of 2 feet. Most of the fence was destroyed by a storm before it could be completed.
