Permafrost and

Related Engineering Problems

in Alaska

GEOLOGICAL SURVEY PROFESSIONAL PAPER 678

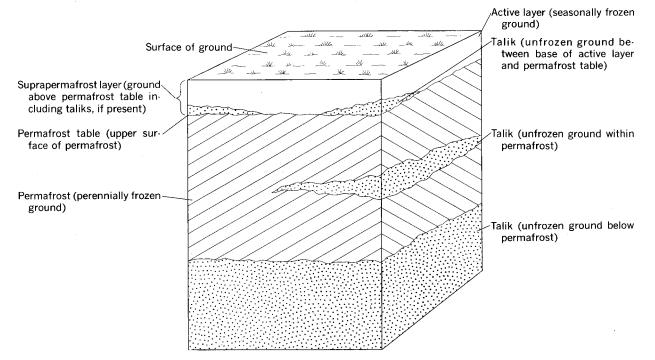
FIGURE 3.—Occurrence of talks in relation to the active layer, suprapermafrost zone, permafrost table, and permafrost.

The *permafrost table* is the upper surface of the permafrost, and the ground above the permafrost table is called the suprapermafrost layer. The active layer is that part of the suprapermafrost zone that freezes in the winter and thaws in the summer, or simply, seasonally frozen ground. Because water in the soil tends to reduce temperature fluctuations from summer to winter, the summer thawing-and hence the active layer-is deeper in drier materials. Seasonal frost penetrates down to the permafrost table in most places; however, if it does not, an unfrozen zone called a talik remains between the bottom of the seasonal frost and the permafrost table. Unfrozen zones within and below the permafrost also are called taliks (fig. 3). If the thickness of permafrost is increasing, permafrost is said to be aggrading, and if decreasing, permafrost is said to be *degrading*.

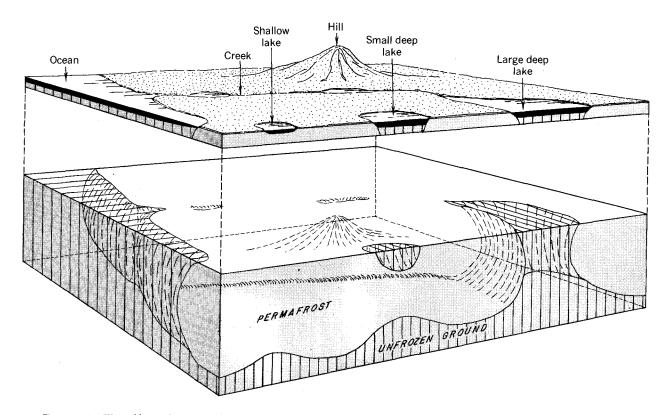
FIGURE 4.—The effect of surface features on the distribution of permafrost in the continuous permafrost zone. After Lachenbruch (1968, p. 837).

have mean annual bottom temperatures above freezing and thus are underlain by a thawed basin. The permafrost beneath a thawed basin is also thinned by upward indentation (fig. 4). If the lake is drained, the thawed basin refreezes and expansion of the ice within it creates a pingo (see p. 12). If the minimum horizontal dimension of a deep lake is greater than approximately twice the local undisturbed permafrost thickness, the upward indentation coalesces with the thawed basin to form an unfrozen "chimney" through the permafrost beneath the lake (fig. 4). Such features provide a potential year-round source of ground water in regions of continuous permafrost.

In the absence of various modifying conditions such as those described above, the top and bottom of the permafrost layer tend to parallel the ground surface, rising under hills and lowering beneath valleys (fig. 4).

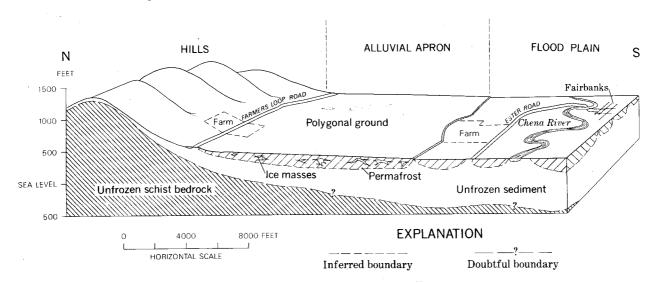
FIGURE 6.—Distribution of permafrost in the discontinuous permafrost zone, Fairbanks area. Slightly modified after Péwé (1954, p. 326).

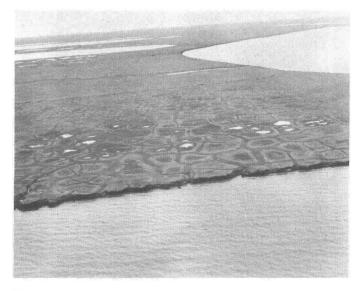
FIGURE 7.—Aerial view of coastal plain near Barrow, in northern Alaska showing polygonal markings on ground surface caused by underlying ice-wedge polygons. The bank along Elson Lagoon in foreground is being undercut by thawing of permafrost and by wave action. Photograph taken in August 1958.

Polygonal ground (figs. 7 and 8), which covers many thousands of square miles of northern Alaska is caused by shallow troughs which overlie a honeycomblike network of vertical wedge-shaped ice masses (ice wedges) that have joined to form polygons in the

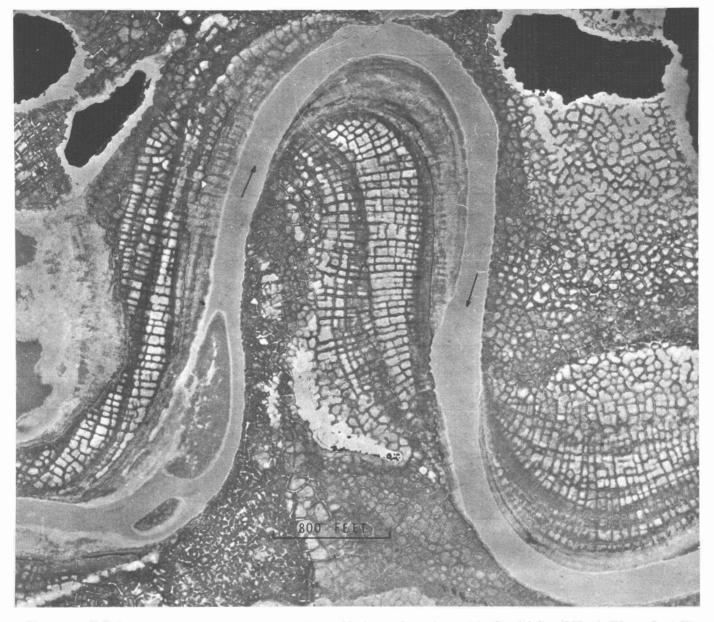
FIGURE 8.--Polygonal markings on ground surface (caused by ice-wedge polygons) in the vicinity of Meade River, about 35 miles southeast of Barrow, in northern Alaska. Photograph by U.S. Navy, July 1949.

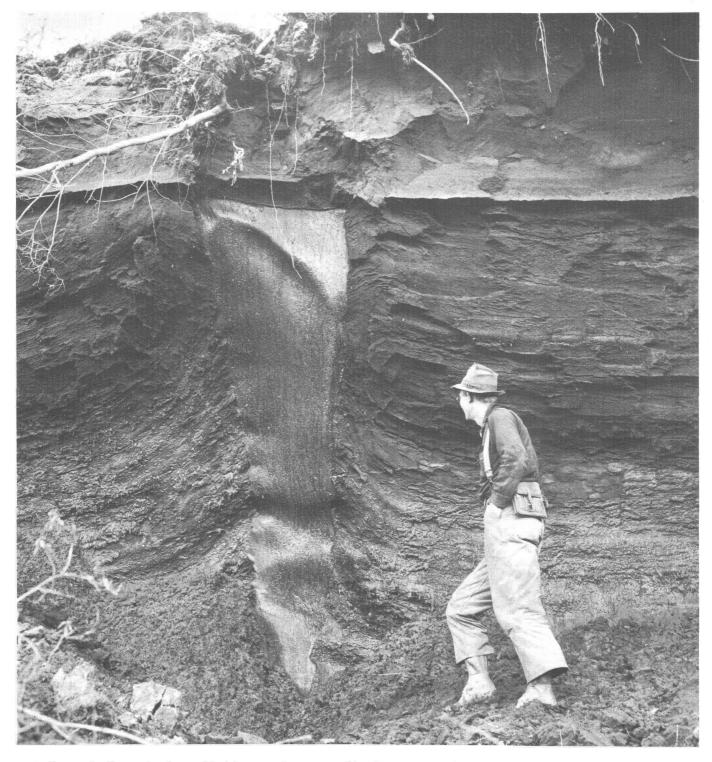
FIGURE 9.—Ice wedge (ground ice) in permafrost exposed by placer mining near Livengood about 50 miles northwest of Fairbanks. Photograph by T. L. Péwé, September 1949.

permafrost. Individual polygons range from 30 to a few hundred feet in diameter. Figure 9 shows a typical ice wedge. Where the surface of the ground is disturbed and the thermal regime upset, the ice wedges can melt, causing severe differential settlement of the ground surface. For example, clearing of the ground near Fairbanks caused ice wedges to melt, and large mounds were left (figs. 10 and 11.)

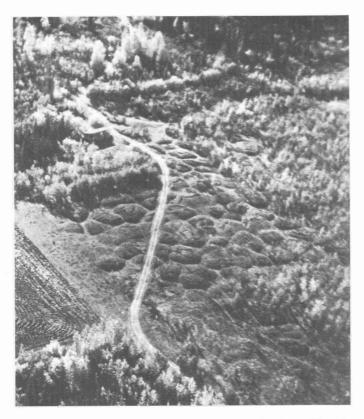
FIGURE 10.—Thermokarst mounds near Fairbanks. Mounds range from 10 to 30 feet in diameter. See figure 11 for ground view of mounds and explanation. Photograph by R. F. Black and T. L. Péwé, September 1948.

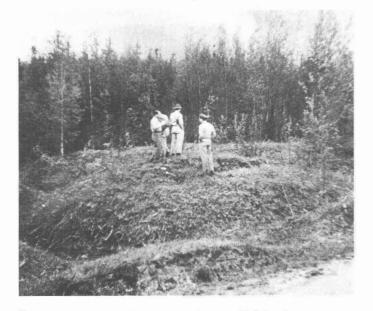
FIGURE 11.—Thermokarst mounds near Fairbanks caused by melting of ice wedges. The resulting ground settlement formed deep trenches in polygonal patterns and left mounds in the intervening areas. The thawing was started after the area was cleared for agricultural purposes. Figure 10 is an aerial view of similar mounds. Photograph taken in June 1955.

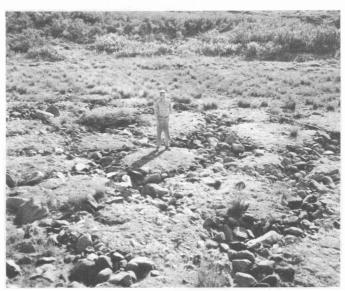
FIGURE 12.—Sorted stone circles caused by frost action, in Alaska Range, south-central Alaska. Photograph by T. L. Péwé, June 1968.

Stone nets, garlands, and stripes are extensive in the arctic. Frost heaving in granular soils produces netlike concentrations of the coarser rocks (fig. 12). If the area is gently sloped, the net is distorted into garlands by downslope movement. If the slope is

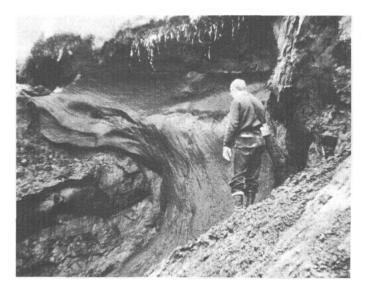
FIGURE 13.—Large mass of ground ice exposed by gold placer mining in silt bluff near Fairbanks. Thawing of a large ice mass causes severe differential settlement of the surface of the ground, as is shown in figure 14. Photograph taken in June 1955.

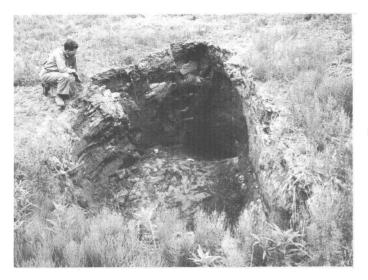
FIGURE 14.—Thaw or thermokarst pit near Fairbanks formed by the thawing of a large ice mass that caused severe differential settlement of the surface of the ground. Photograph by T. L. Péwé, June 1948.

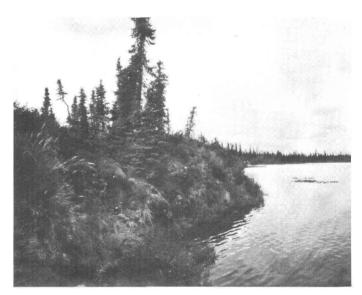
FIGURE 15.—Shoreline of a thaw lake about 40 miles northwest of Glennallen in south-central Alaska. Shoreline undercut because of thawing of permafrost. Vegetation mat of peat is draped over surface of steep bank (8-12 ft high) and is caving into lake. Trees in foreground are leaning toward lake, and they too will cave into the lake as the undercutting progresses landward. Photograph taken in June 1960.

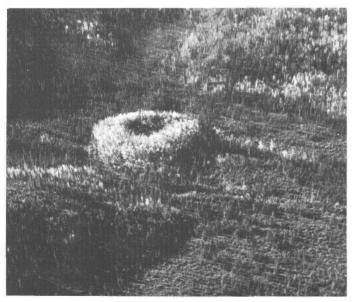
FIGURE 16.—Pingo in Yukon-Tanana Upland, east-central Alaska. Light birch trees on pingo contrast with dark spruce trees surrounding it. Pingo is about 300 feet in diameter and 50 feet high; water-filled crater on its summit makes it "donut shaped." Photograph by H. L. Foster, August 1960.

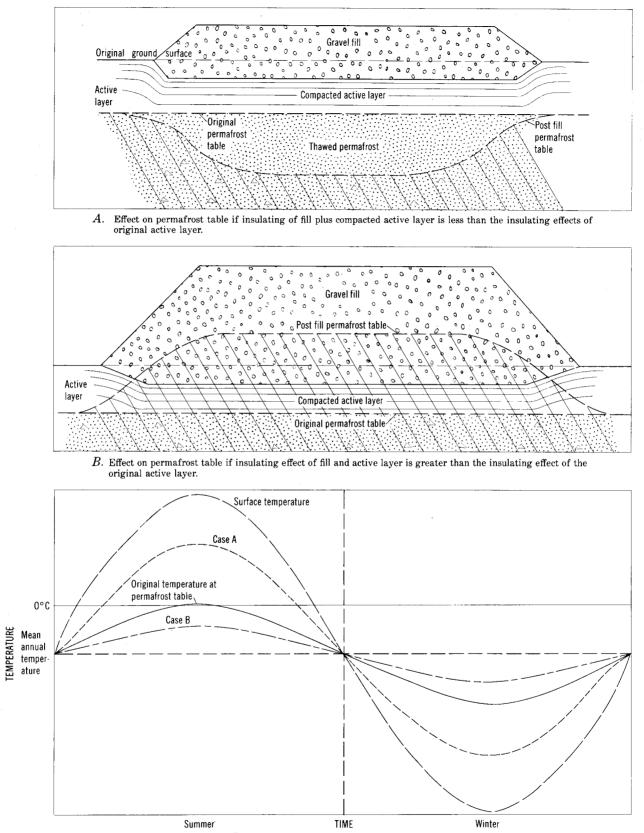
FIGURE 17.—Diagram showing effect of gravel fill upon thermal regime.

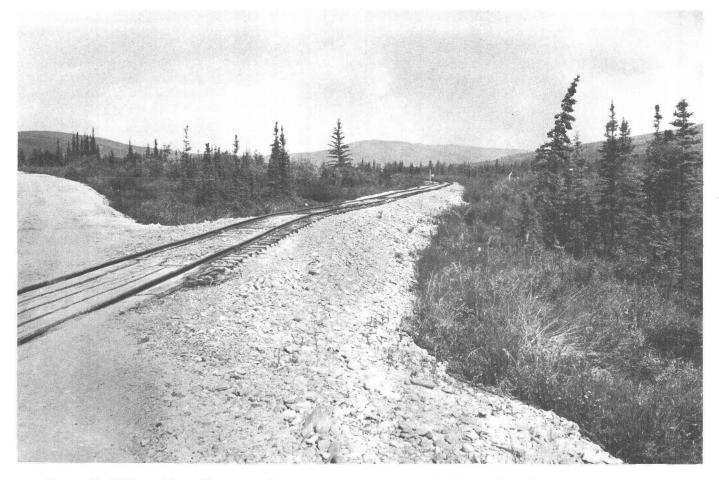
FIGURE 19.—Differential subsidence caused by thawing permafrost along the Murphy Dome Spur of the Alaska Railroad. Roadbed is in Goldstream valley and is underlain by silt. Photograph by T. L. Péwé, June 1954.

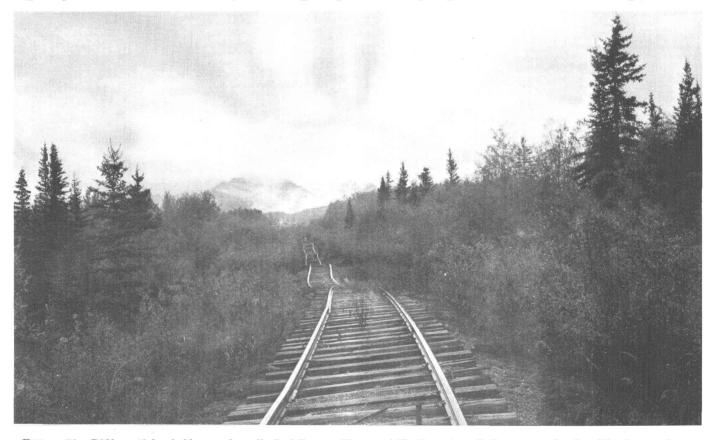
FIGURE 20.—Differential subsidence of roadbed of Copper River and Northwestern Railway near Strelna, 75 miles northeast of Valdez. The thermal equilibrium of the fine-grained sediments underlying the roadbed was disrupted during construction and the permafrost started to thaw. Maintenance and use of the railroad was discontinued in 1938. Subsidence as well as lateral displacement, however, has continued. Photograph by L. A. Yehle, September 1960.

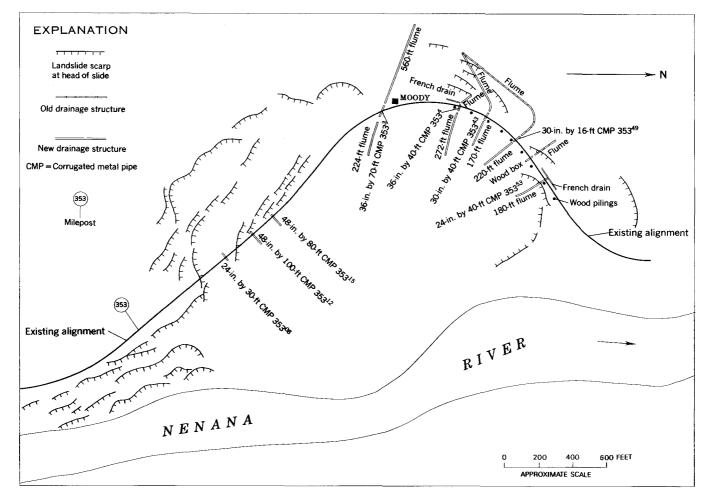
FIGURE 21.—Map of the Moody area on The Alaska Railroad showing landslides and slumps caused by thawing of permafrost and remedial measures taken to combat them. Map prepared by The Alaska Railroad, 1967.

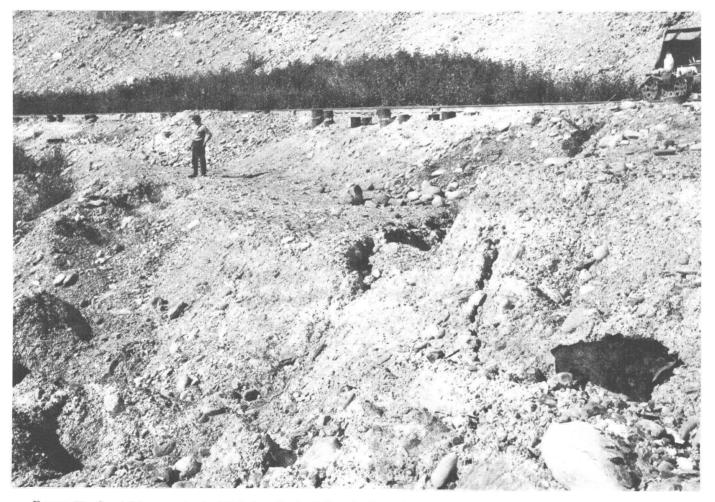
FIGURE 22.—Landslide area at mile 353.5, The Alaska Railroad. Note the tops of piles immediately downslope from the rails to prevent displacement of the tracks.

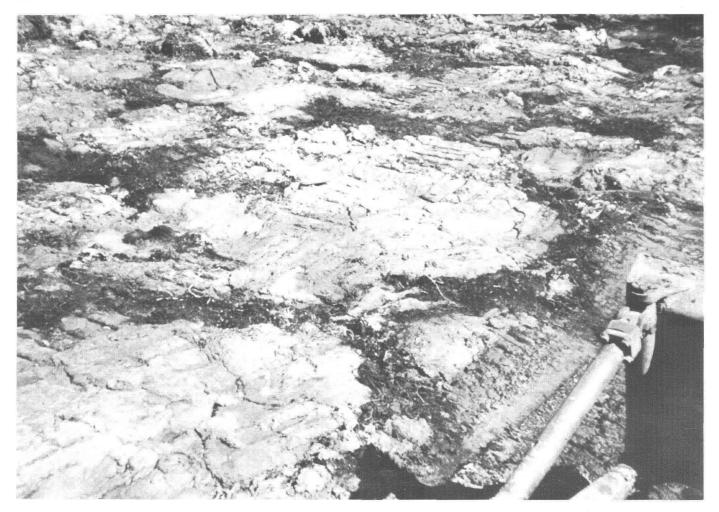
FIGURE 23.—Initial location of part of the Denali Highway near the Susitna River, interior Alaska. Construction crew is removing the insulating vegetation to expose polygonal ground in permafrost. Sediments are windblown sand and silt overlying silty glacial till. The dark areas outlining the polygons overlie ice wedges as much as 12 inches wide. Photograph taken in July 1953.

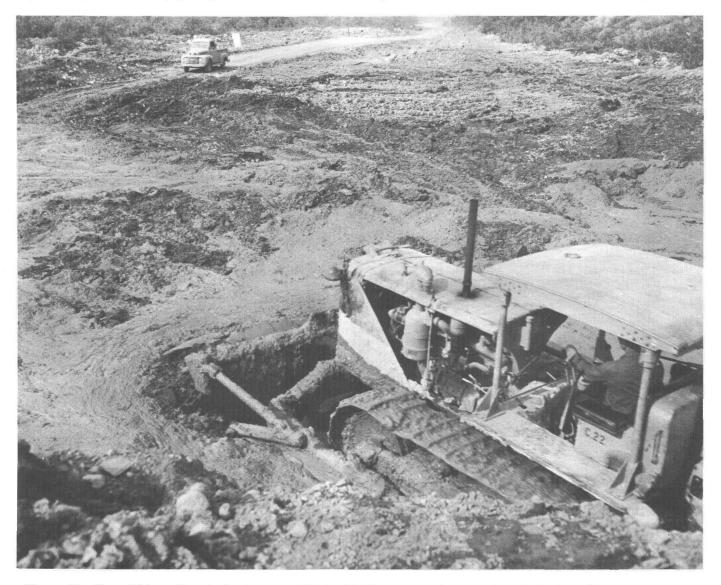
FIGURE 24.—Thawed lake sediments flowing around blade of bulldozer. Ice-rich permafrost in the lake silts was exposed in a cut during the construction of the Richardson Highway 2 miles north of Paxson. Photograph by T. L. Péwé, June 1954.

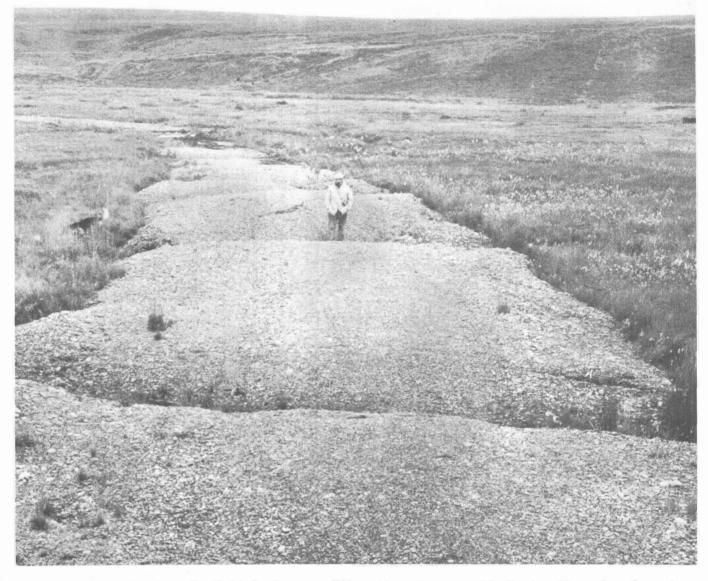
FIGURE 25.—Gravel road near the Umiat showing severe differential subsidence caused by thawing of ice-wedge polygons in permafrost. Photograph taken in August 1958.

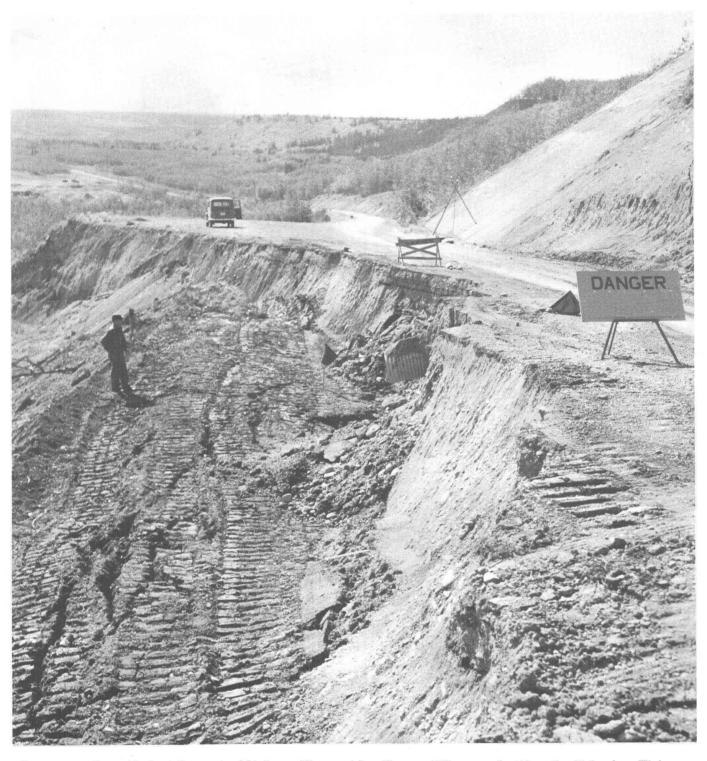
FIGURE 26.—Slump block of fine-grained highway fill material at Simpson Hill, near mile 113 on the Richardson Highway. Centerline of road formerly lay over exposed part of sheared culvert. Note bulldozer tracks on slump block surface, which are a continuation of those at road level on right side of photograph. Photograph by D. R. Nichols, September 1955. and the other with steel piles whose center was heaved—are shown in figures 30 and 31. The pattern of heaving damage depends largely upon the amount and distribution of water in the foundation material. Péwé and Paige (1963) present an explanation for the heaving of the ends of the bridge shown in figure 31.

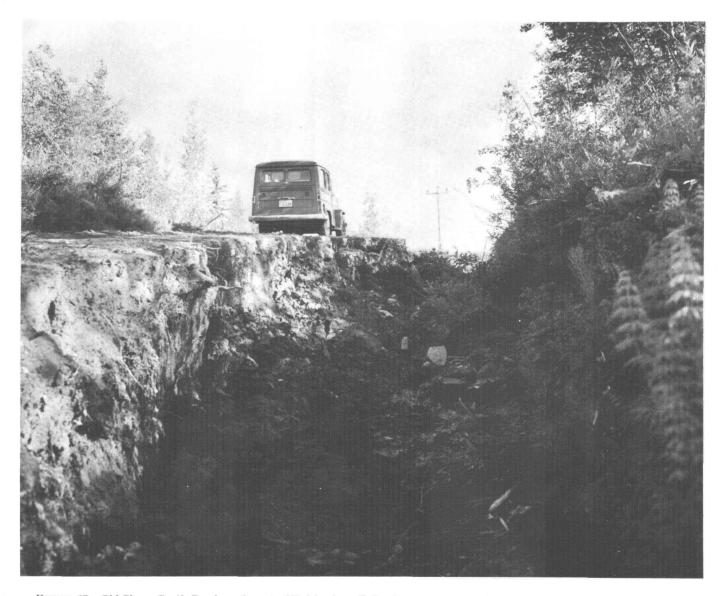
FIGURE 27.—Old Sheep Creek Road northwest of Fairbanks. Gully along edge of road was caused when the surface drainage thawed the permafrost in the underlying loess deposits. Photograph by T. L. Péwé, summer 1955.

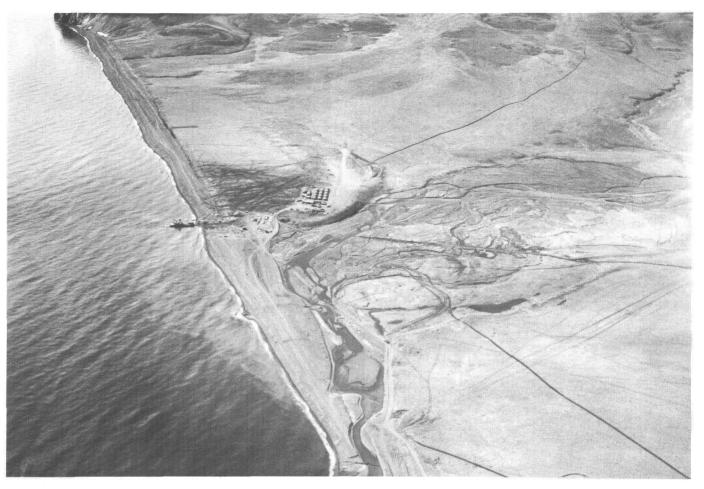
FIGURE 28.—Oblique aerial photograph of Chariot Site, northwestern Alaska. Dark area to the left of camp was caused by the heavy equipment that moved over the terrain while the barges were being unloaded. Trails were caused by tracked vehicles. Photograph by R. H. Campbell, summer 1960.

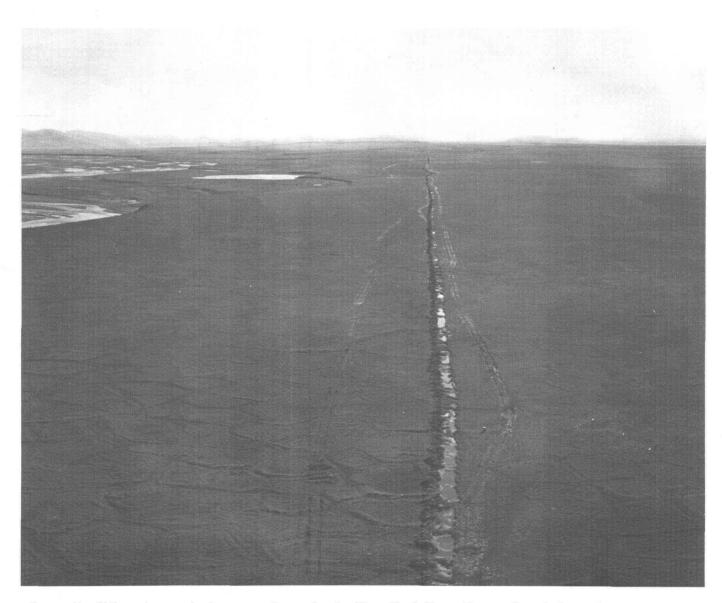
FIGURE 29.—Oblique photograph of tractor trail near Canning River, North Slope. Note small ponds due to thawing permafrost in roadway. Photograph by Averill Thayer, Bureau of Sport Fisheries and Wildlife, August 1968.

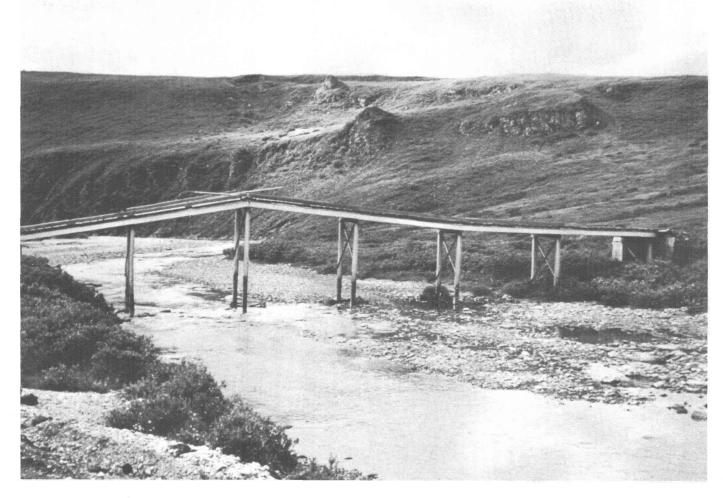
FIGURE 32.—Frost-heaved steel-pile bridge spanning North Fork at about mile 120 on the Kougarok Highway, Seward Peninsula. Photograph by G. D. Eberlein, summer 1955.

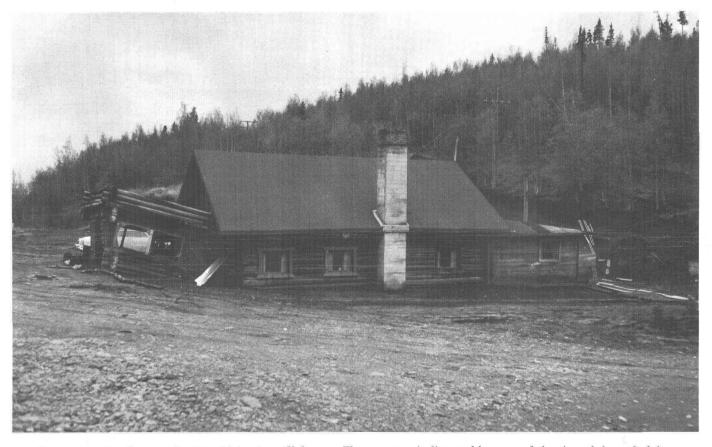
FIGURE 33.—Roadhouse, mile 278.5, Richardson Highway. The structure is distorted because of thawing of the underlying ice-rich permafrost in fine-grained silts and sands. Photograph by T. L. Péwé, May 29, 1962.

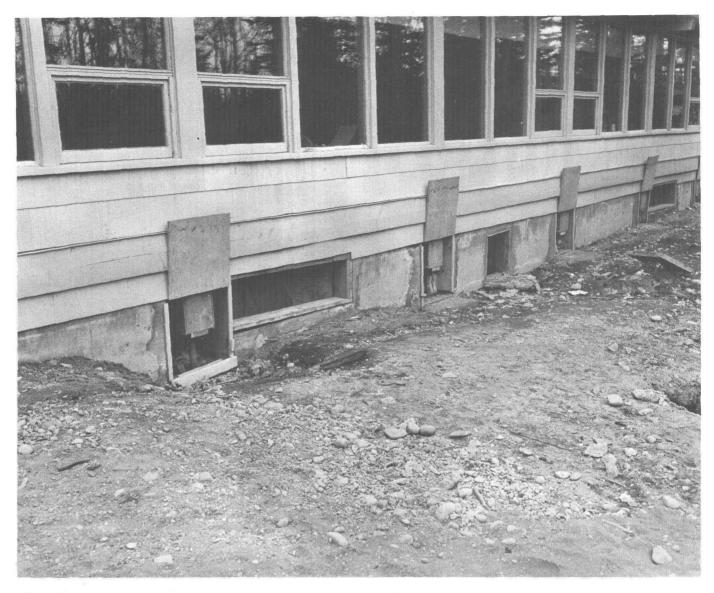
FIGURE 34.—View of the schoolhouse at Glennallen. Air vents, which are open, allow cold air to enter crawlway in winter to counteract heat from building. The vents are closed during the summer. Jacks are used to counteract any differential settlement. Photograph by T. L. Péwé, May 1954.

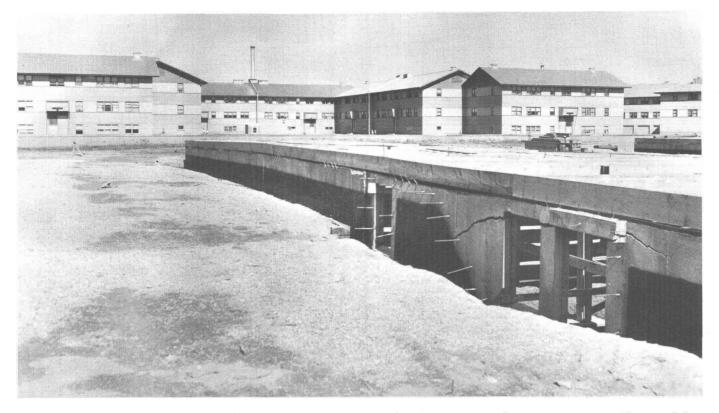
FIGURE 35.—Fracture due to frost heaving of 4-inch concrete foundation of an apartment house in Fairbanks. Photograph by T. L. Péwé, June 1954.

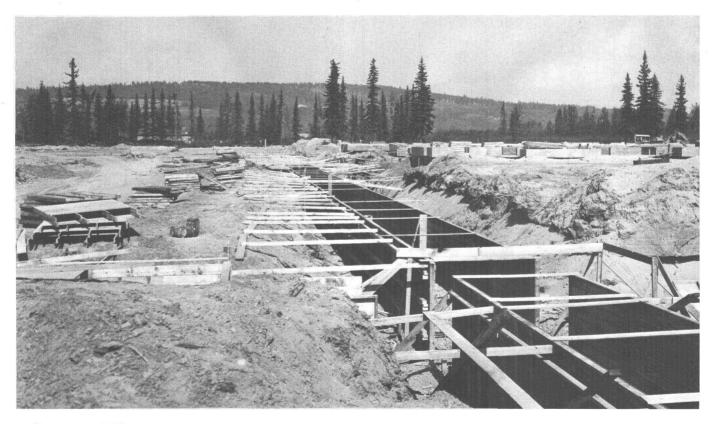
FIGURE 36.-Utilidor under construction at Fort Wainwright near Fairbanks, Alaska. Photograph by T. L. Péwé, July 1947.
