Geology of Waterpower Sites on the Bradley River Kenai Peninsula, Alaska

GEOLOGICAL SURVEY BULLETIN 1031-C

A description of the geologic settings of dam, tunnel, and reservoir sites on the Bradley River, with recommendations for future explorations

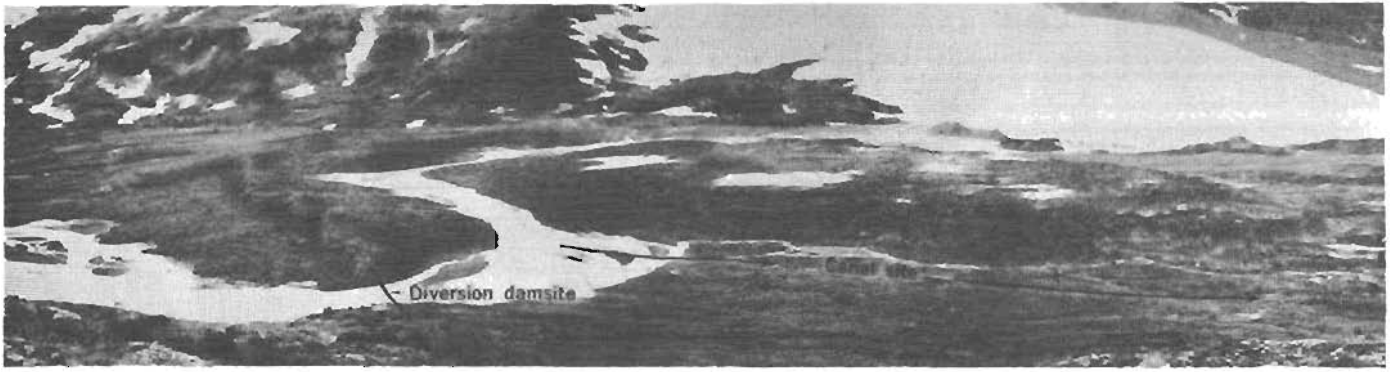
Diversion damsite and canal site at Bradley-Nuka divide.—The glacier at the divide has deposited low gravel-covered ridges that trend parallel to the valley. Most of the exposed material is fairly clean gravel, but below the ground surface considerable sand and silt are intermixed. Till is exposed at three places in the moraine 1,000 to 1,500 feet south of the divide and at a point in the left (east) bank 400 feet downstream from the diversion damsite (fig 12).

FIGURE 12.—Panorama of the diversion damsite and canal site south of Bradley-Nuka divide. The diversion damsite is in the lower left at the near end of the moraine. The canal site extends from the sharp bend in the river to the right (north) along the low in the foreground. August 1, 1953.

At the proposed site of the diversion dam, till is exposed in the right (west) abutment, and silt, sand, and gravel are in the river bottom and on the left (east) abutment. The till probably is tight, but the alluvium in the left abutment may be quite permeable. Graywacke and graywacke conglomerate in a slate matrix crop out 200 to 250 feet east of the left abutment near altitude 1,310, or 25 to 30 feet above the river surface at the damsite.
