# THE ALASKA EARTHQUAKE, MARCH 27, 1964: FIELD INVESTIGATIONS AND RECONSTRUCTION EFFORT

By WALLACE R. HANSEN, EDWIN B. ECKEL, WILLIAM E. SCHAEM, ROBERT E. LYLE, WARREN GEORGE, AND GENIE CHANCE

GEOLOGICAL SURVEY PROFESSIONAL PAPER 541

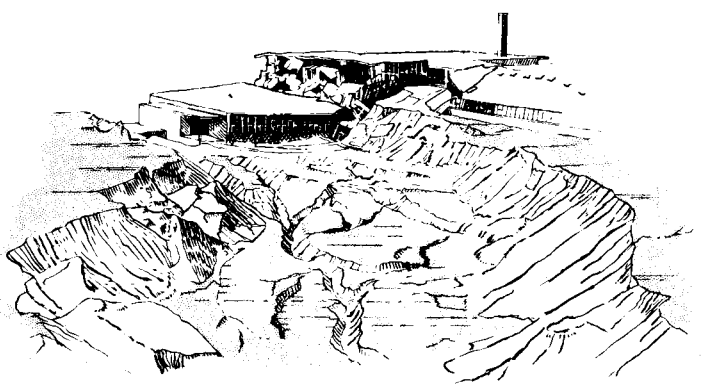
Aerial view, looking east, of part of Turnagain Heights slide, Anchorage, shortly after earthquake.

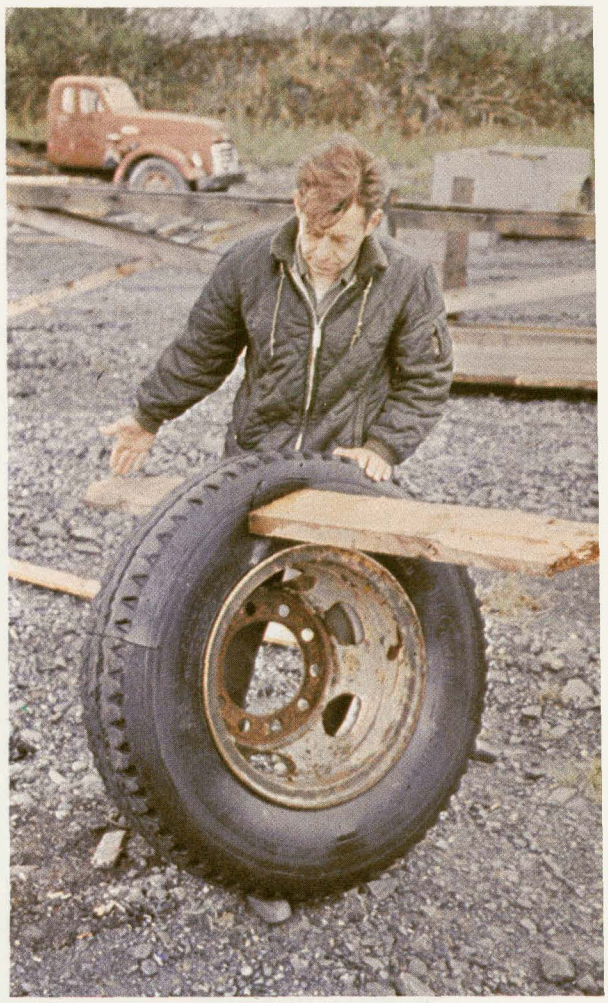
31 (right).—An indication of the violence of the surge-waves that struck Whittier.

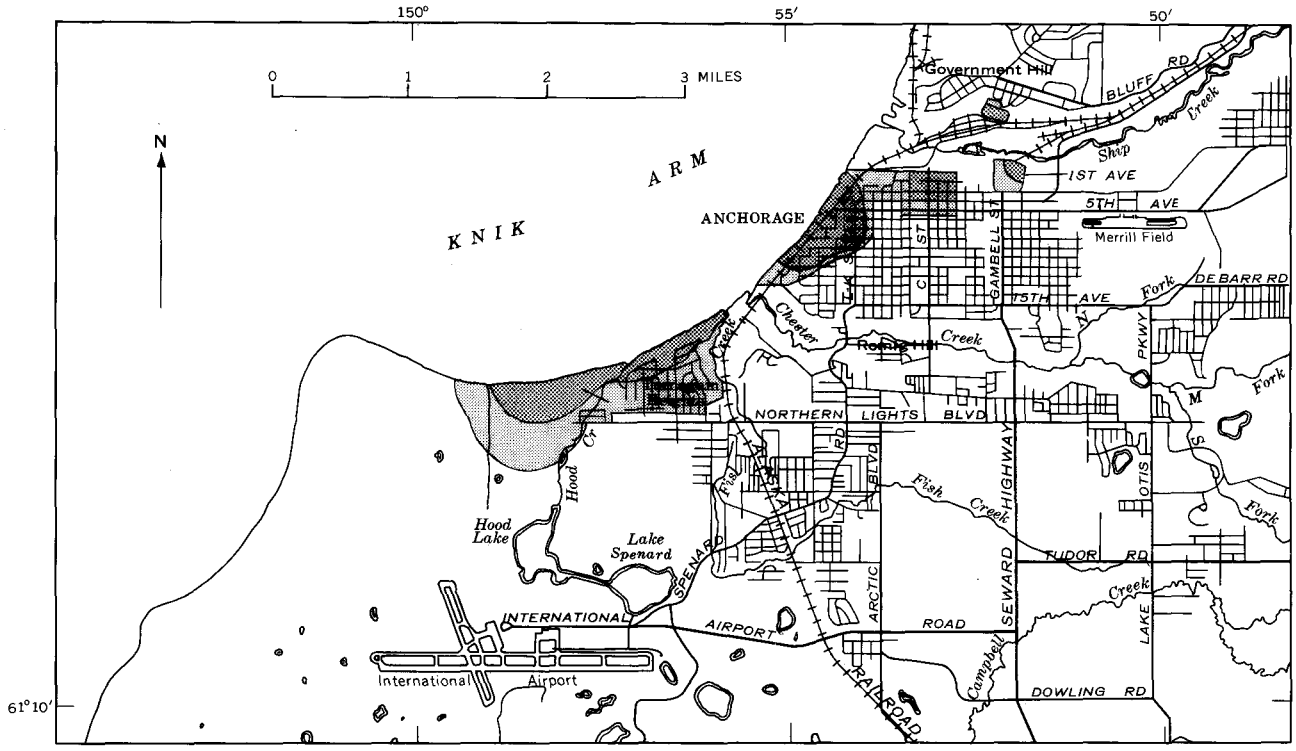
39.—Map showing high- and nominal-risk portions of Anchorage and vicinity, generally excluding military lands. This map and an accompanying press notice were issued May 19, 1964, by the Scientific and Engineering Task Force as the first of a series of interim recommendations to the Federal Reconstruction and Development Planning Commission for Alaska.

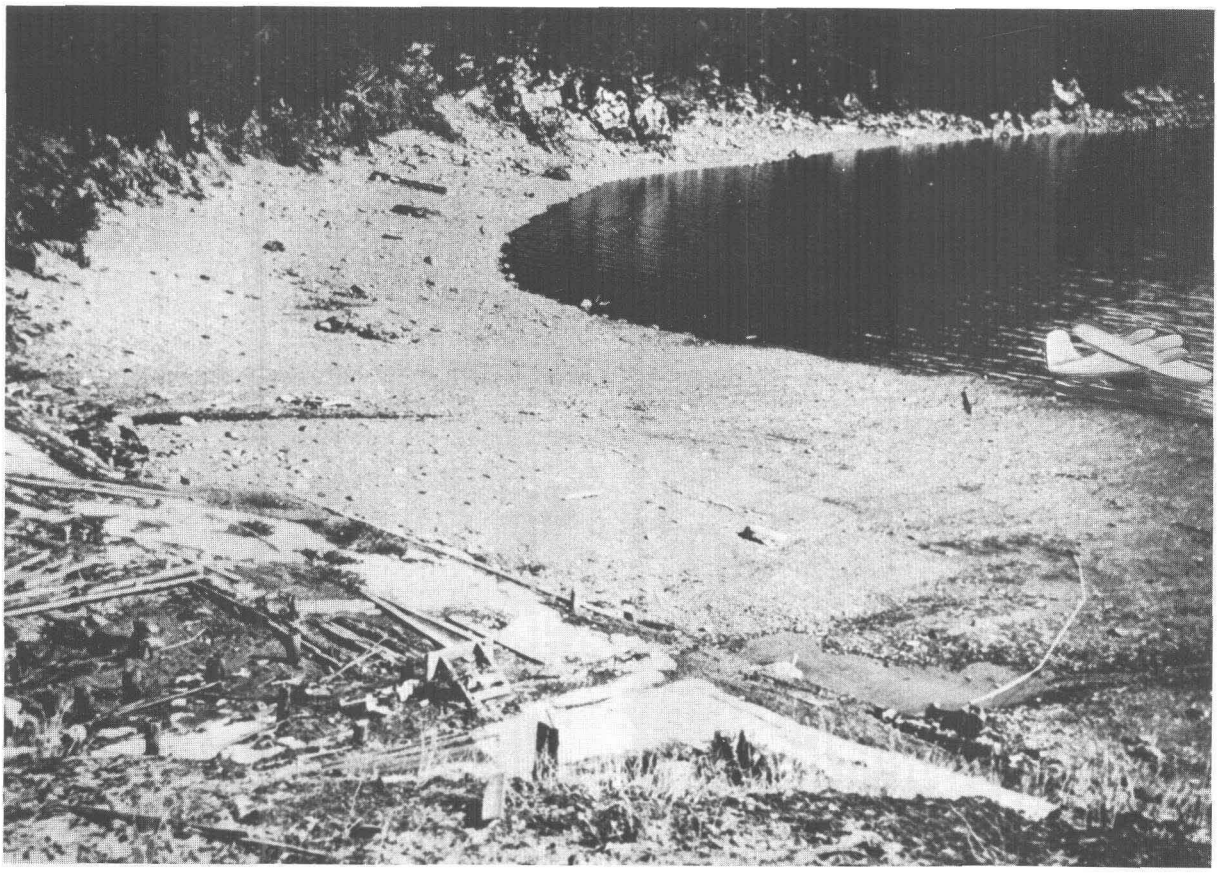
Chenega (fig. 60) was a native fishing village of about 80 persons. Living on a small island in the southwest part of Prince William Sound, the villagers had no tsunami warning. Within minutes after the onset of the earthquake, a wall of water swept across the shoreline, took 23 lives and left hardly a scrap of wood to mark the site. The survivors huddled throughout the cold night on a snow-covered hillside. The next day they were airlifted to Cordova across the sound where the village council held a general meeting in the temporary shelter of a Cordova church and decided unanimously not to return to Chenega. Within a few days the villagers agreed to settle at Tatitlek, another native village where they had relatives and where land was available for homes. Sixteen new homes were built for Chenegans by the Bureau of Indian Affairs (fig. 64). Fishing and hunting equipment purchased with disaster funds enabled the men to resume their occupations as fishermen and seal hunters.

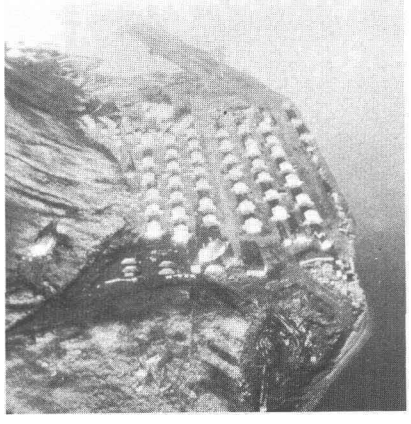
63.—Old Harbor a year after the quake. For the first time the villages were enjoying the comfort and convenience of community light, water, and sewer systems.
