ASSESSMENT OF GEOMORPHOLOGY AND GEOLOGIC HAZARDS IN THE PARKS HIGHWAY–MINTO FLATS–DALTON HIGHWAY INFRASTRUCTURE CORRIDOR: COOK INLET TO PRUDHOE BAY, ALASKA

Rich D. Koehler, Richard D. Reger, Eleanor R. Spangler, and Trent D. Hubbard

Report of Investigation 2016-

State of Alaska
Department of Natural Resources
Division of Geological & Geophysical Surveys

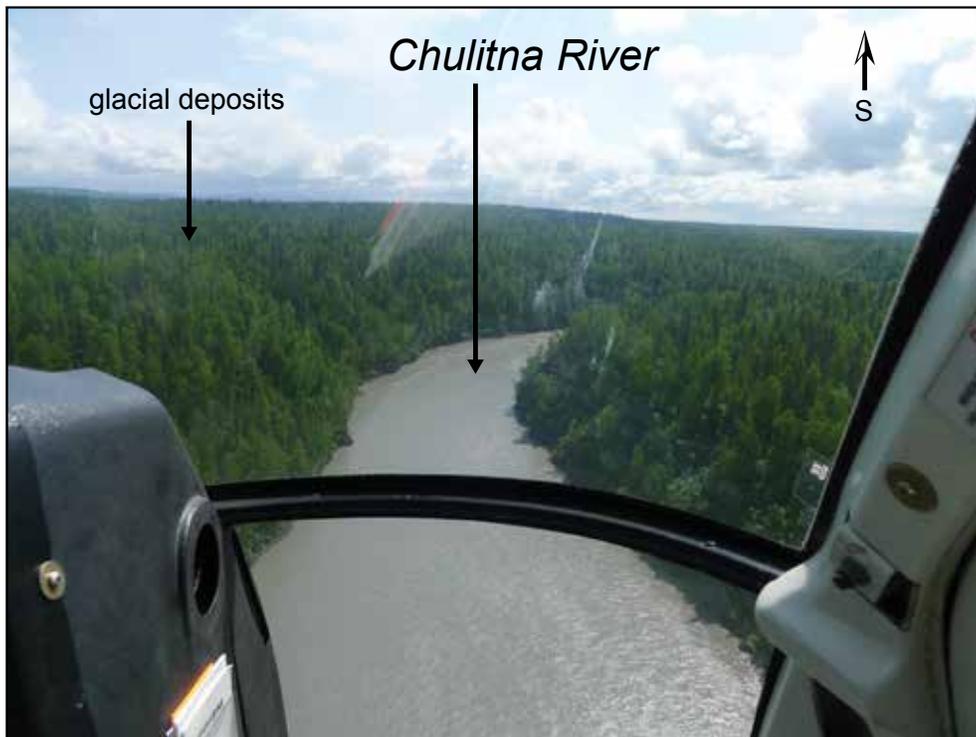
FIGURE 7. Aerial view to the south of the Chulitna River gorge, which is deeply incised through till, glaciolacustrine, and kame terrace deposits. Bedrock is exposed on the lower slopes of the gorge.

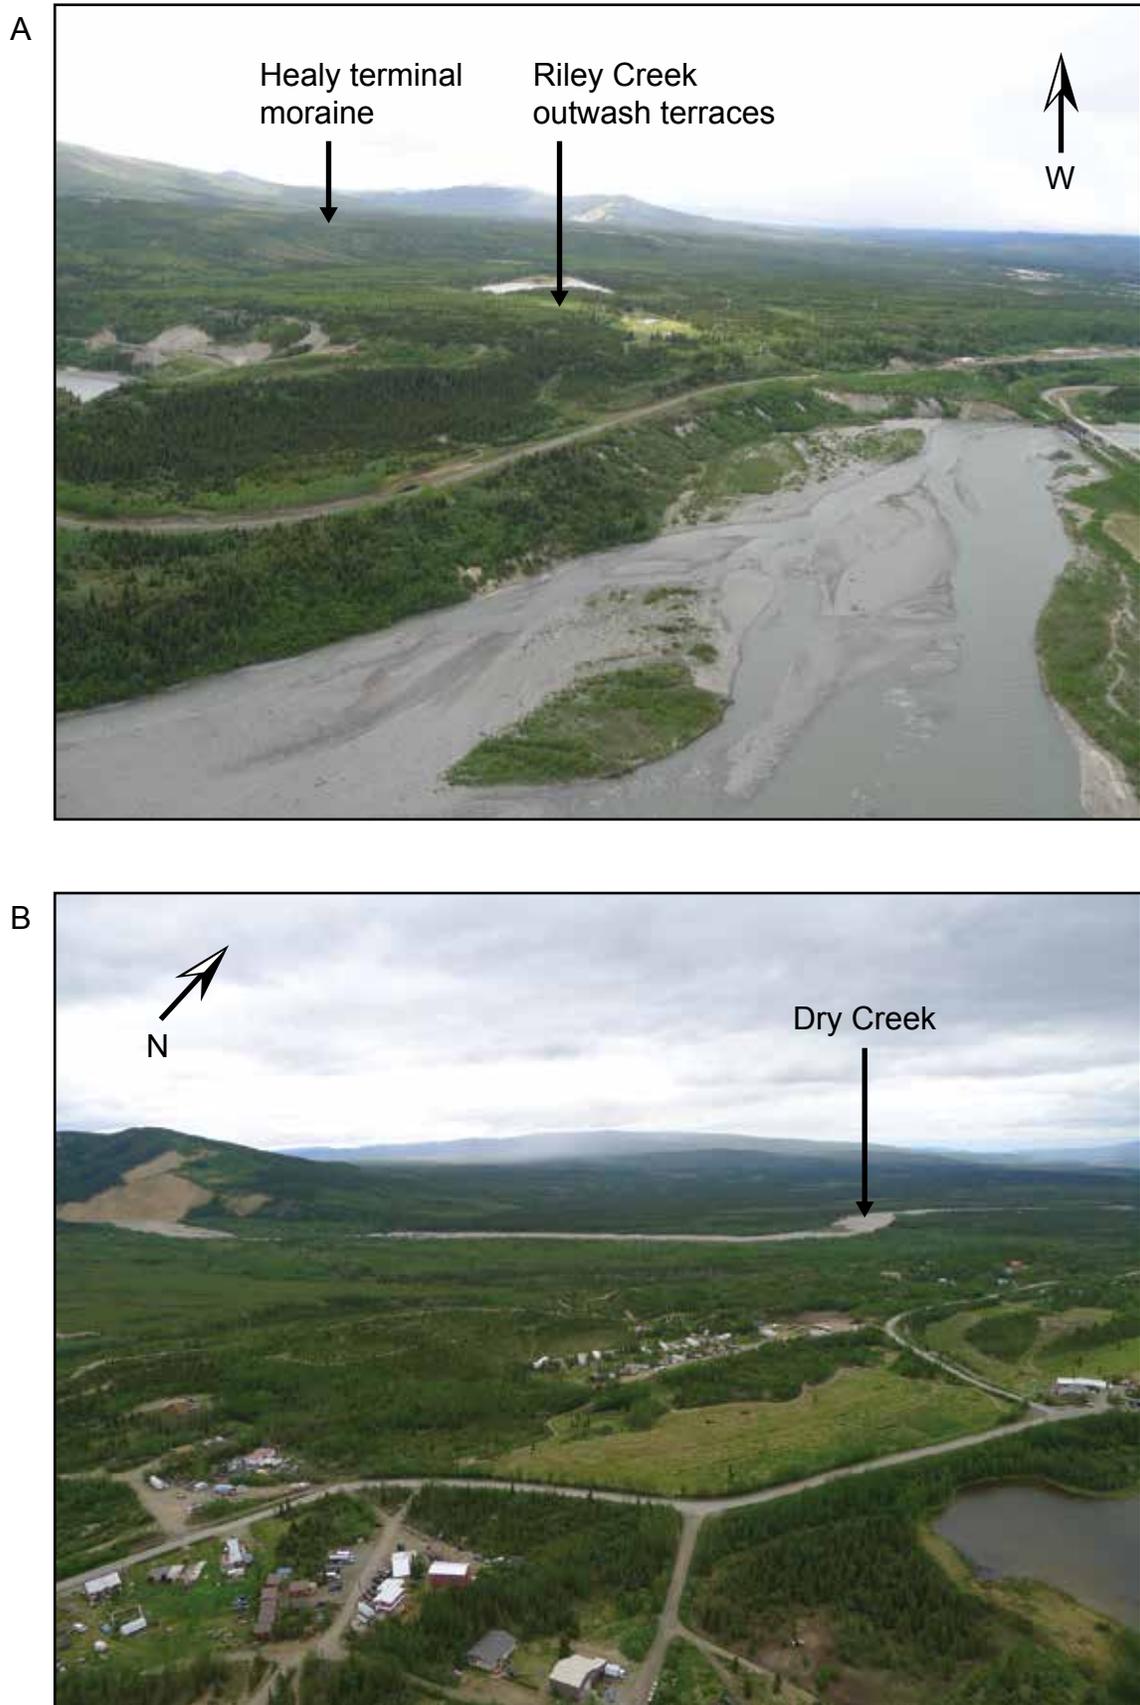
during the penultimate (Healy) glaciation in the Nenana River valley (Wahrhaftig, 1970a,b). From the Healy terminal moraine (site 104a, sheet 2, map 4) near the boundary of the Healy D-4 and D-5 quadrangles, the corridor descends onto granular fluvial outwash terraces of the Healy, Riley Creek, and Carlo Creek glaciations for 1.1 mi before crossing granular alluvium of the Dry Creek alluvial fan and floodplain for 0.8 mi (fig. 11).

FIGURE 11. A. View toward west of Healy terminal moraine and Riley Creek outwash terrace surfaces in the vicinity of the town of Healy. B. View of Dry Creek alluvial valley north of the Healy terminal moraine.

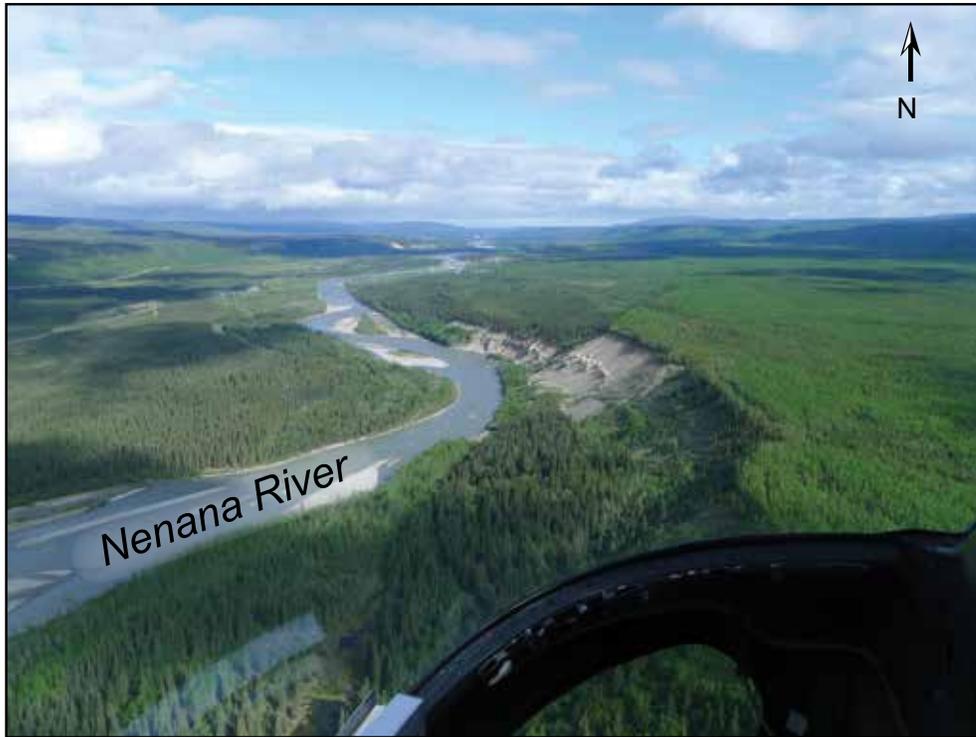
North of Dry Creek the corridor follows the course of the Nenana River for 7.0 mi across fairly thin granular stream and outwash alluvium over Tertiary bedrock (fig. 12). Outwash terraces include those associated with the Healy glaciation along the west side of the corridor and inset Riley Creek outwash surfaces. Incised into these surfaces are three small drainages (Panguingue, Little Panguingue, and Slate creeks), which produce extensive annual surface icings. Small landslides are common along the western side of the corridor through this entire section. These small failures are developed in the weathered schist (probably the Totatlinika Schist of Wahrhaftig, 1968, 1970b) and weathered Tertiary coal-bearing sedimentary rocks of the Usibelli Group (Wahrhaftig and others, 1969; Wahrhaftig, 1987) beneath the Nenana Gravel. Directly north of Slate Creek and west of the Nenana River the corridor crosses a large, chronically active landslide in the Tertiary coal-bearing sandstone (site 113, sheet 2, map 4). This creeping landslide is 0.5 mi long and 0.3 mi wide. Springs emerging from the toe of this lobate failure cause maintenance problems along the Parks Highway, which is diverted around the toe of the landslide.

FIGURE 12. View toward north of thin outwash terraces over Tertiary bedrock on both sides of the Nenana River north of Dry Creek.

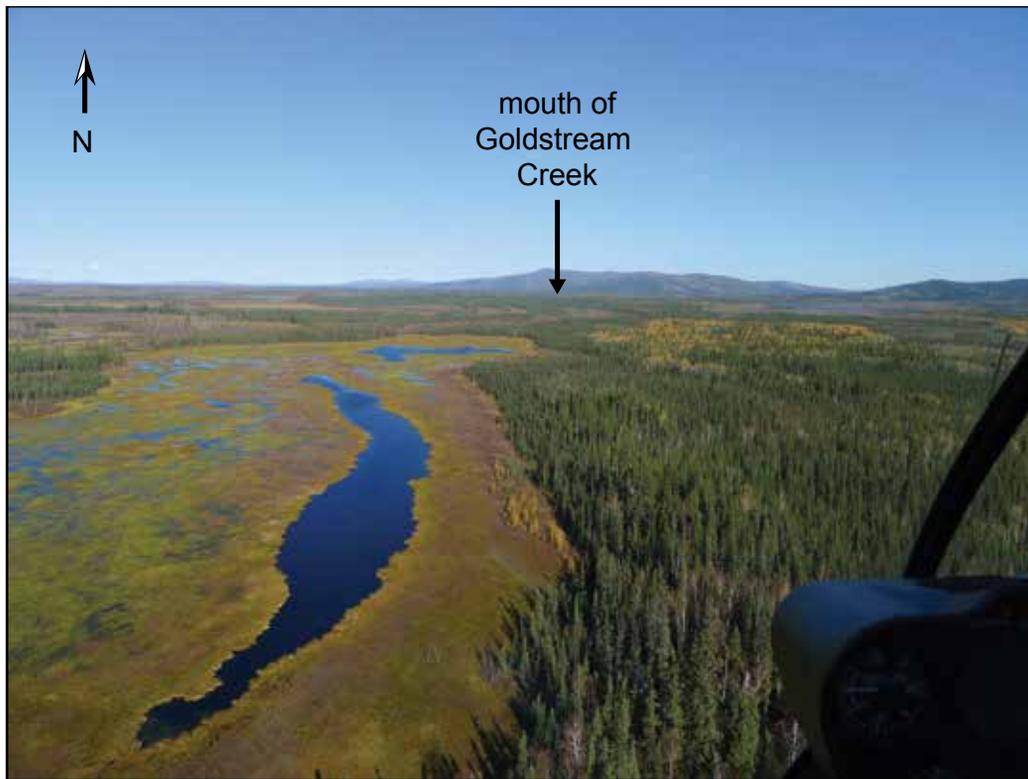
dunes, abandoned meander channels, and thaw lakes (fig. 15). Isolated patches of polygonal ground in this area are formed by development of ice-wedge networks in permafrost. Foundation soils in this segment are mainly alluvial or retransported silts mixed with lowland loess or sand dunes. A preliminary assessment of permafrost in the Dunbar area determined that permafrost is widespread in the lowlands and is at least 150 ft (46 m) thick (Péwé, 1949). The presence of polygonal ground, thermokarst pits, and thaw lakes demonstrates that large ground-ice masses are locally present.

FIGURE 15. View toward north, showing abandoned floodplain channel of the Tanana River, isolated sand dunes, thaw lakes, and polygonal ground that characterize the surface of the corridor in the vicinity of Goldstream Creek.

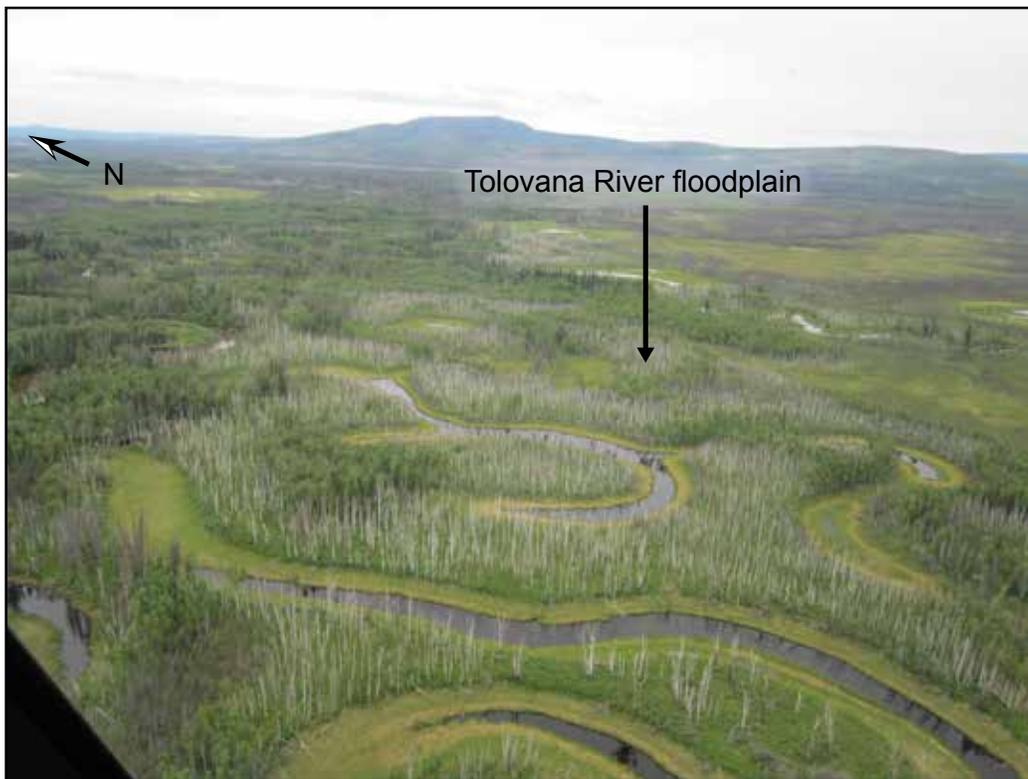
FIGURE 16. Aerial view of the Tolovana River floodplain south of Livengood, where typical landforms include open-system pingos, thermokarst ponds, and abandoned oxbow meanders.

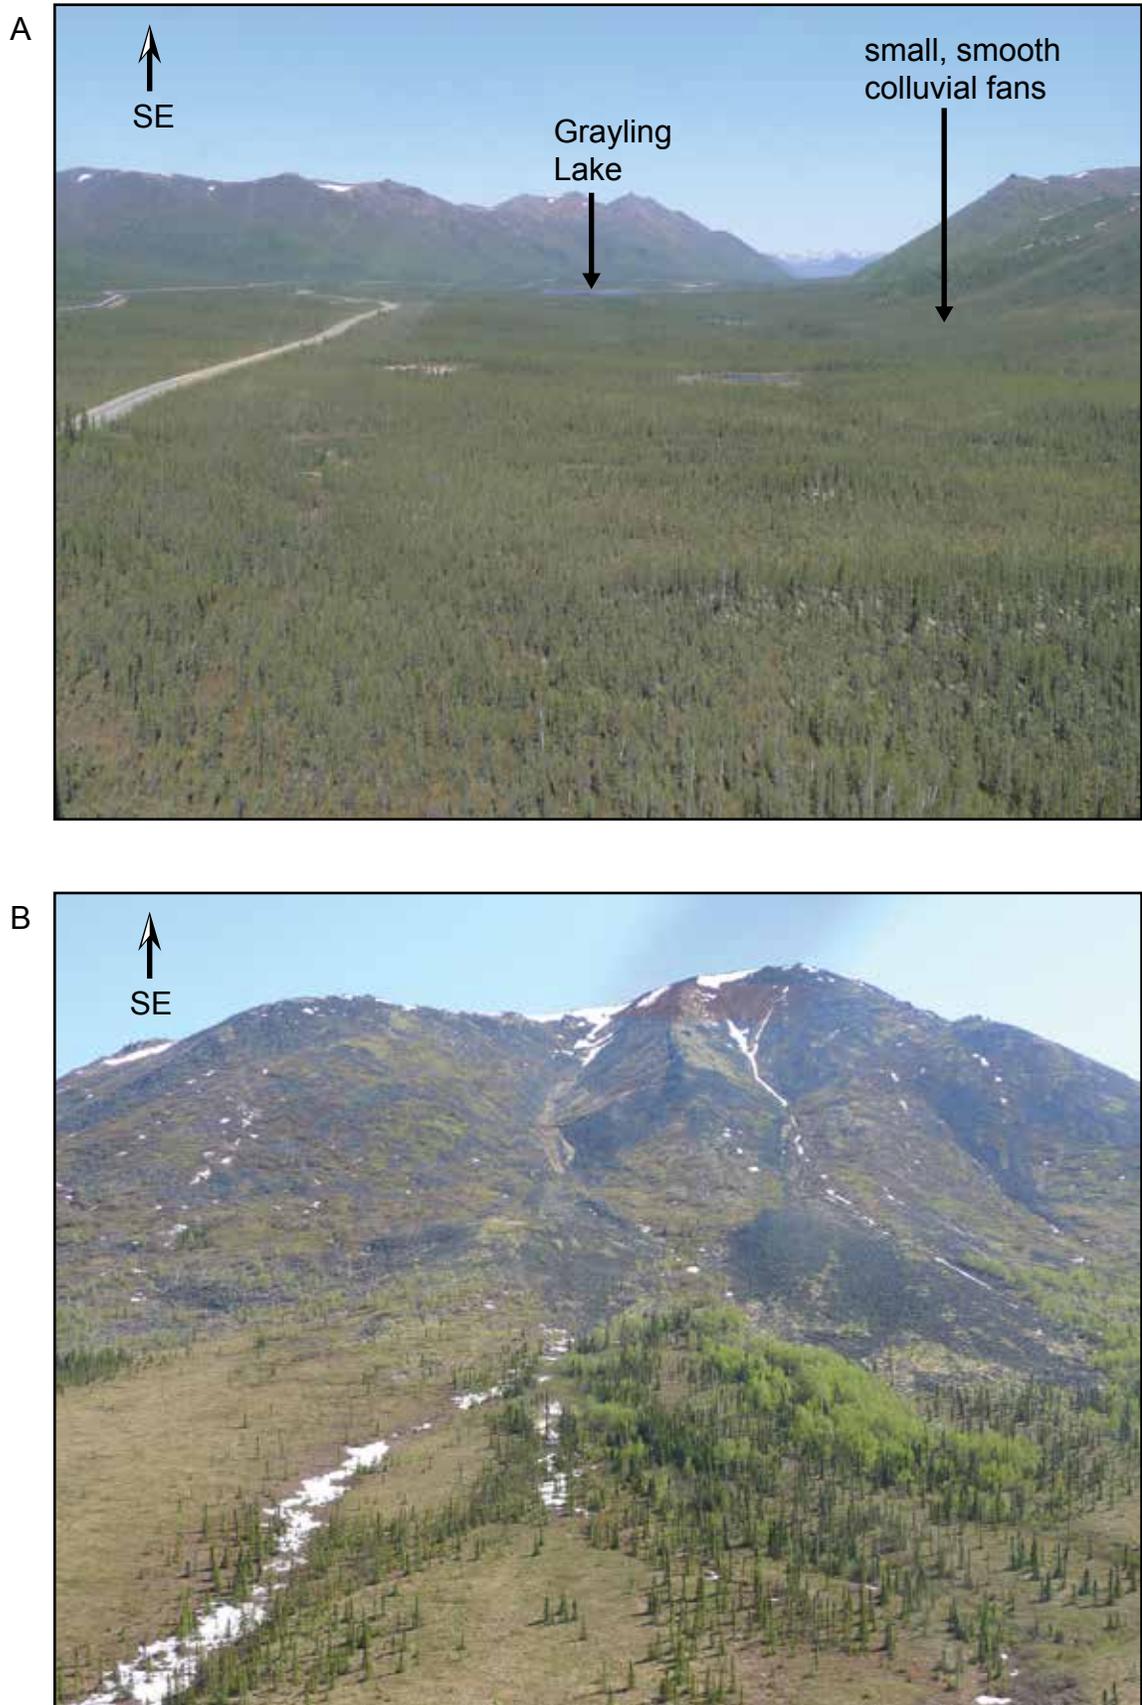
FIGURE 23. A. Southeast view of the Grayling Lake corridor, showing small, smooth colluvial fans along the northwestern valley wall. B. Coarse rock rubble fans along the southeastern valley wall of the Grayling Lake corridor.

by solifluction-modified glacial and glaciofluvial deposits of the Sagavanirktok River glaciation; ice-scoured, weathered bedrock knobs more commonly stand out from the northwestern valley wall than the smoother southeastern valley wall. Colluvial fans, built by slope processes, on opposite valley walls have different appearances. On the lower northwestern valley wall, colluvial fans built by debris flows and solifluction onto deposits of the penultimate glaciation at the mouths of short, steep tributary gullies are smaller, thinner, and smoother than massive colluvial fans deposited on the southeastern valley wall (fig. 23A). Fans there are dominantly composed of coarse rock rubble that was initially deposited on glacial deposits as mixed fine and coarse sediments by slush flows, debris flows, and snow avalanches (fig. 23B). The colluvial fans are associated with colluvial aprons that were also initially composed of fine and coarse solifluction deposits. Subsequently, the fine fractions of the colluvial fans and aprons were removed by subsurface piping, leaving the very coarse rubble fans and rubble sheets as lag on the southeastern valley wall.

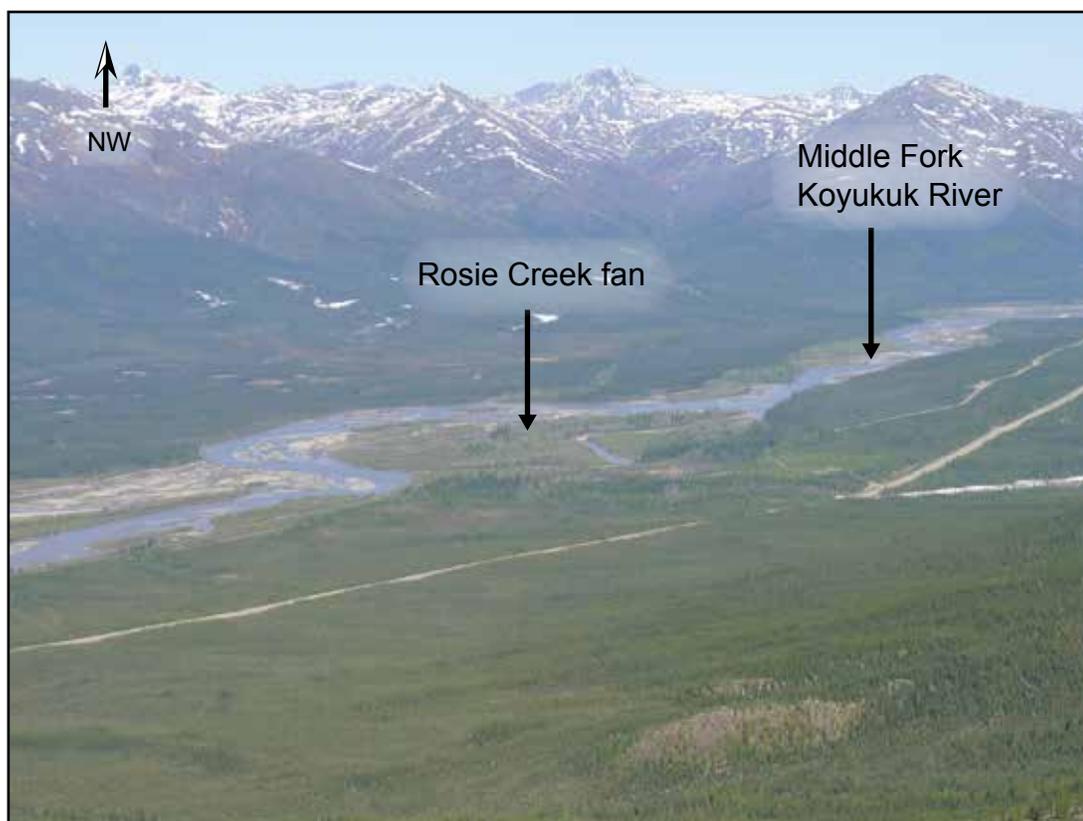
From the southern flank of Cathedral Mountain, the corridor extends for 3.6 mi to the mouth of Rosie Creek and follows the floodplain of the Middle Fork Koyukuk River (fig. 25). In this section, the floodplain is braided and covered by thick stream icings each winter. According to Hamilton (1979), fine-grained lacustrine sediments are present beneath the granular floodplain sediments. We suggest that those fine-grained sediments provide a near-surface impermeable barrier to the downward movement of shallow groundwater, promoting the formation of the surface icing sheets. Rapid mass movements derived from the adjacent slopes during extreme weather events represent a persistent hazard in this area.

FIGURE 25. View, looking northwest from Cathedral Mountain, of the Middle Fork Koyukuk River and the Rosie Creek alluvial fan.
