PRELIMINARY INTERPRETIVE REPORT 2000-3

**TECHNICAL REVIEW OF THE SEPTEMBER 1999
GROUNDWATER DISTURBANCE NEAR ESTER, ALASKA**

Jim Vohden
Alaska Department of Natural Resources
Division of Mining, Land and Water
Alaska Hydrologic Survey

March 2000

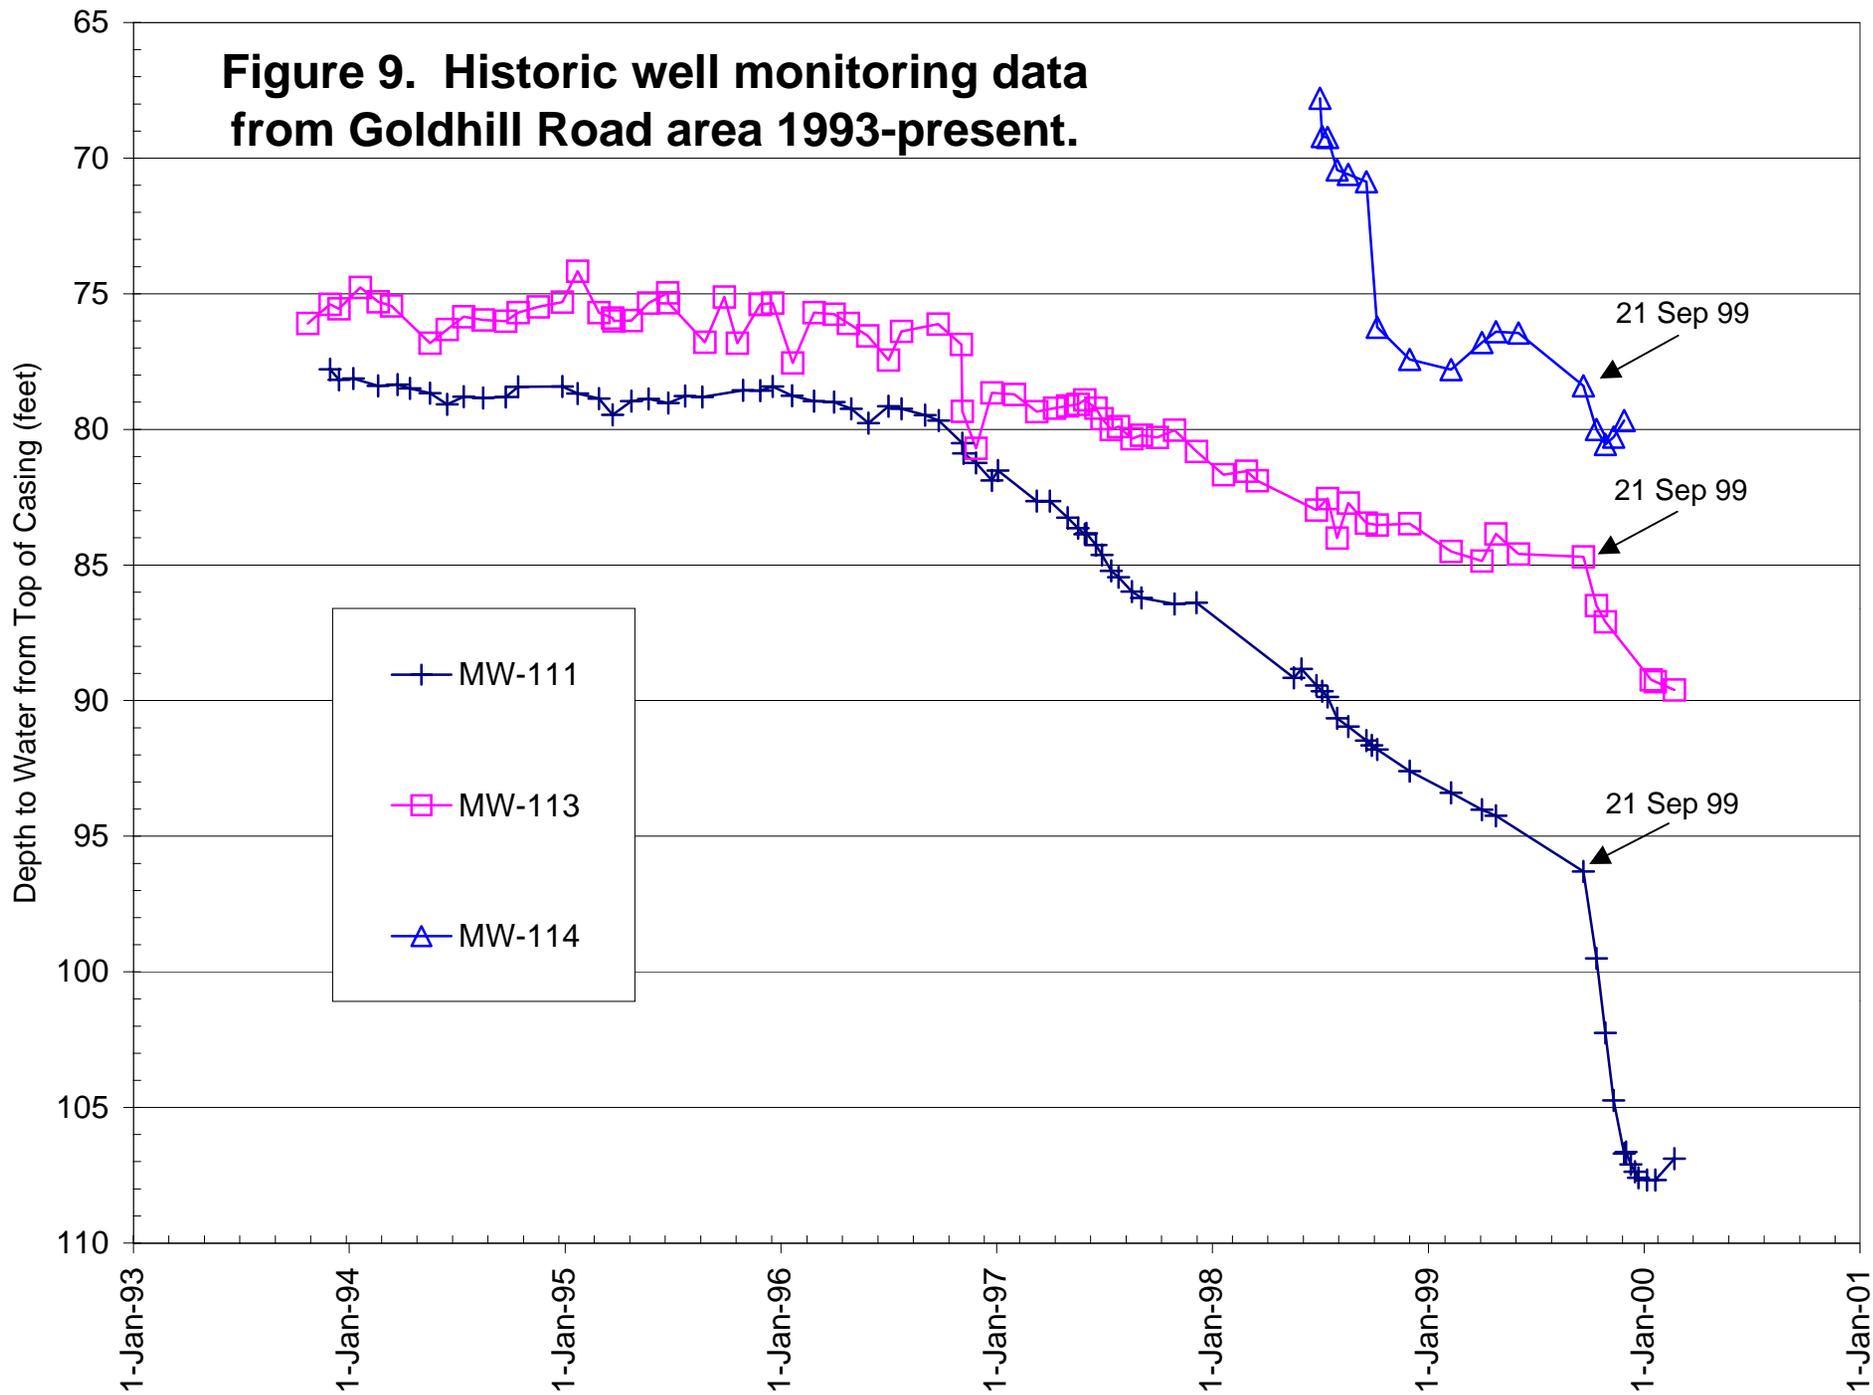
Figure 9. Historic well monitoring data from Goldhill Road area 1993-present.

Coincidentally, a fairly large body of data exists from previous efforts to monitor the groundwater table on Ester Dome, and specifically in the Goldhill Road area. This database was most recently maintained by Design Science and Engineering of Fairbanks Alaska, and was courteously shared with DMLW. One well monitored (MW-111) is located in the middle of the primarily affected area and two are located on the fringe of this area (MW-113 and MW-114). These wells have been monitored sporadically since 1993. These long term hydrographs have been serendipitously useful in describing the state of the groundwater table before, during and after the 25 September 1999 incident at Yellow Eagle (Figure 9). As seen in Figures 9 and 10, there is a marked depression in the groundwater table just following the 21 September measurement. Clearly the best-fit of the data in the individual segments of time since 1996 produce trend lines with very good correlation. Although the long term slope of the hydrograph of MW-111, for instance, prior to 25 September 1999 is declining, the significant decline beginning with the 13 October 1999 measurement indicates that there was a major change in the system, one which hadn't been observed in this long period of record. The regular monitoring of some of these historic wells is now being continued by DMLW as part of this investigation. The seasonal trends in the Fairbanks area dictate that during winter, when the ground is frozen, there is very little probability of increased groundwater recharge occurring (Table 3). However, as seen in Figures 5 through 10, there appears to be recharge in all of the primarily affected Goldhill Road area wells monitored as of 22 February 1999. Additionally, wells upgradient of the Goldhill Road area (i.e. MW-106 and MW-115) appear to be unaffected by the 1999 groundwater disturbance, in effect confirming the extent of the primarily affected area. The “control” wells demonstrate some fluctuation over the period of record, but essentially no significant trend.
