EFFECTS OF THE EARTHQUAKE  
OF MARCH 27, 1964  
AT SEWARD, ALASKA

# Effects of the Earthquake Of March 27, 1964, At Seward, Alaska

BY RICHARD W. LEMKE

GEOLOGICAL SURVEY PROFESSIONAL PAPER 542-E

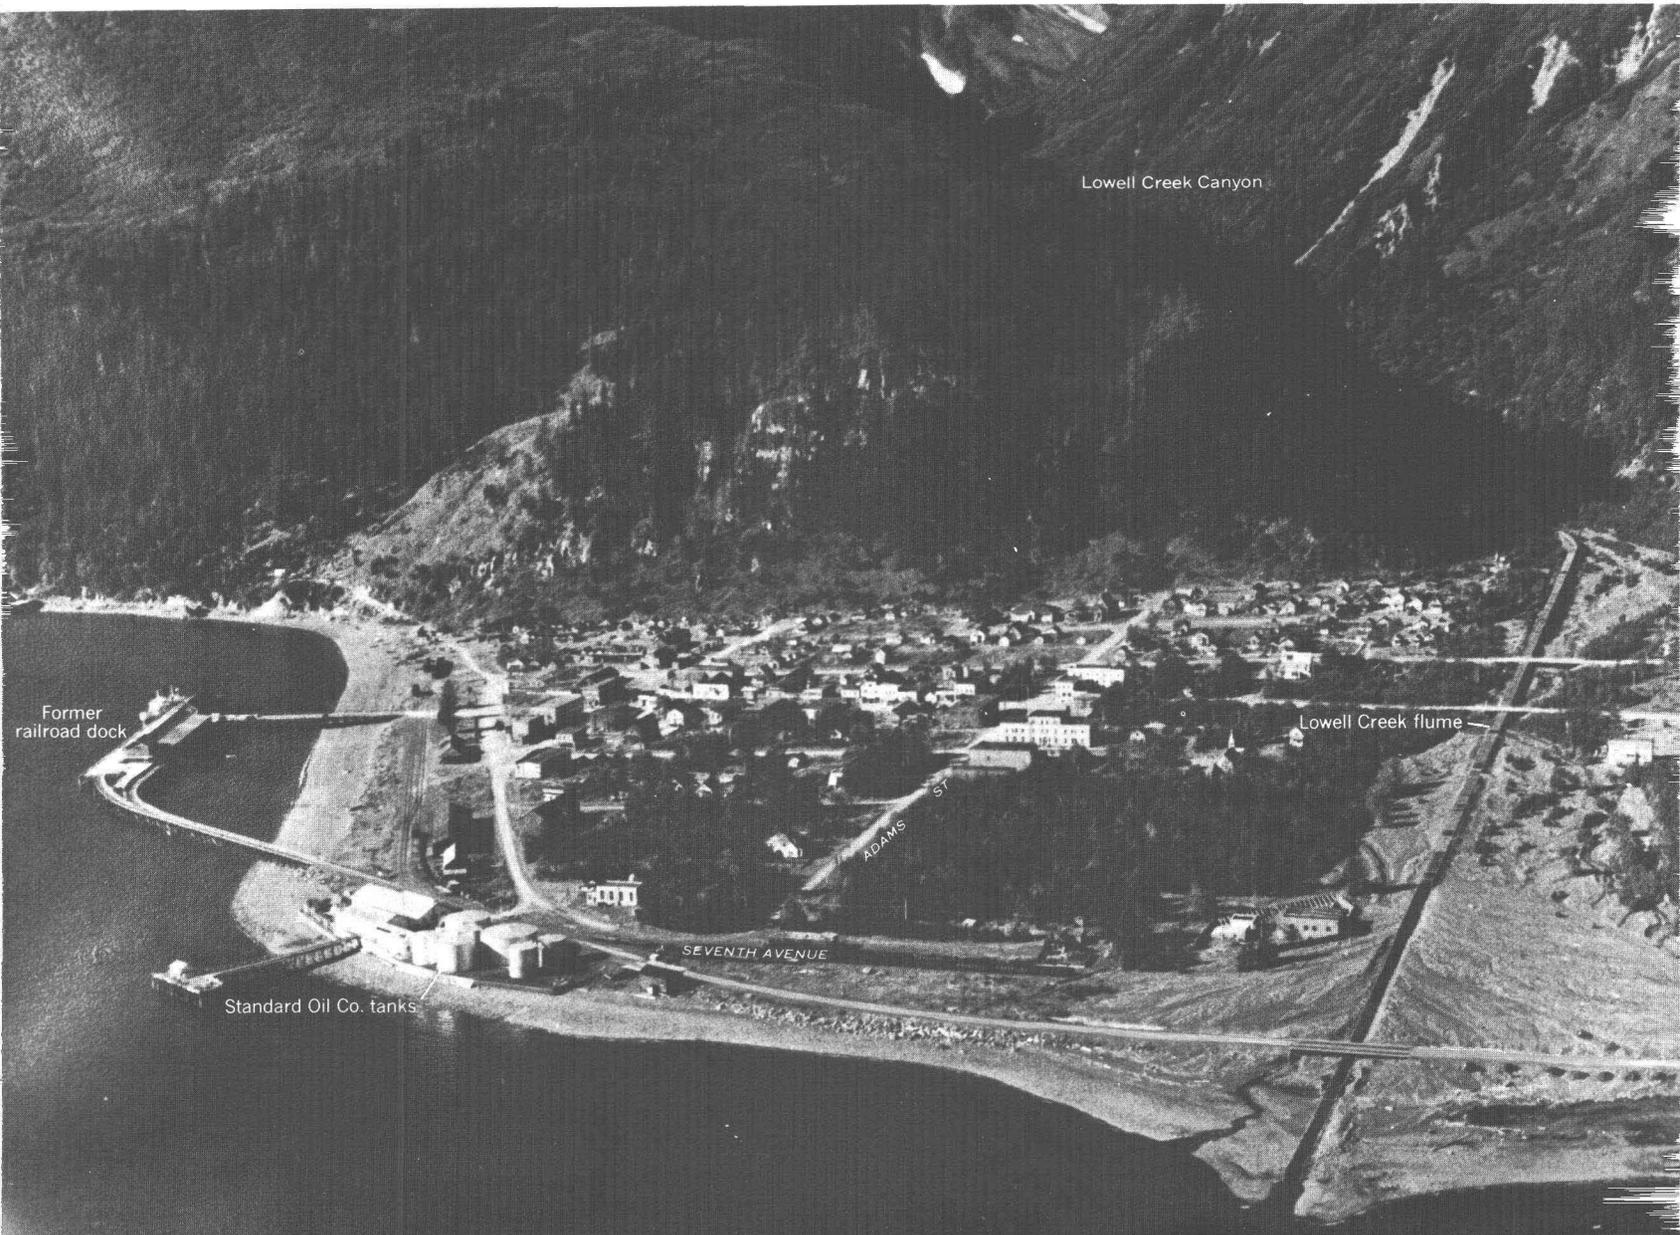
9.—Seward alluvial fan in 1939 showing torrential-type deposition from Lowell Creek after a flood. Photograph by Robert Zentmeyer.
