THE ALASKA EARTHQUAKE, MARCH 27, 1964:  
REGIONAL EFFECTS

# Surface Faults On Montague Island Associated with the 1964 Alaska Earthquake

*A description and tectonic analysis of ground  
breakage and surface warping along two  
reactivated reverse faults*

GEOLOGICAL SURVEY PROFESSIONAL PAPER 543-G

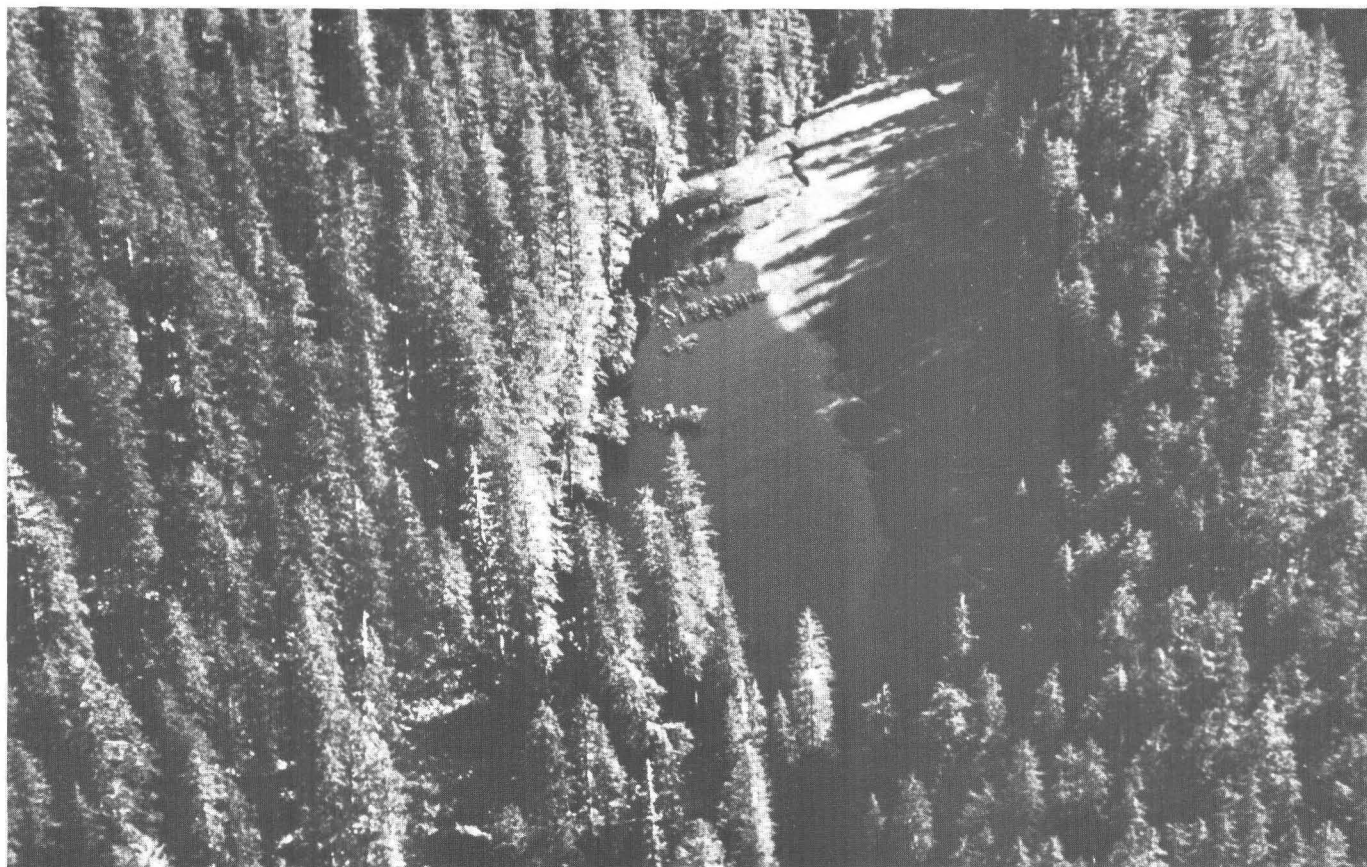
10.—One of the larger fissures along the trace of the Patton Bay fault. The fissure, which is 3 feet wide and 7 feet deep, is in unconsolidated glacial till.

headwall scarps of enormous incipient landslide blocks that occur all along the upper part of the cliff. It reappears some 500 feet inland from the cliff where it coincides with the linear edge of a muskeg swamp. The fault trace here consists of a north-south trending zone of parallel surface fissures and flexures in glacial till and sphagnum peat. Individual fissures that parallel the trace are open as much as 3 feet (fig. 10) and have vertical offsets of as

much as 5 feet with the west (downhill) sides upthrown relative to the east sides. Net vertical displacement across the fissures is about 7 feet; the amount of vertical movement resulting from warping is not known. A possible left-lateral component of horizontal displacement is indicated by a 17-inch offset of segments of a log that had been frozen into the ground in a position almost normal to the trend of one of the larger surface breaks. A few gaping cracks that trend N. 15° W. at an oblique angle to the fault trace are also suggestive of some left-lateral strike-slip movement. No evidence for lateral offsets was found anywhere else along the fault trace.

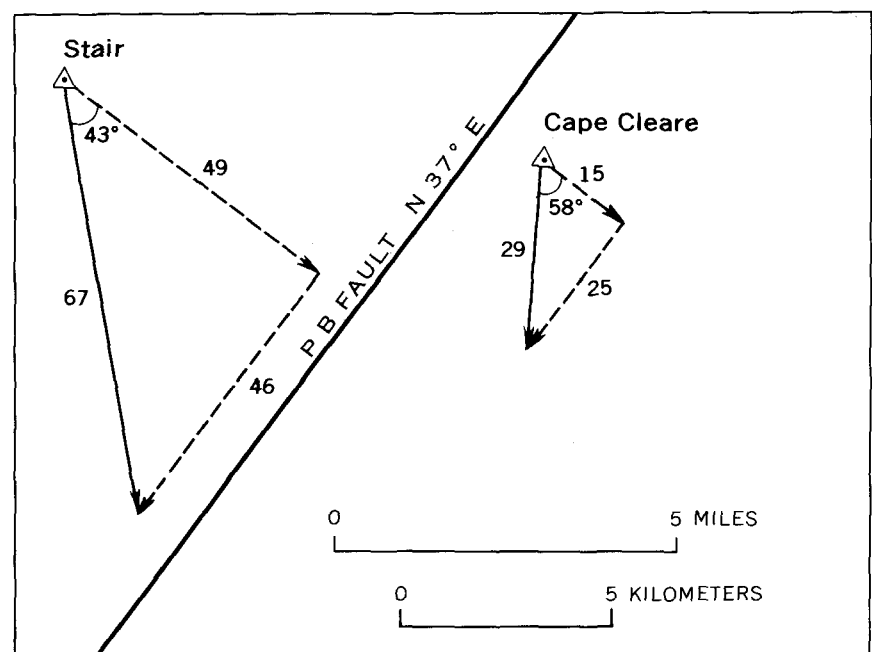
40.—Orientation of horizontal displacement vectors (solid arrows) at triangulation stations Stair and Cape Cleare relative to the average strike of the Patton Bay fault. Dashed arrows are the indicated components of horizontal displacement perpendicular to, and parallel to, the fault. Numerals are horizontal displacement in feet relative to station Fishhook (40 miles northeast of Anchorage), which was held fixed in the adjustment. Triangulation data from Parkin (1966, table 1).

principal vector of horizontal movement derived from the geodetic data is between N. 10° W. and N. 5° E. at an oblique angle to the fault system, whereas the direction indicated by the predominantly dip-slip displacements across the scarps is actually about N. 53° W., or approximately normal to the average strike of the faults. The re-triangulation data further indi-

cate that the two stations moved 34 feet relatively toward one another in the direction of fault dip and that they were relatively displaced 21 feet in a left-lateral sense (fig. 40). The dip-slip shortening could have been taken up by bending of the upthrown block in addition to the fault displacement. The strike-slip displacement, on the other hand, should have been
