THE ALASKA EARTHQUAKE, MARCH 27, 1964:
EFFECTS ON TRANSPORTATION, COMMUNICATIONS, AND UTILITIES

Effects of the Earthquake of March 27, 1964, on the Alaska Highway System

By REUBEN KACHADOORIAN

GEOLOGICAL SURVEY PROFESSIONAL PAPER 545-C

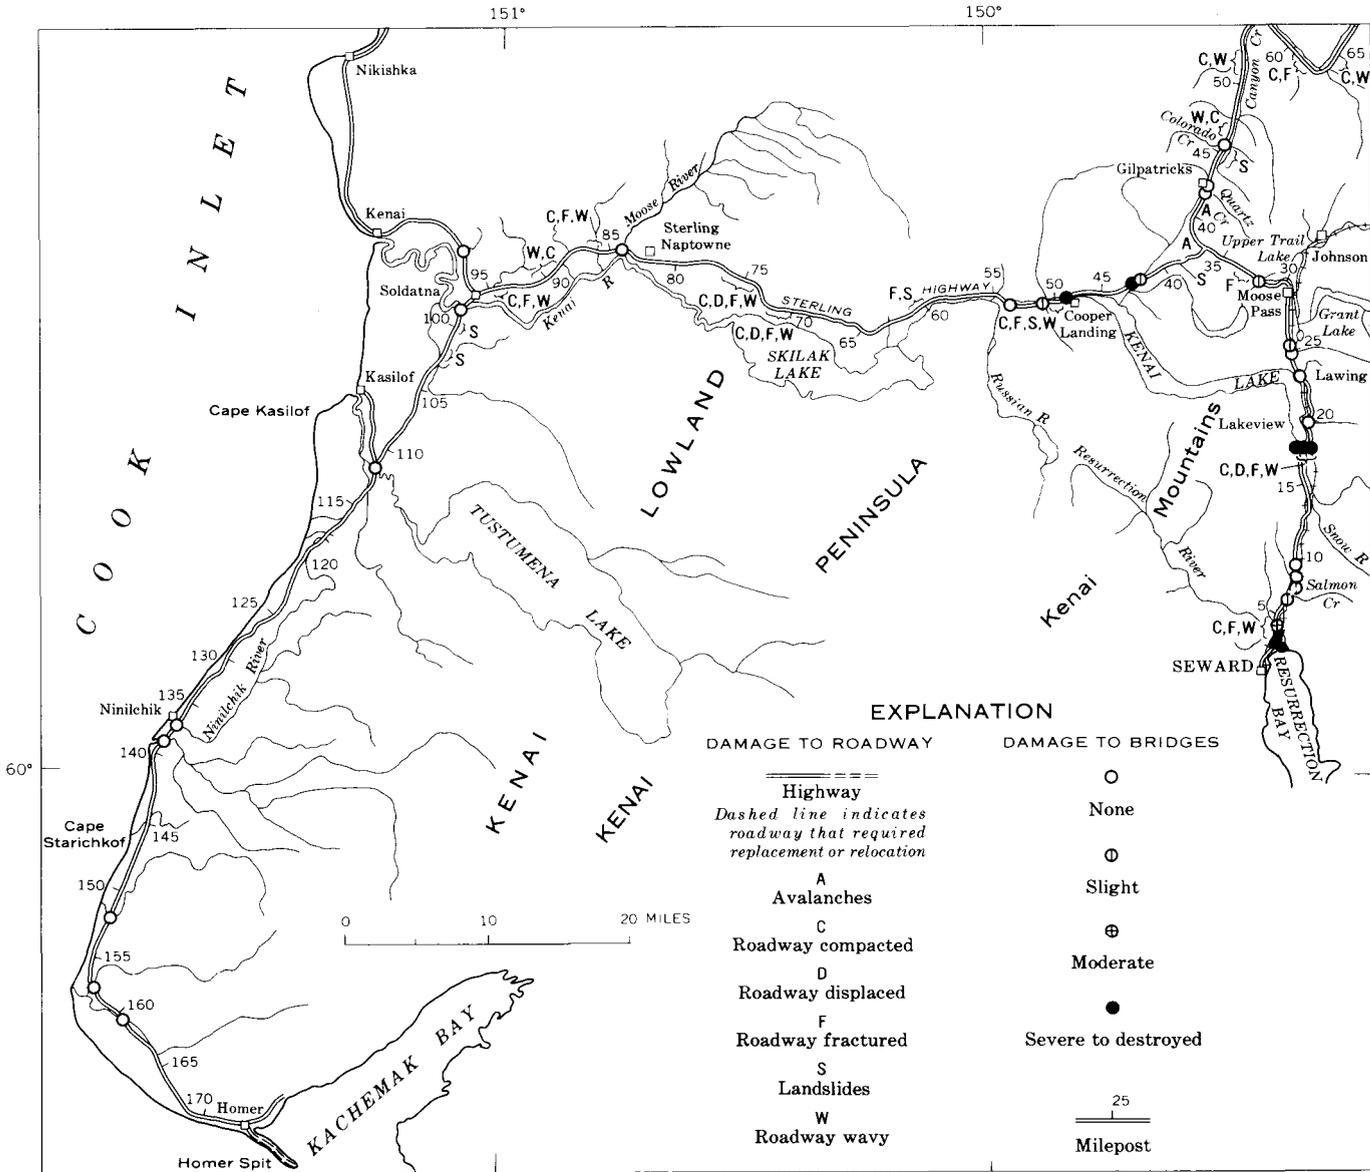
2.—Routes of Sterling Highway and part of Seward-Anchorage Highway, and effects of the earthquake upon the highways.

The most severe damage to roadways occurred at Snow River Crossing (fig. 2) and from mile 75.1 to about mile 90 (fig. 3) on the Seward-Anchorage Highway, on the Copper River Highway (fig. 6), and from mile 1 to mile 5 on the Richardson Highway (fig. 5). The Snow River Crossing is underlain by nonplastic silt and sand (fig. 8; table 7, p. C55). Here the groundwater table is generally within 1 foot of the surface. The Turnagain Arm section of the Seward - Anchorage Highway (mile 75.1 to mile 90) is primarily underlain by silt and sand with minor amounts of gravel (fig. 9). The sediments are nonplastic (tables 8, 9, p. C55, C56). Although not indicated on the graphic logs of the test holes, the water table lies generally within 3 feet of the surface; in the vicinity of the town of Portage the

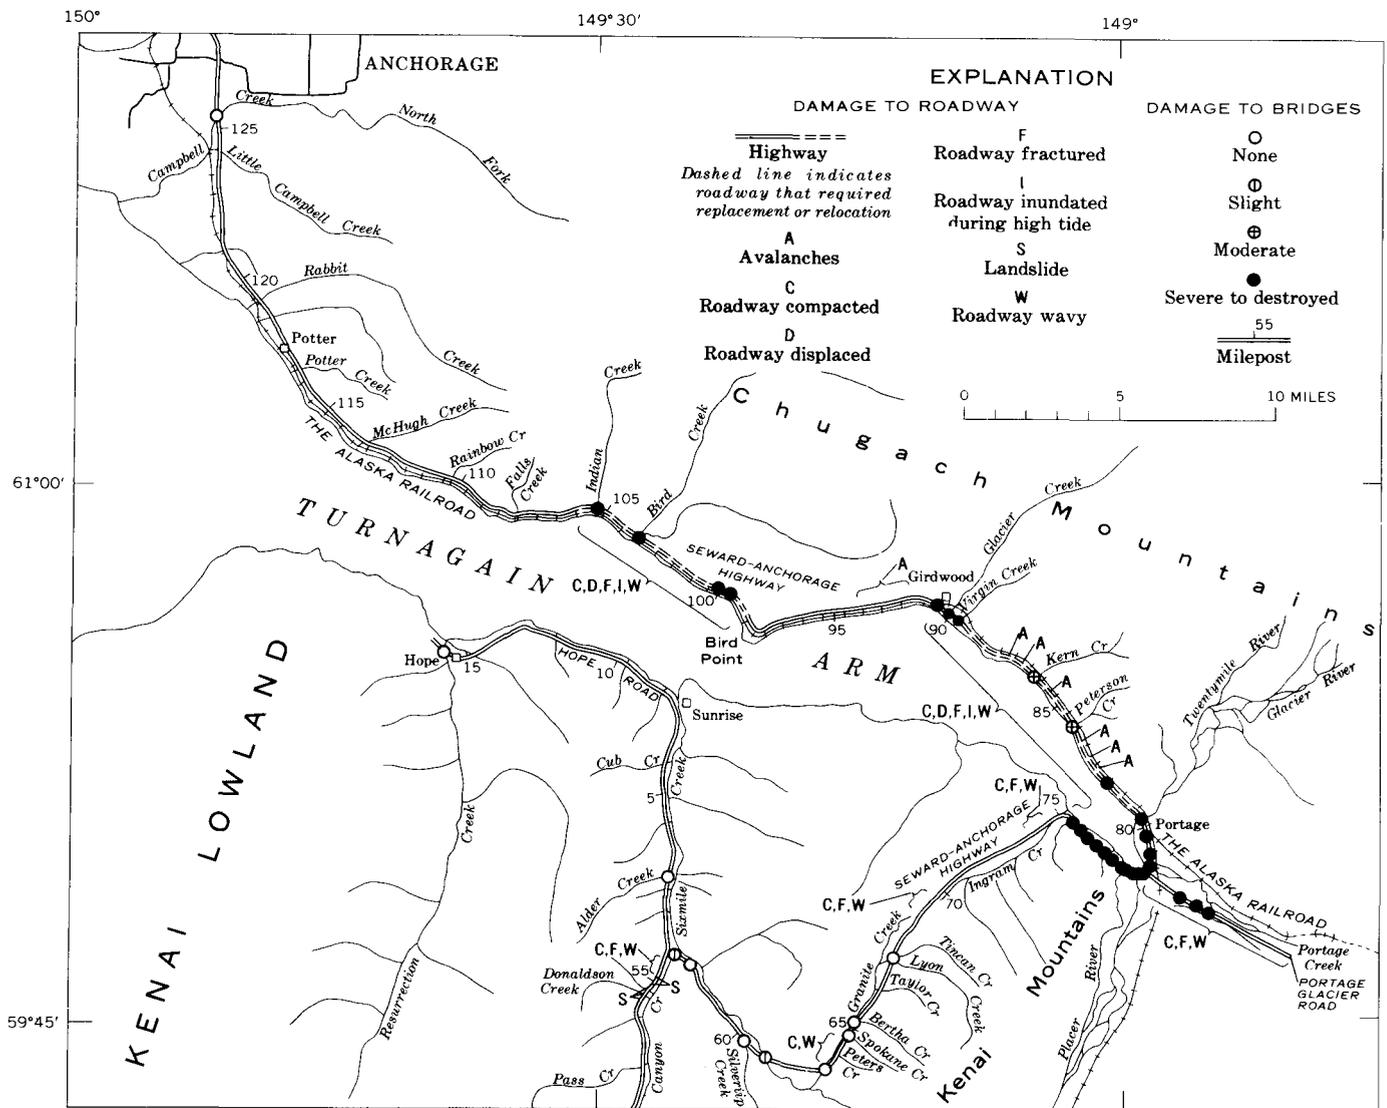
3.—Routes of part of Seward-Anchorage Highway, the Hope Road, the Portage Glacier Road, and effects of the earthquake upon the highways.

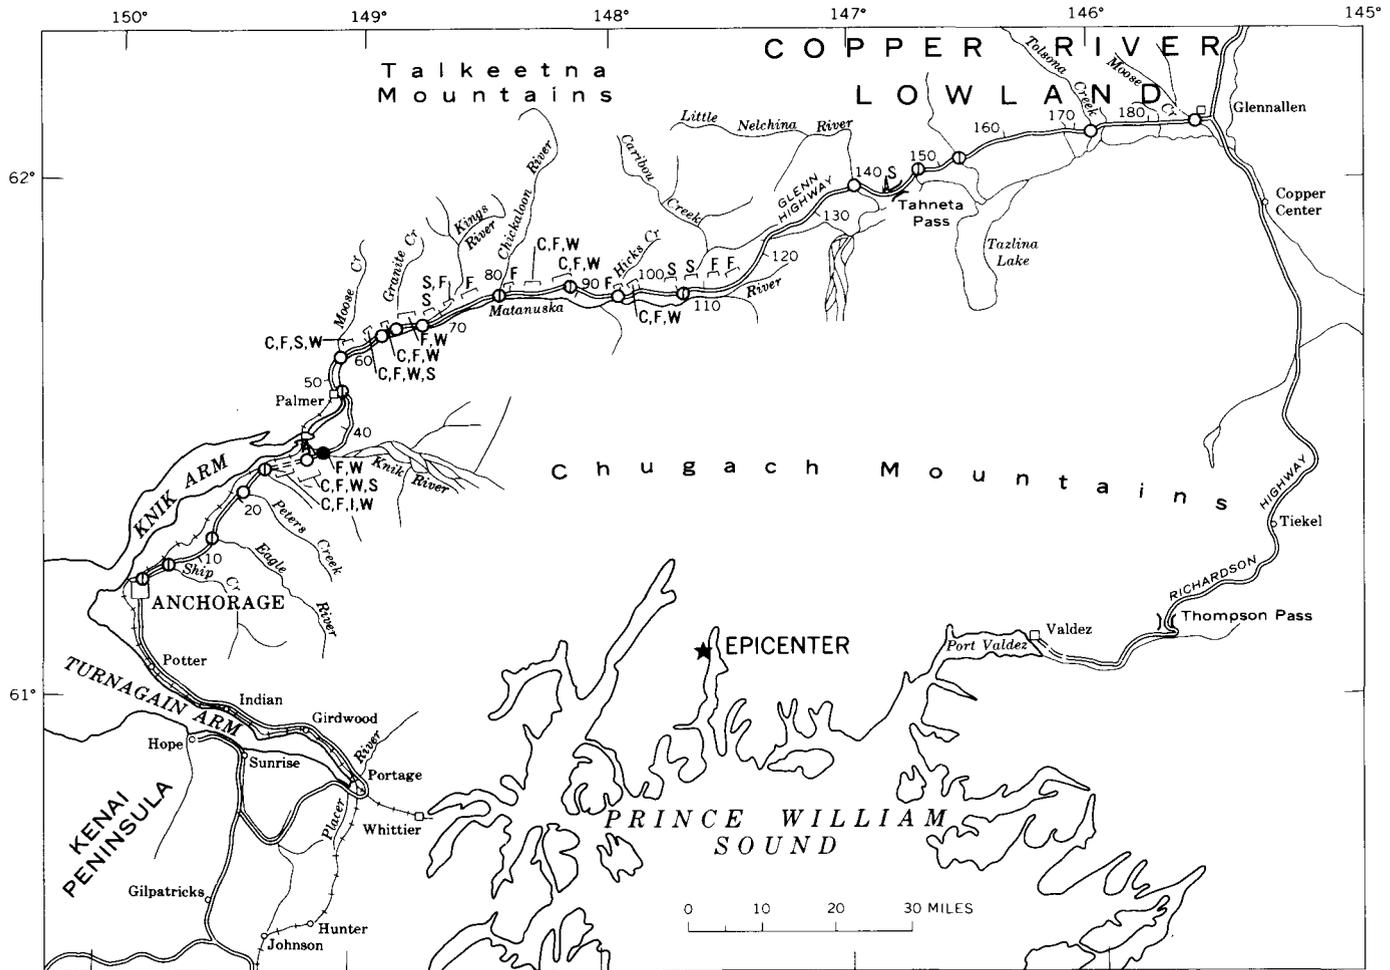
4.—Route of Glenn Highway and effects of the earthquake upon the highway.

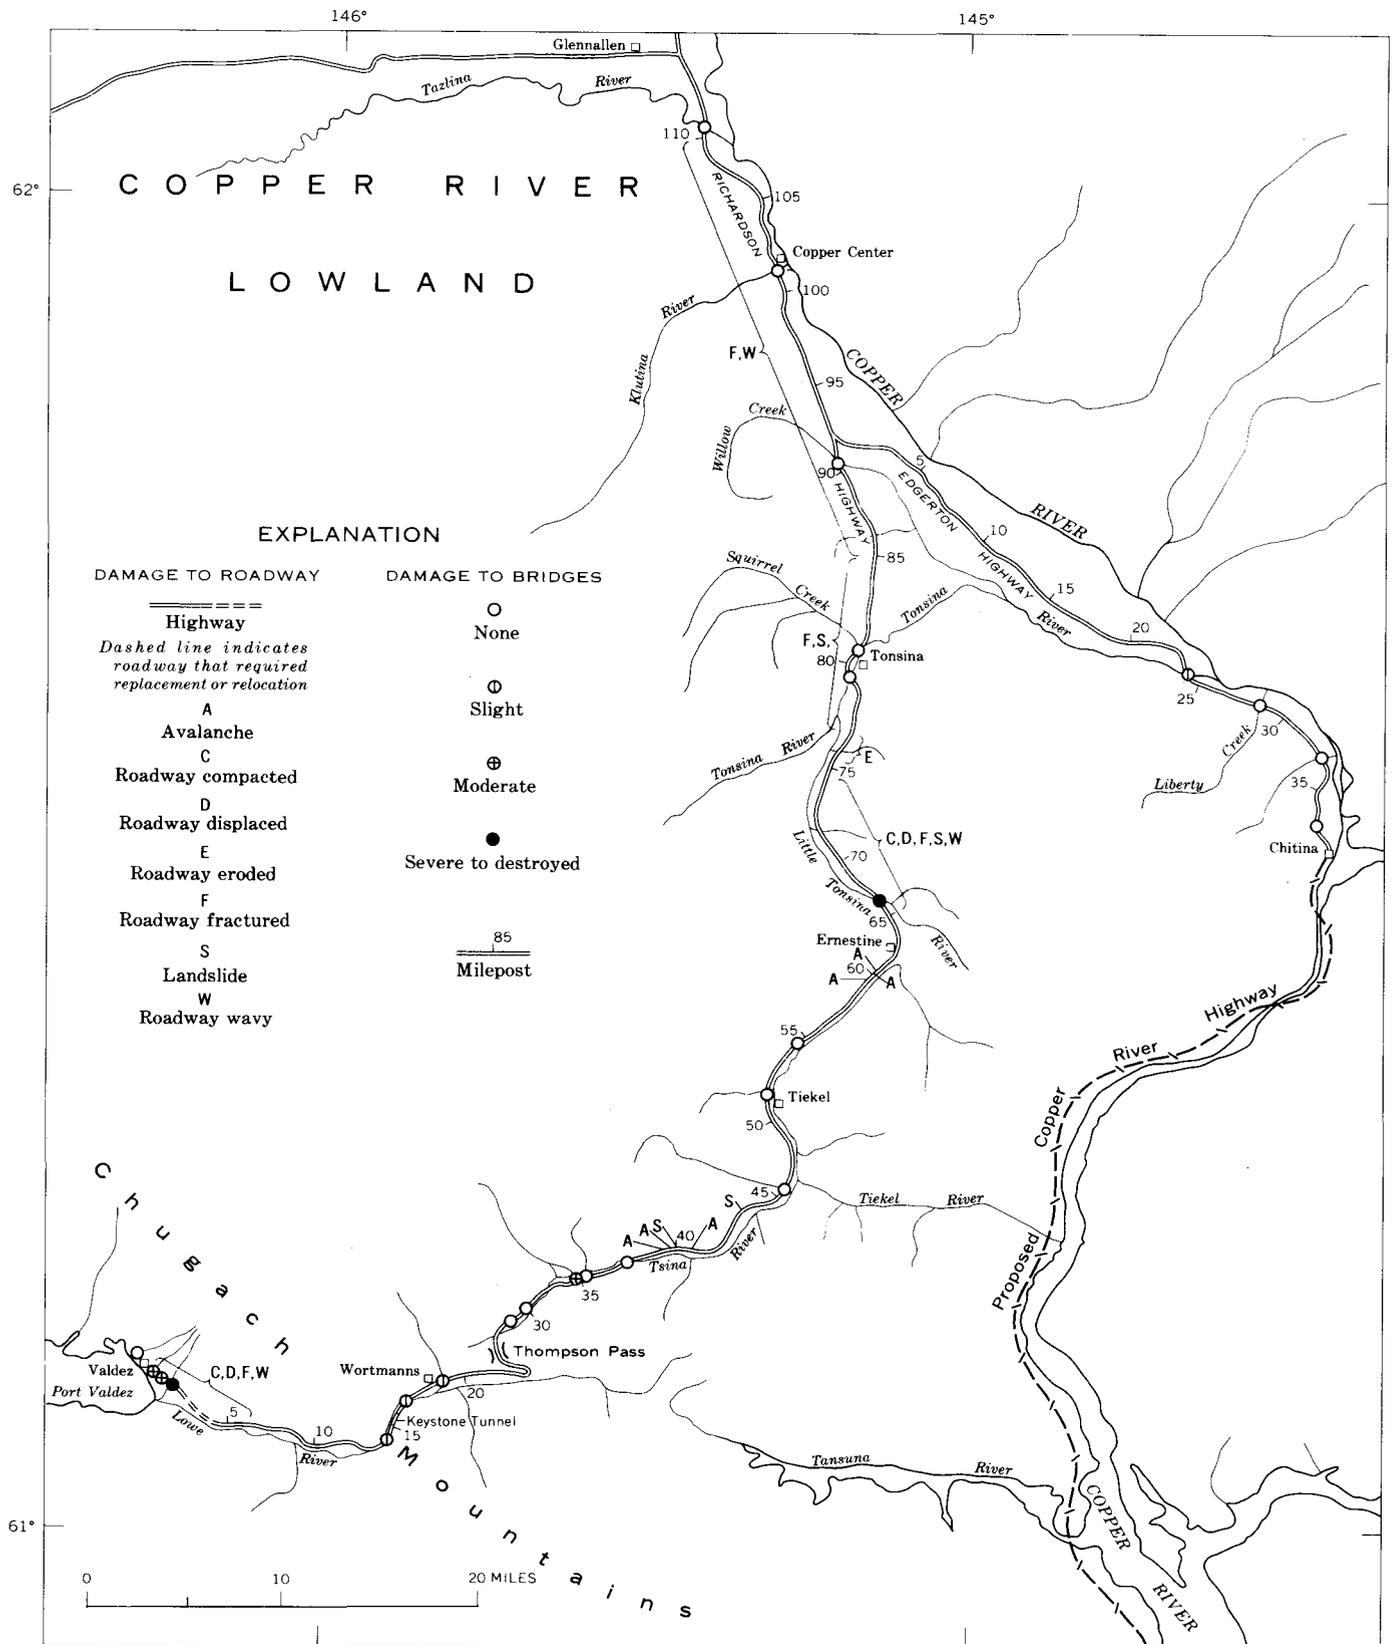
5.—Routes of the Edgerton Highway and part of the Richardson Highway, and effects of the earthquake on the highways.

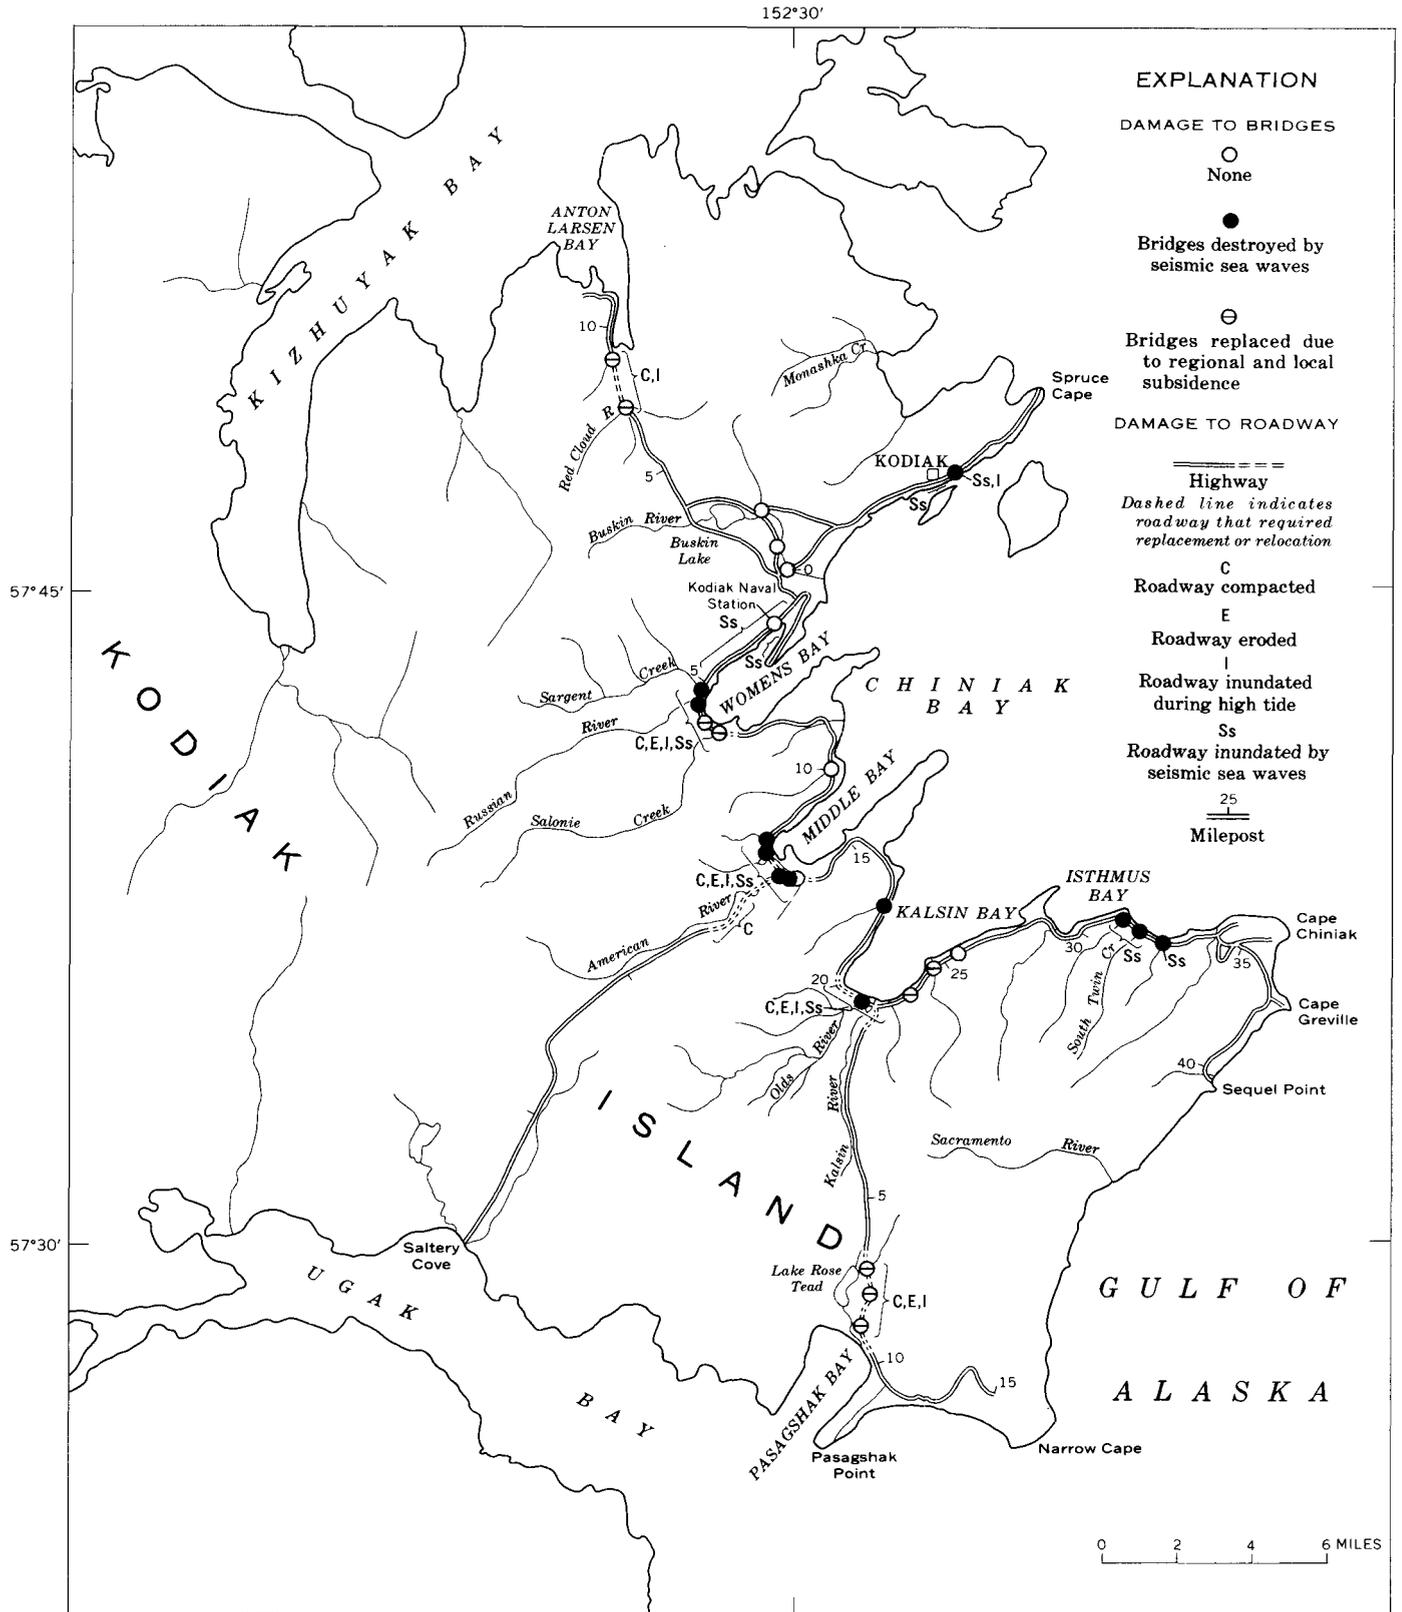
7.—Highway routes on Kodiak Island and effects of the earthquake upon the highways.

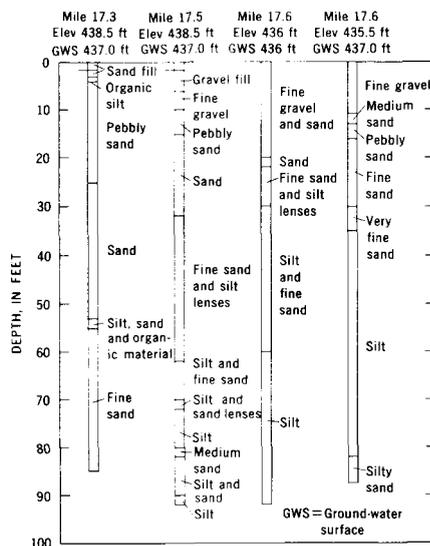
8.—Graphic logs of test holes at Snow River Crossing on Seward-Anchorage Highway. Logged by Alaska Department of Highways.

The Snow River Crossing is underlain by fine sand and silt, covered with a thin veneer of fine gravel (fig. 8). The water table is in many cases at or within a foot of the surface. The fine-grained saturated sediments had very little strength, and, when the seismic shaking struck the area, the sediments failed primarily by liquefaction and lateral spreading or displacement.

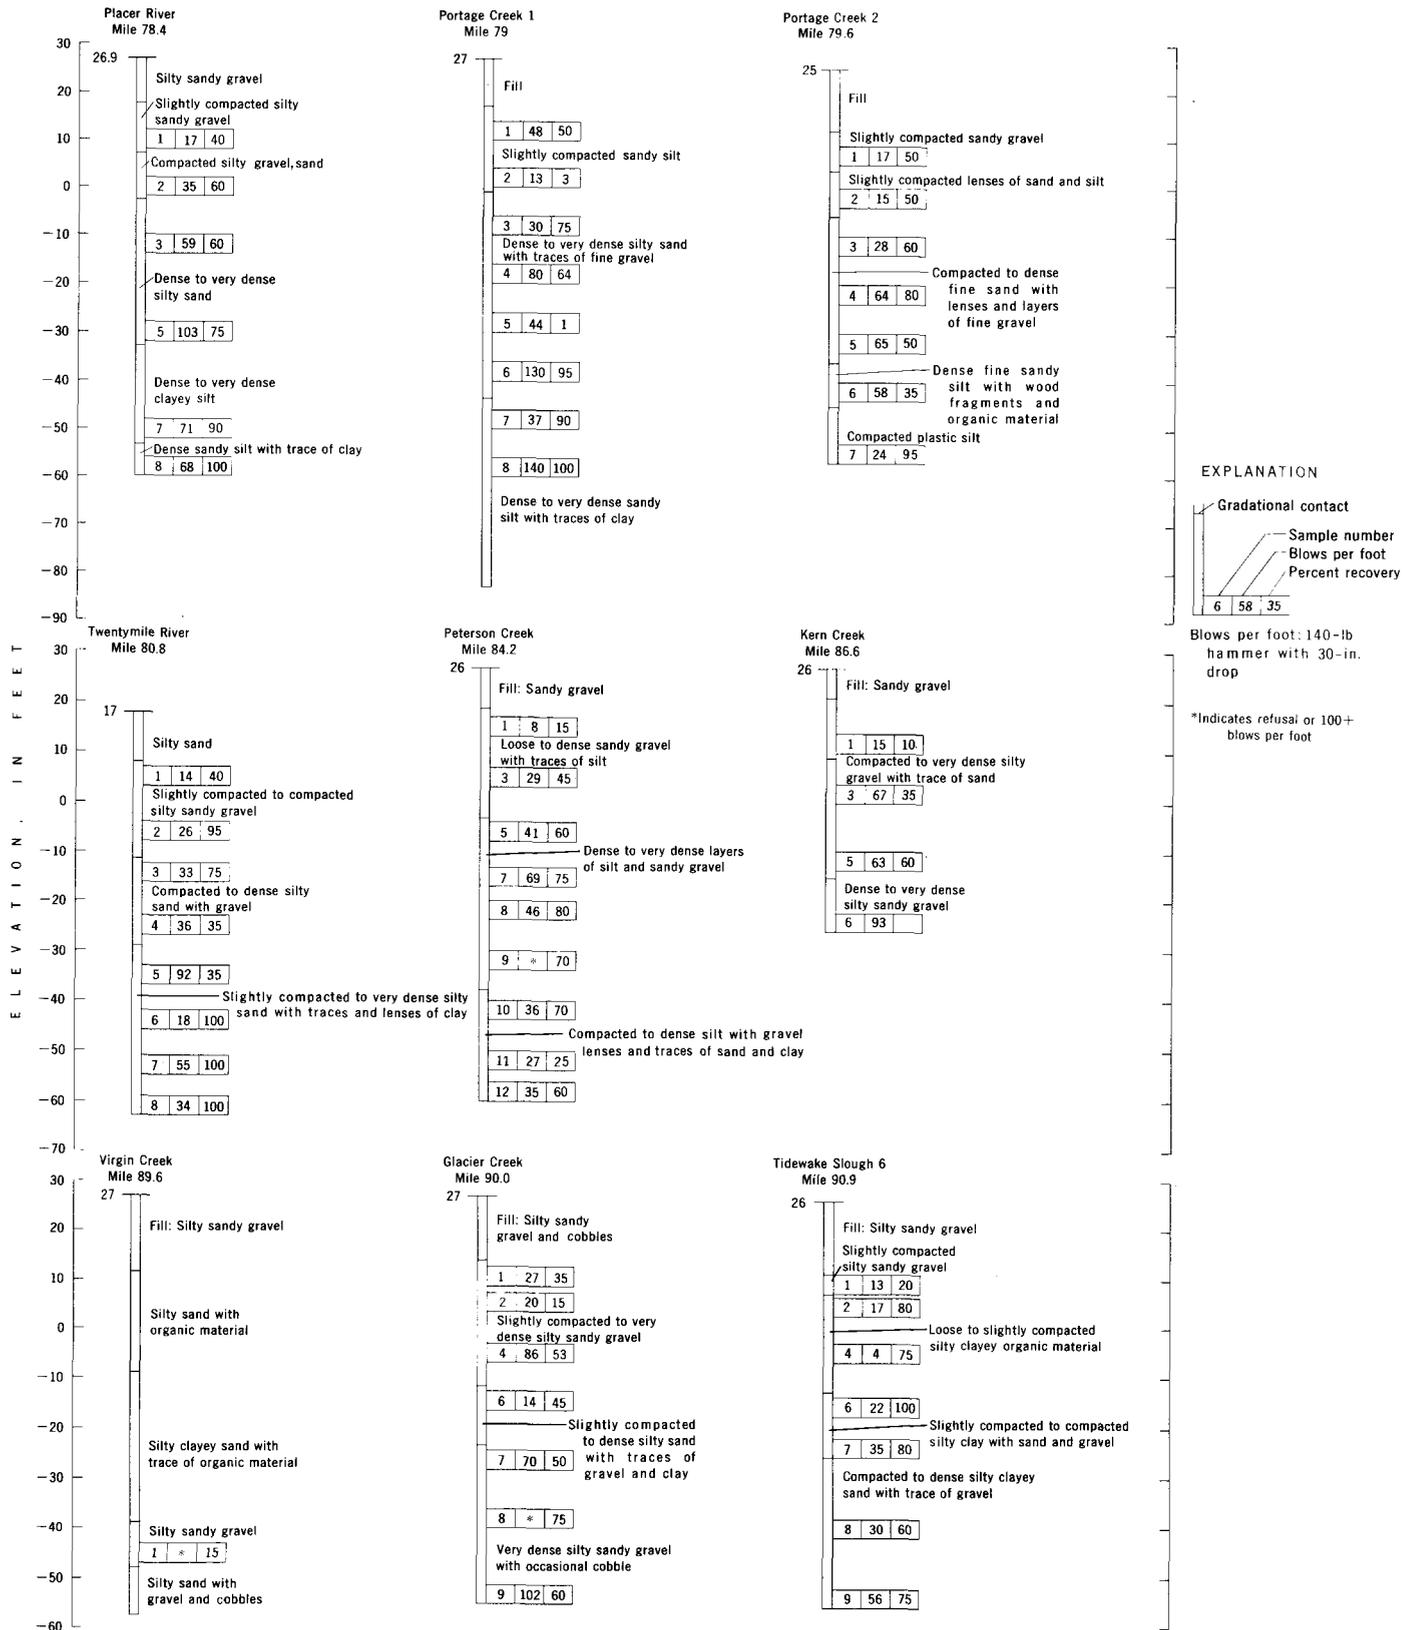
9.—Graphic logs of test holes at miles 78.4, 79.0, 79.6, 80.8, 84.2, 86.6, 89.6, 90.0, and 90.9, Seward-Anchorage Highway.

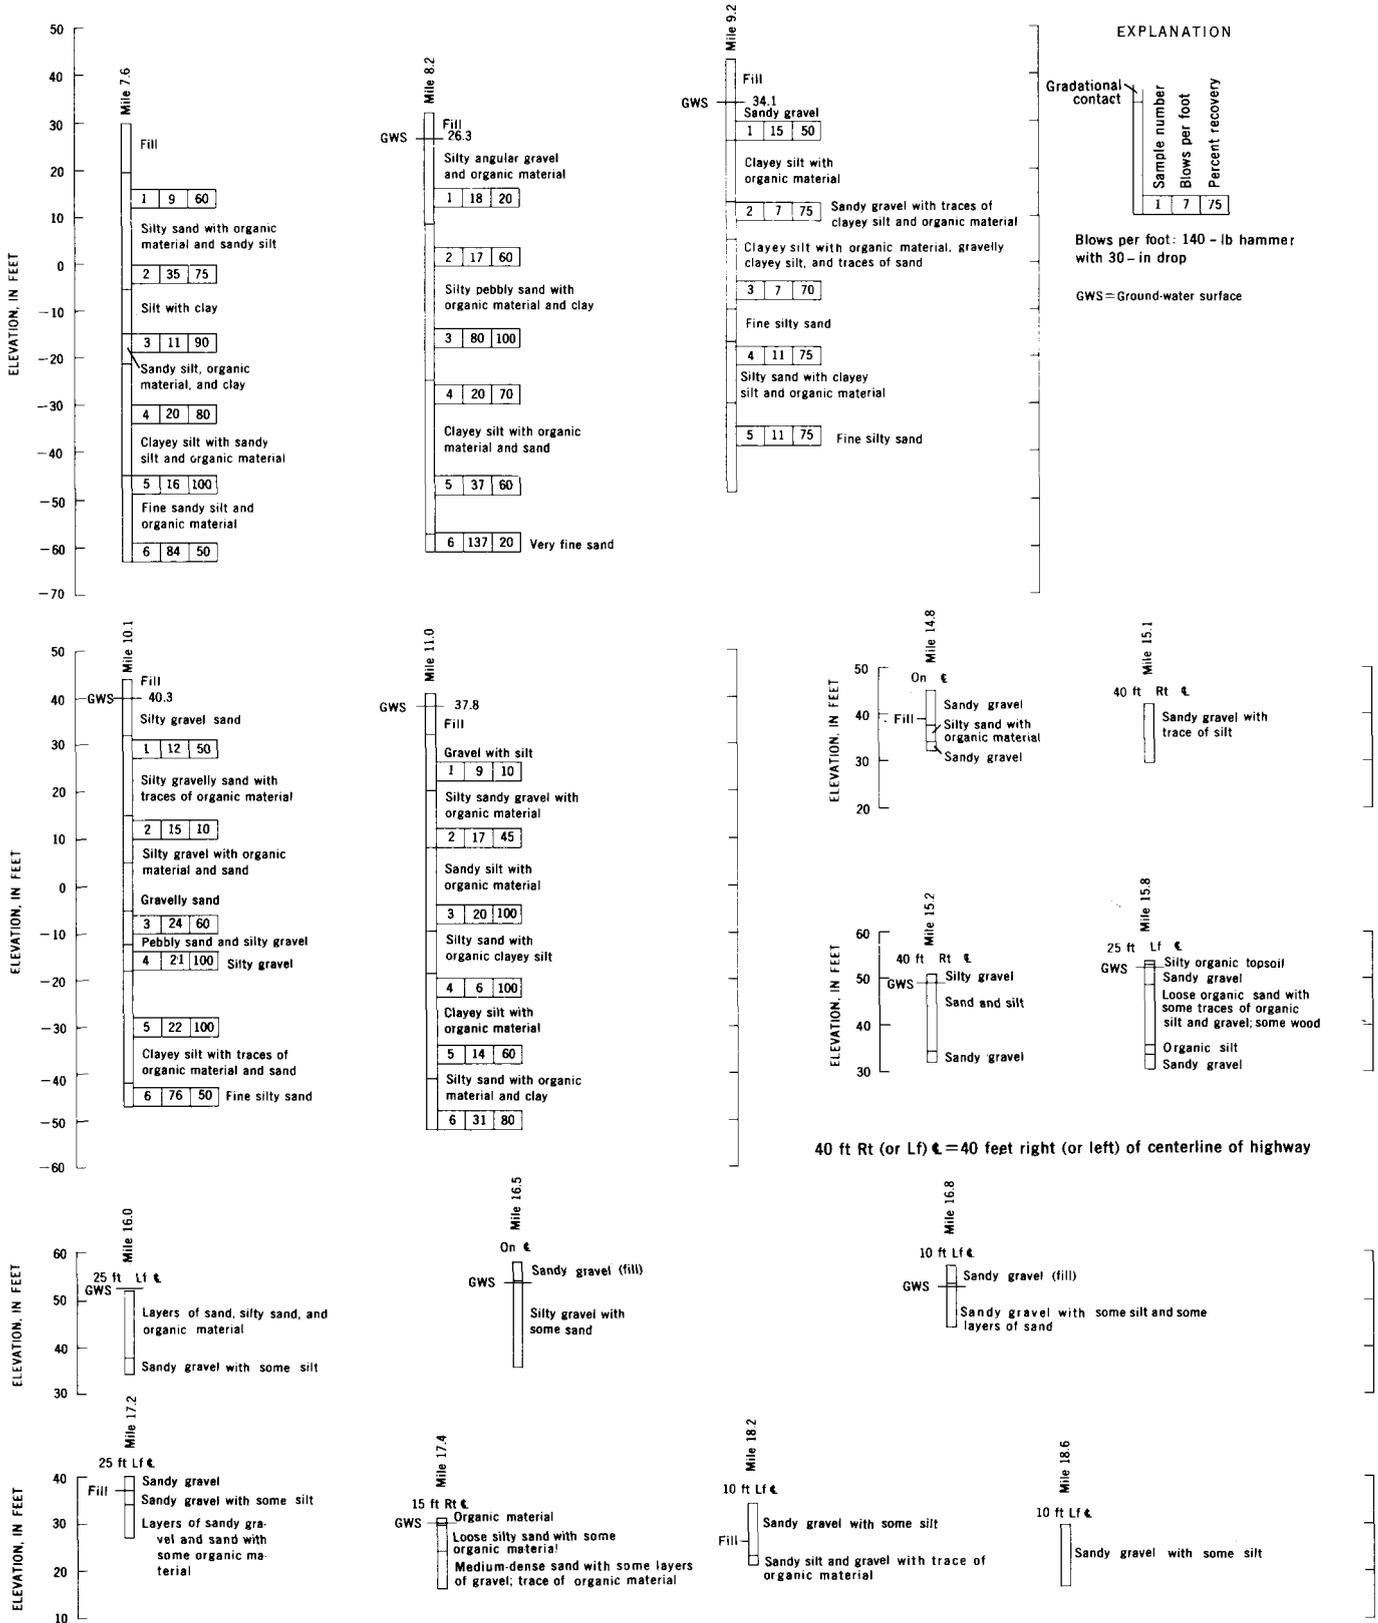
The Copper River Highway is also underlain by nonplastic sediments consisting primarily of silt, sand, and sandy gravel (fig. 10; table 10, p. C56). The water table lies within 6 feet of the surface between mile 5 and mile 18 and locally is within 1 foot of the surface. Within a few feet of the surface, much of the underlying sediments contain organic material. This material leaves much to be desired as road foundation because it will compact when fill is placed upon it or will subside or compact differentially when subjected to seismic shaking.

10.—Graphic logs of test holes at miles 7.6, 8.2, 9.2, 10.1, 11.0, 14.8, 15.1, 15.2, 15.8, 16.0, 16.5, 16.8, 17.2, 17.4, 18.2, and 18.6, Copper River Highway.

Pre- and postearthquake profiles for the Copper River Highway are only available from mile 5.9 to mile 13. In this stretch of the highway a maximum local subsidence of 48 inches occurred at about mile 7.6. Here the roadway is underlain by clay, silt, sand, and organic debris (fig. 10). At mile 10.1, where the roadway is underlain by silty gravelly sand and silty

gravel, it did not subside. There was about 18 inches of subsidence at mile 11.0 where the highway is underlain chiefly by silty sandy gravel, sandy silt, and silty sand (all containing organic material; fig. 10); the water table there is about 2 feet from the surface.

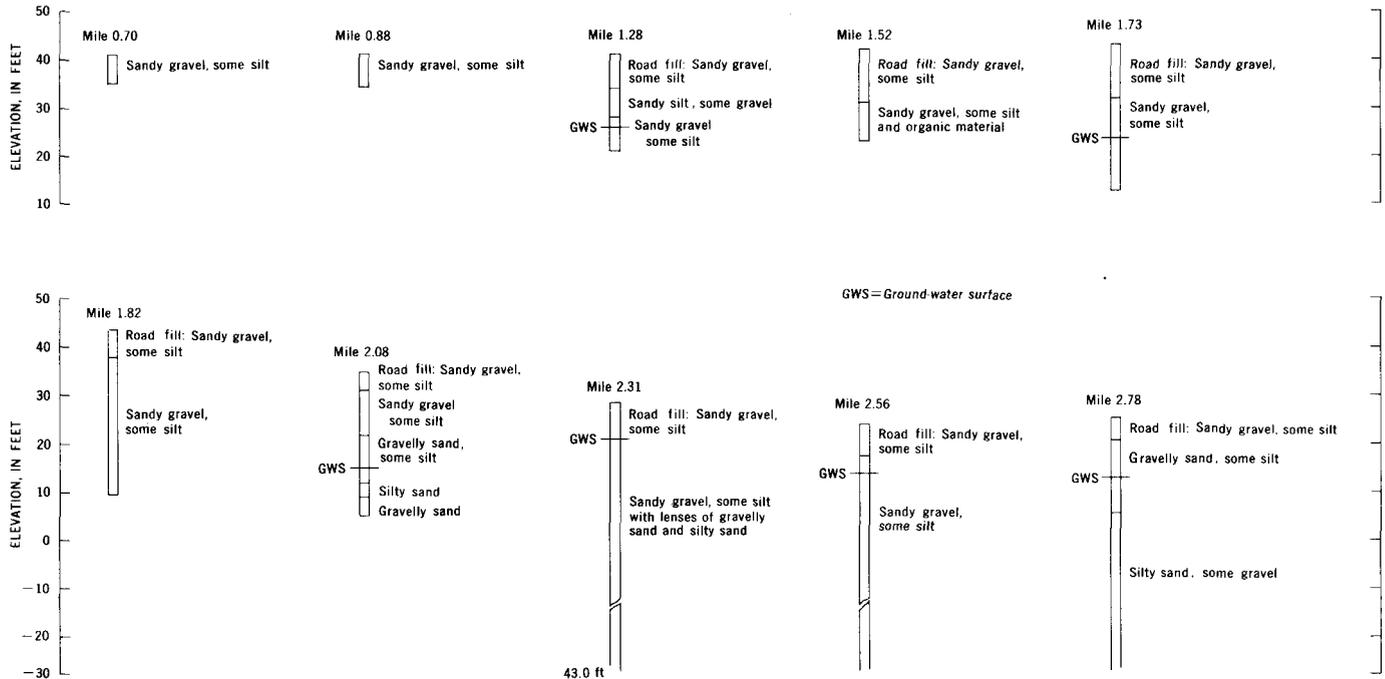
The Richardson Highway roadway was most severely damaged on nonplastic glacial outwash sediments consisting of sandy gravel and minor amounts of silt (fig. 11; table 11, p. C56). The water table lies within 10 feet of the ground upon which the road fill was first placed. At mile 2.1 the water table is within 1 foot of the surface, at mile 2.56 within 3 feet of the surface.

11.—Graphic logs of test holes at miles 0.70, 0.82, 1.28, 1.52, 1.73, 1.82, 2.08, 2.56, and 2.73, Richardson Highway. Analysis by Alaska Department of Highways.

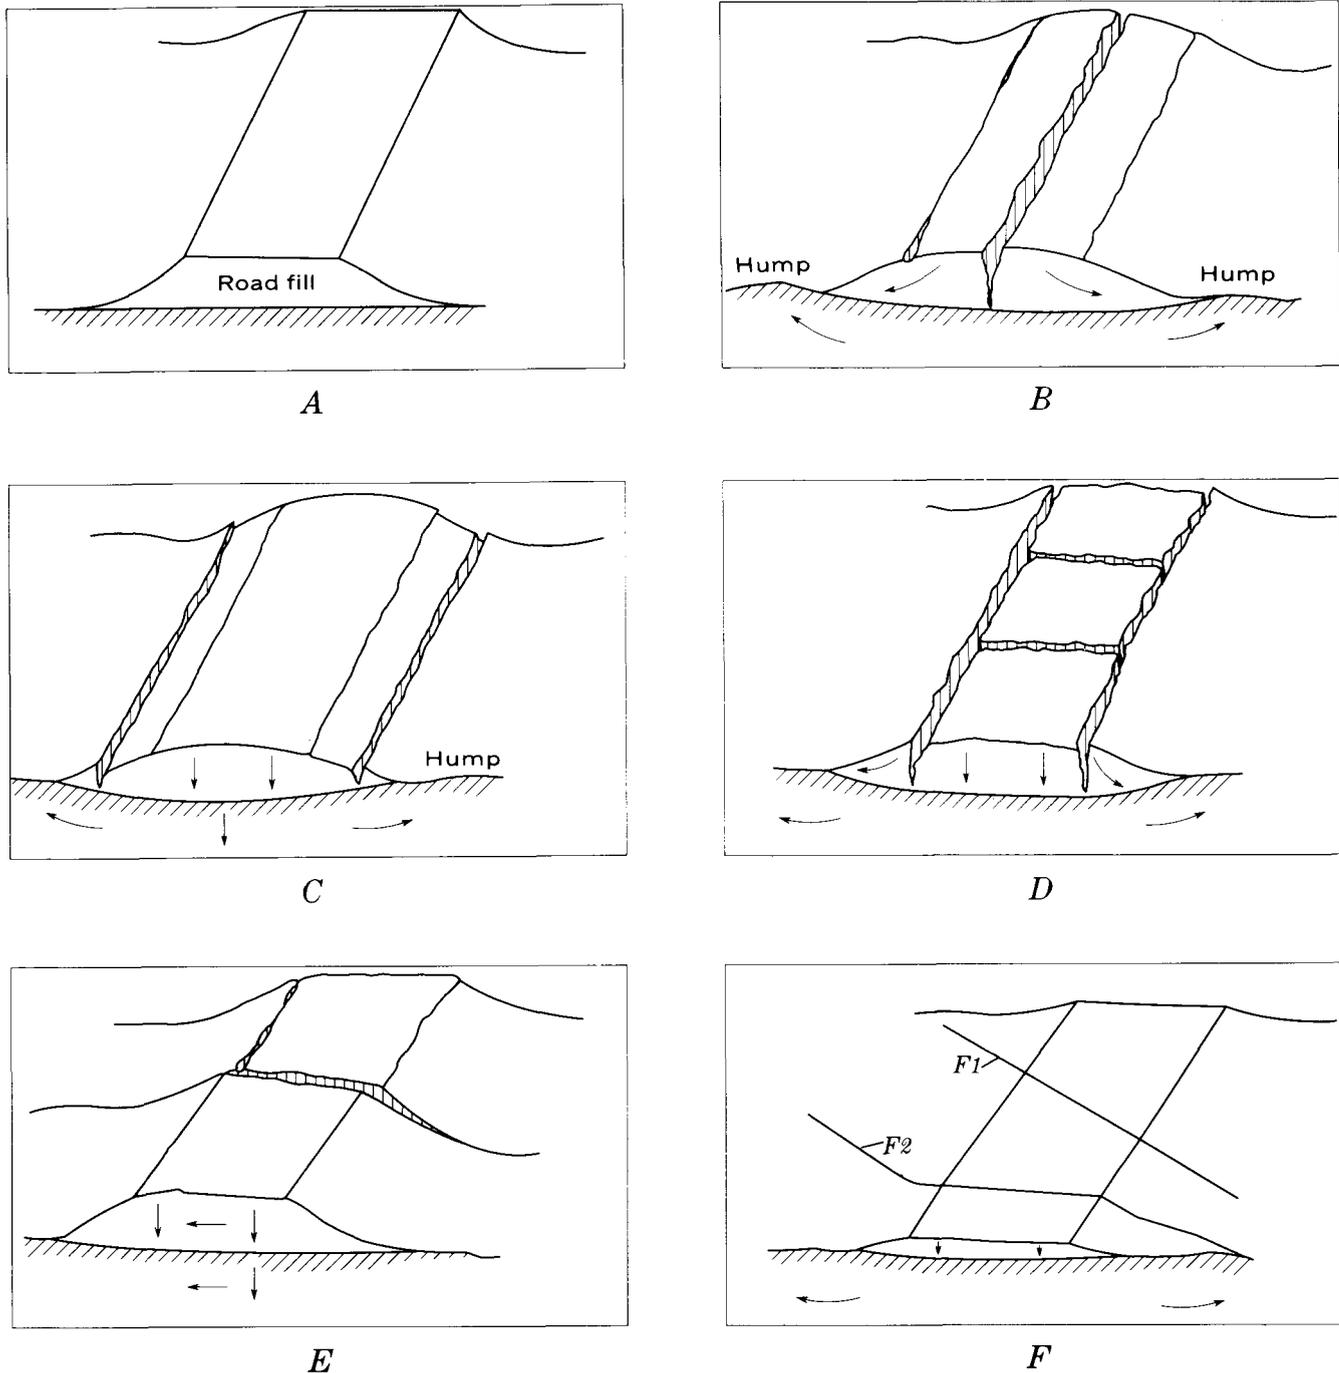
The most conspicuous fractures observed were those normal to the axis of the roadway (figs. 12E, 13); they were extensive along the Seward-Anchorage Highway and on the Richardson, Sterling, and Glenn Highways, particularly in paved sections. These fractures, plus the oblique type shown on figure 12F(2), represent about 90

12.—Schematic drawing of types of fracture generated by earthquake in roadways. *A*, Preearthquake. *B*, Underlying sediments compact and displace laterally. Roadway settles differentially and is moved laterally by underlying sediments; roadway fractures along centerline and is wavy; hump is formed off roadway. *C*, Underlying sediments compact and move laterally; roadway settles and longitudinal fractures develop along edges; roadway also wavy. *D*, Longitudinal fractures form as in *C*; as underlying sediments continue to compact and displace laterally, roadway settles differentially and transverse fractures develop. *E*, Fracture forms owing to horizontal displacement of roadway and underlying sediments; fracture generally originates off roadway. *F*, Fracture forms in original ground oblique to roadway; as it strikes roadway, it either continues at oblique angle (*F1*) or is refracted normal to roadway and, when past roadway, becomes oblique again (*F2*); these fractures occur chiefly in small roadway fills.

Fractures along the centerline of the highway (fig. 12*B*) formed near Portage on the Seward-Anchorage Highway (fig. 13) and on the unpaved Copper River Highway, especially from mile 40 to the Million Dollar bridge (fig. 14). This type of fracture occurred (1) where a relatively thick roadway fill was underlain by fine-grained saturated sediments in swamp deposits, and (2) where the roadway was underlain by fine-grained silty sand and gravel and the water table was within 2 feet of the surface. Most of the axes of the fractures on the centerline of the highway were normal or nearly normal to the direction of seismic

Fractures normal to the roadway are due to shear and tension (fig. 12*E*). The fractures due to shear first form in the ground because of mass displacement of the underlying sediments toward a

Failures along the centerline of the highway fill are due to tension (fig. 12*B*). As the roadway and underlying sediments are subjected to seismic shaking, the denser roadway subsides into the

Fractures along the edges and parallel to the roadway (fig. 12*C*,

D) are caused by compaction of the underlying sediments and lateral spreading of the ground. As seen in figure 12*C* the roadway, although wavy from differential compaction, has maintained its integrity. As the roadway is subsiding differentially, it is also being displaced along the axis owing to displacement of the underlying sediment. Thus, normal and longitudinal fractures are due to tension and are confined to the road fill.

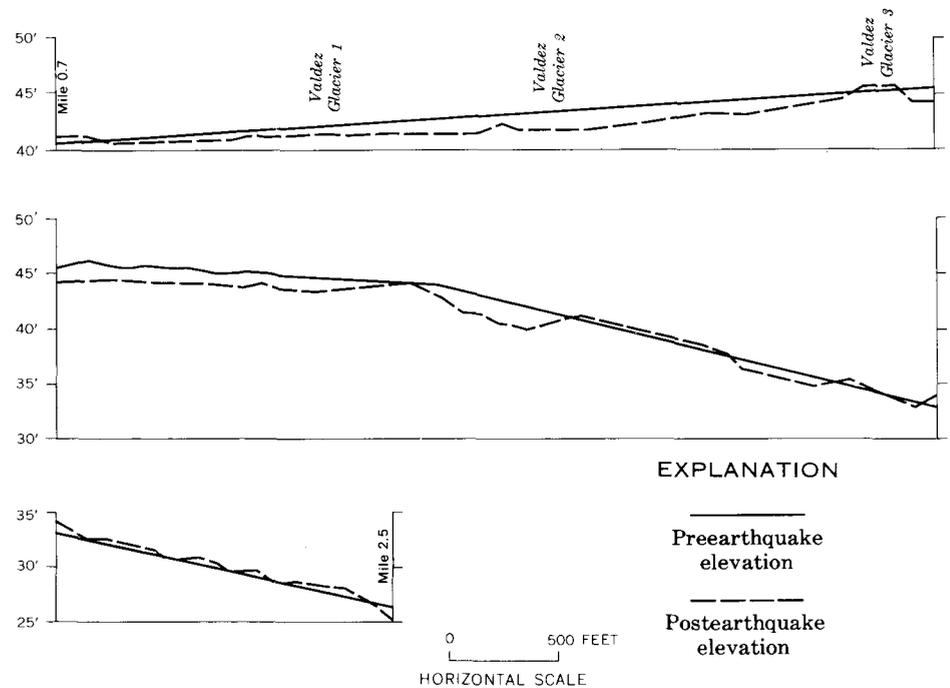
The most spectacular local subsidence occurred (1) on the Richardson Highway between mile 0.0 and mile 5.0, (2) on the Copper River Highway near mile 28.0, and (3) on the Seward-Anchorage Highway at Snow River Crossing and from mile 75.1 to mile 91.0. Figure 17 shows pre- and post-earthquake profiles from mile 0.7 to mile 2.5 of the Richardson Highway; figure 18, pre- and post-earthquake profiles from mile 5.9 to mile 11.0 of the Copper River Highway; figure 19, pre- and post-earthquake profiles from mile 75.1 to mile 85.0 of the Seward-Anchorage Highway; and figure 20, pre- and postearthquake profiles and pier elevations at the Snow River Crossing of the Seward-Anchorage Highway.

None of the postearthquake profiles indicate tectonic subsidence or uplift; they represent only subsidence of the roadway due to compaction and lateral displacement of the underlying sediments. A few profiles indicate uplift due to bulldozing of sediments against bridge abutments or to ground waves. Bulldozing occurs when the laterally displaced sediments of the bridge approaches strike the resisting bridge abutments and form a mound of sediments at the contact between the two.

17.—Pre- and postearthquake profiles from mile 0.7 to mile 2.5, Richardson Highway. Data from Alaska Department of Highways.

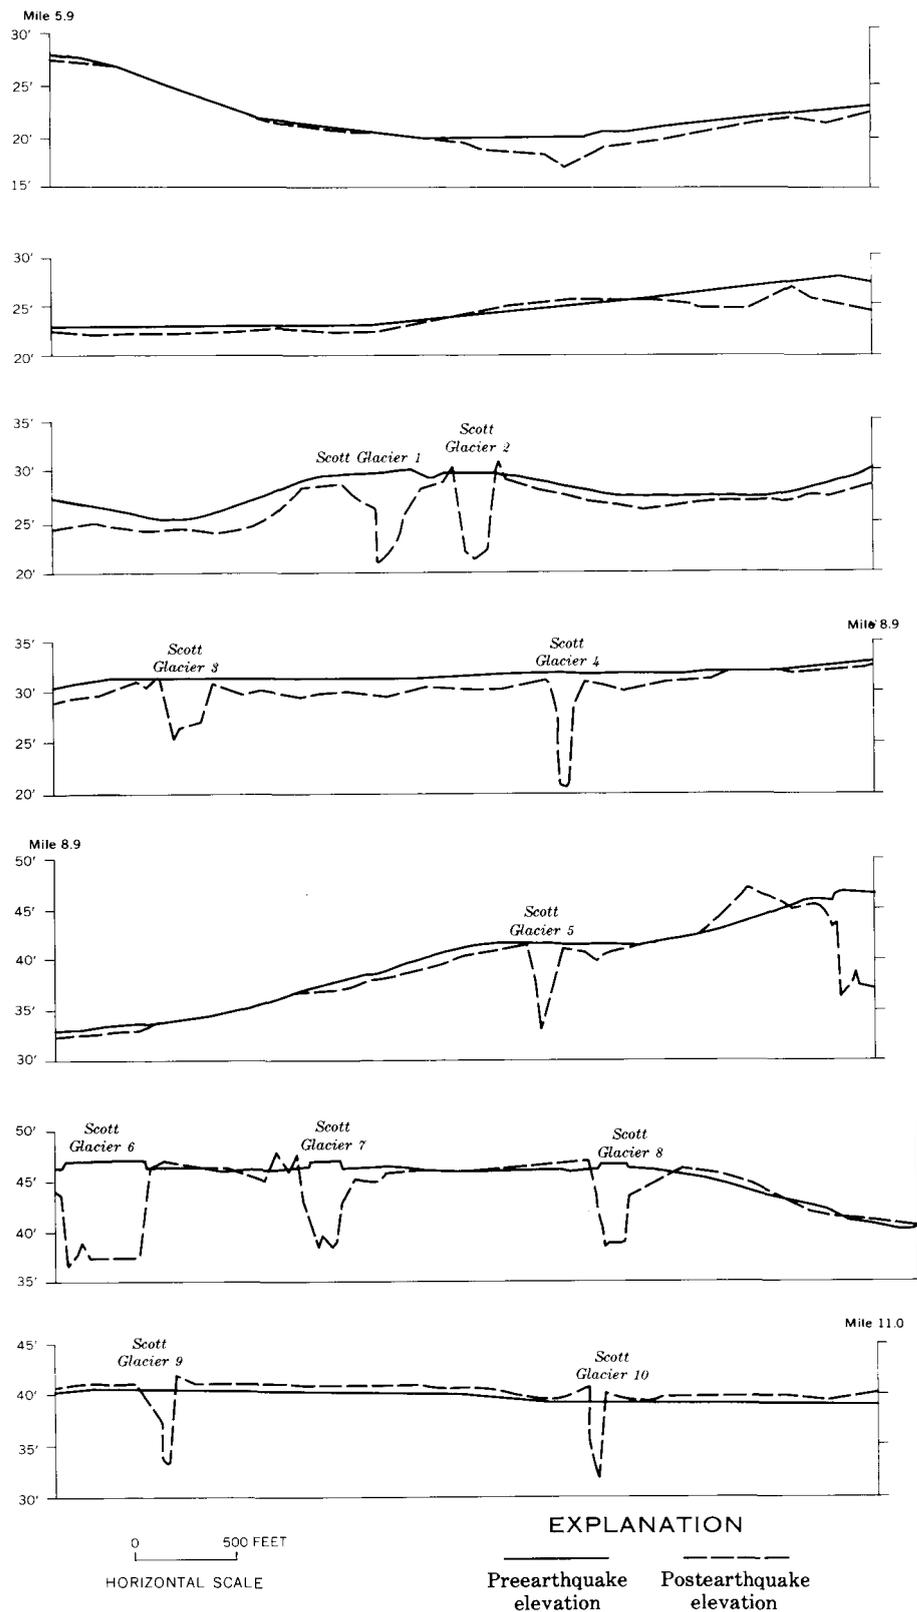
18.—Pre- and postearthquake profiles from mile 5.9 to mile 11.0, Copper River Highway. Data from Alaska Department of Highways.
