THE ALASKA EARTHQUAKE, MARCH 27, 1964:
EFFECTS ON TRANSPORTATION, COMMUNICATIONS, AND UTILITIES

Effects of the Earthquake of March 27, 1964, on the Alaska Highway System

By REUBEN KACHADOORIAN

GEOLOGICAL SURVEY PROFESSIONAL PAPER 545-C

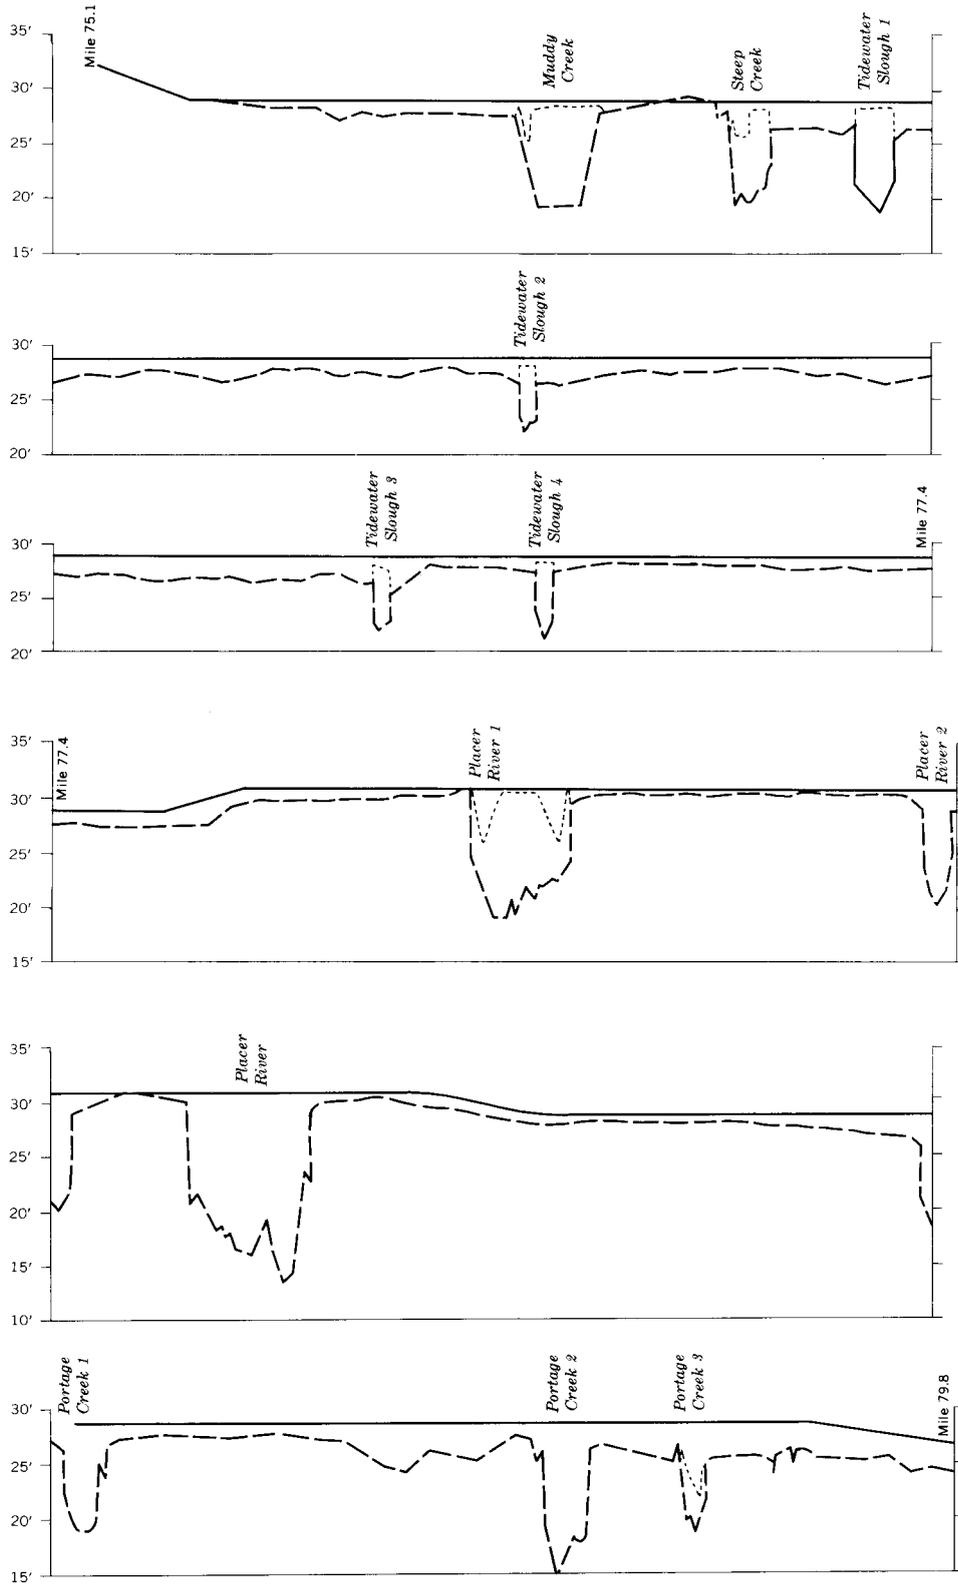
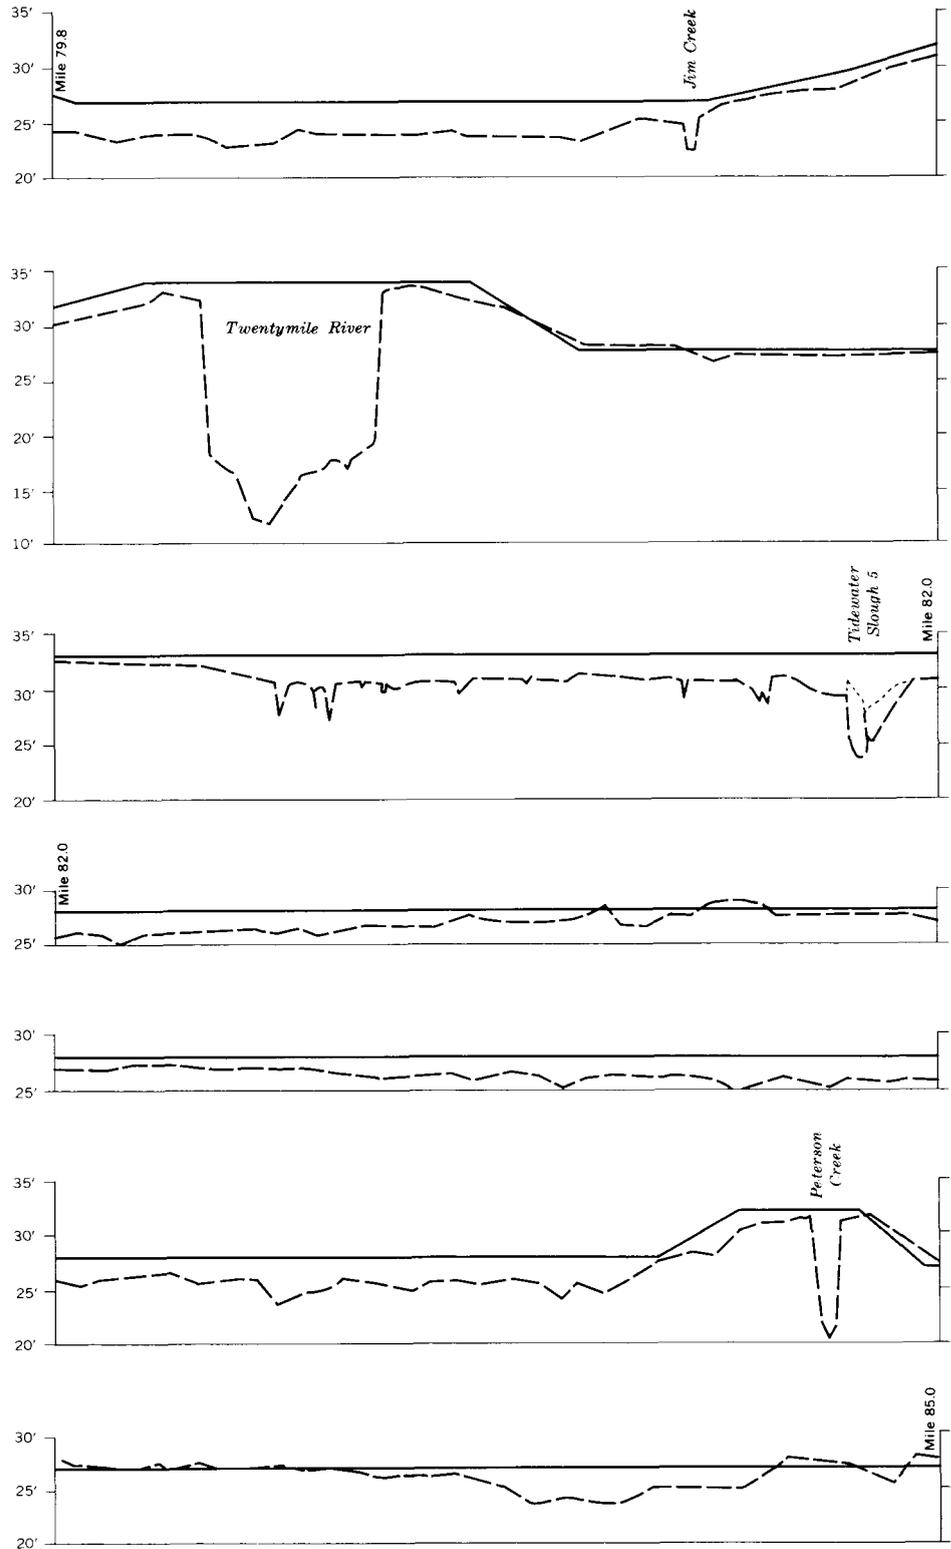
A large amount of local subsidence of the roadway occurred in the Portage area on the Seward-Anchorage Highway. Here a maximum subsidence of 54 inches was measured by the Alaska Department of Highways at mile 79.3 between Portage Creek 1 and

19. (Above and left)—Pre- and postearthquake profiles from mile 75.1 to mile 85.0, Seward-Anchorage Highway. Data from Alaska Department of Highways.

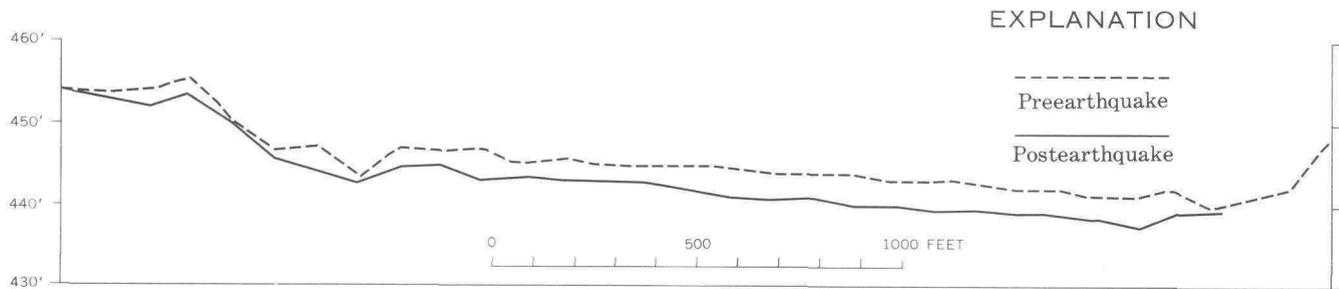
The piers shown on figures 20 and 21, which are part of the new crossing and which subsided as much as 4 feet, rest on 18-inch tubular piles driven to depths of as much as 160 feet. The subsidence of these piers indicates that the underlying sediments either compacted to great depths or that seismic shaking in fine silt liquefied the sediments and allowed the piles to sink. In addition, when the piles at abutment 1 (fig. 20) were pulled, they were found to be distorted and bent by the earthquake below the ground surface.

The roadway fill at the Snow River Crossing prior to the earthquake was from 4 to 7 feet thick. After the earthquake the 4-foot part of the fill had subsided as much as 2 feet beneath the ground surface. The profile in figure 20 indicates that the ground surface subsided about 5 feet. Thus, in places the roadway must have subsided as much as 11 feet, that is, the 4-foot fill subsided 6 feet and

20.—Pre- and postearthquake pier elevations (A) and profiles (B) near mile 17.3 at Snow River Crossing, Seward-Anchorage Highway. Profiles are at east side of Snow River Crossing. Data supplied by Alaska Department of Highways.

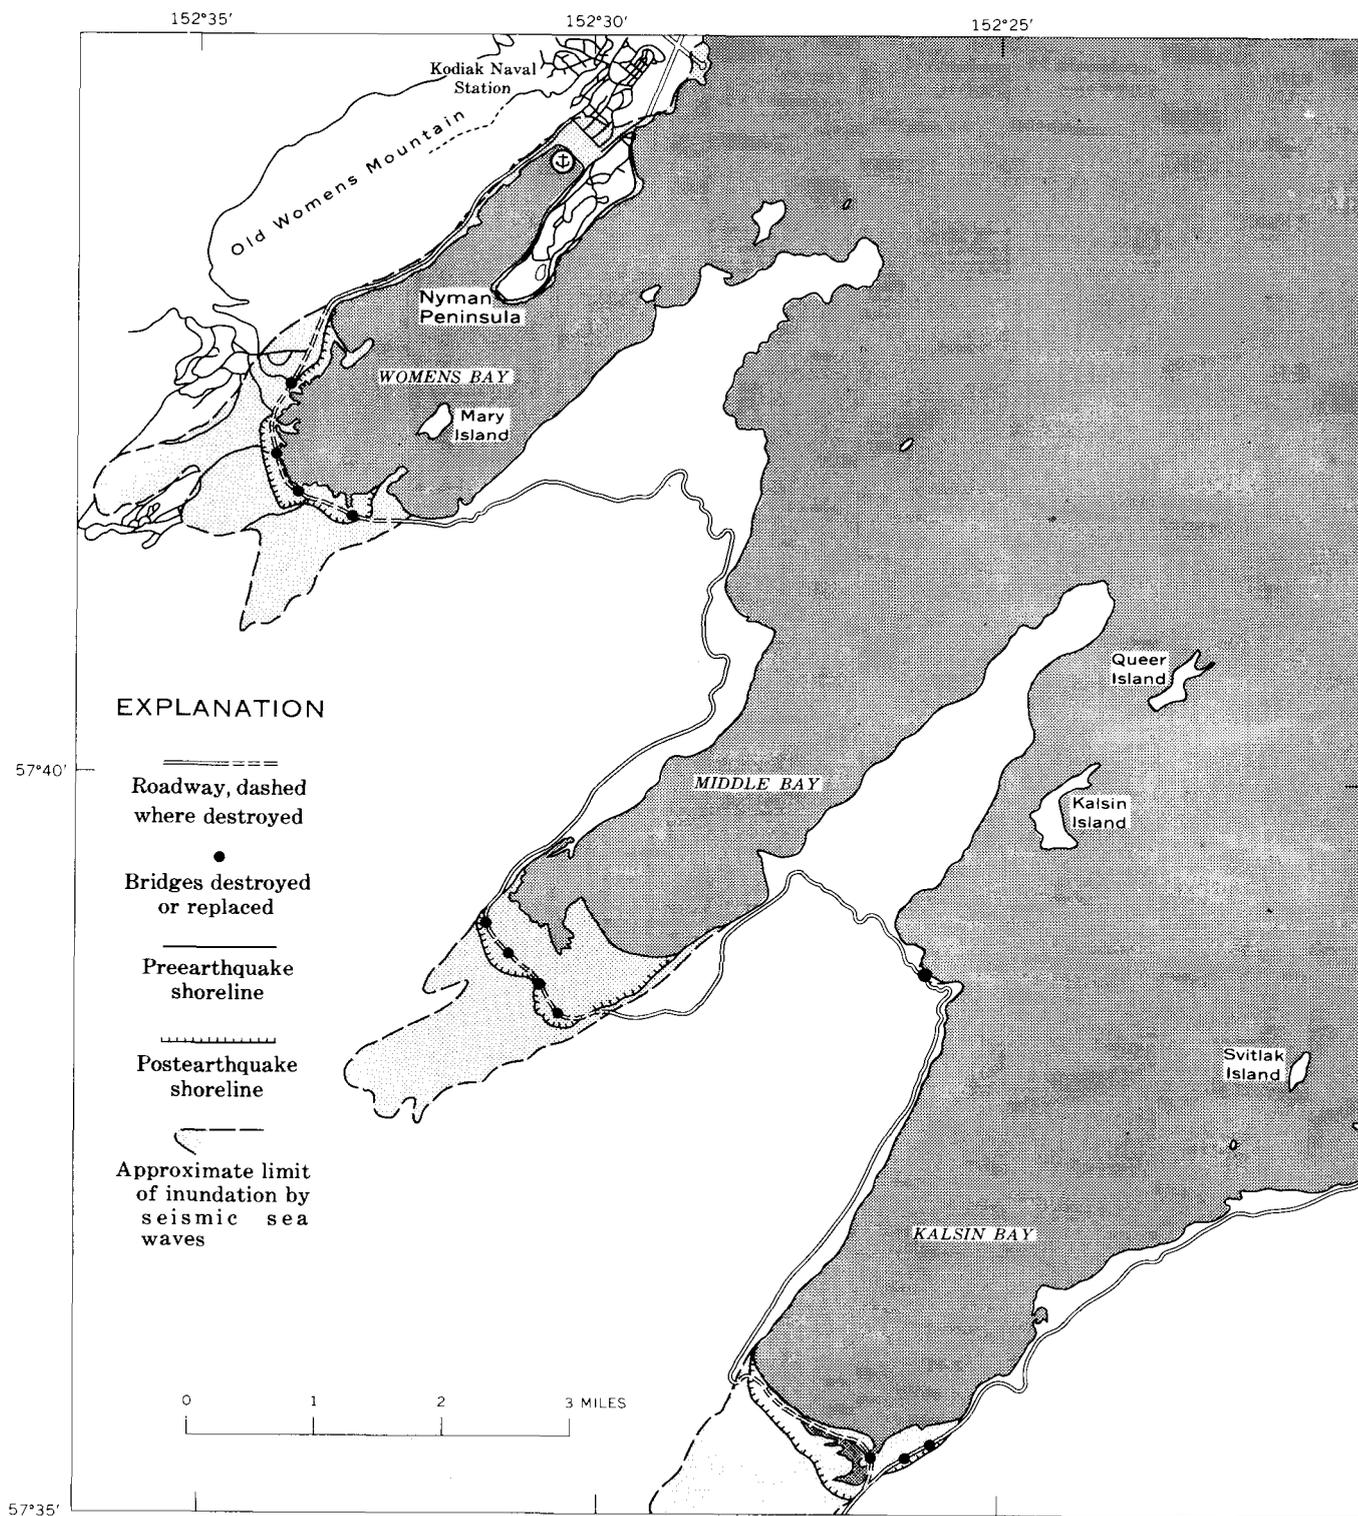
25.—Pre- and postearthquake shorelines and area of inundation by seismic sea waves on Kodiak Island.

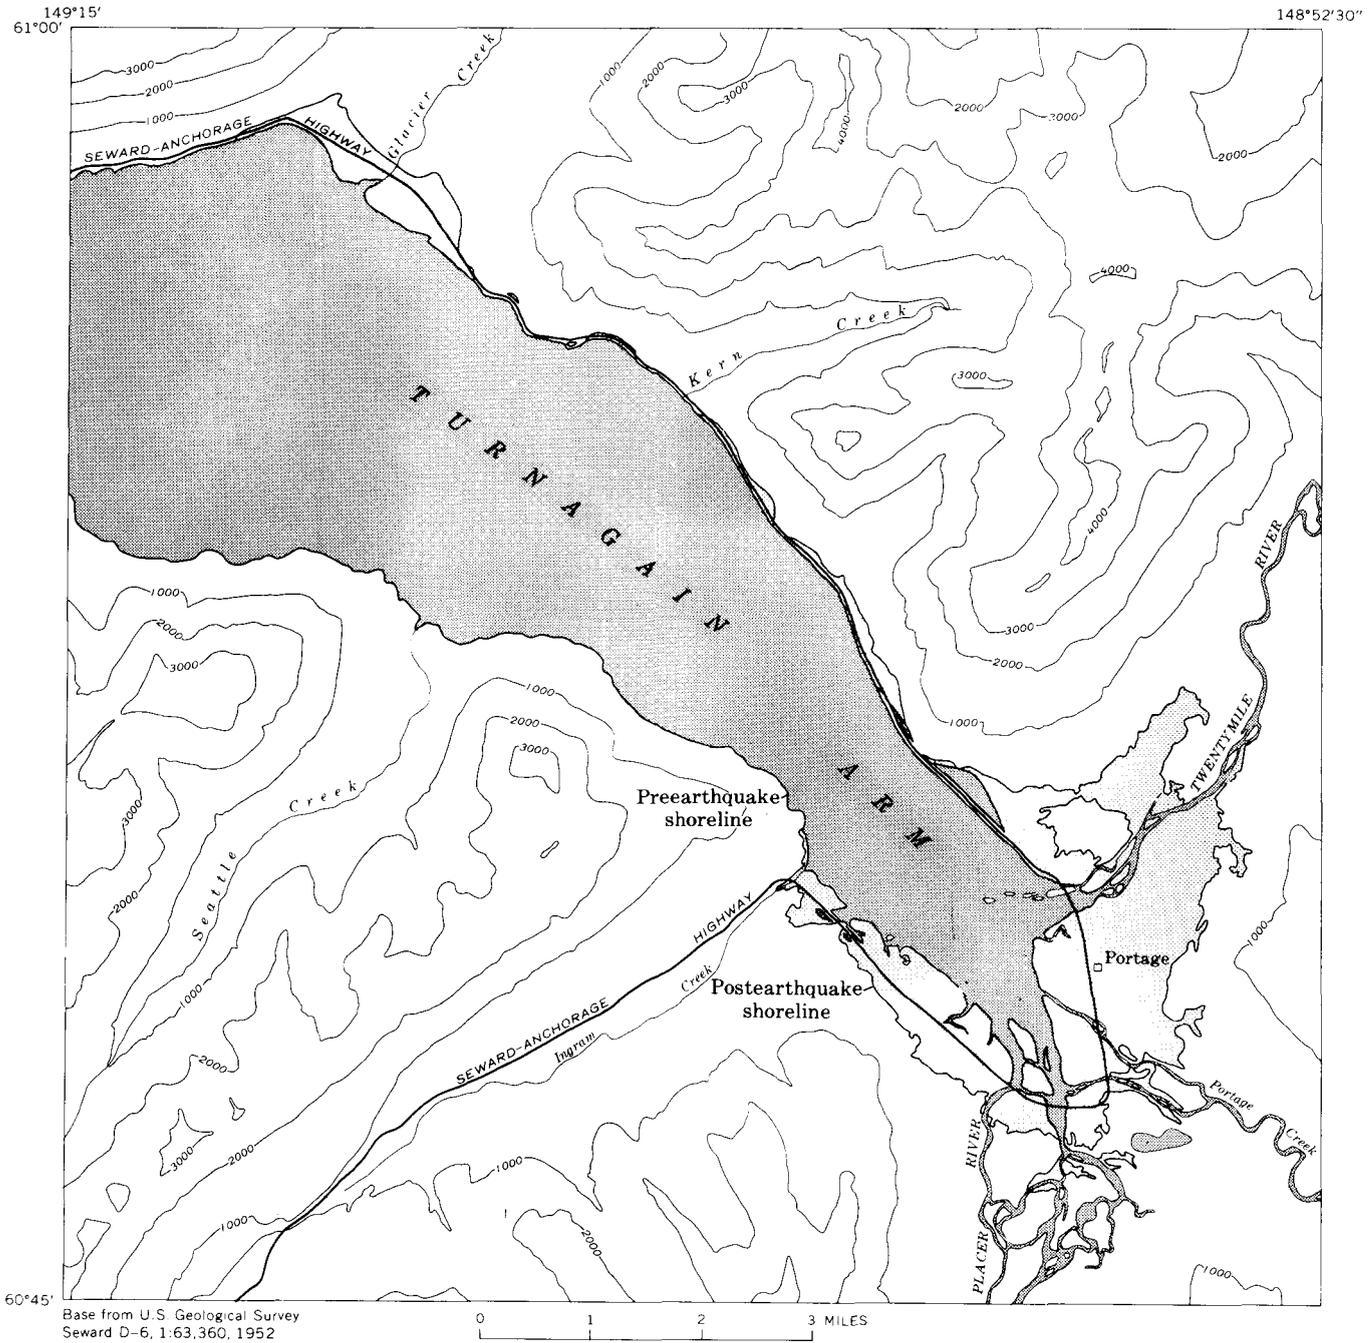
28.—Map of Turnagain Arm showing pre-earthquake shoreline based on mean high water and showing also the area inundated by the 33-foot tide of April 14, 1964. Tide height datum is mean lower low water.

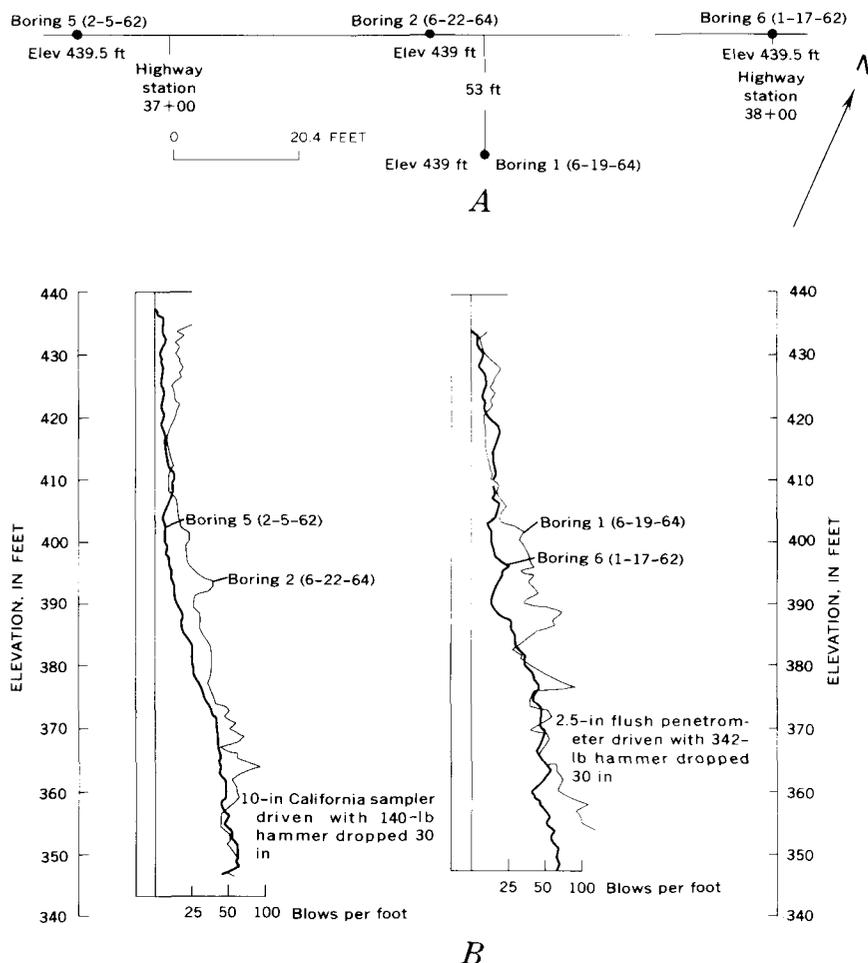
46.—Sketch of boring locations (A) and pre- and postearthquake penetrometer tests (B) at Snow River bridge 605, mile 17.7, Seward-Anchorage Highway. Data after George E. Utermole, Jr., Alaska Department of Highways.
