Report of Investigations 2011-2

**FIELD OBSERVATIONS FROM THE JANUARY 12, 2010,  
HAITI EARTHQUAKE: IMPLICATIONS FOR SEISMIC  
HAZARDS AND FUTURE POST-EARTHQUAKE  
RECONNAISSANCE INVESTIGATIONS IN ALASKA**

by  
R.D. Koehler and P. Mann

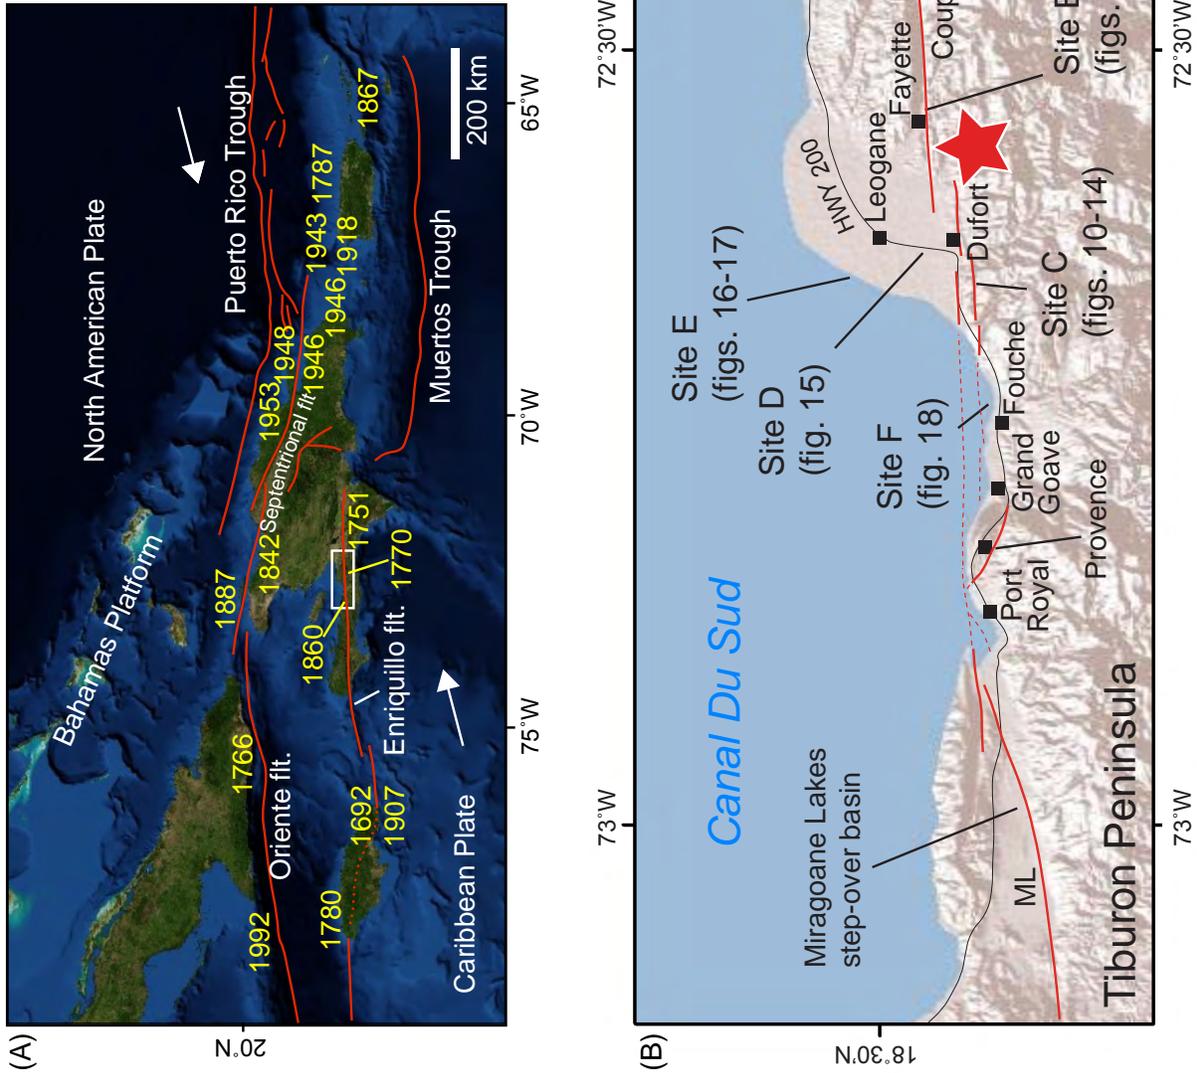
The U.S. Geological Survey's National Earthquake Information Center (NEIC) located the earthquake epicenter at 18°27'25"N latitude and 72°31'59"W longitude, approximately 15 km southwest of Port-au-Prince, close to the surface trace of the Enriquillo fault (fig. 1). Initial assessments determined that the earthquake initiated at a depth of 13 km. The focal mechanism was consistent with oblique left-lateral strike-slip motion along a 252°-trending nodal plane or oblique thrusting along a northwest-trending plane. Preliminary finite fault model

Figure 1. (A) Regional plate tectonic setting showing major faults (red) and the year and approximate relative location of historic earthquakes. Arrows indicate relative plate motion between the North American and Caribbean plates. Area of figure 1B is outlined by white box. Base map from NASA Blue Marble, next generation 500-m-resolution imagery. (B) Terrain model of the eastern part of the Tiburon Peninsula and Port-au-Prince showing locations of ground reconnaissance (Sites A-F, described in text). Red star indicates epicenter of the January 12, 2010, earthquake. Generalized on-land Quaternary trace of the Enriquillo fault shown by red lines. Thin dashed red lines are offshore traces of the fault interpreted by Hornbach and others (2010). Base map from Shuttle Radar Topography Mission (SRTM) 90 m data. EPGFZ = Enriquillo-Plantain Garden fault zone; ML = Miragoane Lakes; RM = Rivière Mornance; RF = Rivière Froid.
