Report of Investigations 2012-2  
Version 1.1

**COASTAL HAZARD FIELD INVESTIGATIONS  
IN RESPONSE TO THE NOVEMBER 2011  
BERING SEA STORM, NORTON SOUND, ALASKA**

by  
Nicole E.M. Kinsman and Meagan R. DeRaps

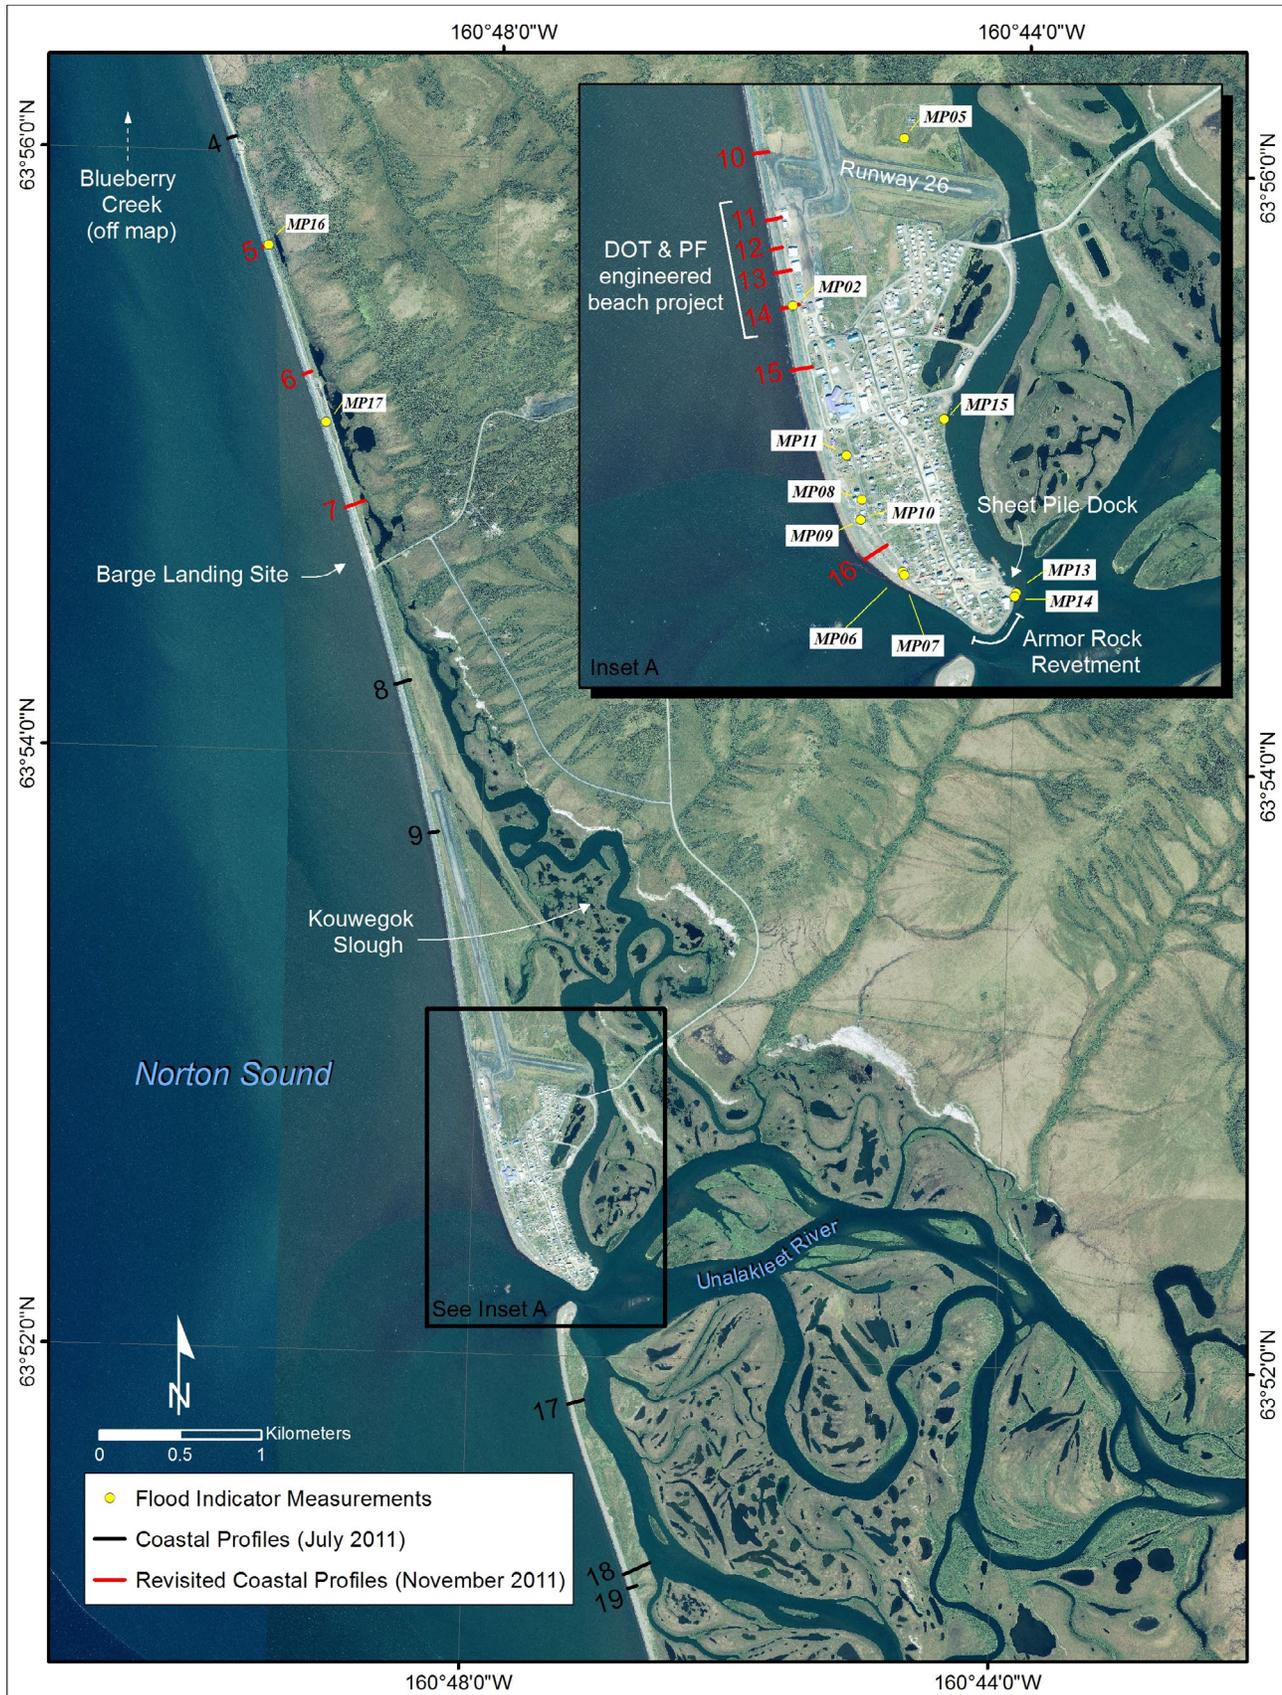
Inundation limits on the Kouwegok Slough side of the community are most indicative of a surge tide level because this area was protected from wind waves. Our team measured a water level elevation of 2.7 m (9 ft) MSL alongside Runway 26 (fig. 9) and at the crane on the sheet pile dock (fig. 6d); we interpret this to be the peak water level attributed to the storm surge and astronomical tide. On the seaward side of the community where wave setup resulted in an additional increase in water level, the floodwater levels reached 4.2 m (14 ft) MSL (fig. 10). We were able to document maximum wave runup elevations in the community of up to 5.8 m (19 ft) MSL along the raised Beach Front Road (fig. 11a) and at the airport (fig. 11b). Near the barge landing and farther to the north, where beach and surf zone are narrower and breaking waves dissipate less energy in the nearshore, we observed higher runup elevations of up to 6.1 m (20 ft) MSL.

Remeasured beach profiles in front of the community (profiles 15 and 16, fig. 6) revealed no modification other than the accretion of a ridge of ice at approximately 2.5 m MLLW. Profiles north of the community near the barge landing site indicate the removal of mid-beach gravel berms that were present in the summer. The removal of these berms by fall storms is typical of seasonal beach cycle modification and do not represent a permanent change to the beach morphology. Permanent and irreversible erosion of the back beach was observed at the northernmost profile (profile 5) that was remeasured. Numerous block failures at the edge of the low bluff along the road to Blueberry Creek were observed up and down the coast in the vicinity of this profile (fig. 12b). The plots in figure 12 illustrate the pre- and post-storm beach profiles at this location. The initial profile collected in July 2011 (green) has a mid-beach gravel berm at 3 m MLLW and a rounded, low bluff typical of terrestrial weathering processes (see fig. 12a). The post-storm profile reveals a sharp, vertical bluff at the backbeach, caused by basal marine erosion, and a bluff edge retreat of 2.3 m inland. A complete set of plotted profile change figures is included in Appendix B. A remeasured vegetation line on the Kouwegok Slough side of the community revealed no erosion or retreat in this area.

Figure 6. Summary map depicting the locations of coastal profiles and points where flood indicators were measured in the vicinity of Unalakleet, Alaska. The base map is a 2005 IKONOS satellite image.

At the DOT&PF engineered beach (profiles 11–14, fig. 6) a steepening of the upper beach slope from approximately 15° to 23° occurred at profiles 11 and 13. The base of the upper scarp, near the crest of the constructed beach, retreated inland 0.7 m. At profile 12, a significant volume of material was transported seaward, translating into 4.5 m retreat at the crest and a loss of 12.5 m<sup>2</sup> from the upper cross-sectional area. There was no significant modification to the beach at profile 14. Minor overtopping of the profile crest and adjacent roadway was observed along the length of the constructed beach project (fig. 11b). Based on the slight steepening observed at two of the profiles, we anticipate that subsequent crest retreat will occur along some portions of the project as the beach profile re-equilibrates. In the last two years, human modifications to the engineered beach project involving the placement of finer-grained sediment to the upper face of the beach may have contributed to the overtopping that was observed. Wave runup heights can be reduced through the dissipation of energy over coarser-grained material (United States Department of the Army, Coastal Engineering Research Center [CERC], 1984); efforts to leave the coarser materials that were newly exposed at the surface by this event could reduce runup heights during future events.

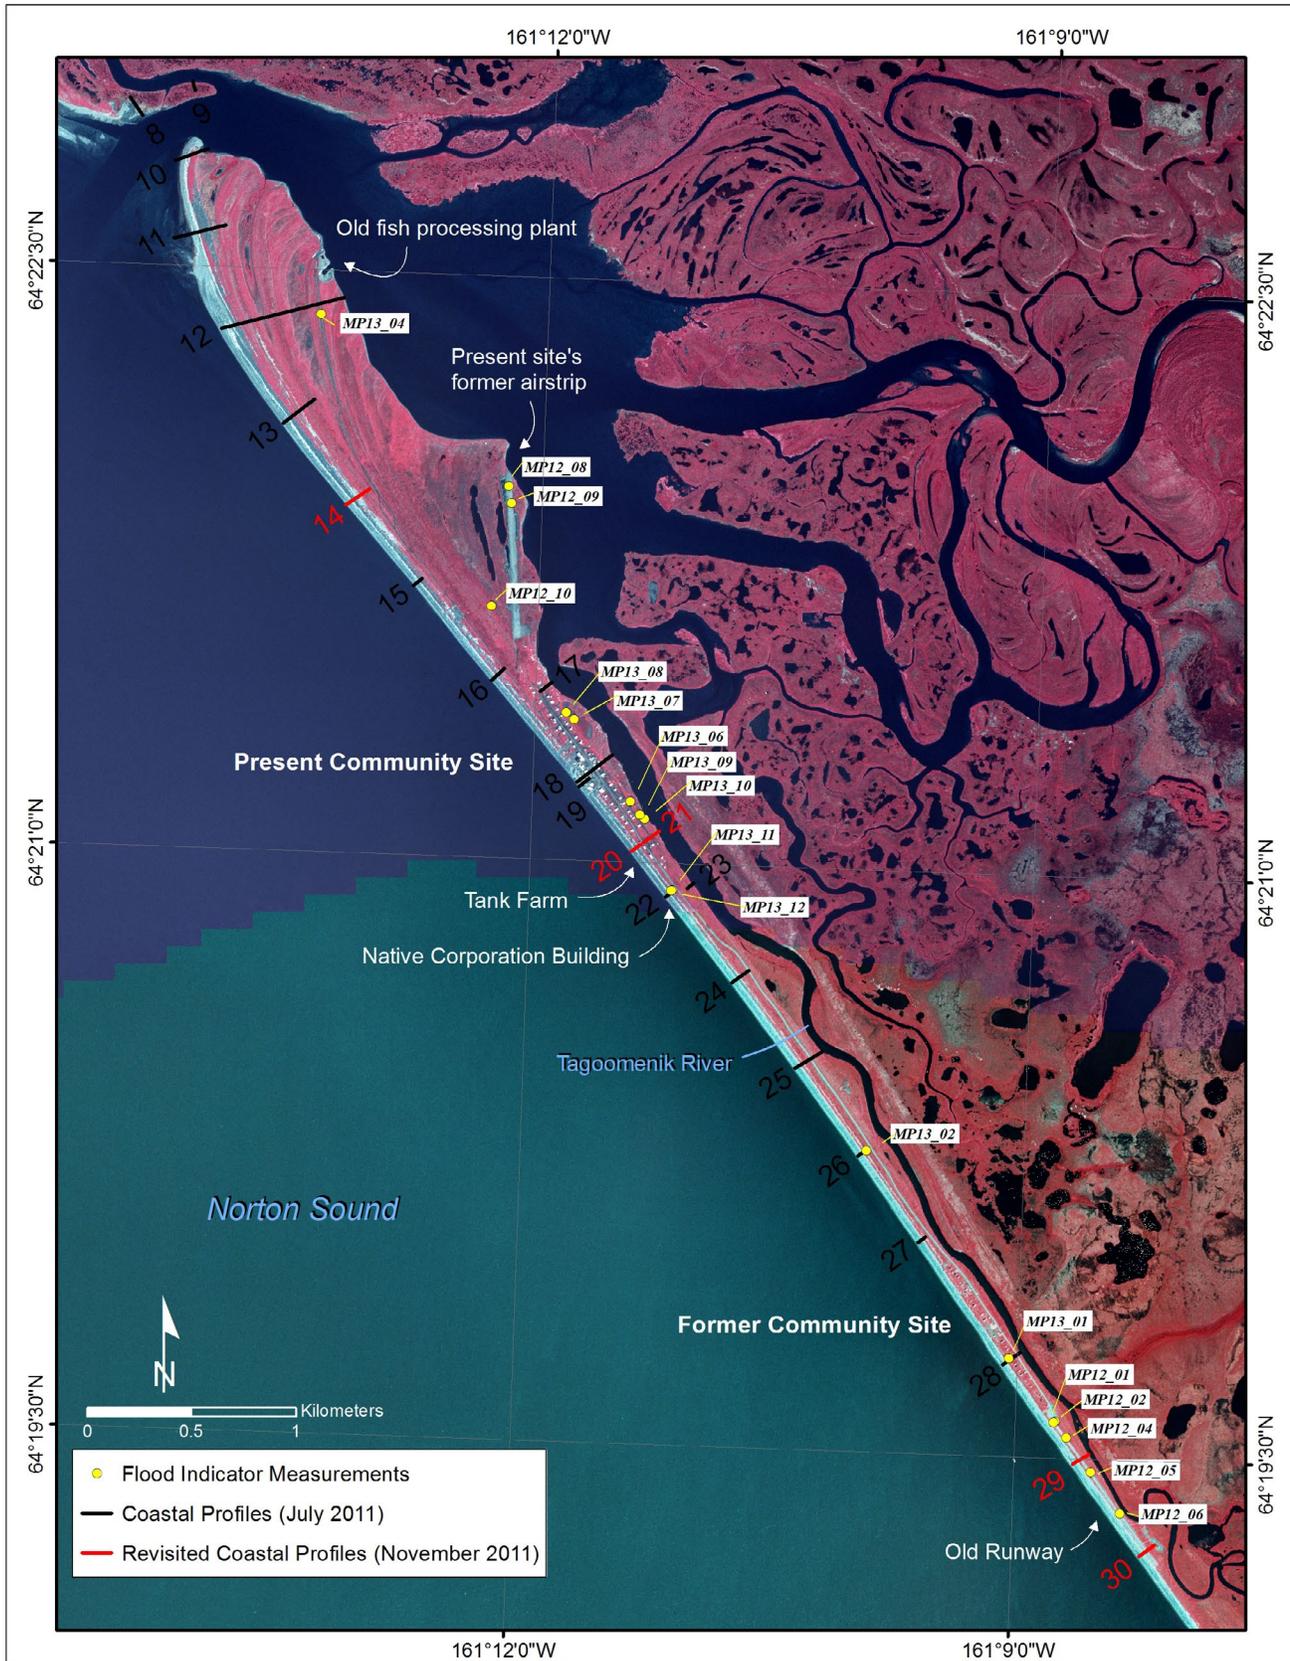
November 2011 DGGs field investigations in Shaktoolik consisted of 1.5 days of fieldwork, during which our team was able to reoccupy five of the coastal profiles established in summer 2011, measure 23 marine flood indicators, and collect photographs and video (summarized in fig. 13). A water-level sensor that was deployed in Tagoomenik River during the summer of 2011 was still in place for the November storm; however, significant ice activity on the river displaced the sensor and it has not been located to date (August 2012). The results of measurements made to evaluate the elevations of the storm water levels in Shaktoolik are presented in table 3.

Remeasured coastal profiles in the vicinity of Shaktoolik did not reveal any immediate, obvious changes to the coastal morphology as a result of the November 9 storm surge. However, we observed significant undercutting of the low bluff, up to 60 cm into the base of the bluffs, at the old community site (fig. 17). In many areas around the old community site, the protective talus toe had been removed and the bluff edge was being held aloft and in position by a combination of frozen ground, vegetation, and frozen slush that was deposited on the back beach as elevated water levels ebbed. When thawing occurs in the spring and summer, block failures in the bluffs along the front of the old community are expected to be prevalent. Overtopping of the wood debris deposit that extends along the coast fronting Norton Sound was isolated to only a few locations at the present community location.

Figure 13. Summary map depicting the locations of coastal profiles and points where flood indicators were measured in the vicinity of Shaktolik, Alaska. The base layer is composed of orthorectified 1981 Alaska High-Altitude Photography (AHAP) imagery.

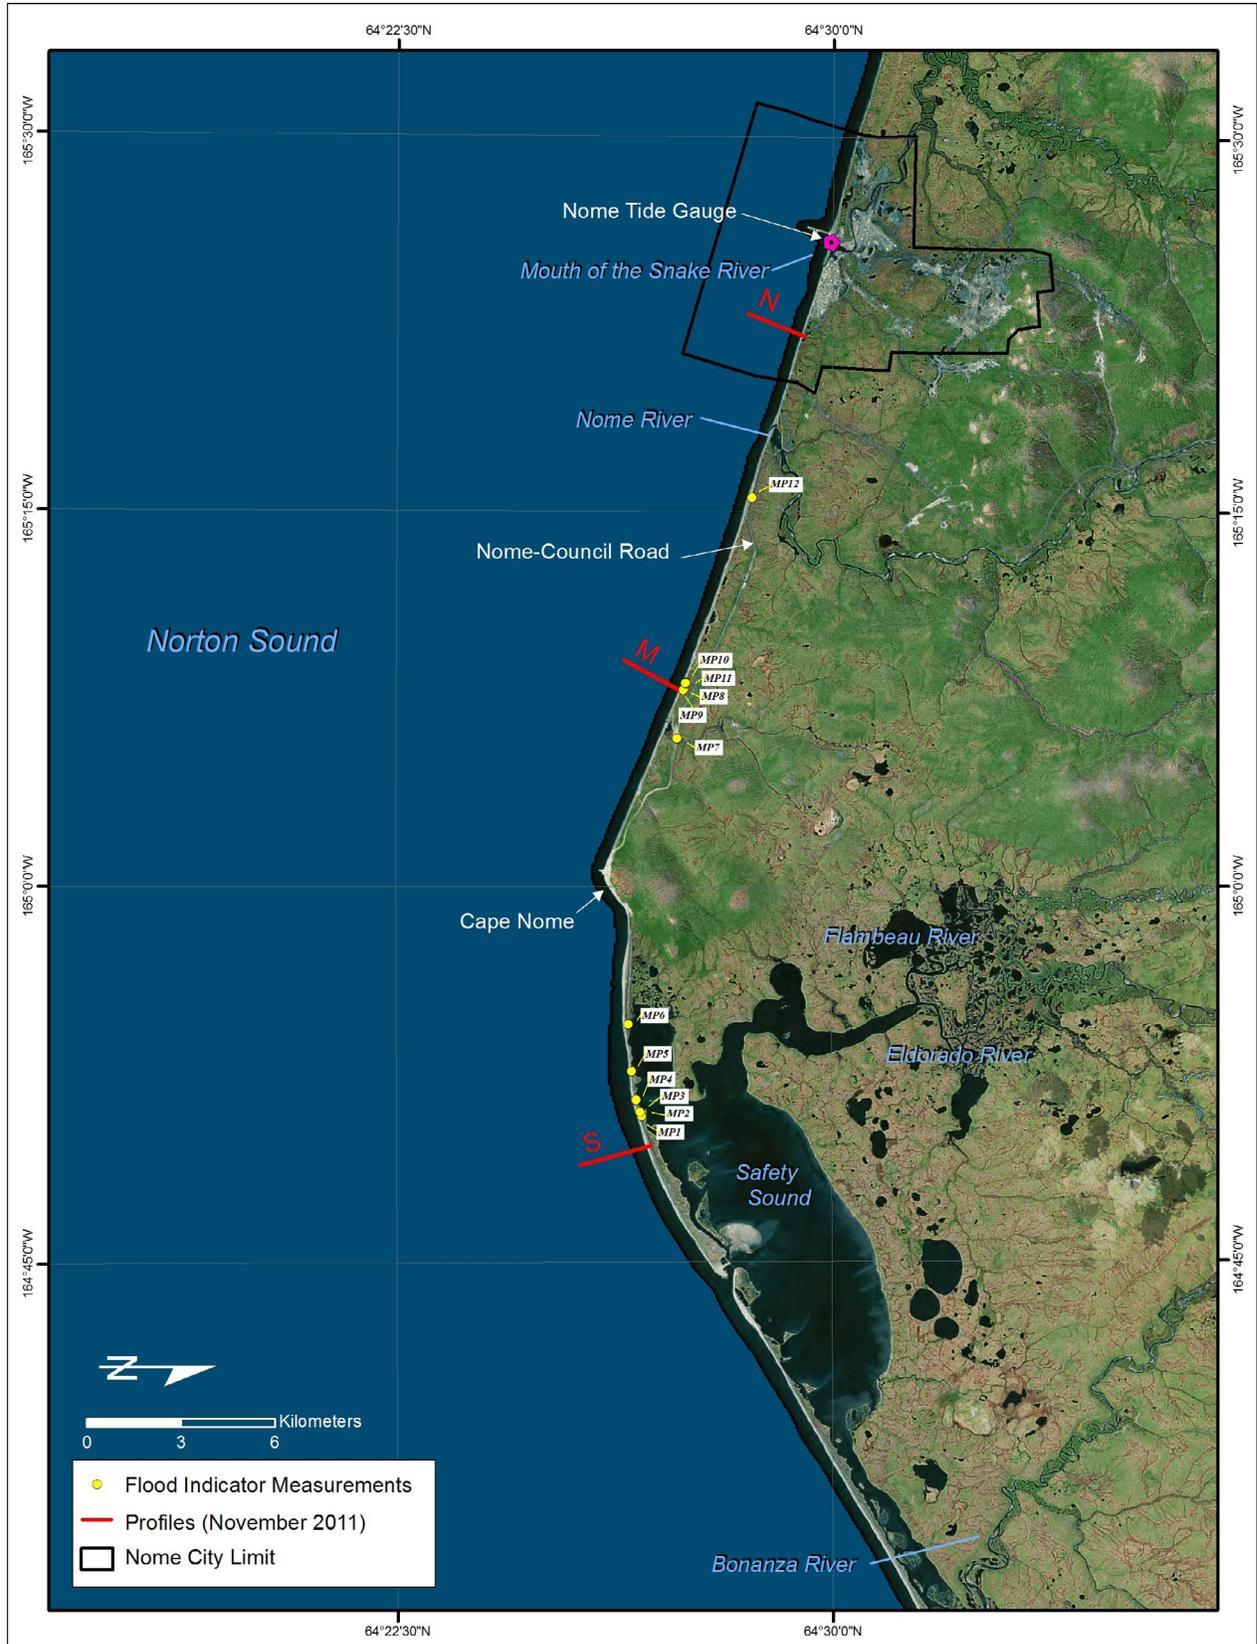
Unlike in Unalakleet and Shaktoolik, staff from the DGGs Coastal Hazards Program had not previously conducted work or established coastal profiles in the Nome area. November 2011 DGGs field investigations consisted of one day of fieldwork, during which our team was able to establish three coastal profiles along the Nome–Council Road and measure 14 marine flood indicators (summarized in fig. 18). Significant clearing of the road and clean-up that was already underway limited the total number of flood indicators that could be measured. The results of measurements made to evaluate the inundation and runup elevations in Nome are presented in table 4.

Figure 18. Summary map depicting the locations of coastal profiles and points where flood indicators were measured along the Nome-Council Road east of Nome, Alaska (note direction of north arrow). The base layer is a 2000 LANDSAT satellite image.

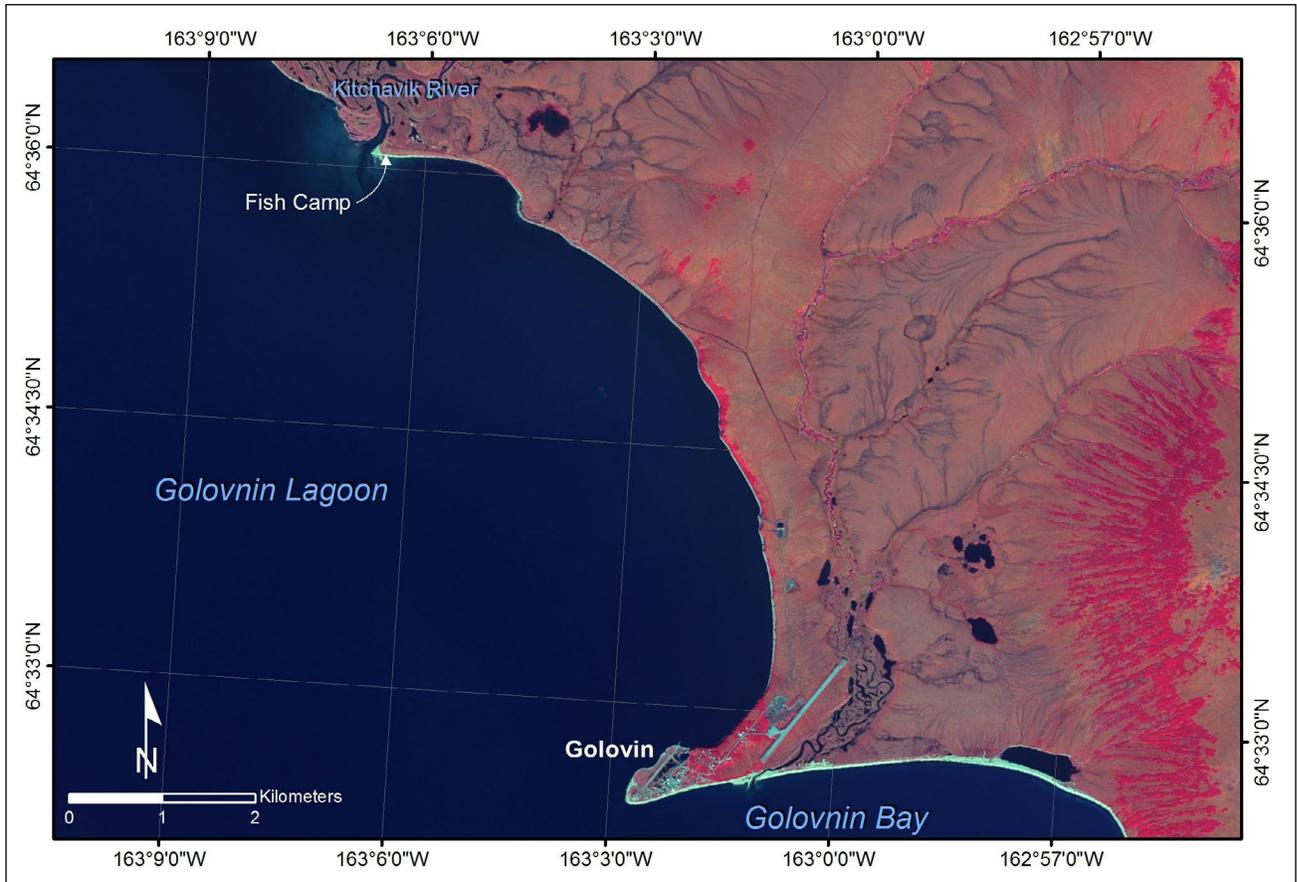
Eyewitness accounts that our team received were in general agreement that flooding from the November 2011 storm was not as severe as other storms that have occurred during the last decade, such as in 2005. Many people reported that Antone Street, which was elevated in 2006, helped to reduce the amount of flooding within the town and around the school. Although Golovin received little media coverage during the storm, at least nine structures were reported to be fully surrounded by water during the peak of the marine flooding, cell phone communications were lost when electronic equipment at the towers was damaged by floodwater and some of the fuel was contaminated by water. Further, flooding may have contributed to the freeze-up of the primary underground water transmission line (written commun., Anungazuk, 2012). Residents expressed relief that peak flooding occurred during daylight hours and that it did not last for as long as it has during past events. Concern was voiced over the location of the flooding relative to the power transformer and about the damage caused by the ivu at the fish camp.

Figure 21. Summary map of Golovin, Alaska, area including the location of fish camp shown relative to the position of the community. The base layer is a 2009 SPOT5 infrared satellite image (vegetation appears red).

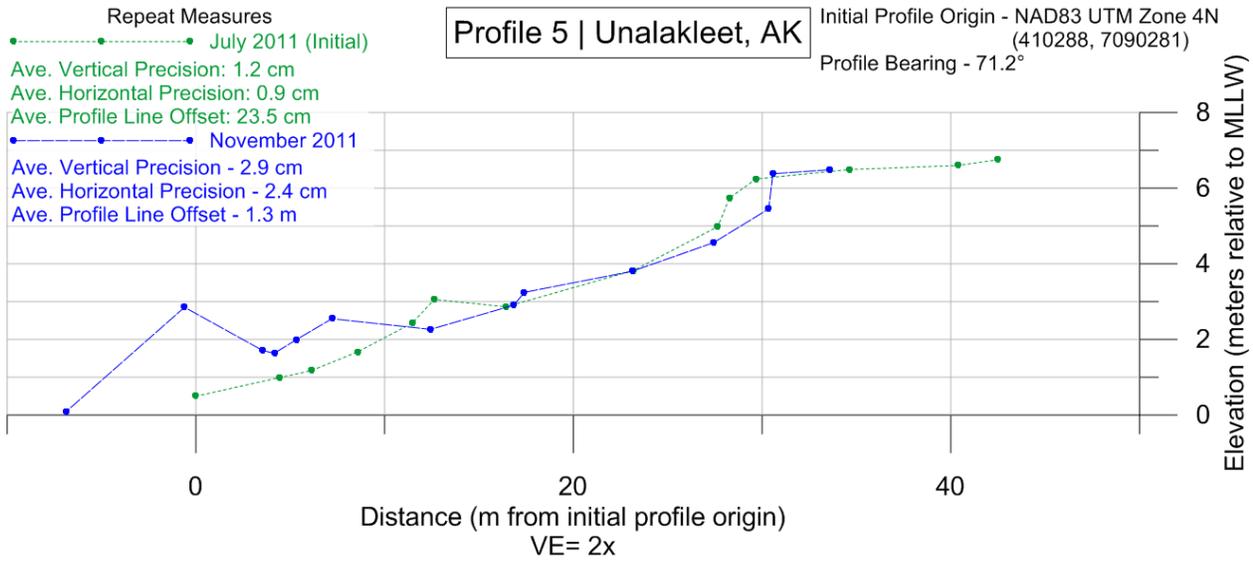
<p><b>Profile Setting:</b>                  Located 5.4 km north of the Unalakleet airport. Profile extends from Norton Sound to the road (across the road in July profile) that leads north to Powers Creek. The backbeach is characterized by a low coastal bluff capped by grassy vegetation.</p>	
<p><b>July 2011 Notes:</b></p> <ul style="list-style-type: none"> <li>• Coarse sand lens present in the intertidal zone</li> <li>• Moderately-well-developed gravel horns/beach cusps on lower shoreface</li> <li>• Well-developed berm on the mid shoreface</li> <li>• Woody debris concentrated in mid shoreface runnel and at the toe of low backbeach bluff</li> <li>• Scarped portion of bluff composed of interbedded sands and gravels with organic cap</li> <li>• Talus toe present at base of coastal bluffs</li> <li>• Woody debris observed atop shoulder of bluffs</li> </ul>	
<p><b>November 2011 Notes:</b></p> <ul style="list-style-type: none"> <li>• Block failures and bluff face steepening due to marine erosion at the base of the bluffs</li> <li>• Woody debris and slush was tossed up and over the bluff edge onto the edge of the road by waves</li> <li>• Wave notching/undercutting observed at bluff toe</li> <li>• Upper shoreface is not covered by thick layer of ice, the shoreface is exposed</li> <li>• Two gravel-rich ice ridges have formed on the lower shoreface</li> </ul>

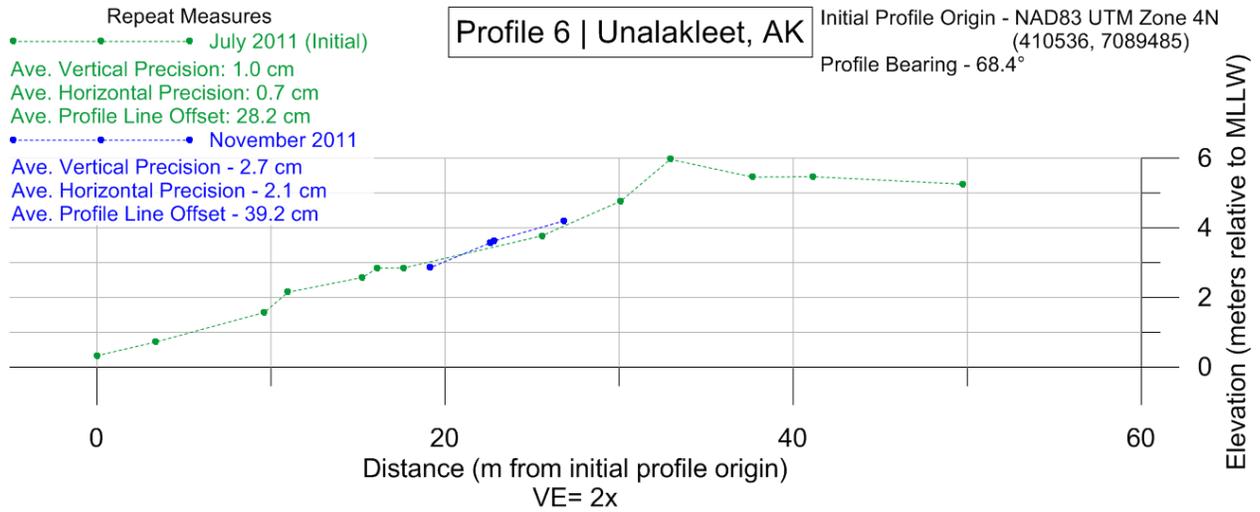
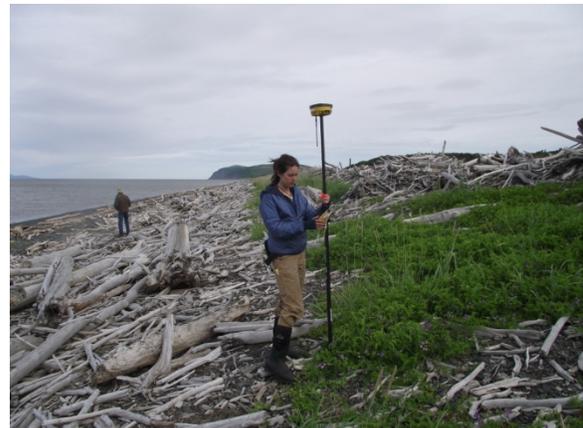
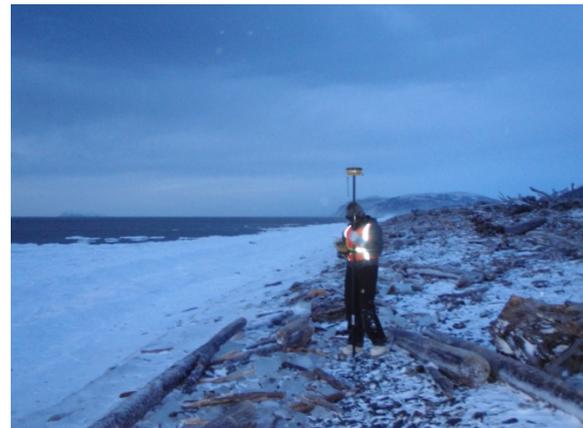
Located 4.5 km north of the Unalakleet airport, just north of the barge landing site. Profile extends from Norton Sound across the road that leads north to Powers Creek. The backbeach is characterized by a tall driftwood debris deposit.

- Poorly-developed gravel horns/beach cusps on lower shoreface
- Low and poorly-developed gravel berm on the mid shoreface
- Large, woody debris across the entire upper half of the shoreface
- Patch of beach peas and grass on upper shoreface fronting tall line of woody debris at backbeach

- Limited/no overtopping or beaching of the backbeach woody debris line occurred
- Woody debris and rounded ice chunks limited to upper shoreface only
- One ice ridge is present on the lower mid shoreface
- Wide bands of accreted slush in the intertidal region

The November profile is incomplete; the number of measured locations along profile 6 is small because of a processing failure at several points along the profile, likely due to an inadequate satellite lock between the rover and base receivers.

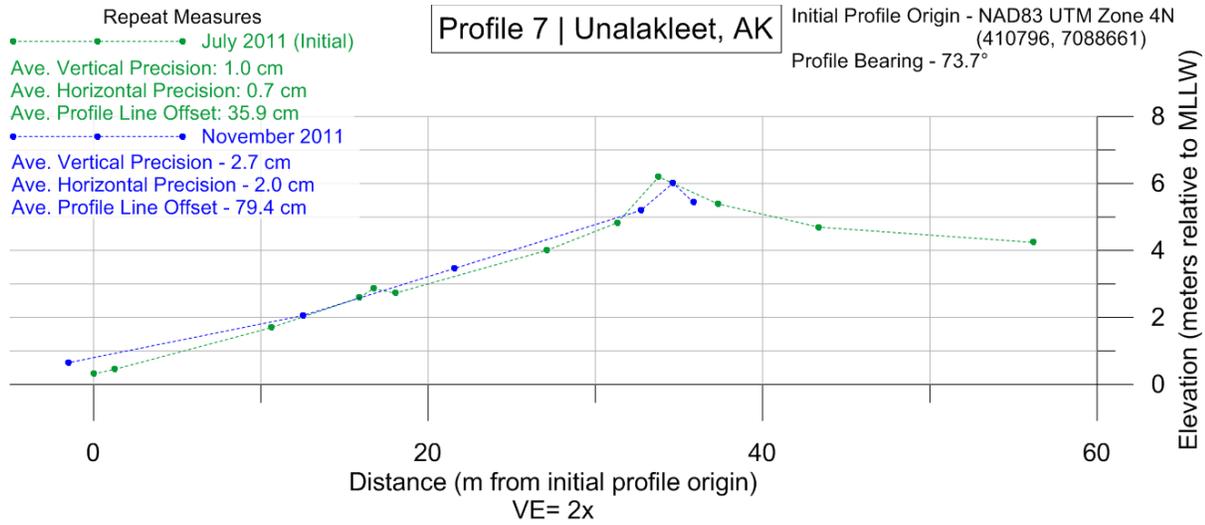
<p><b>Profile Setting:</b>                  Located 3.6 km north of the Unalakleet airport, north of the bridge across Kouwegok Slough. Profile extends from Norton Sound to/across the road that leads north to the barge site and Powers Creek. The backbeach is characterized by a low, woody debris deposit atop a vegetated gravel ridge.</p>	
<p><b>July 2011 Notes:</b></p> <ul style="list-style-type: none"> <li>• Sand lens present atop gravel on the lower shoreface along the ATV trail</li> <li>• Low and poorly-developed gravel berm on the mid shoreface</li> <li>• Woody debris across the entire upper half of the shoreface to vegetation line</li> <li>• Dense/wide patch of beach peas and grass on upper shoreface fronting low, woody debris line</li> </ul>	
<p><b>November 2011 Notes:</b></p> <ul style="list-style-type: none"> <li>• Low, woody debris line at backbeach was overtopped and partially breached during storm</li> <li>• Woody debris moved upslope in the storm, extending from mid shoreface to base of low, woody debris line on backbeach ridge</li> <li>• Low, cusped ice ridge just above accreted bands of slush in the intertidal</li> </ul>

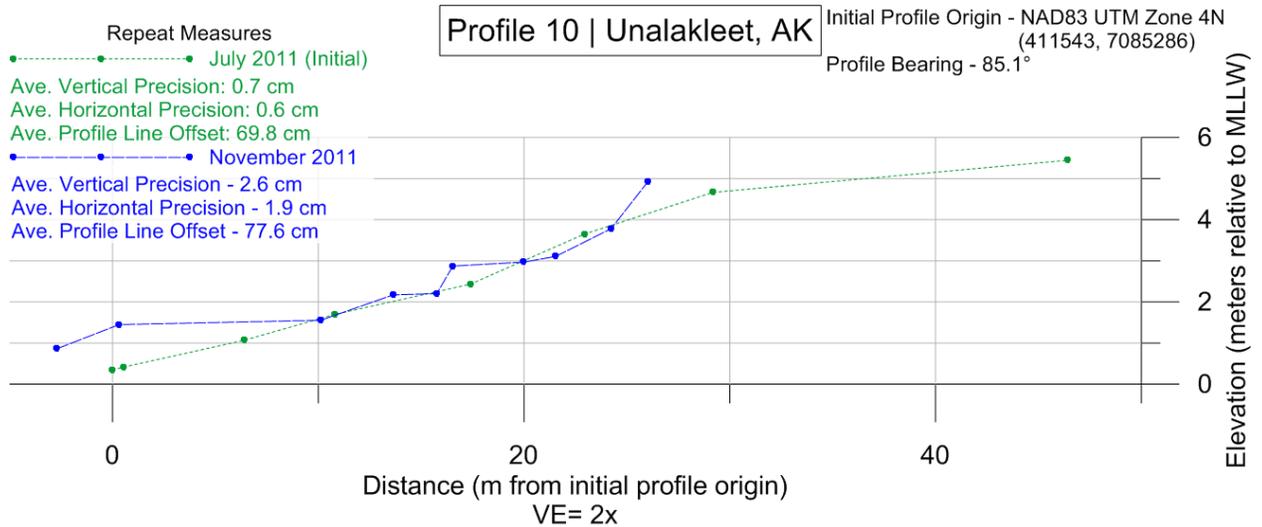
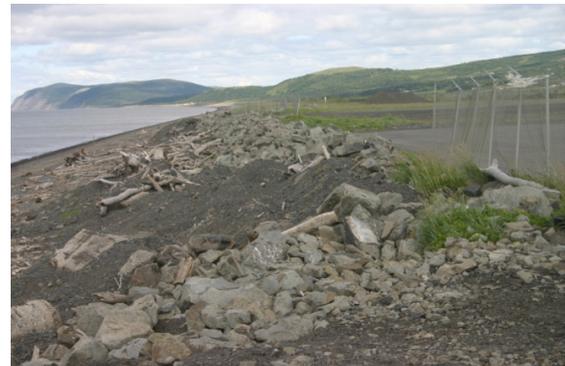
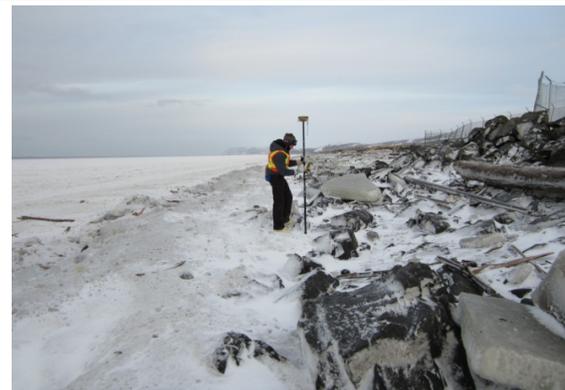
Located at the seaward end of Runway 26 in front of an armor rock revetment north of the dynamically stable engineered beach project. Profile extends from Norton Sound to the paved runway threshold. The airport fence is discontinuous at this location.

- Locally quarried rip rap forms a revetment at the end of the runway
- Fine-grained sediment has been pushed up and placed on top of low half of revetment by a bulldozer
- Some large, woody debris is strewn at the base of the revetment
- Sand lenses are present on the lower shoreface along the ATV trail

- Log-sized woody debris was deposited on paved runway threshold during storm
- Convex profile of armor rock suggests some slumping of the revetment occurred
- Large ice ridge present at the base of the revetment
- Ice blocks and logs on the lower shoreface are pushed up against the ice ridge
- Cuspate bands of accreted slush in the intertidal region

Additional armor rock was emplaced at this location on top of the finer-grained fill prior to Fall 2011. The effects of this addition are visible in the measured profiles and in the appearance of the revetment. Some debris had been cleared from the paved runway surface and pushed onto the revetment by work crews prior to the post-storm measurements. The complete summer profile includes offshore bathymetry at this location.

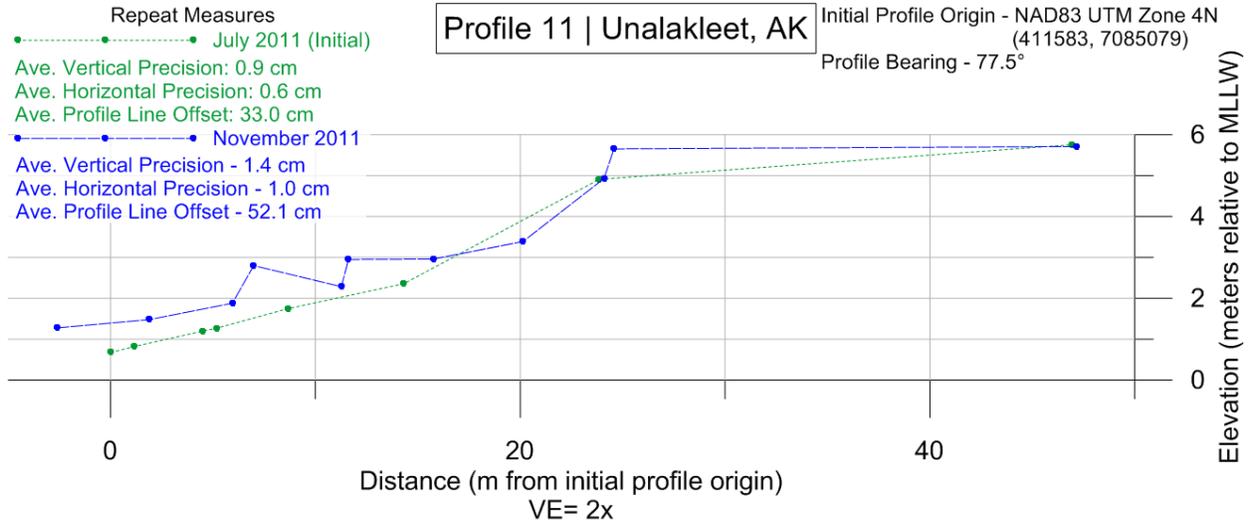
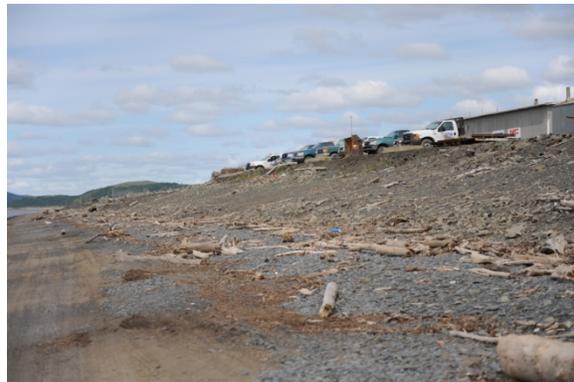
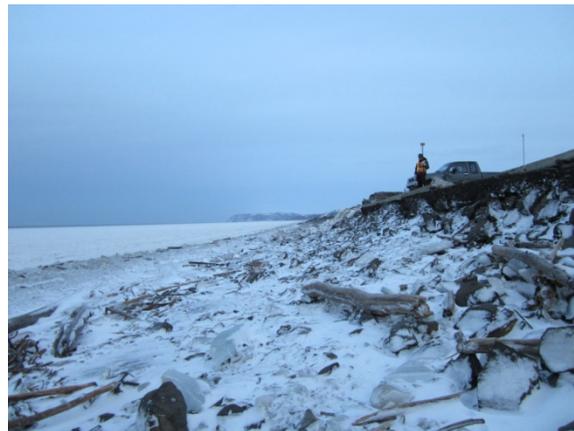
Located next to the main building at the DOT&PF-engineered beach project. Profile extends from Norton Sound to the parking area next to the airport building. Concrete barriers atop the revetment mark the outer edge of the parking area.

- Dynamically stable beach (engineered by DOT&PF)
- Parking area extends onto crest of engineered portion of beach
- Fine-grained material has been added to the face of the engineered beach project by a bulldozer
- Some minor woody debris is strewn at the base of the revetment
- Sand lenses are present on the lower shoreface along the ATV trail

- Steepening and minor undercutting below the concrete barriers has occurred at the crest of the dynamically stable beach
- No overtopping of the crest by water or debris was observed at this profile location
- Two large ice ridges have developed on the lower shoreface
- Woody debris is all oriented parallel to shore in front of and between the ice ridges
- Linearly accreted bands of slush are present in the intertidal zone

The dynamically stable beach was extended seaward of the recommended design template at this location. This resurveyed profile is discussed in more detail in the report.

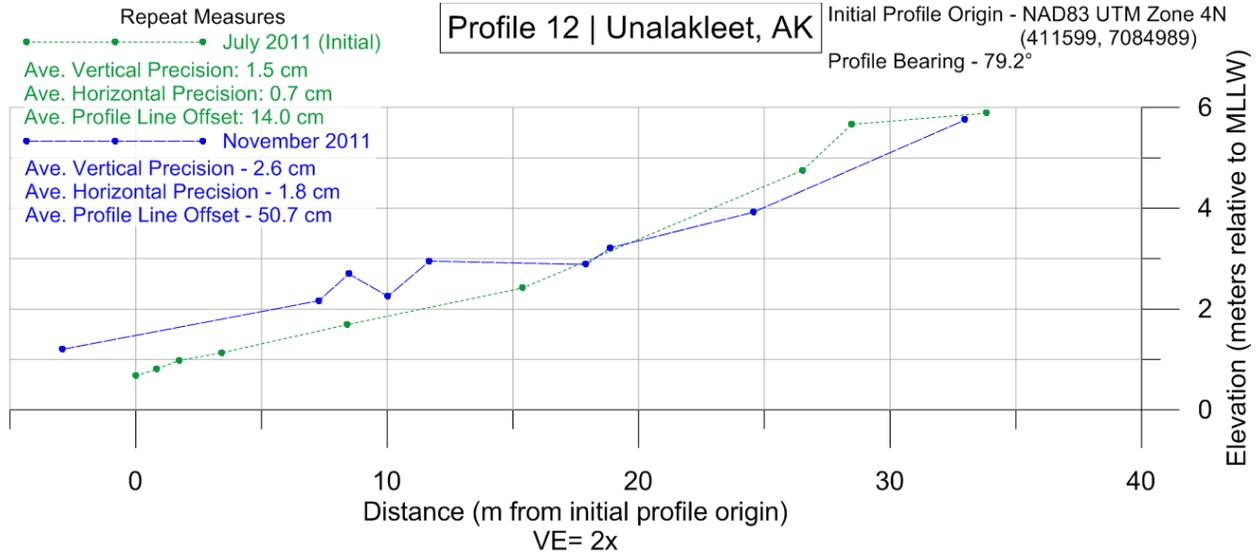
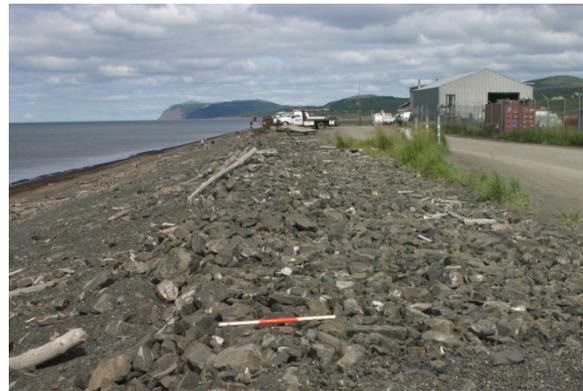
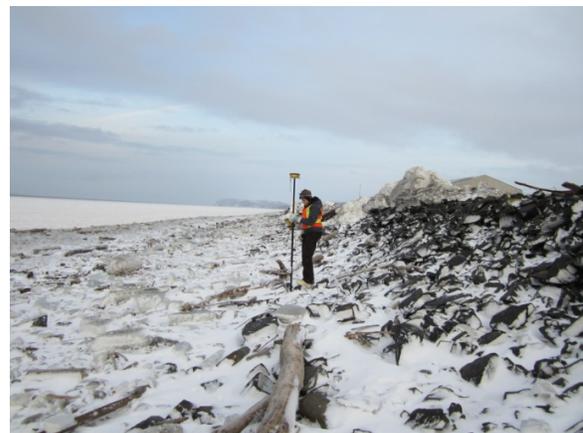
Located next to the ATS building at the dynamically stable engineered beach project. Profile extends from Norton Sound to the edge of the DOTPF road.

- Dynamically stable beach (engineered by DOT&PF)
- Fine-grained material has been added to the face of the engineered beach project by a bulldozer
- Some minor woody debris is present on the face of the engineered beach
- Sand lenses are present on the lower shoreface along the ATV trail

- Woody debris from overtopping was observed at the crest of engineered beach
- Woody debris and ice chunks are evenly strewn across the mid shoreface
- Two ice ridges present on the lower shoreface
- Woody debris is all oriented parallel to shore in front of and between the ice ridges
- Linearly accreted bands of slush are present in the intertidal area

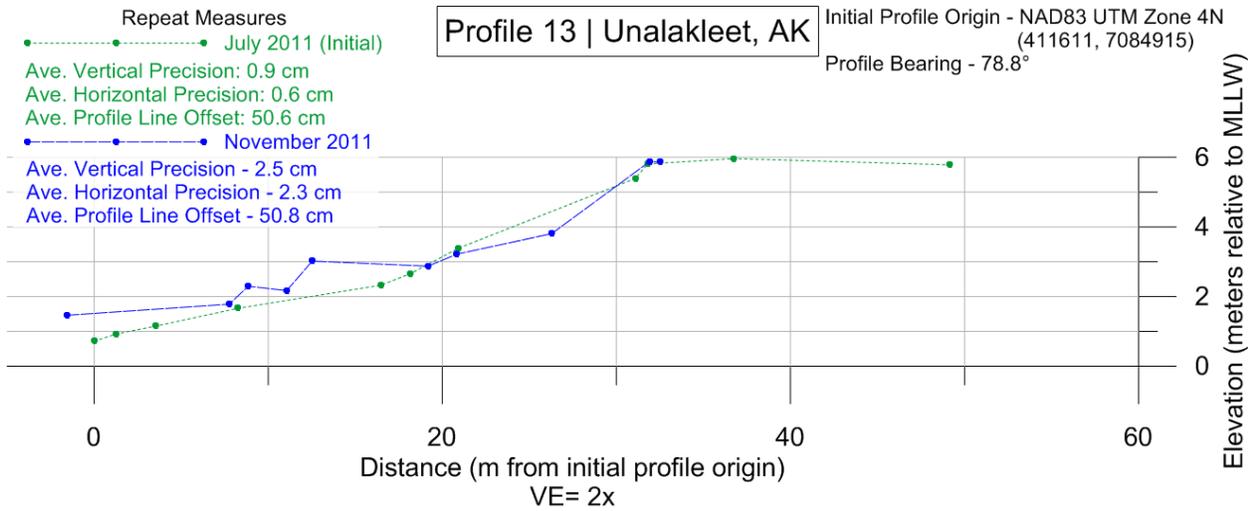
<p><b>Profile Setting:</b> Located next to the BSSD Hanger at the dynamically stable engineered beach project. Profile extends from Norton Sound to the inland edge of the DOT&amp;PF road.</p>	
<p><b>July 2011 Notes:</b></p> <ul style="list-style-type: none"> <li>• Dynamically stable beach (engineered by DOT&amp;PF)</li> <li>• Fine-grained material has been added to the face of the engineered beach project by a bulldozer, in some areas obscuring coarse clasts entirely</li> <li>• Some minor woody debris is present on top of the fill material on the face of the engineered beach</li> <li>• Sand lenses are present on the lower shoreface along the ATV trail</li> </ul>	<p><i>Photo by Harvey Smith, DOT&amp;PF</i></p>
<p><b>November 2011 Notes:</b></p> <ul style="list-style-type: none"> <li>• Abundant woody debris from overtopping was observed at the crest of engineered beach, some was reportedly cleared away already</li> <li>• Engineered beach slope was visibly scarped near the base and frozen blocks of finer-grained material had been deposited at the toe</li> <li>• Two ice ridges present on the lower shoreface</li> <li>• Woody debris is all oriented parallel to shore in front of and between the ice ridges</li> <li>• Linearly accreted bands of slush are present in the intertidal</li> </ul>

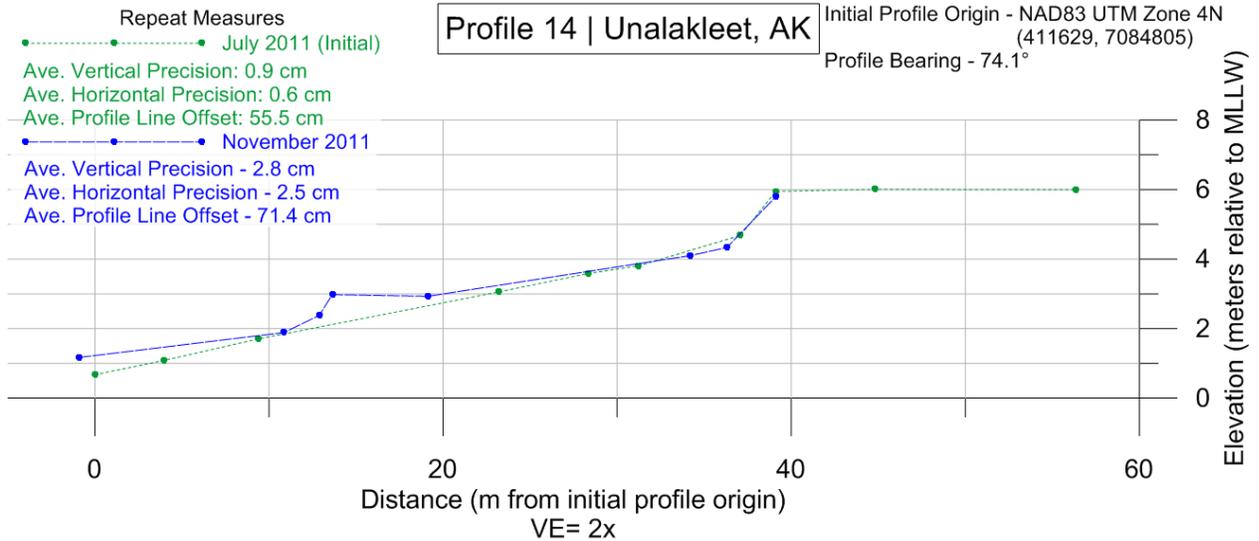
<p><b>Profile Setting:</b>                  Located between the old DOT&amp;PF garage and the FAA building at the dynamically stable engineered beach project. Profile extends from Norton Sound to the inland edge of the DOT&amp;PF road and crosses an ATV access trail to the beach.</p>	
<p><b>July 2011 Notes:</b></p> <ul style="list-style-type: none"> <li>• Dynamically stable beach (engineered by DOT&amp;PF)</li> <li>• Boulders are present in fine gravel at the base of the engineered portion of the beach</li> <li>• Woody debris has been cleared from this area</li> <li>• Some beach peas have grown next to the upper ATV trail (fine gravel)</li> <li>• Sand lenses are present on the lower shoreface along the lower ATV trail</li> </ul>	
<p><b>November 2011 Notes:</b></p> <ul style="list-style-type: none"> <li>• Abundant storm-deposited driftwood debris was observed at the crest of engineered beach, some was reportedly cleared away before our observation</li> <li>• Large blocks of ice and some woody debris deposited near toe of engineered beach slope</li> <li>• Two ice ridges present on the lower shoreface</li> <li>• Linearly accreted bands of slush are present in the intertidal region</li> </ul>

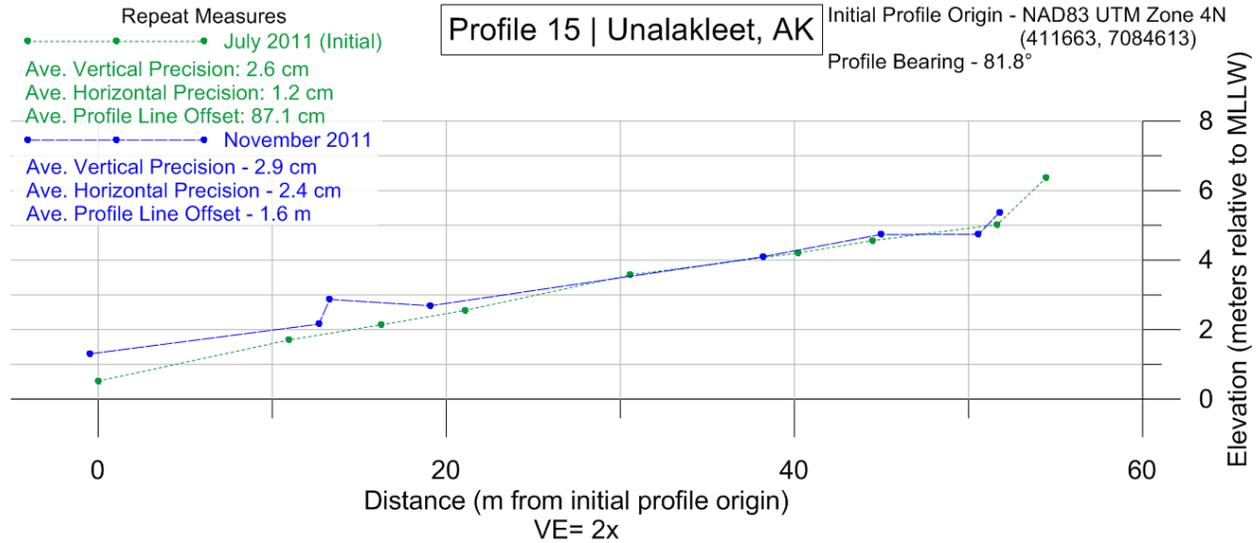
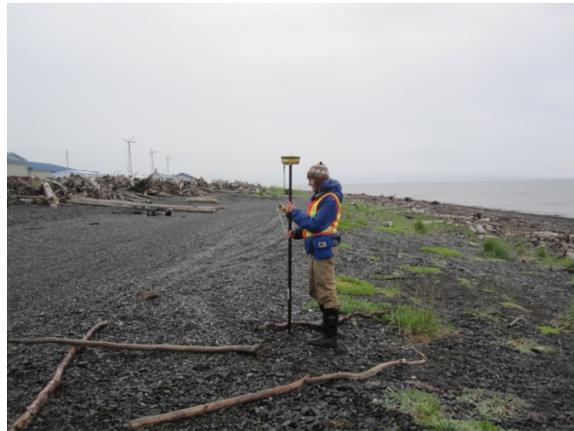
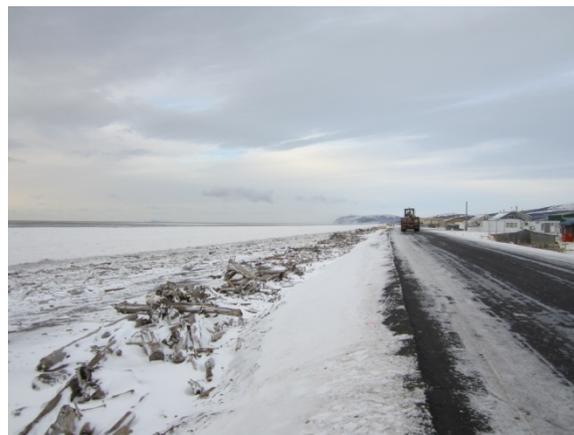
Located next to the BSSD garage. Profile extends from Norton Sound to the seaward edge of Beach West Road.

- A mid-beach line of coarse gravel is present but a berm has not formed
- The mid-upper shoreface is sparsely vegetated by beach peas and grass
- A woody debris line, mixed with minor vegetation, is present along the base of the graded road

- Slush and small, woody debris deposited by runup on slope of the graded road surface
- Large, woody debris line present along base of roadway
- At location of profile, a woody debris line was breached and large volumes of coarse sand and slush were deposited on the upper shoreface
- Ice ridge present on lower shoreface
- Woody debris is all oriented parallel to shore in front of the ice ridge
- Linearly accreted bands of slush are present in the intertidal zone

See Figure 9a in report for example of a runup line collected along this profile on the road grade.

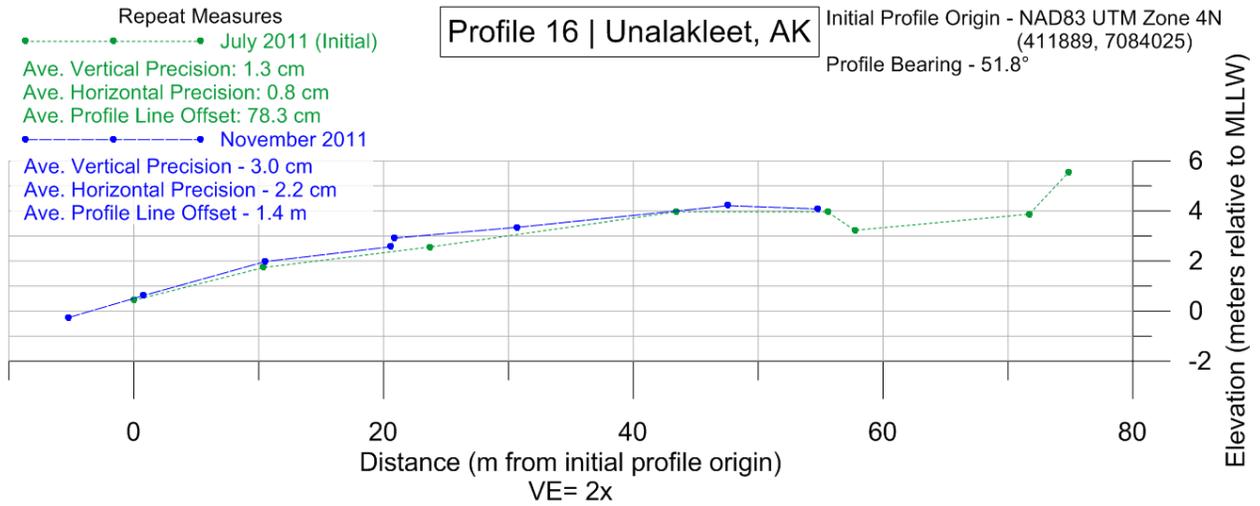
<p><b>Profile Setting:</b>                  Located near the inlet mouth, 100 m north from the end of the U.S. Army Corps of Engineers (USACE) revetment. Profile extends from Norton Sound to the seaward edge of the raised Beach Road.</p>	
<p><b>July 2011 Notes:</b></p> <ul style="list-style-type: none"> <li>Wide, low-angle beach composed primarily of coarse sand</li> <li>Woody debris present on the lower shoreface just above the intertidal zone</li> <li>Low area adjacent to the raised road is filled with beach grasses and log-sized woody debris</li> </ul>	
<p><b>November 2011 Notes:</b></p> <ul style="list-style-type: none"> <li>Stable vegetation inland of remeasured portion of profile, adjacent to the raised road</li> <li>Fish-drying racks in area were not damaged even though they were inundated at the base</li> <li>Abundant jumbled ice and woody debris present across entire remeasured profile</li> <li>Minor ice ridge present on the mid shoreface</li> </ul>
