Report of Investigations 2012-2  
Version 1.1

**COASTAL HAZARD FIELD INVESTIGATIONS  
IN RESPONSE TO THE NOVEMBER 2011  
BERING SEA STORM, NORTON SOUND, ALASKA**

by  
Nicole E.M. Kinsman and Meagan R. DeRaps

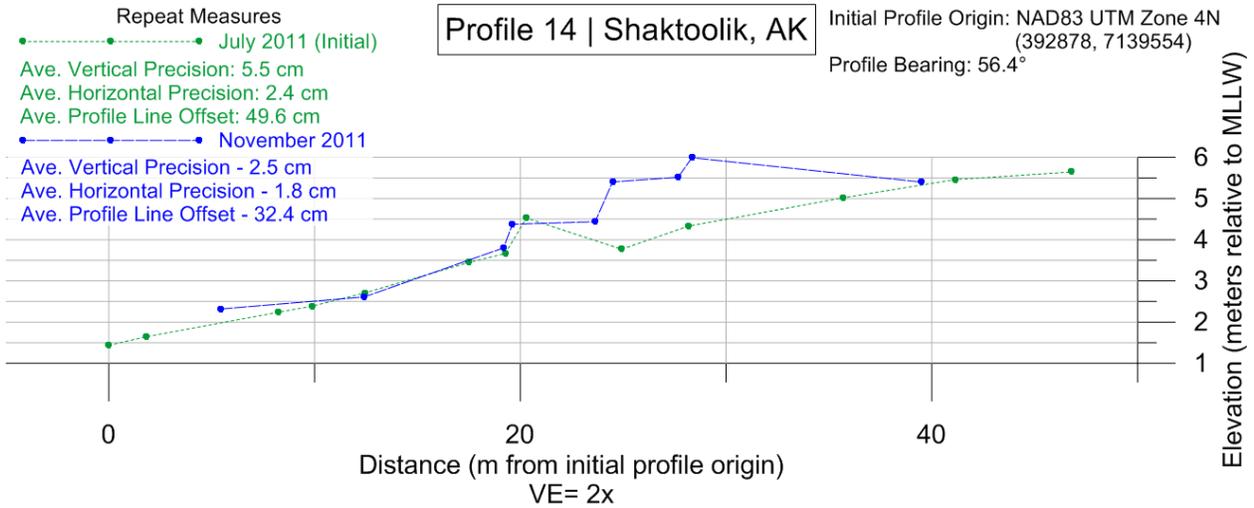
<p><b>Profile Setting:</b>                  Located next to the runway and apron near the airport building. Profile extends from Norton Sound to the inland extent of woody debris observed on the berm adjacent to the runway surface.</p>	
<p><b>July 2011 Notes:</b></p> <ul style="list-style-type: none"> <li>• Mid-profile berm is capped by a large amount of log-sized woody debris</li> <li>• Woody debris present from crest of lower berm to area below the runway surface</li> <li>• Sparse vegetation (grasses) present in area inland from lower berm</li> </ul>	
<p><b>November 2011 Notes:</b></p> <ul style="list-style-type: none"> <li>• Large quantities of slush were washed up and frozen atop pre-existing woody debris</li> <li>• Area between lower berm and edge of runway surface is filled with drifted snow and ice</li> <li>• Multiple generations of steep ice and slush ridges present across the profile</li> </ul>

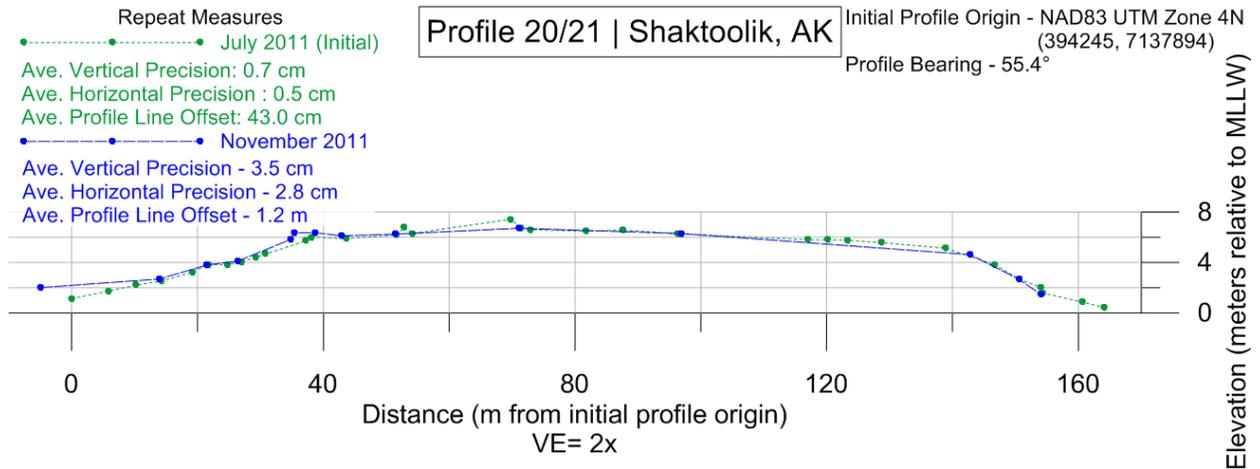
<p><b>Profile Setting:</b></p> <p>Located next to the tank farm and adjacent to the community. Profile extends from Norton Sound across the barrier spit to the bank of Tagoomenik River.</p>	
<p><b>July 2011 Notes:</b></p> <ul style="list-style-type: none"> <li>Sand lenses present on the lower shoreface along the lower ATV trail</li> <li>Two lines of woody debris on the upper shoreface; one sits atop a lower berm and one caps the upper berm directly in front of the tank farm</li> <li>Beach peas and grasses present between the woody debris lines</li> <li>Tank farm is surrounded by a low levee of sandbags and geotextile material</li> <li>Edge of Tagoomenik River is well vegetated by grasses, with a narrow, sandy beach at the base of a &lt;1 m scarp in the riverbank</li> </ul>	
<p><b>November 2011 Notes:</b></p> <ul style="list-style-type: none"> <li>Low ice and frozen slush ridge with a stepped surface present at front edge of upper woody debris line</li> <li>Lower woody debris line is no longer present</li> <li>Waves did not overtop the upper woody debris line at this location; runoff of slush is visible below snow cover</li> <li>Shoulder of Tagoomenik River bank is heavily drifted over by snow that has an icy crust that is difficult to penetrate</li> <li>Tagoomenik River is slushy and covered with large floating pieces of ice</li> </ul>

<p><b>Other Notes:</b></p> <p>The engineered berm surrounding the tank farm was not remeasured in November 2011. This resurveyed profile is discussed in more detail in the report.</p>

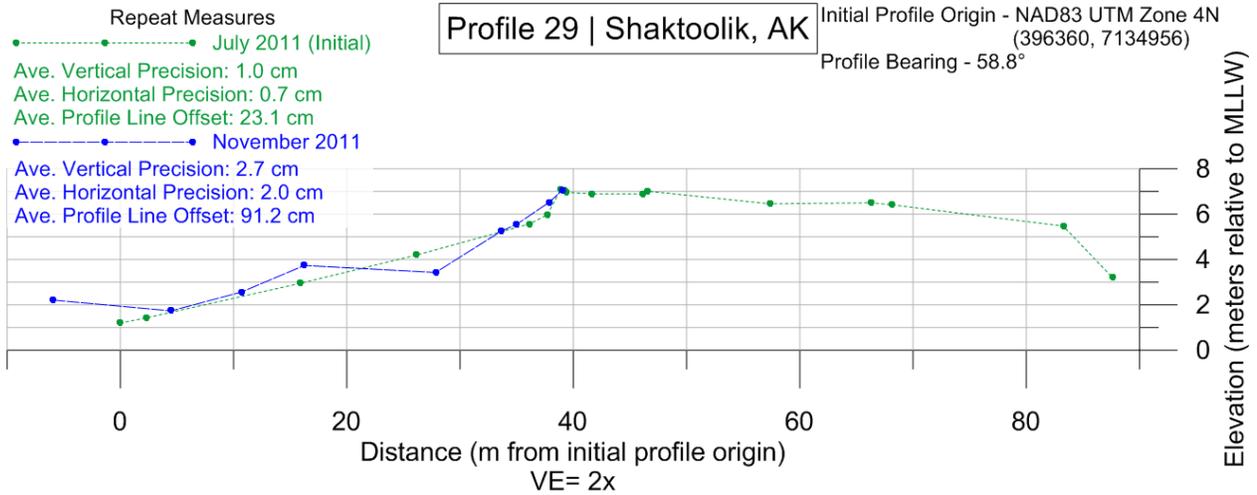
<p><b>Profile Setting:</b>                  Located next the old runway at the former community site. Profile extends from Norton Sound to the bank of Tagoomenik River.</p>	
<p><b>July 2011 Notes:</b></p> <ul style="list-style-type: none"> <li>• Well-developed gravel horns and beach cusps</li> <li>• Abundant large, woody debris on entire upper half of shoreface</li> <li>• Debris toe with sparse vegetation at base of low, eroding gravel bluff</li> <li>• Woody debris had been deposited atop low bluff and across old runway</li> <li>• Bank of Tagoomenik River is steep and densely covered by low willows</li> </ul>	
<p><b>November 2011 Notes:</b></p> <ul style="list-style-type: none"> <li>• Extensive slush and woody debris overwash 2 m north of profile location</li> <li>• Wood debris and frozen slush pushed up against the low bluff at the backbeach</li> <li>• Less woody debris on the upper shoreface than was seen at this location in the summer</li> <li>• Low ice ridge containing lots of gravel on the mid shoreface</li> <li>• Slush ridges containing logs are present in the intertidal zone</li> </ul>

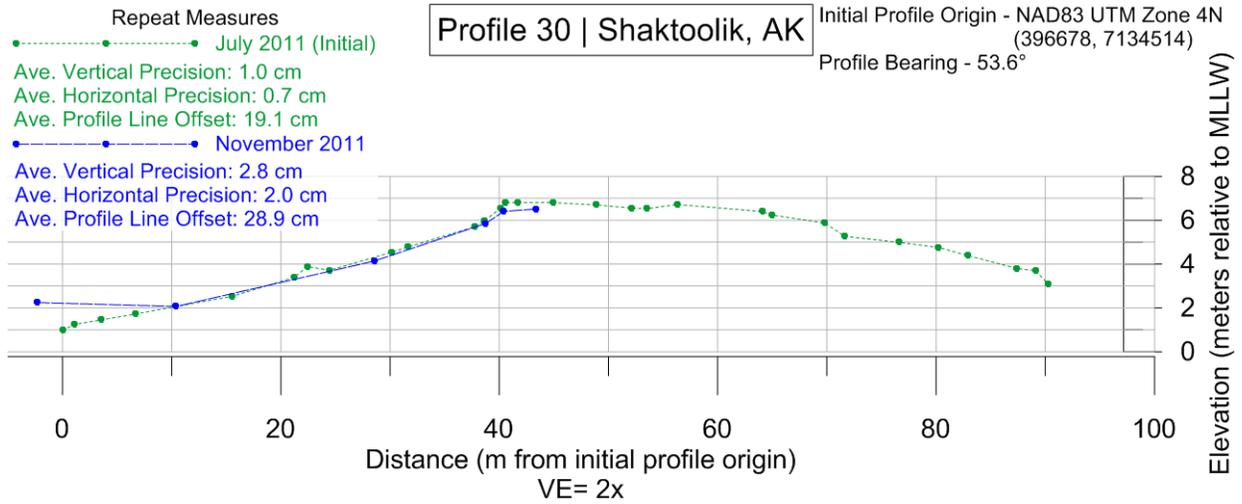
<p><b>Profile Setting:</b>                  Located next the old runway at the former community site and near an ATV access trail to the beach. Profile extends from Norton Sound to a low floodplain adjacent to Tagoomenik River.</p>	
<p><b>July 2011 Notes:</b></p> <ul style="list-style-type: none"> <li>• Well-developed gravel horns and beach cusps</li> <li>• Low gravel berm present at the mid shoreface</li> <li>• Abundant large, woody debris on entire upper half of shoreface</li> <li>• Debris toe with sparse vegetation at base of low, eroding gravel bluff</li> <li>• Woody debris observed on inland side of old runway</li> <li>• Floodplain is grassy with patches of shrubby willow and birch</li> </ul>	
<p><b>November 2011 Notes:</b></p> <ul style="list-style-type: none"> <li>• Additional woody debris has been deposited atop the old runway surface</li> <li>• No horizontal retreat of the low bluff observed</li> <li>• Less woody debris on the upper shoreface than was seen at this location in the summer</li> <li>• Slush and ice ridges are present in the intertidal area</li> </ul>

<p><b>Other Notes:</b>                  Snow cover obscured the full extent of woody debris deposited atop the old runway during the November 2011 storm.</p>
