COASTAL FLOOD IMPACT ASSESSMENTS FOR ALASKA COMMUNITIES—KOTLIK

Richard M. Buzard, Jacquelyn R. Overbeck, Marvin M. Turner, and Jessica E. Christian

Report of Investigation 2021-1C Kotlik

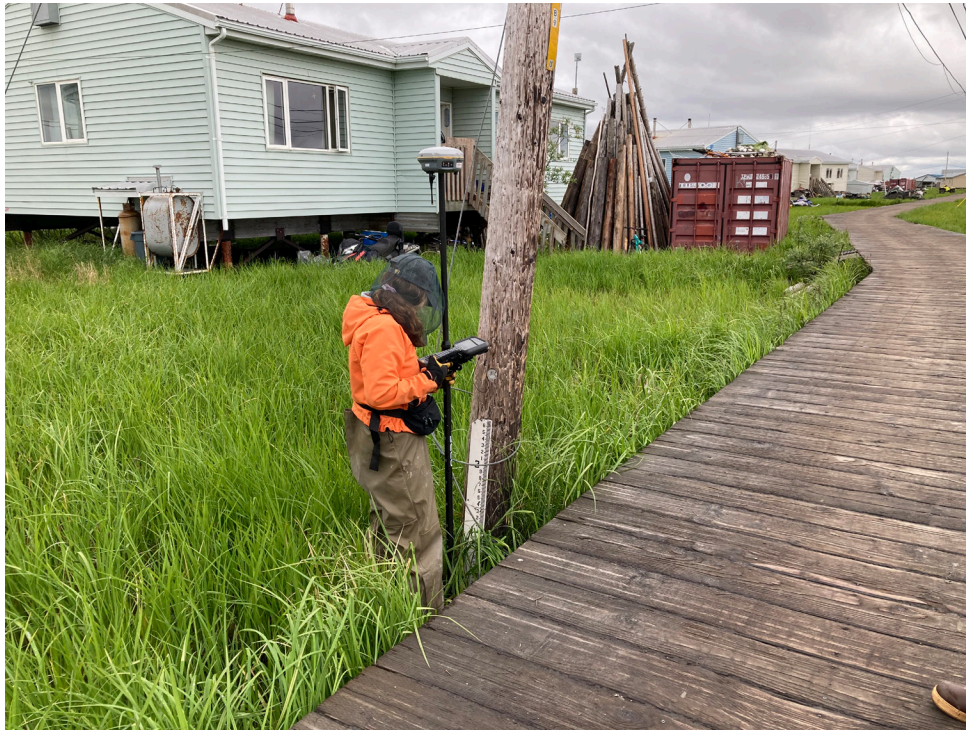
DGGS installed a flood staff in Kotlik in June 2017. It is on a power pole next to the main boardwalk by the ANTHC yard, east of the Alaska Commercial store (fig. 13; see map sheet Kotlik). The zero mark on the flood staff is 2.6 ± 0.1 ft MHHW. We can use a photo of the staff in floodwater to estimate the height of floods.

Figure 13. Flood staff installed on power pole in Kotlik.
