EROSION EXPOSURE ASSESSMENT—EGEGIK

Report of Investigation 2021-3 Egegik

State of Alaska
Department of Natural Resources
Division of Geological & Geophysical Surveys

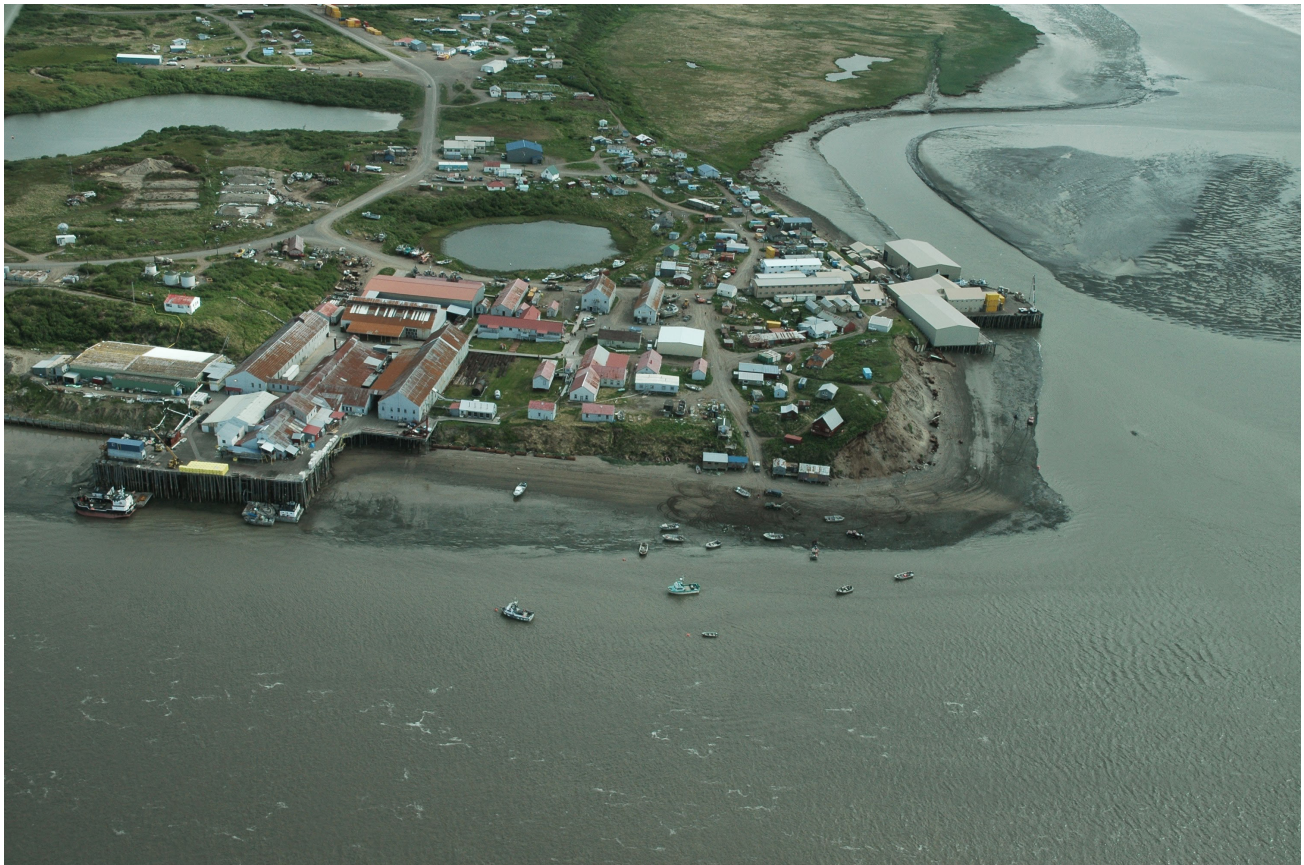
Egegik, Alaska, in 2006. Photo: ShoreZone, shorezone.org.

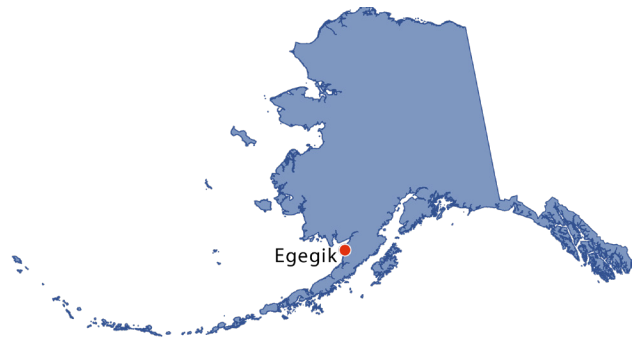
Egegik is located on the Alaska Peninsula in the eastern section of Bristol Bay, at the mouth of the Egegik River upstream of Egegik Bay. Fall storm surge is the primary driver of erosion in the community (Bristol Bay Native Association [BBNA], 2019). Additionally, BBNA (2019) reports that icebergs from Egegik Bay erode the beach. During spring break up, the Egegik River undercuts the bluffs along the riverbank (BBNA, 2019). Overbeck

and others (2020) show erosion rates of low-lying vegetation near the community that range between 1.0 and 13.5 feet per year, but the bluff is considered stable.
