EROSION EXPOSURE ASSESSMENT—KOYUK

Report of Investigation 2021-3 Koyuk

KOYUK EROSION EXPOSURE ASSESSMENT

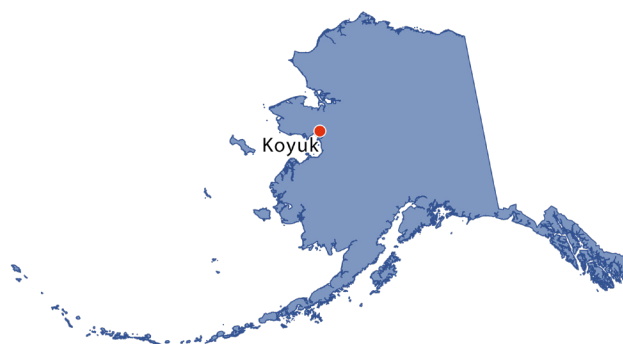
Koyuk is located at the northeastern side of Norton Sound in Koyuk Inlet at the mouth of the Koyuk River. Koyuk experiences riverine erosion and erosion from storm surge, high tides, and waves

(U.S. Army Corps of Engineers [USACE], 2007). From 1950 to 2015, the shoreline eroded up to 3.3 feet per year (Overbeck and others, 2020). The greatest erosion occurred in front of the community, but the surround shoreline is mostly stable. A berm was built in front of the retail store but has not stopped erosion (USACE, 2007).

We forecast erosion 60 years from the most recent shoreline (2015) at 20-year intervals to identify the exposure of infrastructure to erosion. One road on the eastern side of town is within the 2075 erosion forecast area (tables 1 and 2). The total estimated cost of replacement due to exposure of the road to erosion is \$200 thousand (\pm \$60 thousand) by 2035 (table 2).
