EROSION EXPOSURE ASSESSMENT—SHAKTOOLIK

Report of Investigation 2021-3 Shaktoolik

SHAKTOOLIK EROSION EXPOSURE ASSESSMENT

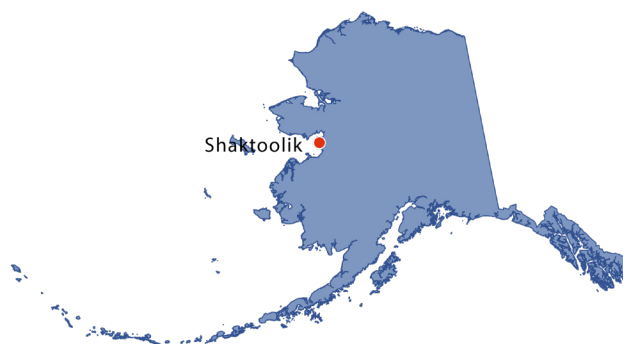
Shaktoolik is located at the head of Norton Sound. The community is constructed on a long, vegetated, gravel spit. The Tagoomenik River travels along the inland side of the spit to meet with the larger Shaktoolik River before exiting into Norton Sound. From 1950 to 2015, the beach remained relatively stable with accretion up to 3.3 feet per year near the tip of the spit (Overbeck and others, 2020). Despite long-term stability, large storms can erode the vegetated soil above the beach, undercut-

ting infrastructure near the coastline. Shaktoolik constructed a gravel berm in 2014 to buffer soil erosion and undercutting (HDR and RIM First People, 2016). Due to the relatively stable beach erosion trends and the construction and maintenance of the gravel berm, we cannot forecast erosion at Shaktoolik.
