EROSION EXPOSURE ASSESSMENT—TUNUNAK

Report of Investigation 2021-3 Tununak

TUNUNAK EROSION EXPOSURE ASSESSMENT

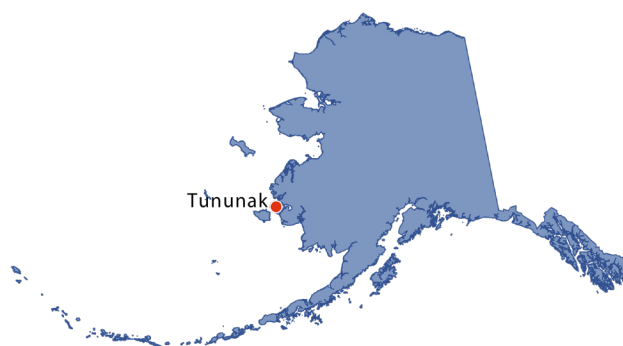
the bridge is likely exposed to erosion. Given this forecast and community observations of continued bridge foundation erosion, we include the bridge replacement cost estimated by The Native Village of Tununak (2015; table 2; fig. 1). The timing of exposure is estimated to be the same as the road. The total estimated cost of infrastructure exposed to erosion is \$500 thousand (\pm \$150 thousand) by 2075 (table 2; fig. 1).

Figure 1. This figure summarizes the replacement cost of all infrastructure in the erosion forecast area. The road and bridge are both within the 2035 (purple) forecast.
