PRELIMINARY LANDSLIDE INVENTORY OF PARTS OF THE FAIRBANKS NORTH STAR BOROUGH, ALASKA

Report of Investigation 2022-1

State of Alaska
Department of Natural Resources
Division of Geological & Geophysical Surveys

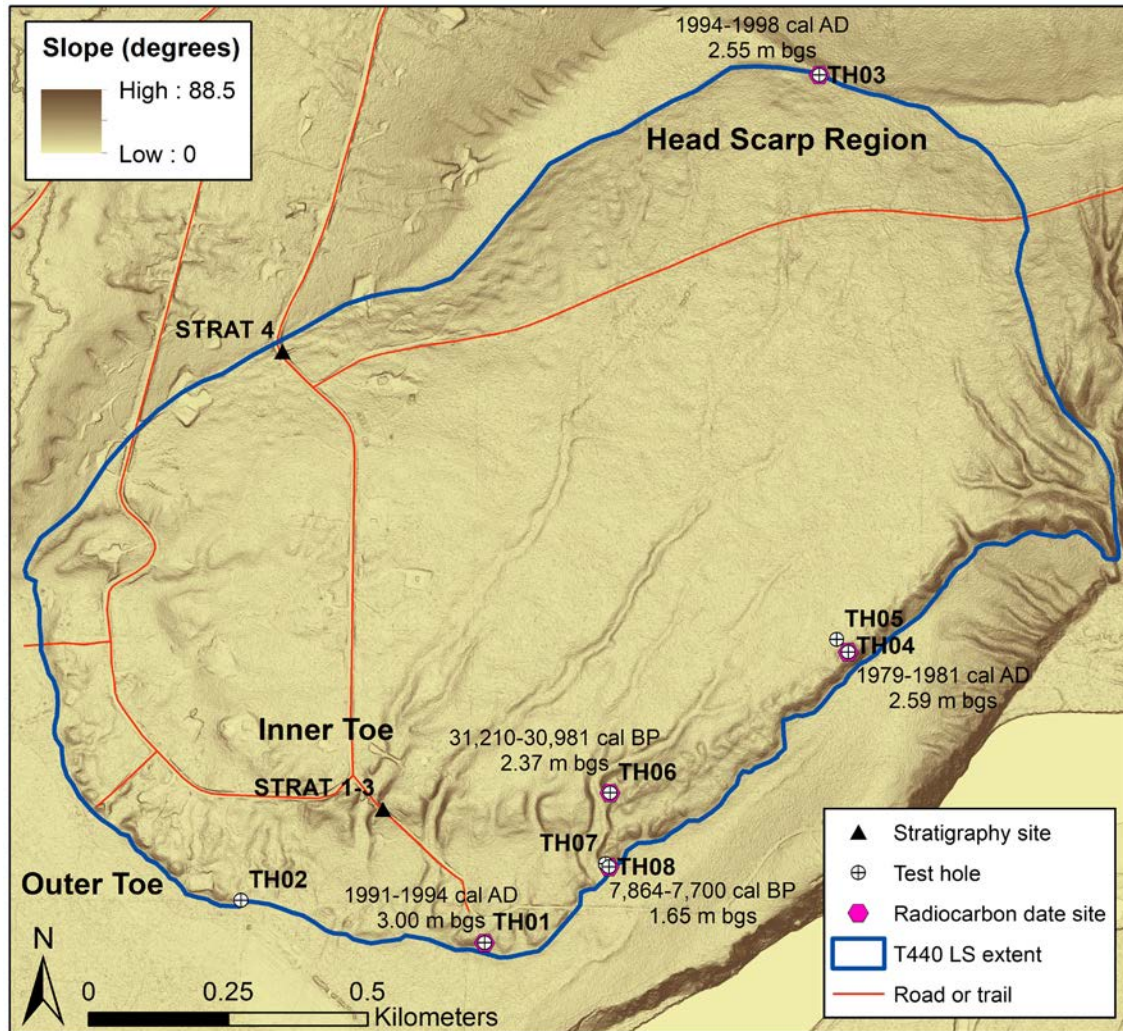
We are the first to document the extent and details of the Tanana 440 landslide (fig. 3), a large paleoslide in loess on a wooded south-facing slope adjacent to the Tanana River. The landslide is approximately 2 km (1.2 miles) by 1 km (0.6 miles) with a total areal extent of 1.9 km² (470 acres). The

Figure 3. Tanana 440 landslide showing major landslide features and test hole and stratigraphy locations. Lidar-derived slope map background (FNSB, 2020). Radiocarbon dates and depths are shown next to the corresponding test holes.

head scarp region and right flank are along the local ridgeline and there are two distinct toe deposits; referred to here as the inner and outer toe deposits. The extent of the upper left flank is unclear as the landslide flows into the adjacent valley, but the lower left flank section is a well-defined ridge of silt. Steep-walled dry gullies incise the toe deposits in several places.

The other two samples were a brown paleosol (TH06, 2.37 m [7.78 ft] bgs; from a gully cut into the inner toe) and charcoal (TH08, 1.65 m [5.41 ft] bgs; downslope of the outer toe; figs. 3, 5). The dates of these samples were 31,210–30,981 and 7,864–7,700 yr cal BP, respectively, and support the hypothesis that T440 is prehistoric. They do not provide enough information to bracket the age of this landslide conclusively, but support at least two possible interpretations:

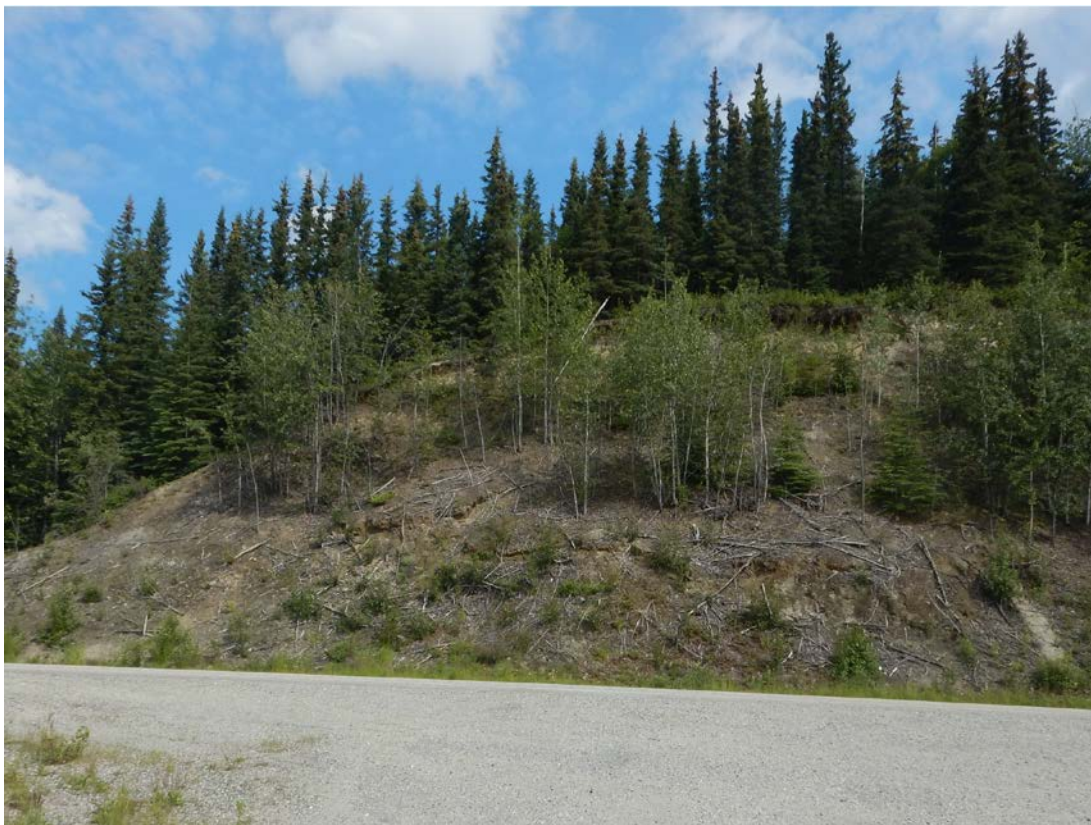
LS Name: *BigB5_7S_6E_24_SW4* **Relative Age:** *Historic (5)*
Date: *July 1, 2020* **Material:** *Earth (10)*
Personnel: *JAS, MD* **Movement Type:** *Rotational (5)*
Current Movement: *None*
Total confidence: *38/40 (High)*

We observed this small (380 m²) landslide (fig. B15B) in its entirety from the road at the base of the slope. All features of flanks (10), toe deposit (10), and head scarp (10) were easily identifiable. The inner morphology (8) included vegetation cracks and exposed soil at the scarp and throughout the body. The movement was surficial and historic.

Figure A38. Image of BigB5_7S_6E_24_SW4 from July 1, 2020; image taken from the Richardson Highway. Photograph taken by MD.

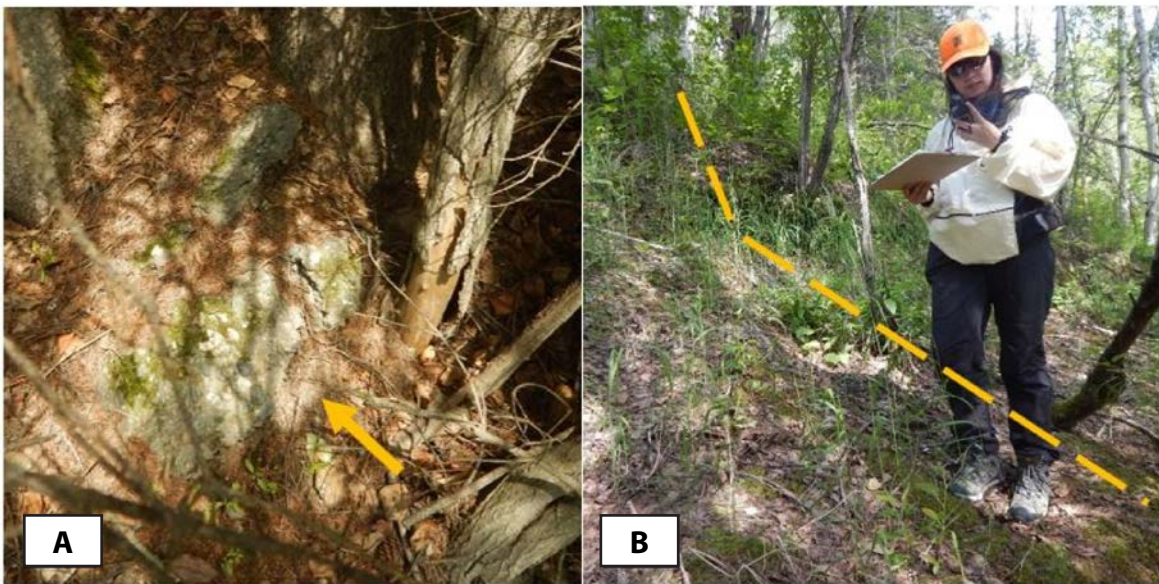
LS Name:	<i>BigB5_7S_6E_24_SE2</i>	Relative Age:	<i>Prehistoric (5)</i>
Date:	<i>July 1, 2020</i>	Material:	<i>Bedrock (5)</i>
Personnel:	<i>JAS, MD</i>	Movement Type:	<i>Rotational (5)</i>
Current Movement: <i>None</i>			
Total confidence: <i>28/40 (Moderate)</i>

We began at the toe (10) and hiked upslope along the left flank (5) toward the head scarp region (10). We saw concrete at the toe, probably a remnant from the Old Valdez Trail—the original route of the Richardson Highway. The trail was originally constructed from 1898 to 1906, and in 1919 it became the Richardson Highway (Bleakley, 2015). Inner morphology (3) included only some small slope breaks on the landslide body. Similar to BigB5_7S_6E_24_SW2, this small (695 m²) landslide (fig. B15B) may be deep-seated in the bedrock due to its clearly defined head scarp.

Figure A43. Images of BigB5_7S_6E_24_SE2 from July 1, 2020. **A.** Concrete near the toe, and **(B)** JAS standing along a slope break (indicated by dashed line) on the left flank. Photographs taken by MD.

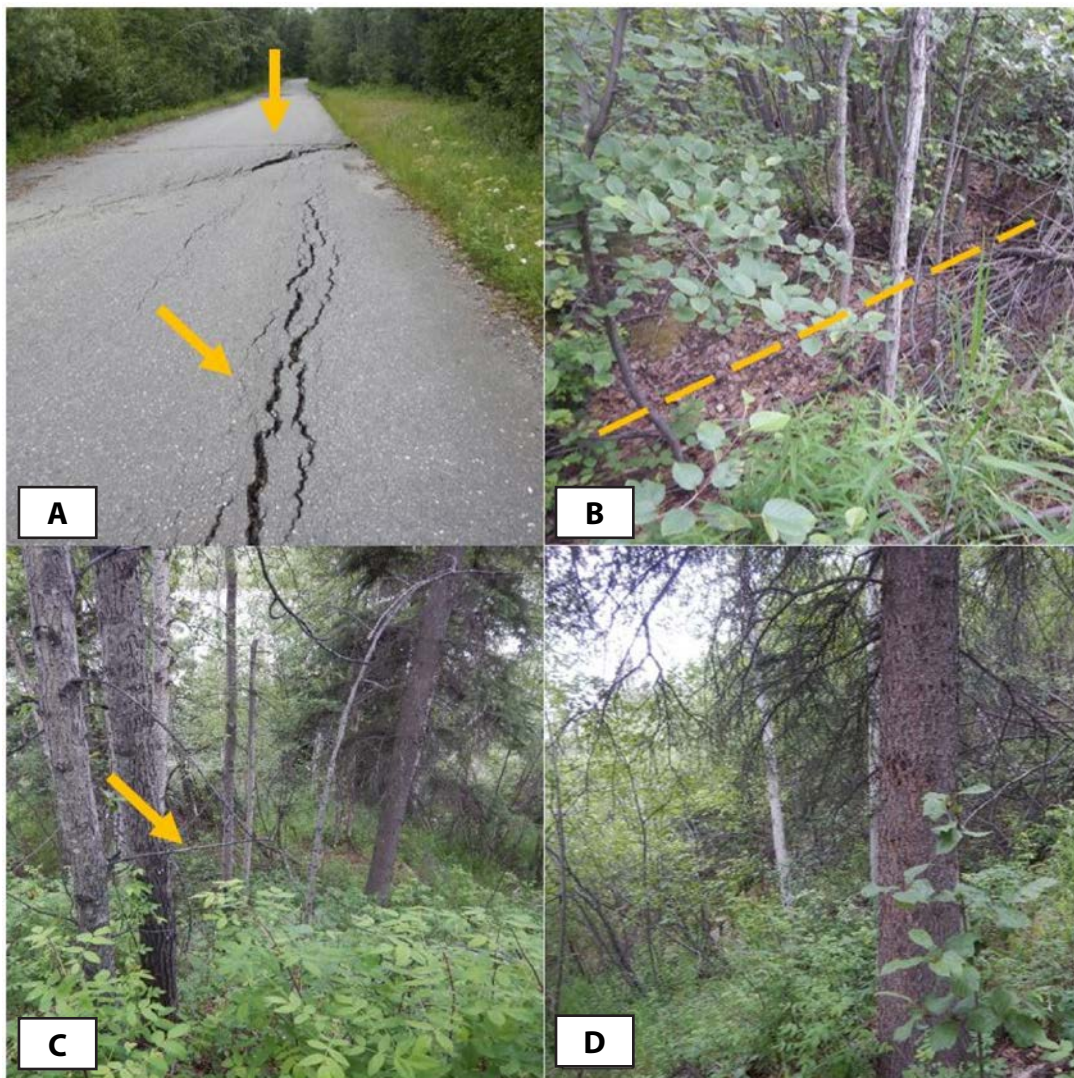
LS Name: *BigB5_7S_7E_19_SE3* **Relative Age:** *Historic (10)*
Date: *July 2, 2020* **Material:** *Bedrock (10)*
Personnel: *JAS, MD* **Movement Type:** *Rotational (5)*
Current Movement: *Yes*
Total confidence: *28/40 (Moderate)*

We hiked down to the head scarp region (10) and continued along the left flank (5). The right flank was not surveyed, and we only observed the toe deposit (5) from upslope. We found tension cracks along the access road just above the head scarp region. We also saw inner morphological features (8) of cracks and down-dropped blocks within the landslide body (fig. B16A). This small landslide is historic, but the straight mature vegetation on the steep slopes indicates that there has been no recent movement in the main landslide body. The cracks in the access road may indicate the onset of activity.

Figure A44. Images of BigB5_7S_7E_19_SE3 from July 2, 2020. **A.** Cracks on the access road above the head scarp region, **(B)** crack (indicated by dashed line) below the road, **(C)** view downslope toward a slope break (indicated by arrow) and down-dropped block, and **(D)** straight mature spruce tree on a steep slope below the head scarp area. Photographs taken by MD.

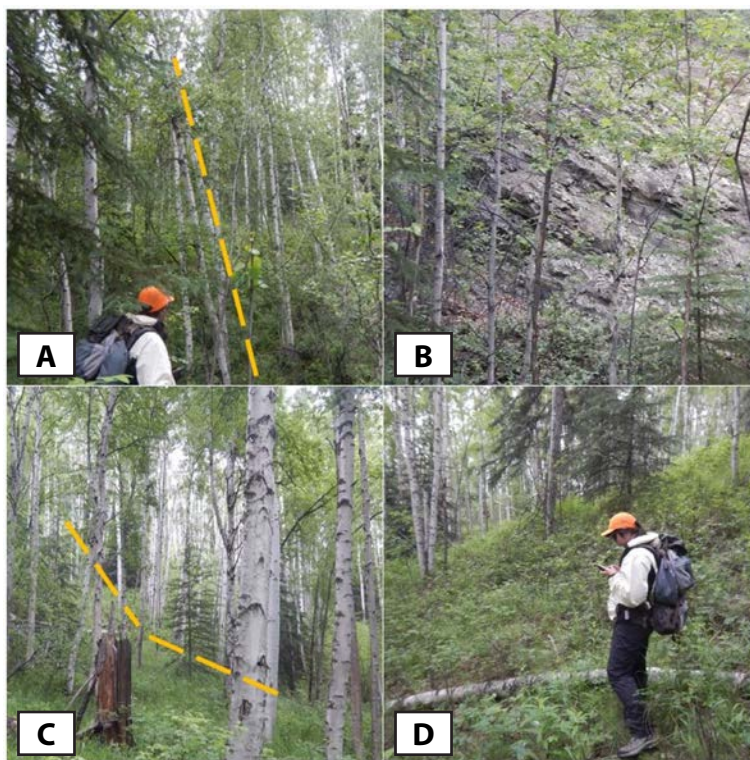
LS Name:	<i>BigB5_7S_7E_20_SW8</i>	Relative Age:	<i>Prehistoric (10)</i>
Date:	<i>July 2, 2020</i>	Material:	<i>Bedrock (10)</i>
Personnel:	<i>JAS, MD</i>	Movement Type:	<i>Rotational (5)</i>
Current Movement: <i>None</i>			
Total confidence: <i>40/40 (High)</i>

We hiked along the lower landslide body and toe deposits (10) from west to east, and then traveled upslope along the left flank (5) and across the middle landslide body toward the head scarp region (10). We moved along the head scarp region to the right flank (5) and returned downslope to the highway. Inner morphological features (10) included cracks, grabens, closed depressions, down-dropped blocks, and mid-slope terraces. We saw leaning trees along the lower landslide body. We hypothesize that this large, deep-seated landslide in bedrock is prehistoric, with some historic movement on the lower body and at the toe. We saw rock exposures on the lower landslide body and within historic scarp exposures. The head scarp region was interesting, as the slope break along the left extent was much steeper than the right. This may be due to bedrock control and the orientation of planes of weakness. It is unlikely that permafrost is present in this landslide, as the vegetation was typically birch and aspen forest with grassy ground cover. The landslide was likely triggered in the past due to the toe being eroded by the river.

Figure A45. Images of BigB5_7S_7E_20_SW8 from July 2, 2020. **A.** JAS and leaning trees (dashed line indicates direction of lean) below the Old Valdez Trail on the lower landslide body, **(B)** bedrock exposure below the Richardson Highway on the lower landslide body, **(C)** steep slope of the head scarp (dashed line indicates slope break), and **(D)** JAS standing along the right flank near the head scarp region. Photographs taken by MD.

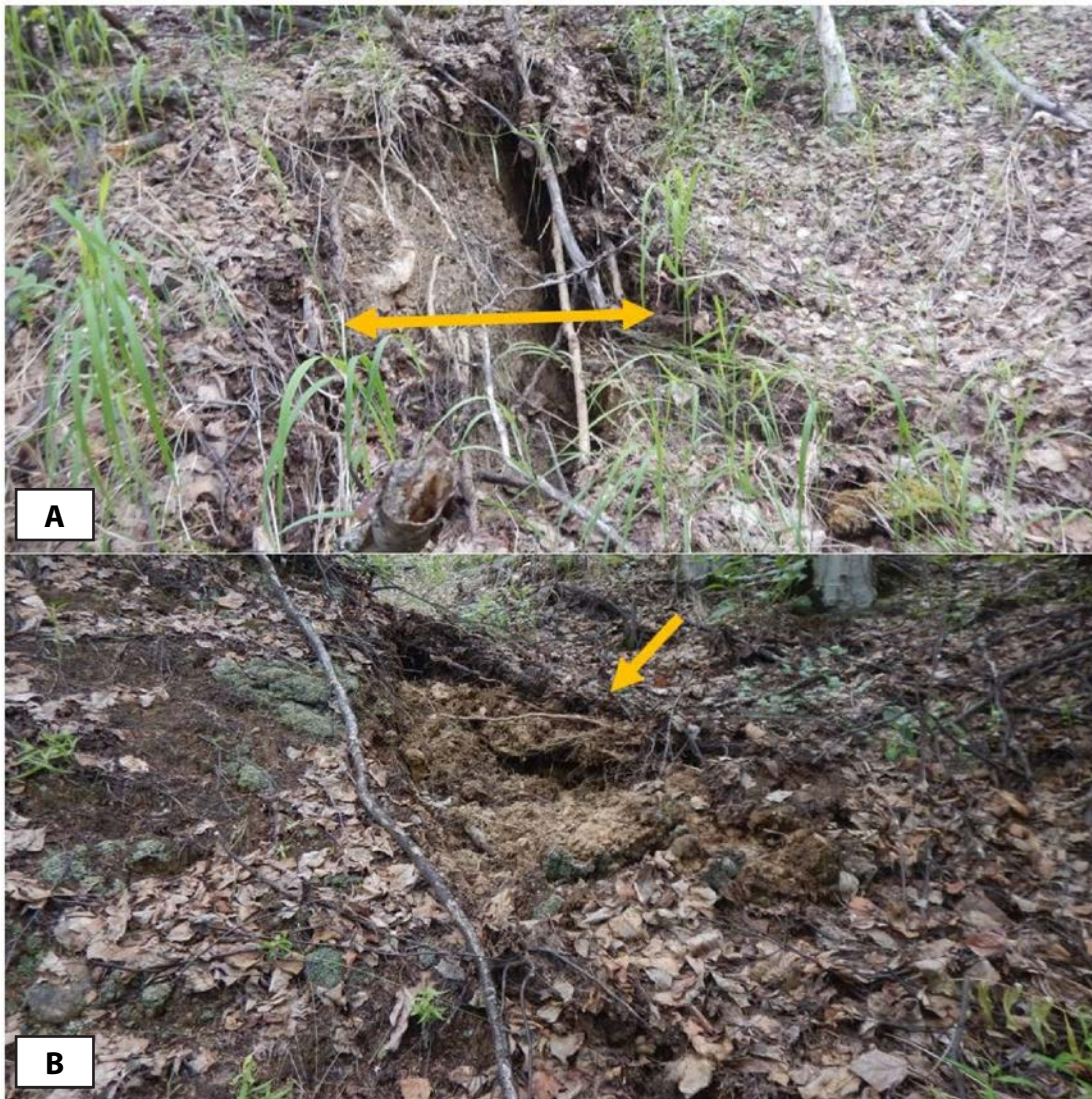
We hiked along the right flank (5) and head scarp region (10), then down the landslide body toward the left flank (5) and toe deposit (10). Inner morphological features (8) and vegetative movement indicators included large cracks and leaning trees, respectively. The cracks we observed were all fresh, and this small landslide is likely currently moving because the toe is being eroded by the Tanana River.

Figure A47. Images of BigB5_7S_7E_20_SW5 from July 2, 2020. **A.** Crack with exposed soil along the right flank (arrows indicate separation), and **(B)** crack with exposed soil (indicated by arrow) at the head scarp. Photographs taken by MD.

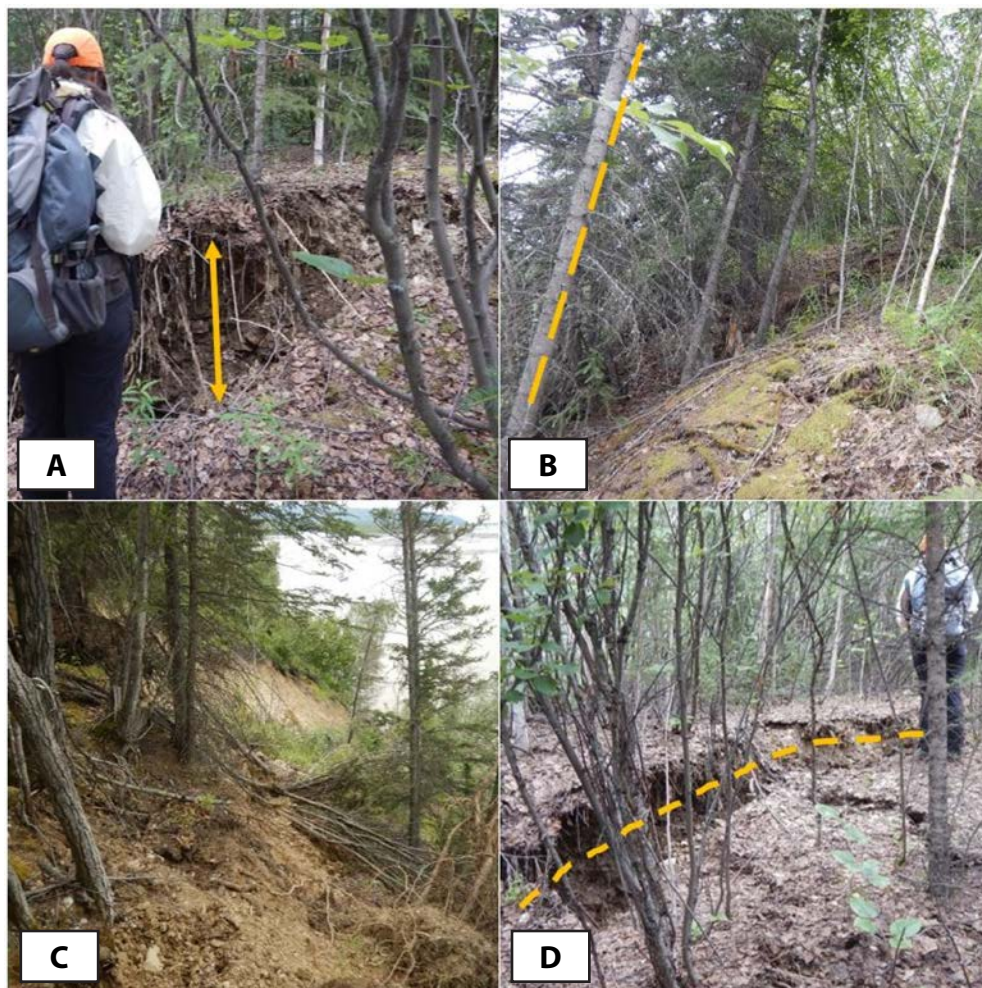
LS Name: *BigB5_7S_7E_20_SW6* **Relative Age:** *Historic (10)*
Date: *July 2, 2020* **Material:** *Bedrock (5)*
Personnel: *JAS, MD* **Movement Type:** *Rotational (5)*
Current Movement: *Yes*
Total confidence: *40/40 (High)*

We hiked along the head scarp region (10) and then down the landslide body toward the toe deposit (10). The flanks (10) were easy to identify. Inner morphological features (10) included large cracks, small gullies and grabens, and down-dropped blocks. Vegetative movement indicators included leaning trees on the landslide body. Cracks occurred throughout the landslide, from the head scarp region to the toe deposit. These cracks were all fresh and indicate recent landslide movement, likely due to the toe being eroded by the Tanana River.

Figure A48. Images of BigB5_7S_7E_20_SW6 from July 2, 2020. **A.** JAS standing on a dropped block with a relatively fresh crack (arrows indicate separation), **(B)** cracks with leaning trees (dashed line indicates direction of lean), **(C)** head scarp with exposed soil near the river, and **(D)** JAS and a relatively fresh crack (dashed line positioned mid-crack). Photographs taken by MD.

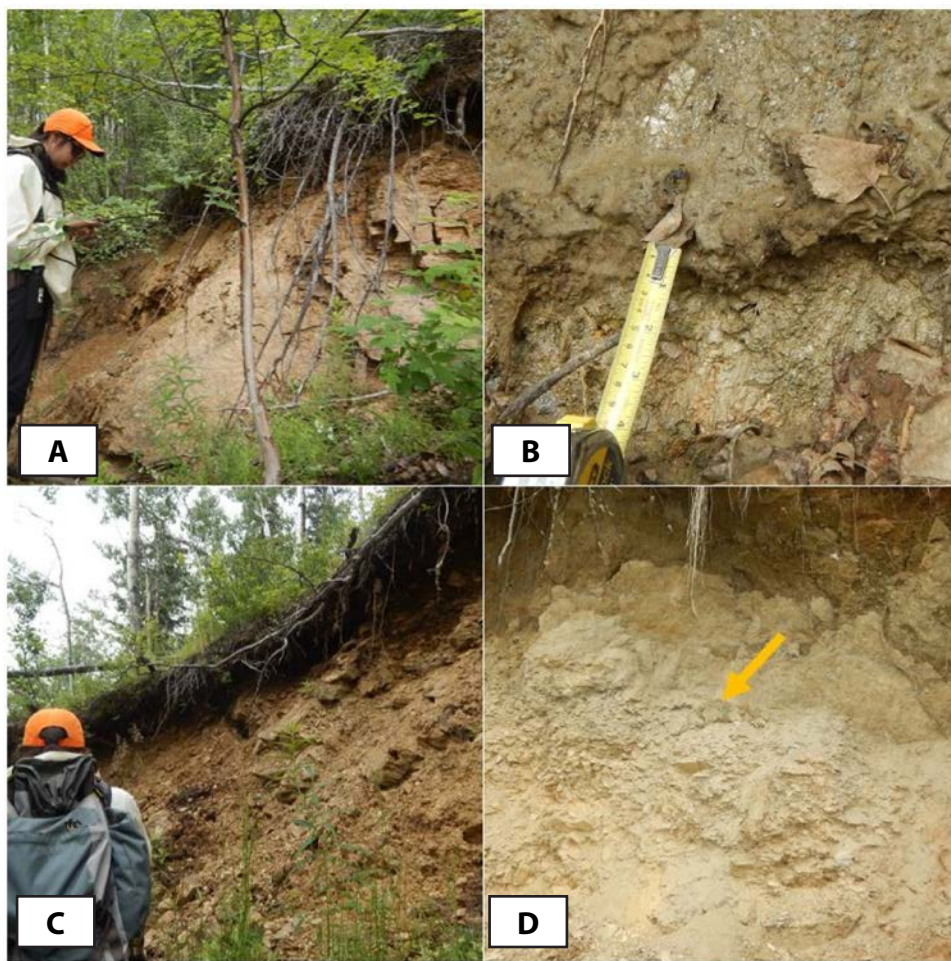
Heavy rain events—We saw some evidence of recent landslide movement during our summer 2020 fieldwork likely caused by high precipitation causing high pore water pressure (fig. A49).

LS Name:	<i>BigB5_7S_7E_20_SW4</i>	Relative Age:	<i>Historic (10)</i>
Date:	<i>July 2, 2020</i>	Material:	<i>Bedrock (10)</i>
Personnel:	<i>JAS, MD</i>	Movement Type:	<i>Rotational (5)</i>
Current Movement: <i>Yes</i>			
Total confidence: <i>34/40 (High)</i>

We observed surface roughness of the lower landslide body and toe deposit region (8) from the Richardson Highway. Then we hiked upslope through the body toward the left flank (4) and head scarp region (10), eventually angling toward the right flank (2). Inner morphological features (10) included surface roughness on the landslide body and down-dropped blocks. We observed blocky bedrock in all of the head scarp exposures. This small landslide is historic, and we observed evidence of recent movement, including about 10 cm of displacement in the soil at the head scarp.

Figure A49. Images of BigB5_7S_7E_20_SW4 from July 2, 2020. **A.** JAS standing in front of exposed bedrock at the head scarp, **(B)** approximately 10 cm of recent movement at the head scarp likely caused by high precipitation, **(C)** JAS standing in front of the right flank and scarp with exposed soil and bedrock, and **(D)** a light gray ash layer (indicated by arrow) in the exposed head scarp. Photographs taken by MD.

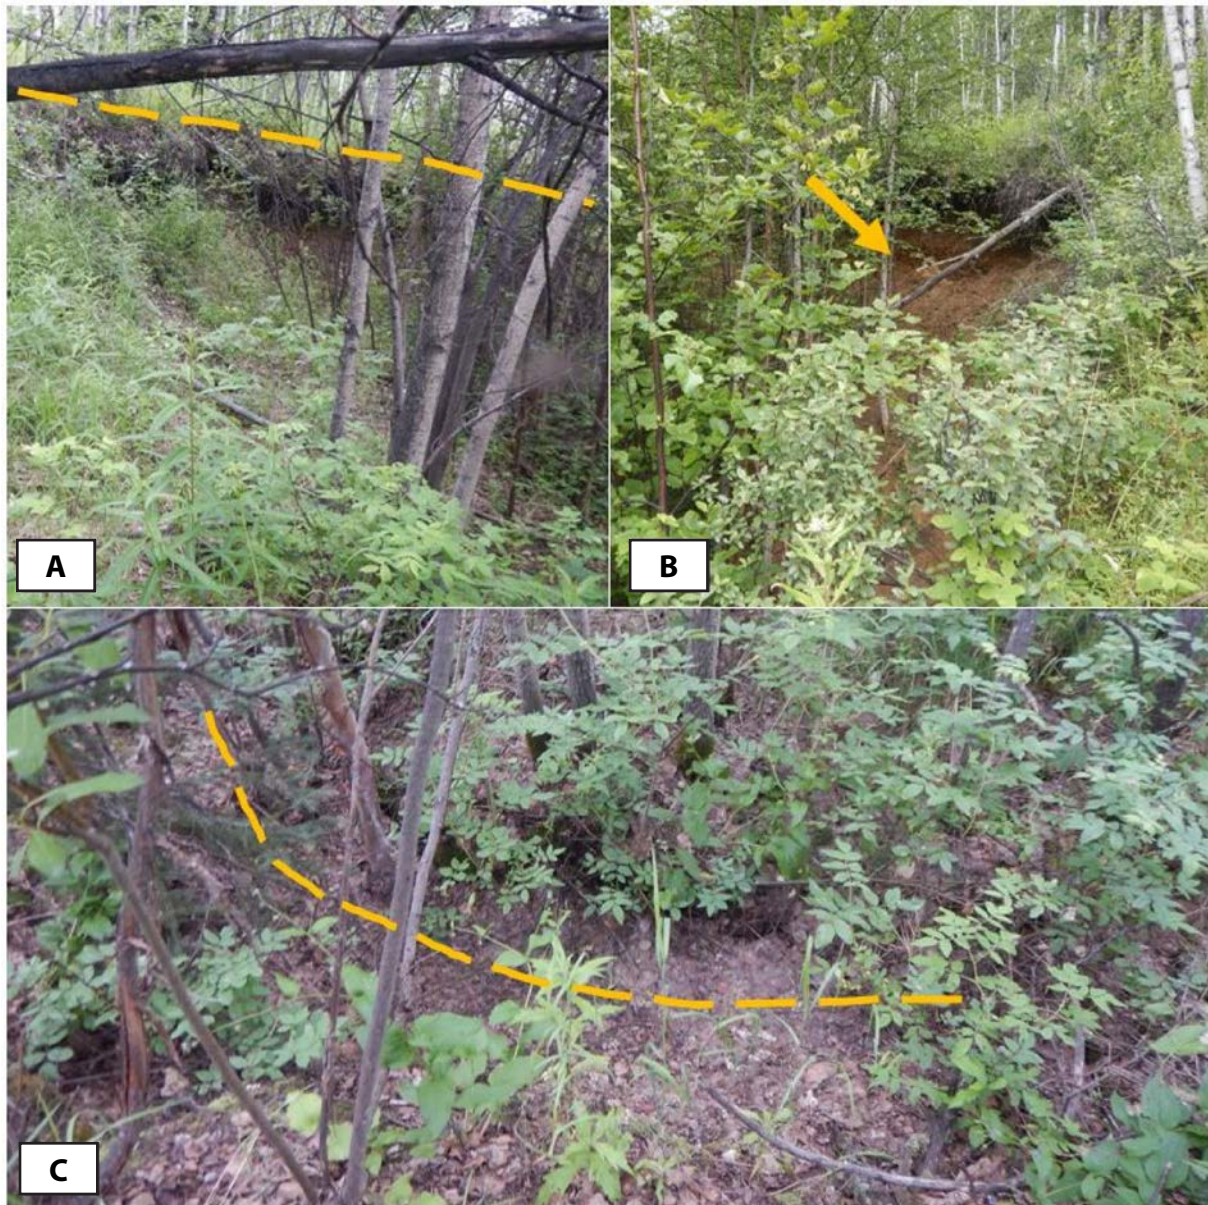
LS Name: *BigB5_7S_7E_19_SE1* **Relative Age:** *Historic (10)*
Date: *July 2, 2020* **Material:** *Bedrock (5)*
Personnel: *JAS, MD* **Movement Type:** *Rotational (5)*
Current Movement: *Yes*
Total confidence: *35/40 (High)*

We hiked down to the head scarp region (10) and continued downslope along the left flank (5) toward the toe (10) of the landslide (fig. B16A). We did not observe the right flank in the field. Inner morphology (10) included cracks in the upper landslide body and fresh soil exposures in the scarps.

Figure A50. Images of BigB5_7S_7E_19_SE1 from July 2, 2020. **A.** Lower head scarp (top of scarp indicated by dashed line), **(B)** fresh soil exposure (indicated by arrow) at the upper head scarp, and **(C)** crack (indicated by dashed line) just below the head scarp region. Photographs taken by MD.

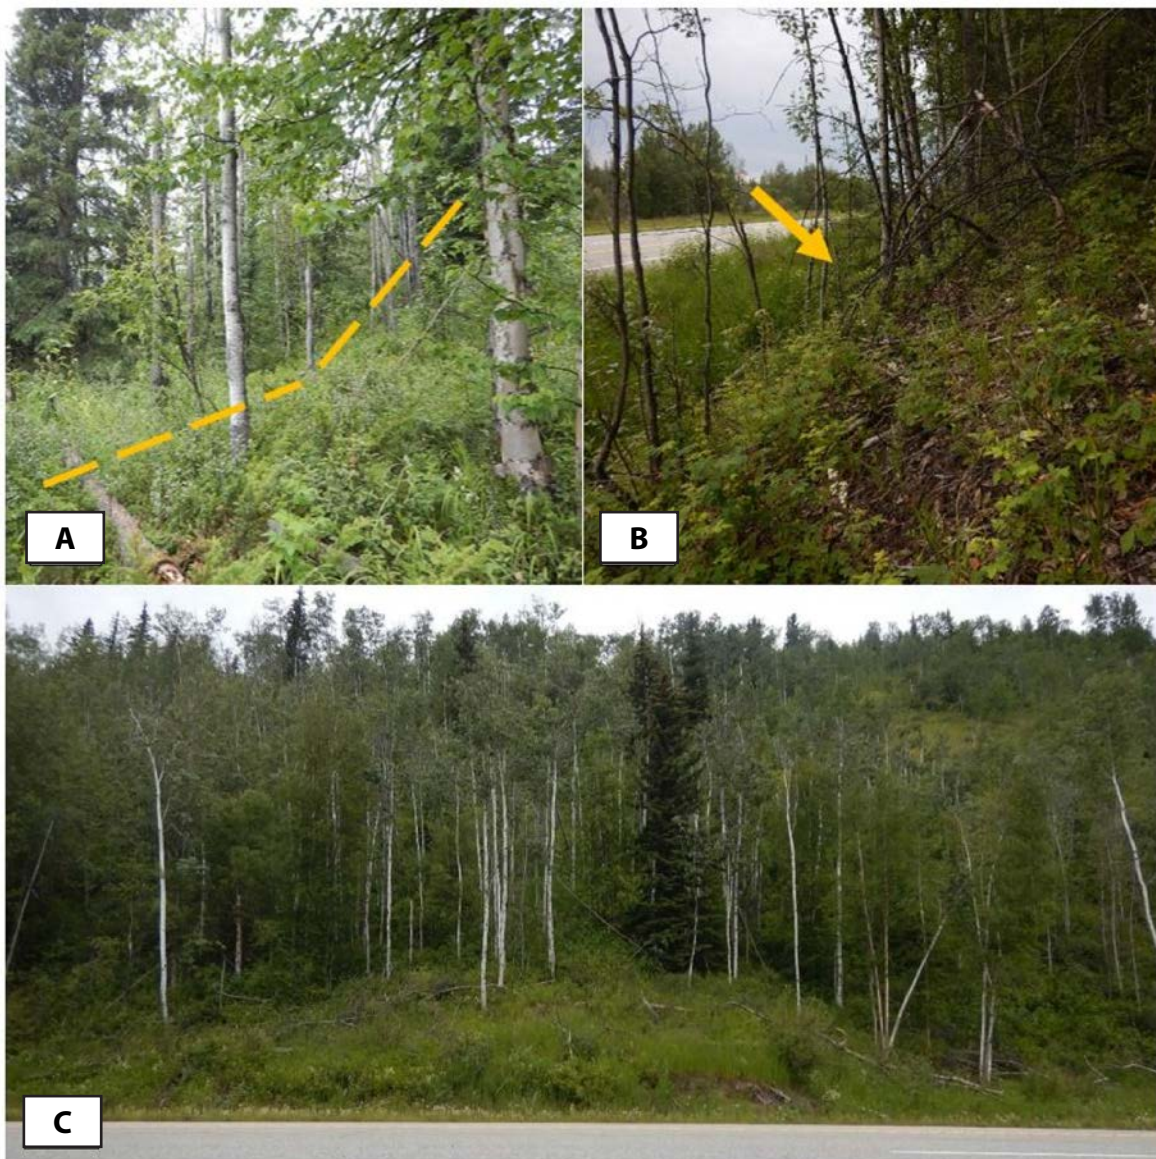
We began at the toe deposit (10) and then hiked upslope along the left flank (5) toward the head scarp region (10) of the landslide (fig. B16B). The right flank was apparent (5), and we observed inner morphological features (3). The head scarp was covered in vegetation and there were no fresh soil exposures. It appears that the toe has bulged out toward the road, which leads us to think that it may be a historic surficial landslide.

Figure A51. Images of BigB5_7S_6E_24_SE1 from July 2, 2020. **A.** View of the head scarp region with a slope break (indicated by dashed line), **(B)** the landslide toe deposit (indicated by arrow), and **(C)** looking straight upslope at the landslide from the toe. Photographs taken by MD.

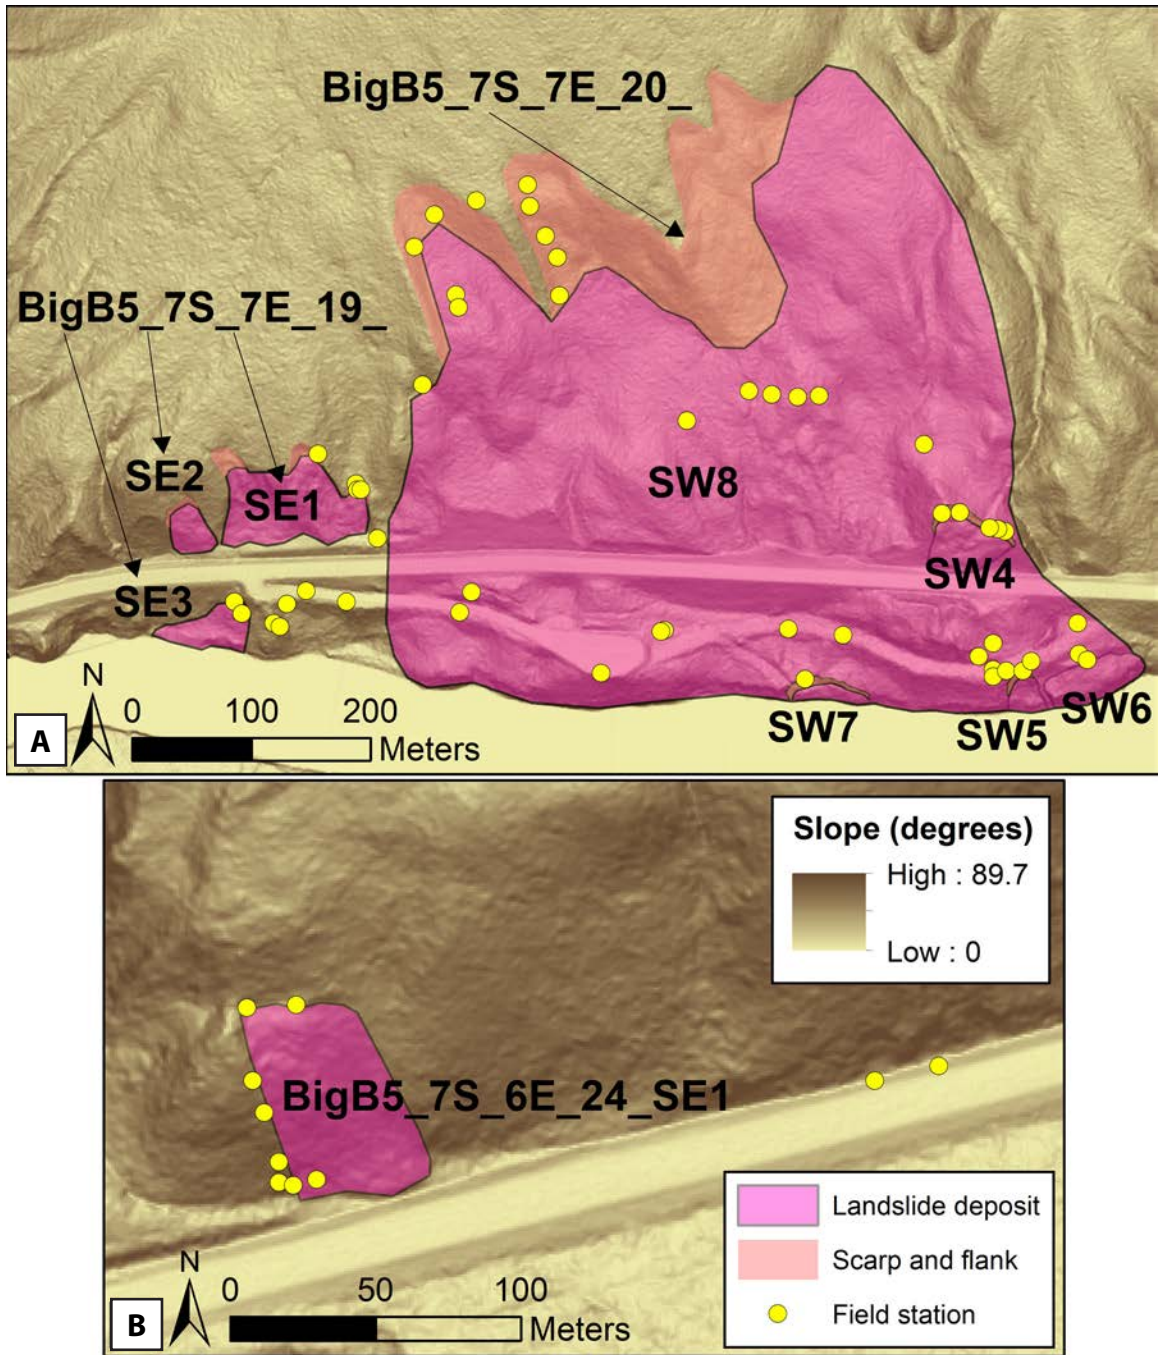
Figure B16. Mapped landslide deposits and field stations from July 2, 2020. **A.** Landslide complexes and **(B)** small landslide along the Richardson Highway. The background is QL2 lidar-derived slope map (FNSB, 2020).

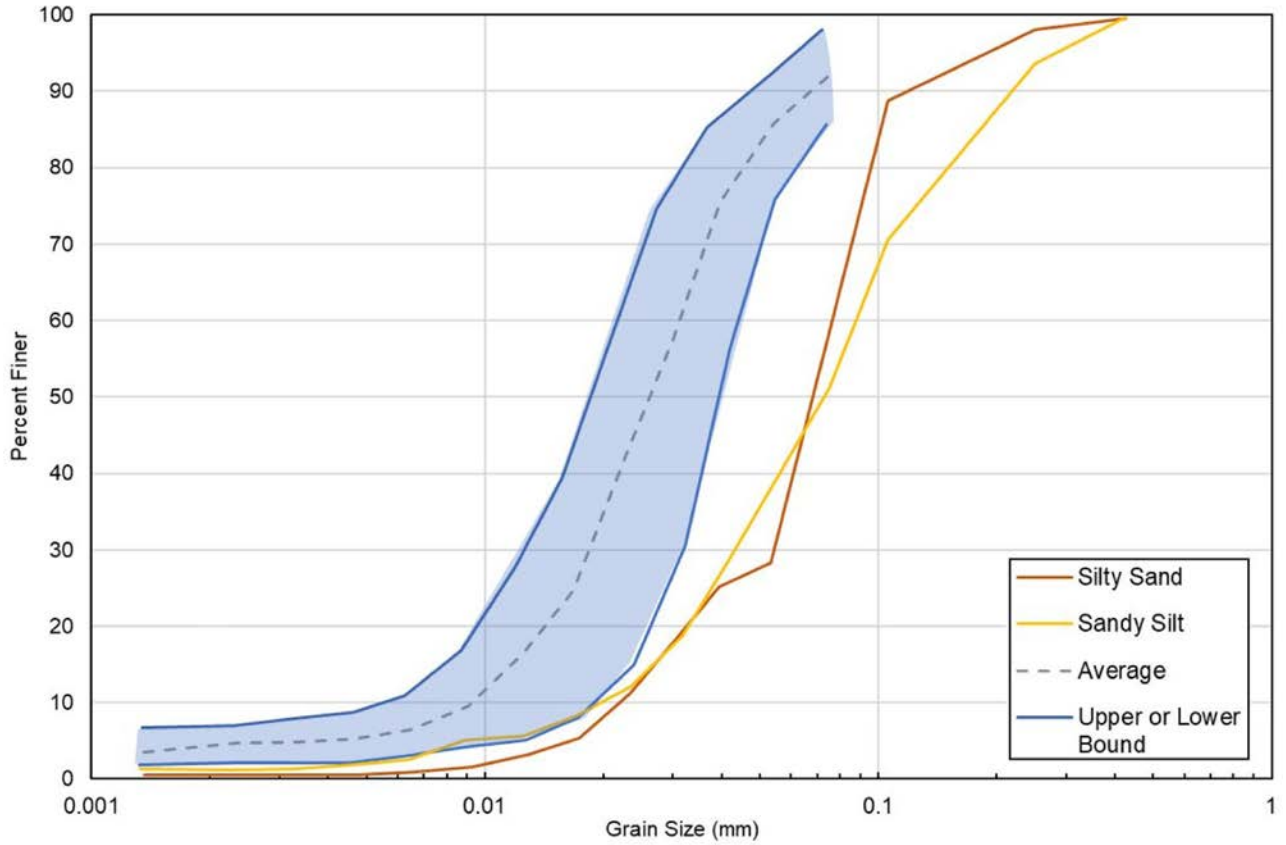
Figure C1. Particle size analysis of the T440 landslide samples. The blue lines indicate the upper and lower boundaries of the grain size distributions of all hydrometer-tested materials (N = 18), and the dotted gray line is the approximate average grain-size distribution within the shaded blue region. There was one discrete sample each of silty sand and sandy silt.
