RECONNAISSANCE REPORT ON GEOLOGY OF EKULINA LAKE DAM SITE AND CONDUIT ROUTE NEAR ANCHORAGE, ALASKA

A. F. Bateman, Jr.

**U. S. Geological Survey
Great Falls, Montana**

August 1947

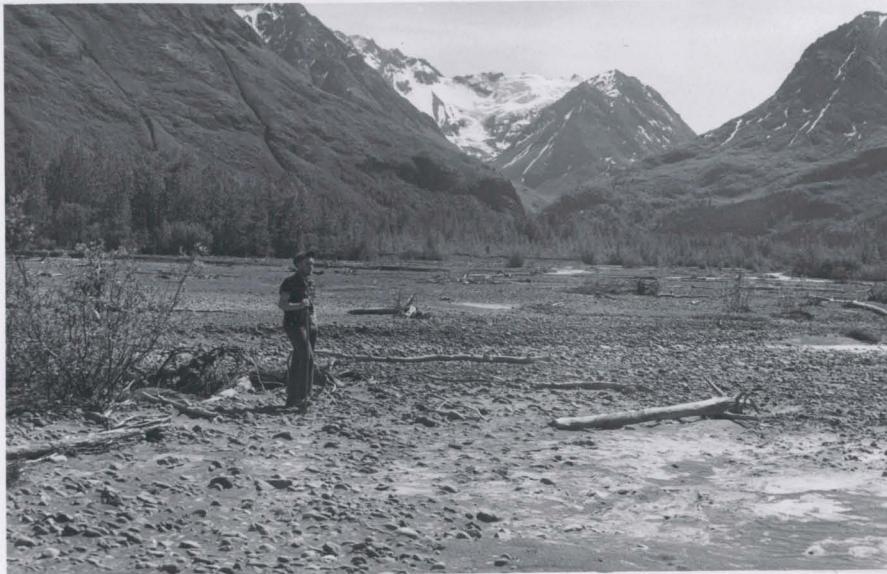
Plate I. View up Eklutna Valley from about a quarter of a mile above head of Eklutna Lake, showing surface of alluvium partially filling valley in this stretch. This is upper end of reservoir area for proposed dam. In center background are ice fields which feed main tributary to Eklutna Creek.

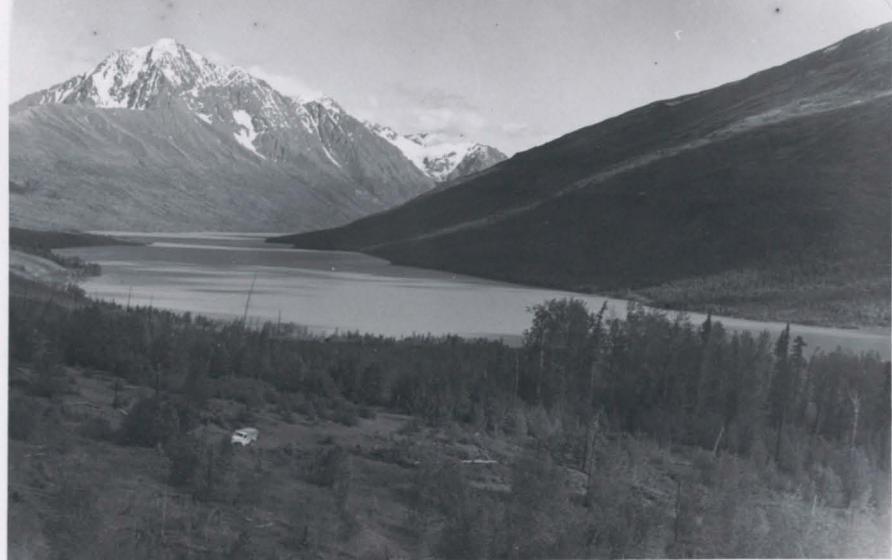
Plate II. View upvalley showing portion of Eklutna Lake from point on valley wall about a quarter of a mile downstream from right abutment and at about 1,500 feet altitude.

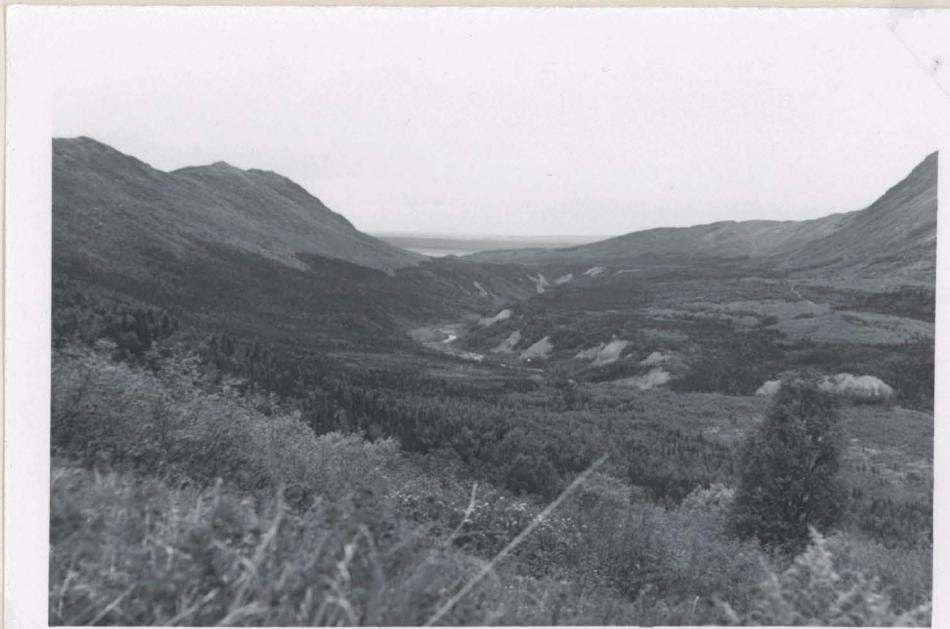
Plate III. View down Eklutna Valley from altitude 2,120 feet on hill south of dam site. Steep upper valley walls are bedrock. River occupies narrow inner gorge cut into glacial deposits filling valley to about 1,000 feet in altitude. Conduit route would be along gravel cliffs in center middle ground. Knik Arm in distance.

3. Delivery of water from the forebay of the reservoir to the powerhouse eight miles downvalley by means of a conduit is regarded as infeasible because: difficult terrain of the route will require earthwork more expensive than the volume of the dam; the route is subject to land slides, and will require expensive maintenance; it is more or less completely exposed to adverse winter conditions that may engender icing conditions; and it is easily subject to sabotage. It is recommended that the water be taken to the powerhouse through a rock tunnel.

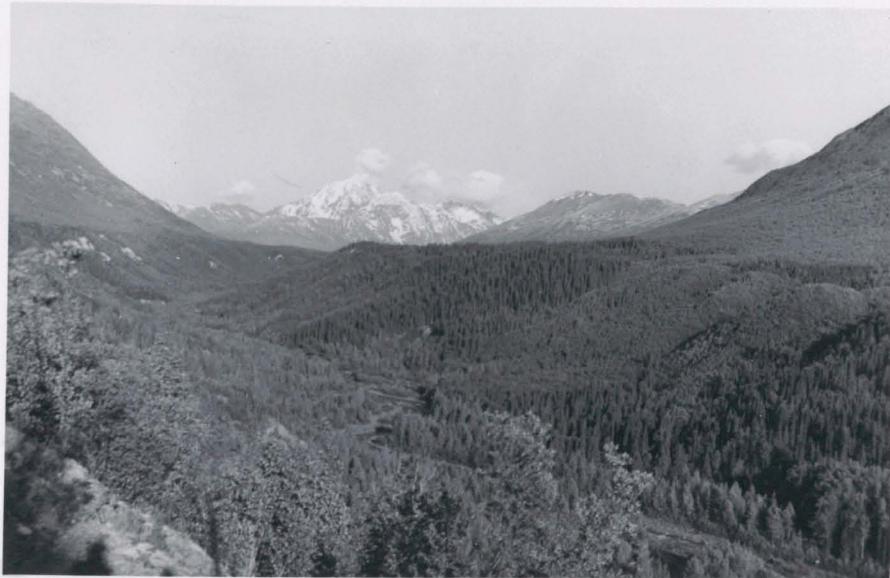
Plate IV. View up Eklutna Valley from point on rim of inner gorge $6\frac{1}{2}$ miles by road below dam site and at 700 feet altitude. Top of glacial deposits filling valley which shows up as the nearly flat surface in middle ground is at about 1,000 feet altitude.

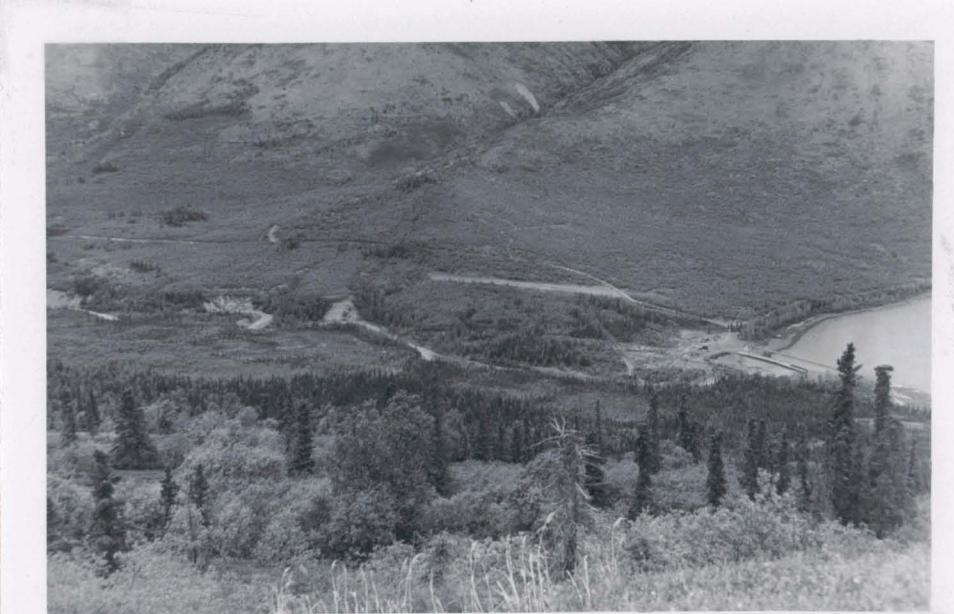
Plate IX. View of dam site from altitude 2,120
on hill south of dam site. Present dam at
outlet of Eklutna Lake in right fore-
ground. Landing strip in center of middle
ground.

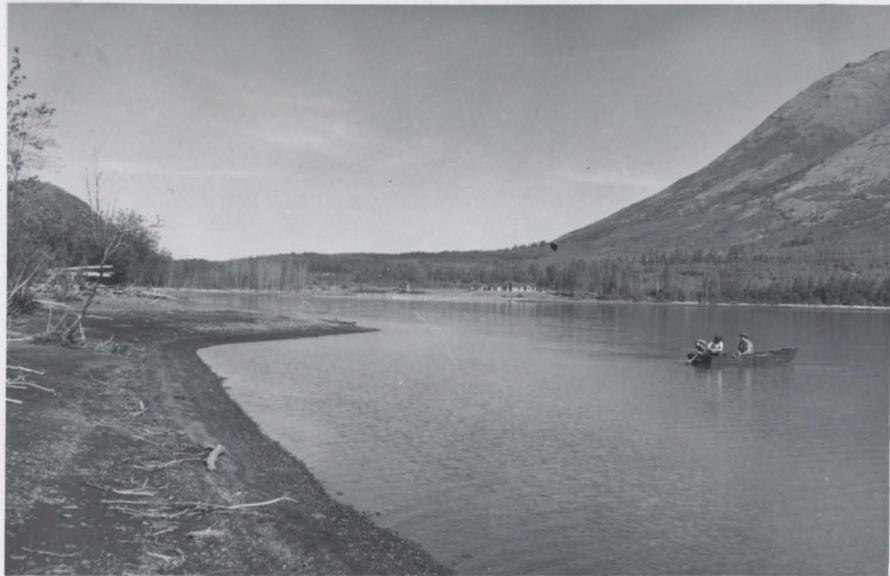
Plate XI. View of dam site from about three-quarters
of a mile up left shore of Eklutna Lake.
