Alaska Railroad Terminal
Reserve, Anchorage
Soil stability study

Stability in the vicinity of
Boring Lines 1 and 2

David J. Varnes

Open-file report

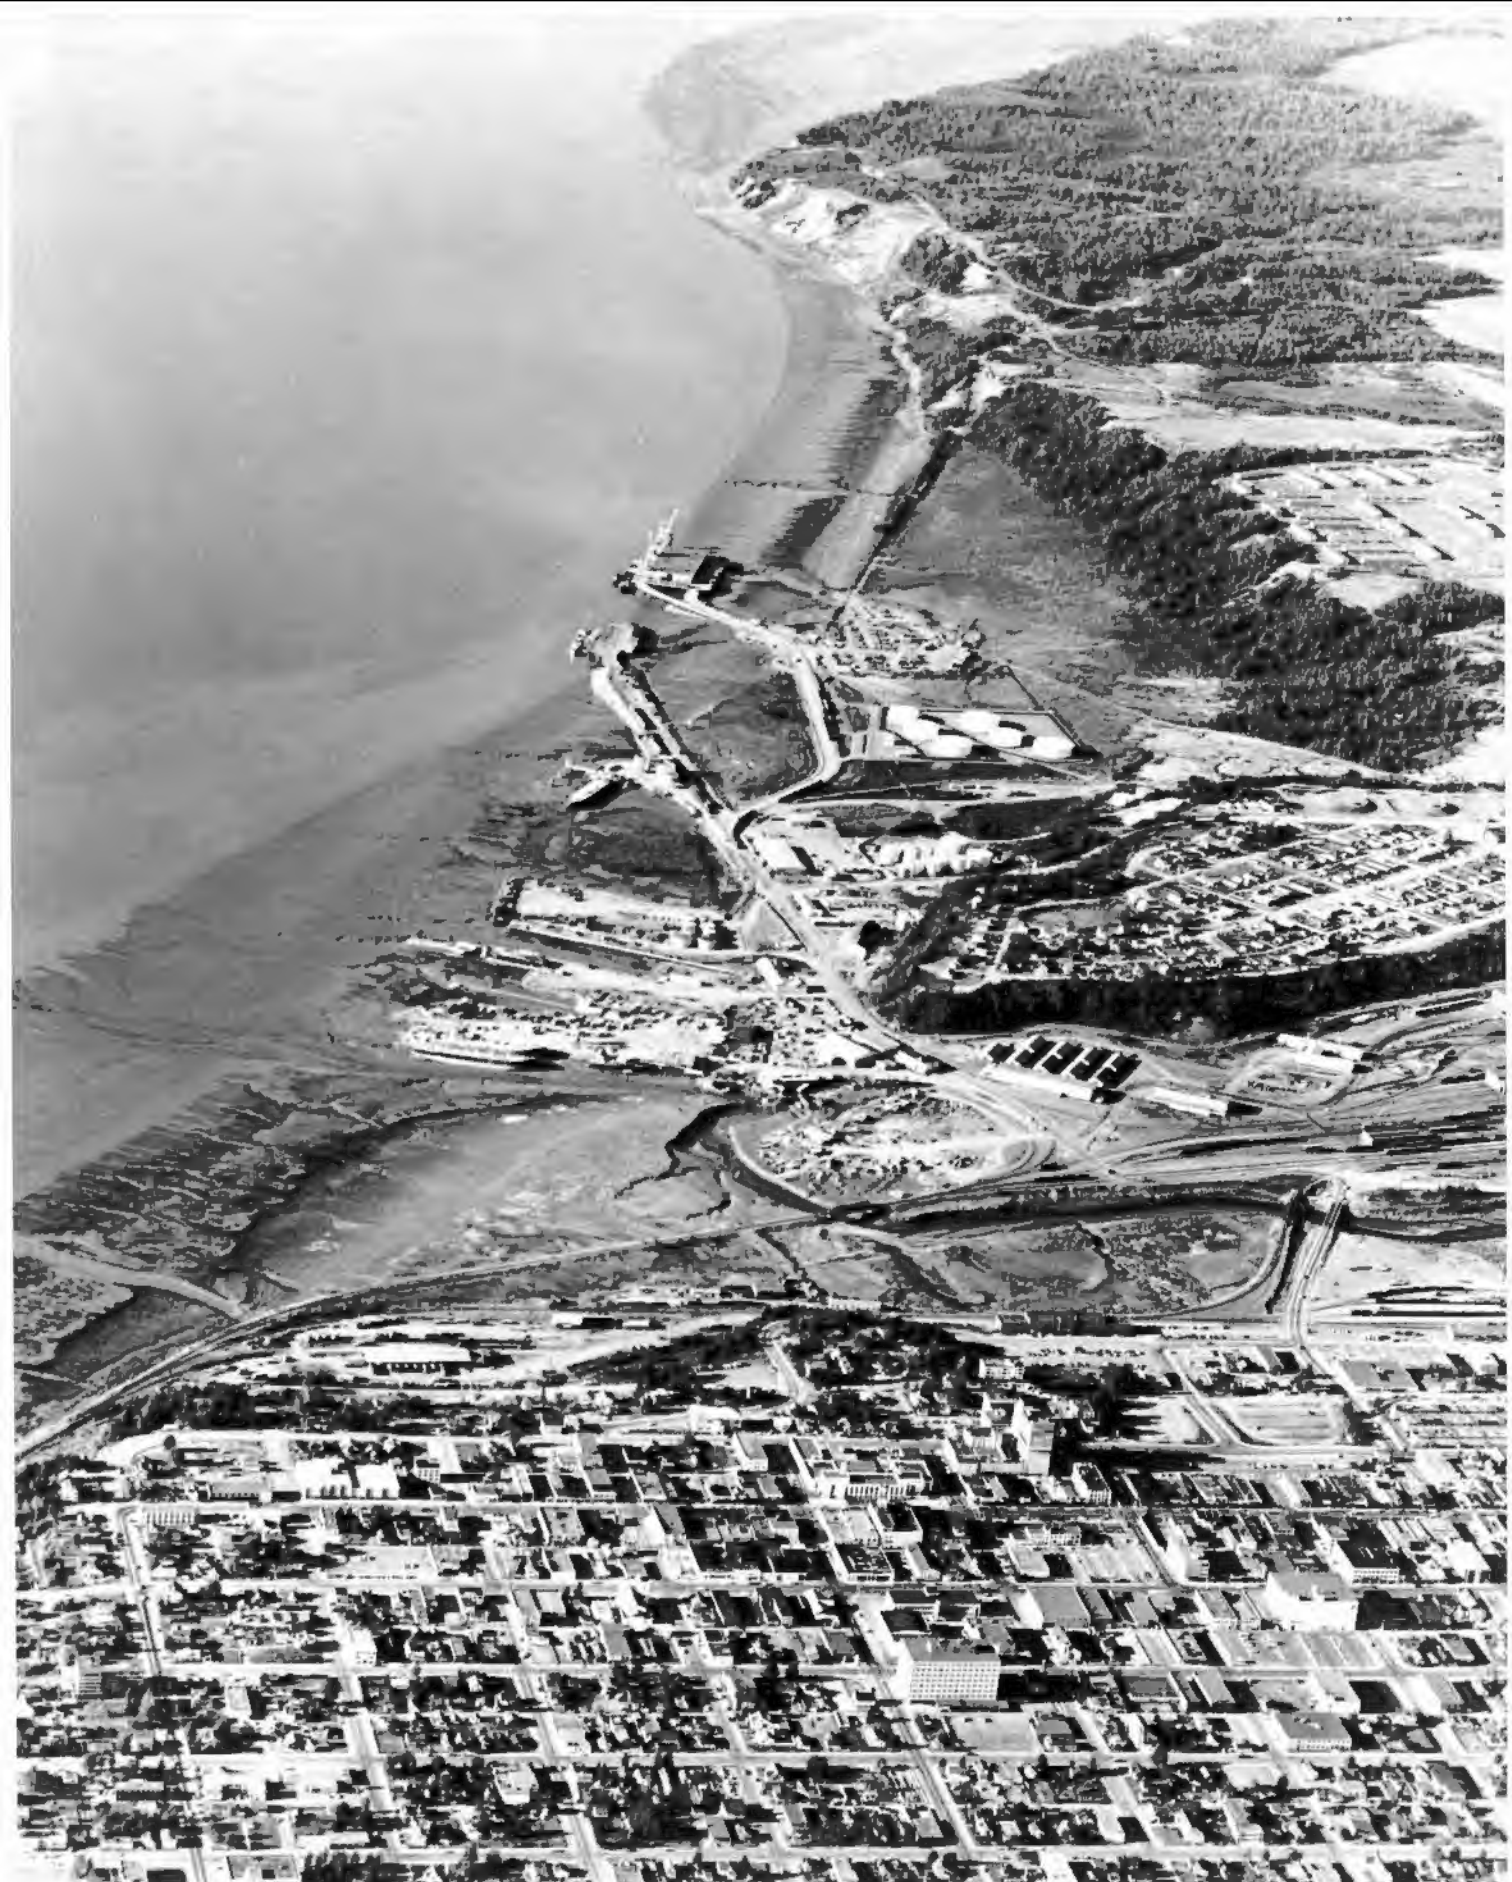
FIG. 1

Figure 1.--Looking northward toward the port area from over the main part of the city of Anchorage, Alaska. Business district is in right foreground. Ship Creek flows to the left into Knik Arm of Cook Inlet. Government Hill rises beyond Ship Creek in right center. In the middle distance is Army Dock, and beyond is the newly constructed City Dock. Photograph taken August 11, 1963, by Steve McCutcheon, Anchorage.

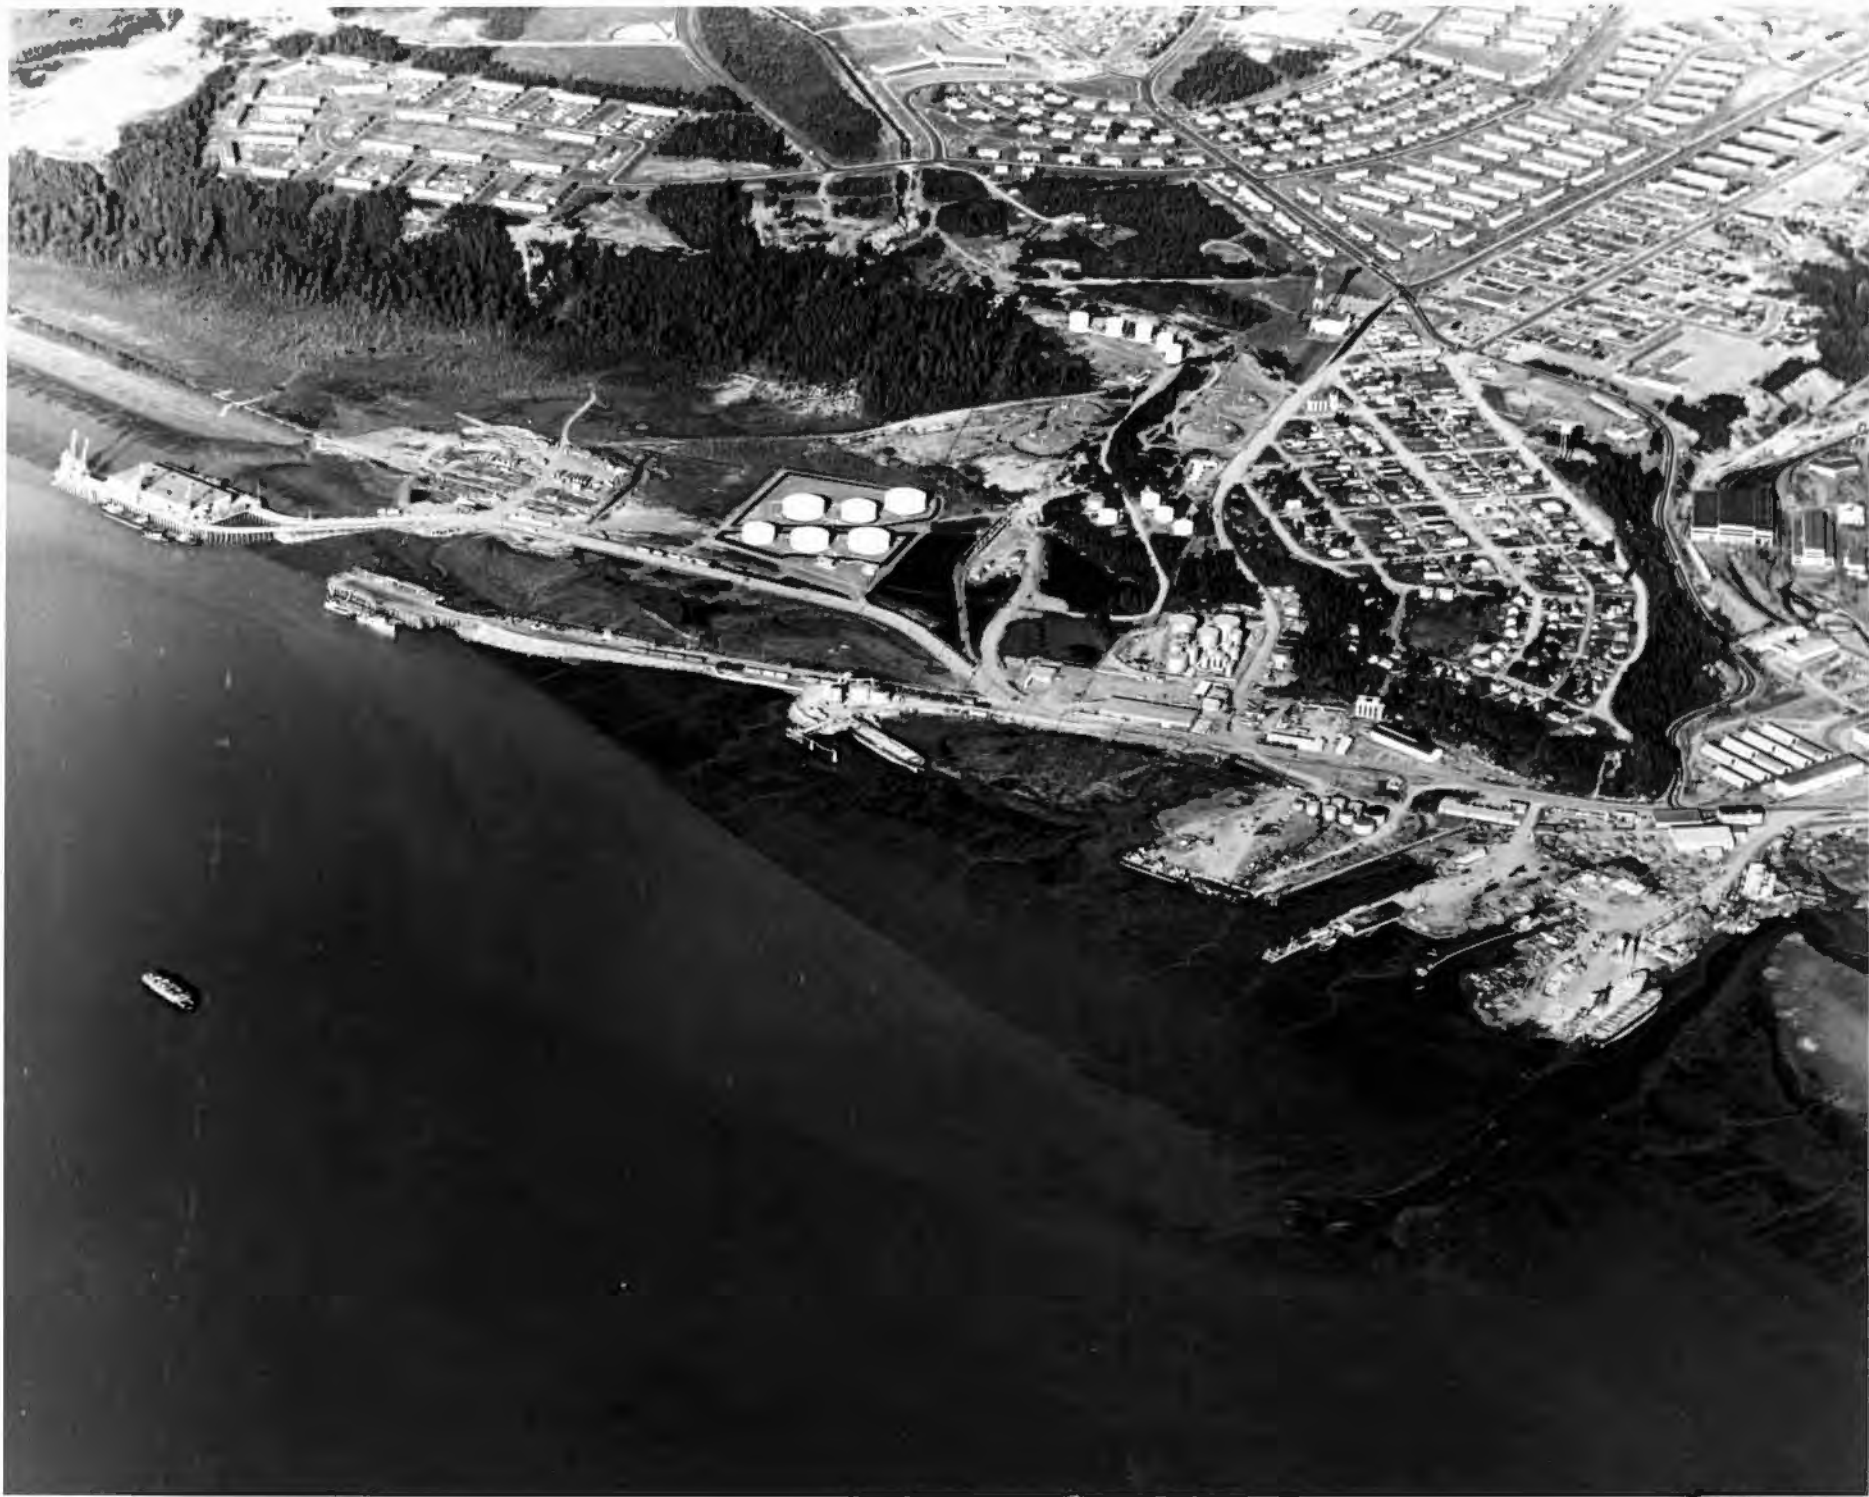
FIG. 2

Figure 2.--Looking eastward toward the port area of Anchorage, Alaska, from over Knik Arm. Photograph taken August 11, 1963, by Steve McCutcheon, Anchorage.

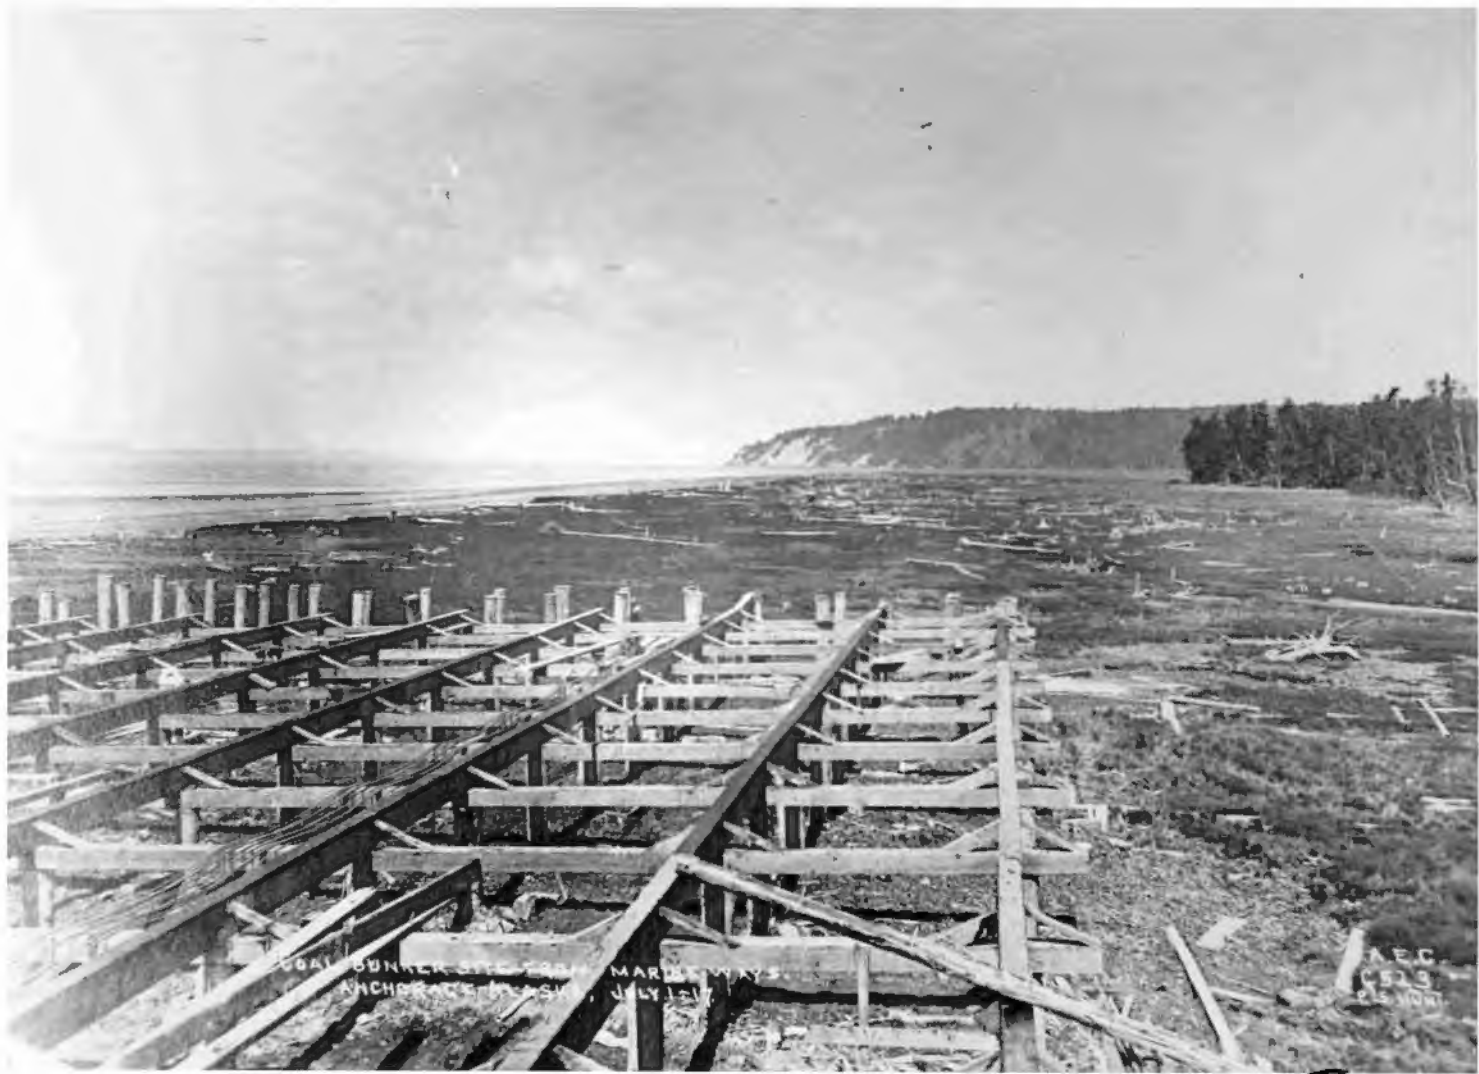
FIG. 5

Figure 5.--Coal bunker site from marine ways, Anchorage, Alaska, July 1, 1917. Photograph by Alaskan Engineering Commission. Toe of flow-slide is in the woods at the right.

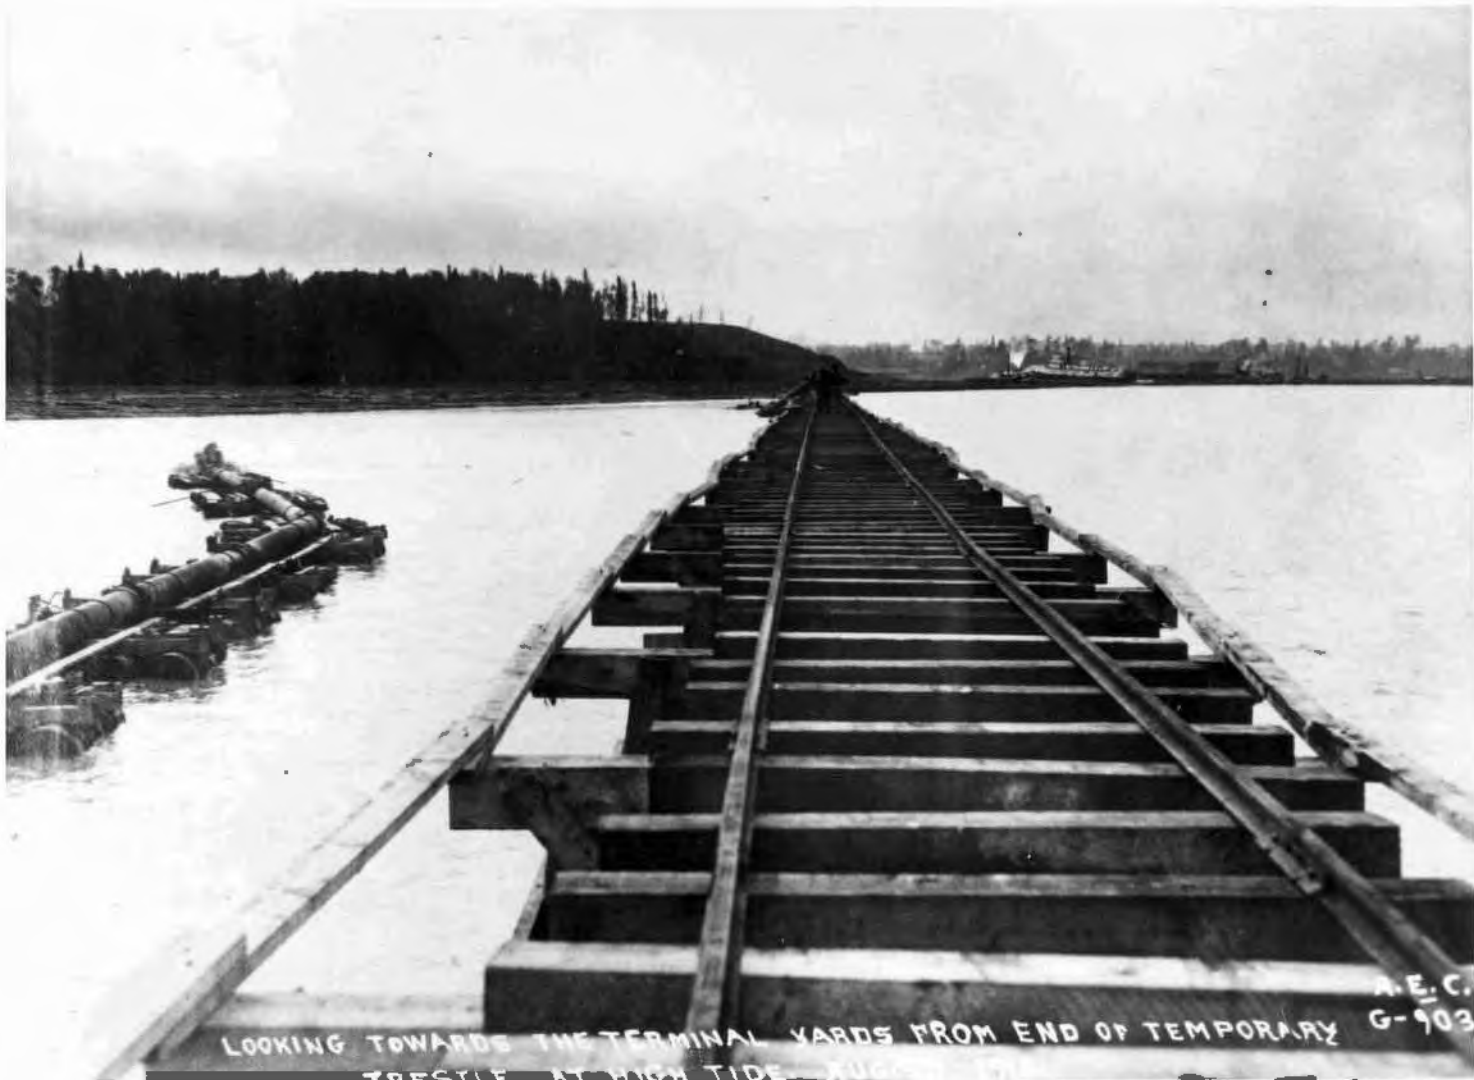
FIG. 10

Figure 10.--Looking towards the terminal yards from end of temporary trestle at high tide, Aug. 20, 1918. Photograph by Alaskan Engineering Commission.

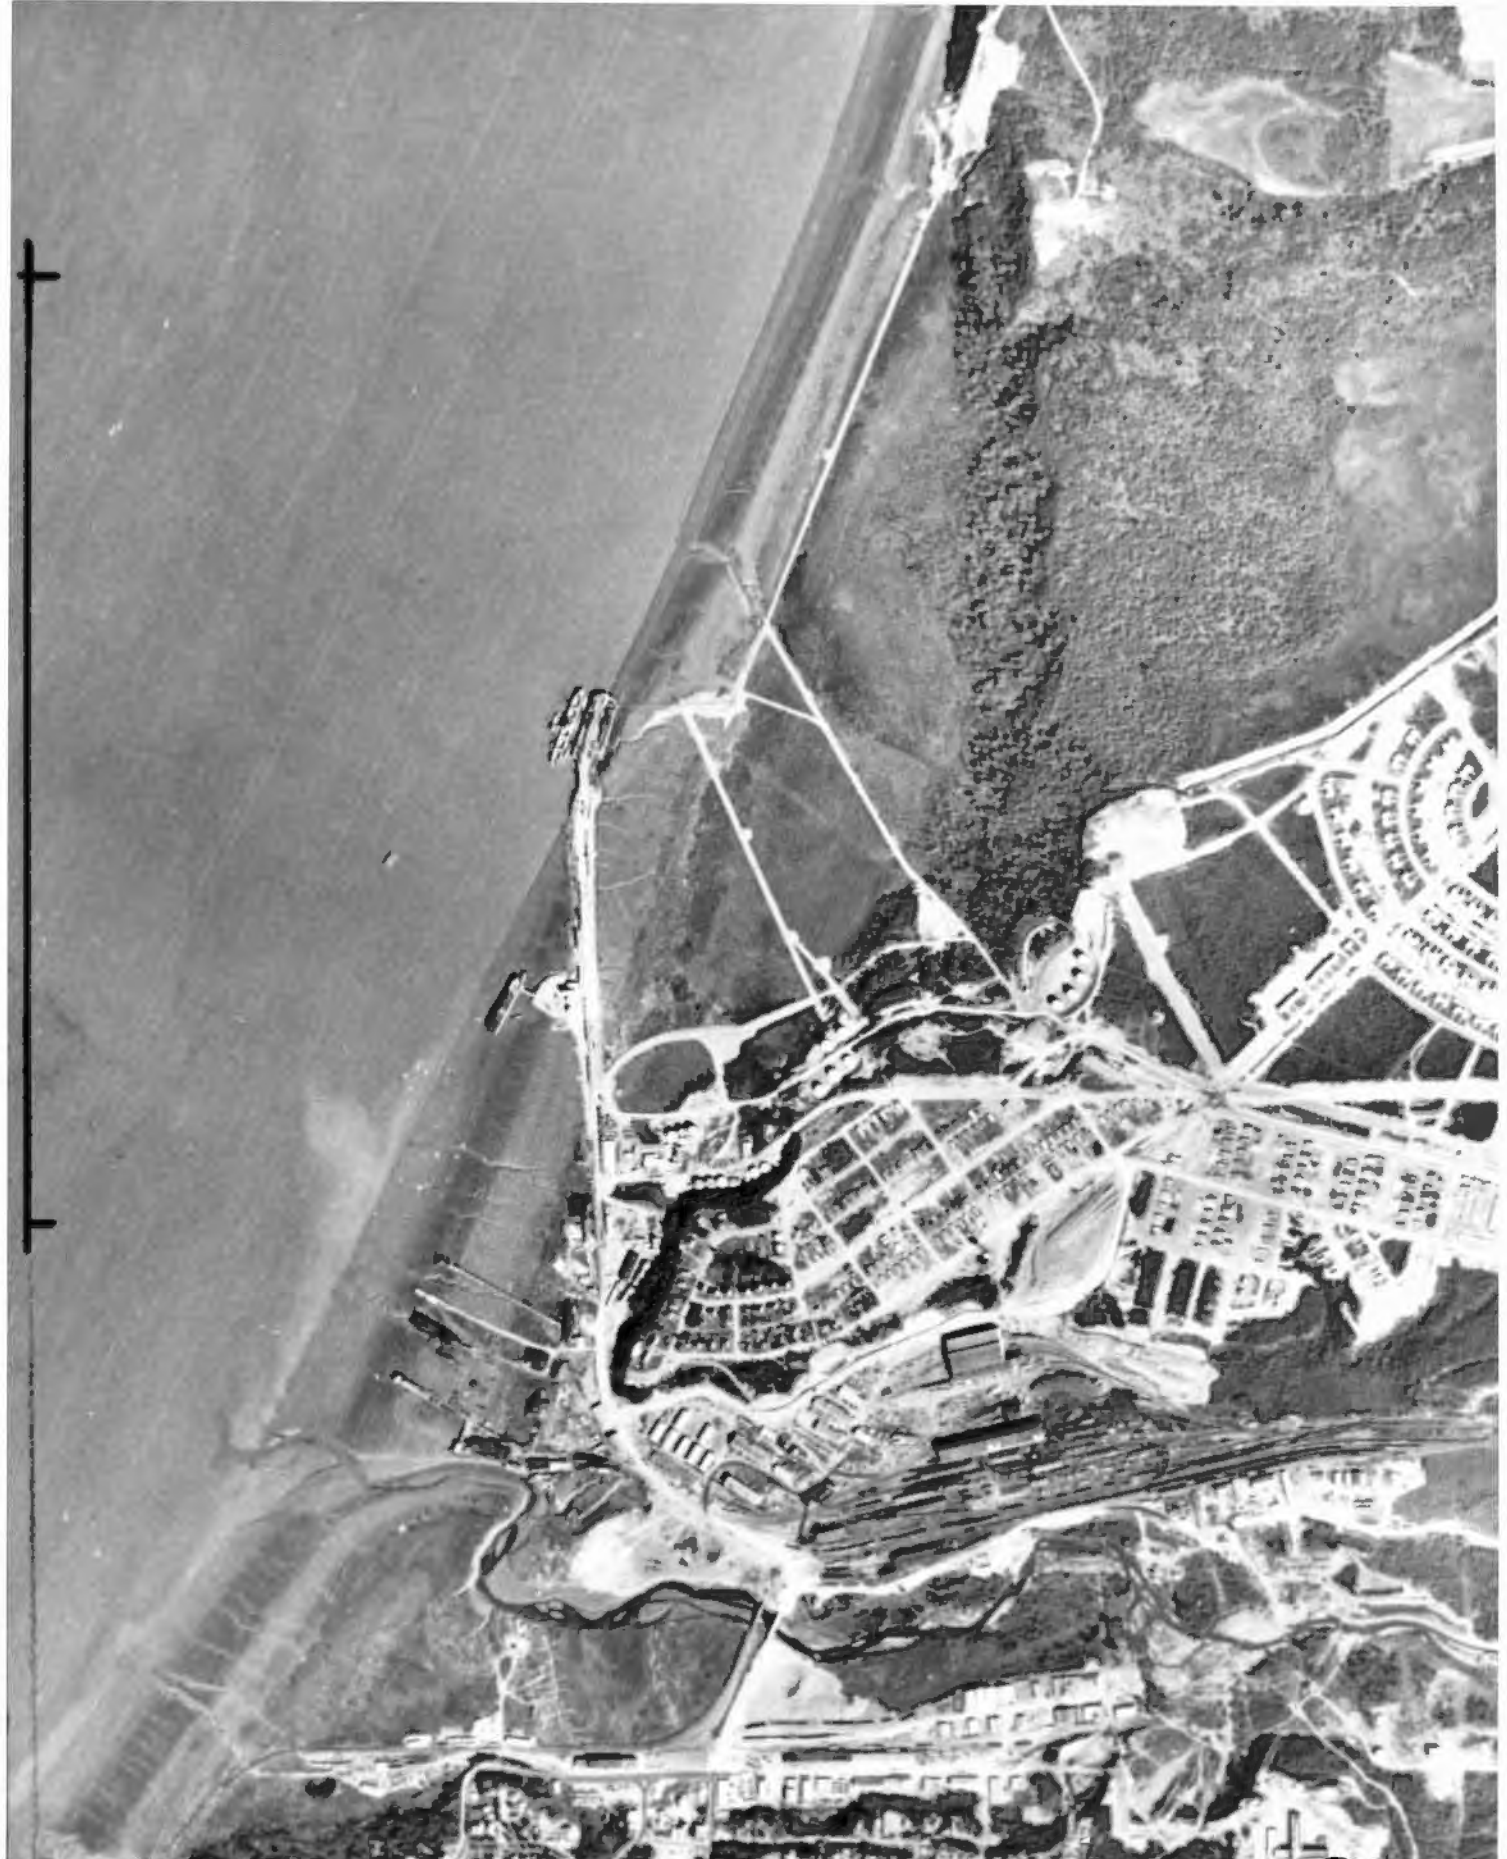
FIG. 13

Figures 11-19.--Vertical aerial views of the port area, Anchorage, Alaska, 1942-67. Photographs from various sources have been brought to a common scale of about 1,000 feet to an inch by enlargement of parts of single prints or reduction of uncontrolled mosaics. Distance between ticks on bar is about 5,000 feet; bar is oriented about N-S. Date of photography is shown on print.

The progressive derangement of the natural drainage in recent years is evident from the aerial photographs reproduced as figures 11-19. Part of this is due to new fills, dikes, and roads. It is possible that much of the standing water could be removed, and that ponds could be at least partly drained prior to filling them in. Improved drainage could decrease hazards of instability.
