CHANNEL EROSION SURVEYS ALONG THE TAPS ROUTE, ALASKA, 1977

78-611

by
Robert M. Loeffler
and
Joseph M. Childers

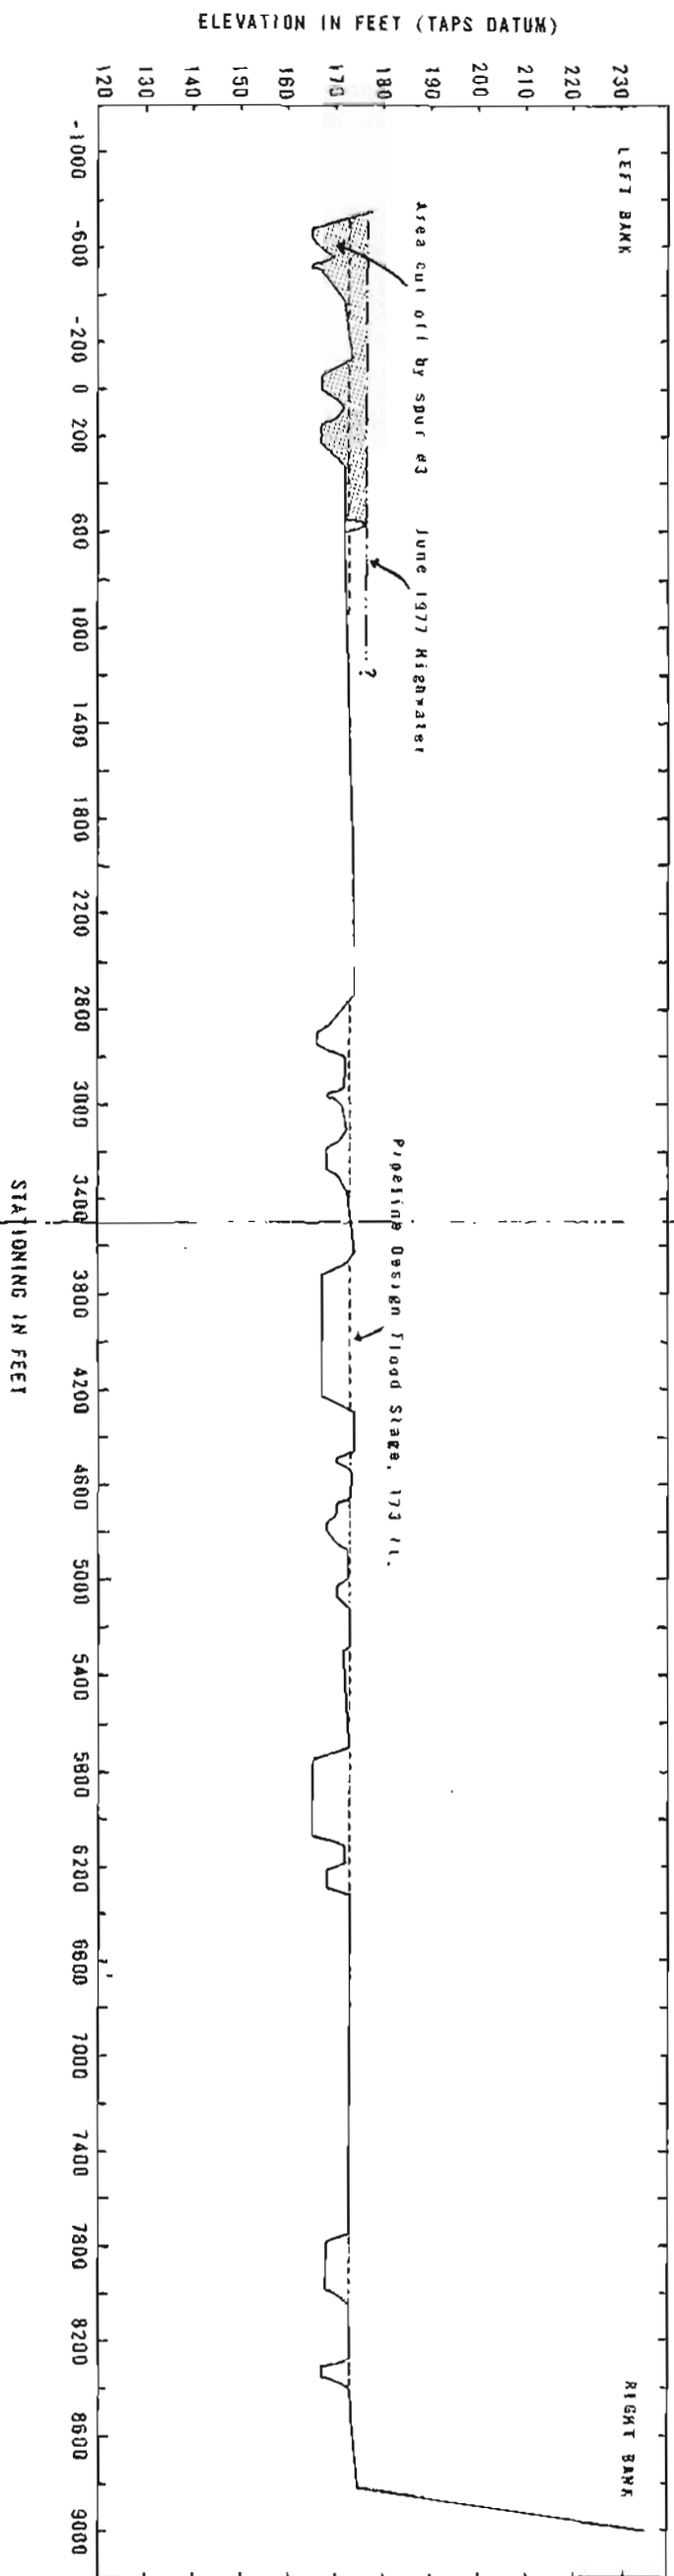
Figure 5. -- Cross section 5411+70 on alignment #134 of the Sagavanirktok River near Deadhorse, taken from Alyeska Pipeline Service Co. (1974), plate C-9a.

Figure 5 shows a cross section of the Sagavanirktok River just downstream from spur No. 3. The figure displays a typical wide, flat profile of braided river. The pipeline design flood stage of approximately 173 ft and the June 1977 flood stage of approximately 177 ft are shown. Spur No. 3, just downstream, is projected onto the cross section. The average fall for this section of the river is 0.00174 feet per foot.

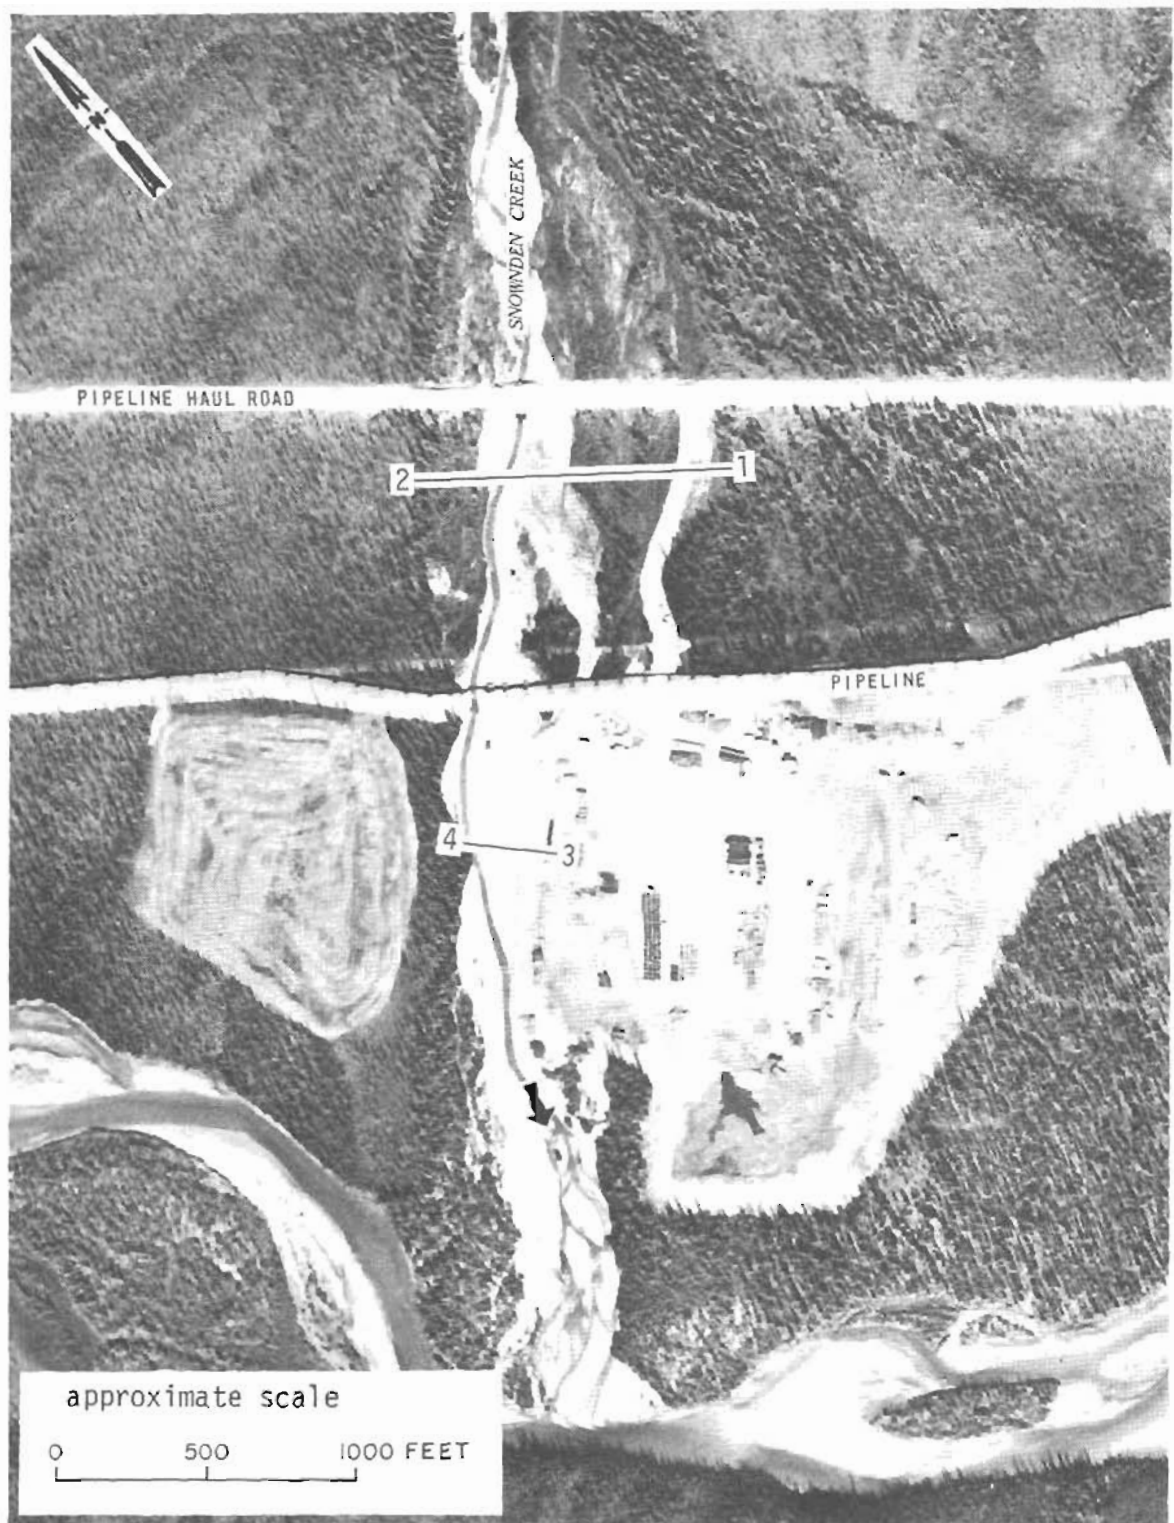
Figure 6. -- Snowden Creek near Dietrich camp, July 12, 1977
AIR PHOTO TECH

1977 Surveillance.--Figure 6 shows the Snowden Creek crossing site on July 12, 1977. During the past year, protective rip-rap has been installed around the centerline.

The crossing site was resurveyed on both May 21 and September 16, 1977. In May, changes were found in the upstream cross section and changes due to the completion of construction were found in the centerline section. In addition, the September survey showed that upstream thalweg had deepened since May (fig. 7). The peak discharge of July 31, 1976, was measured by indirect methods on May 21, 1977, at a site about 0.5 mi upstream from the pipeline. The peak discharge was 460 ft³/s or about 30 (ft³/s)/mi².

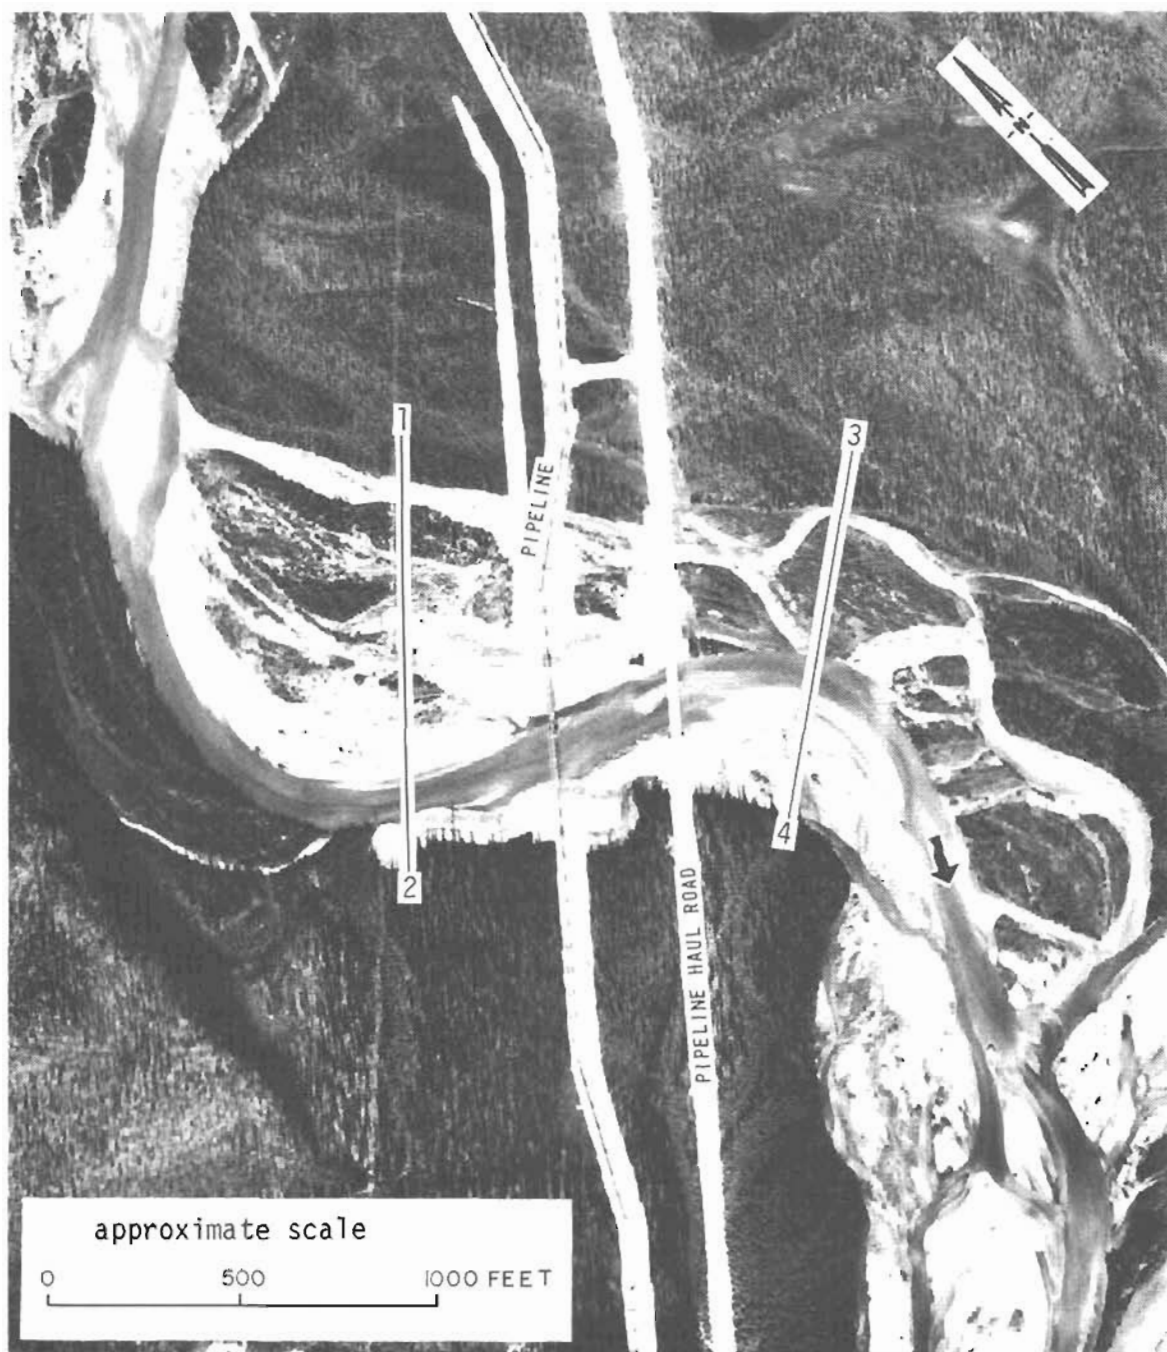
Figure 8. -- Dietrich River at Bettles River, July 12, 1977.

1977 Surveillance.--Figure 8 shows the Dietrich River site on July 12, 1977. During the last year, rip-rap has been installed along the right bank of the centerline.

The site was resurveyed on May 19, 1977. No reliable datum was established for this year's centerline section; thus it cannot be rigorously compared to last year's. However, it is evident that the construction activities have changed the section's shape considerably. Both the upstream and the highway bridge section have also changed (fig. 9). No survey was taken on the downstream section.

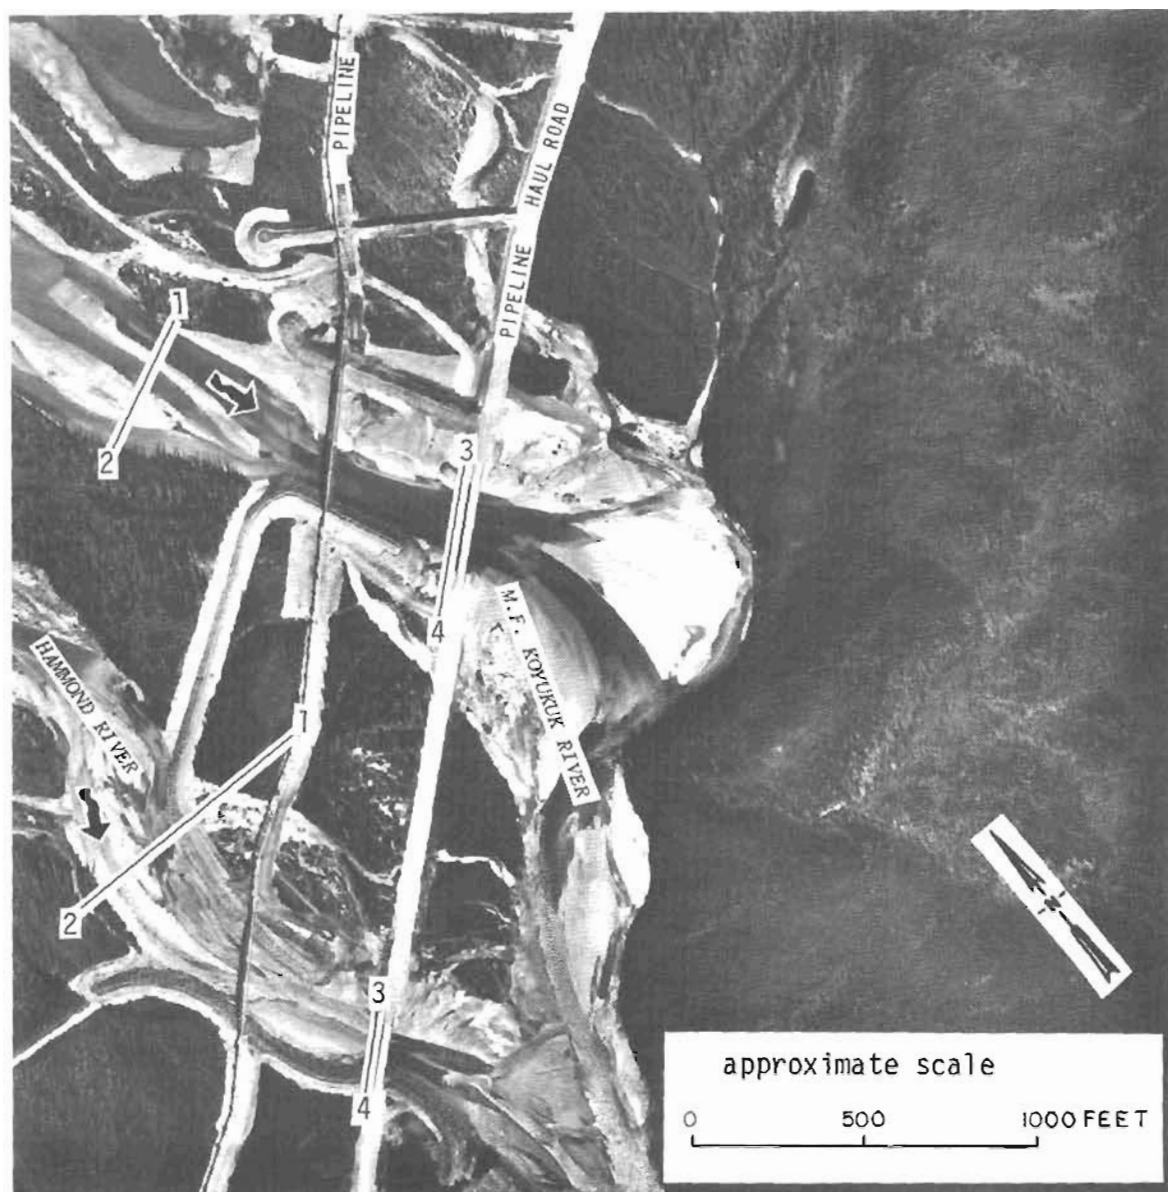
Figure 10. -- Middle Fork Koyukuk River at Hammond River and Hammond River near Wiseman, July 12, 1977. AIR PHOTO TECH

1977 Surveillance.--Figure 10 shows the Middle Fork Koyukuk River at the Hammond River crossing site on July 12, 1977. A protective dike extending from the right bank of the Middle Fork of the Koyukuk to the left bank of the Hammond River has been completed. A dike has been constructed on the left bank, extending from above the centerline to the haul road. In addition, fill which extended out from the left bank of the centerline has been removed by erosion.

1977 Surveillance.--Figure 10 shows the Hammond River crossing site on July 12, 1977. A protective dike has been completed on the left bank of the river. Fill extending off the right bank of the center-line has eroded.

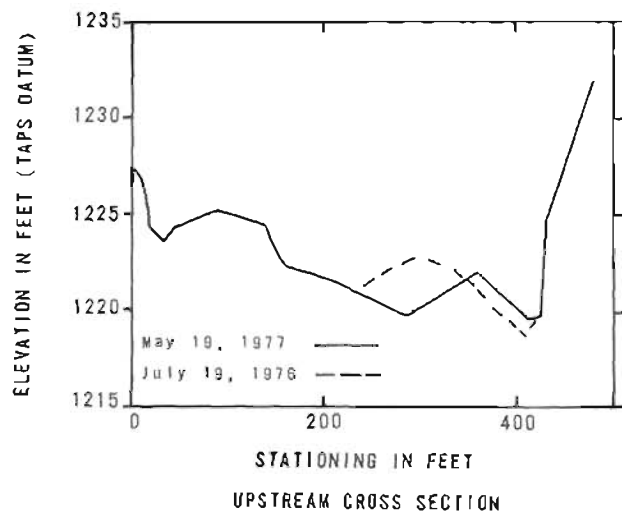
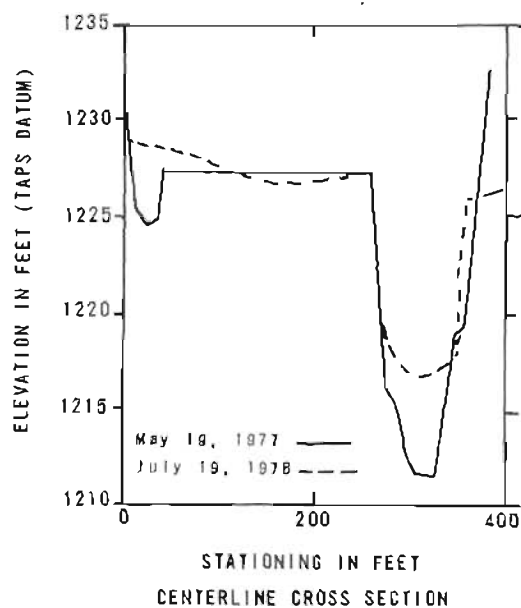
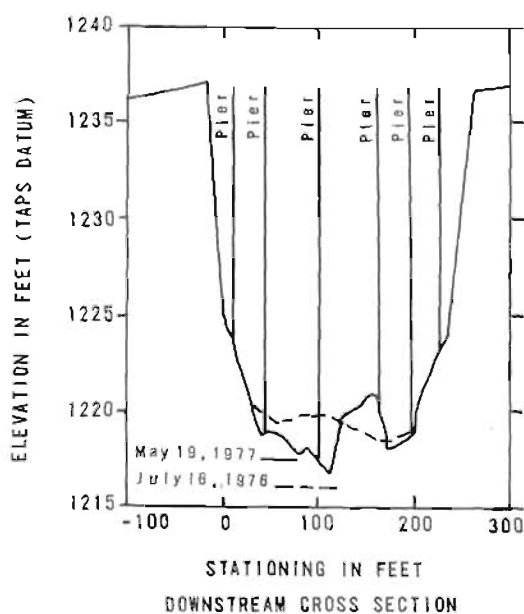
Figure 11. -- Cross sections of the Middle Fork Koyukuk River at Hammond River.

The site was resurveyed on May 19, 1977. All cross sections are significantly changed. Construction activities have radically constricted the centerline and helped deepen the thalweg to more than 5 ft. The thalweg of the downstream section has been slightly deepened (fig.11).

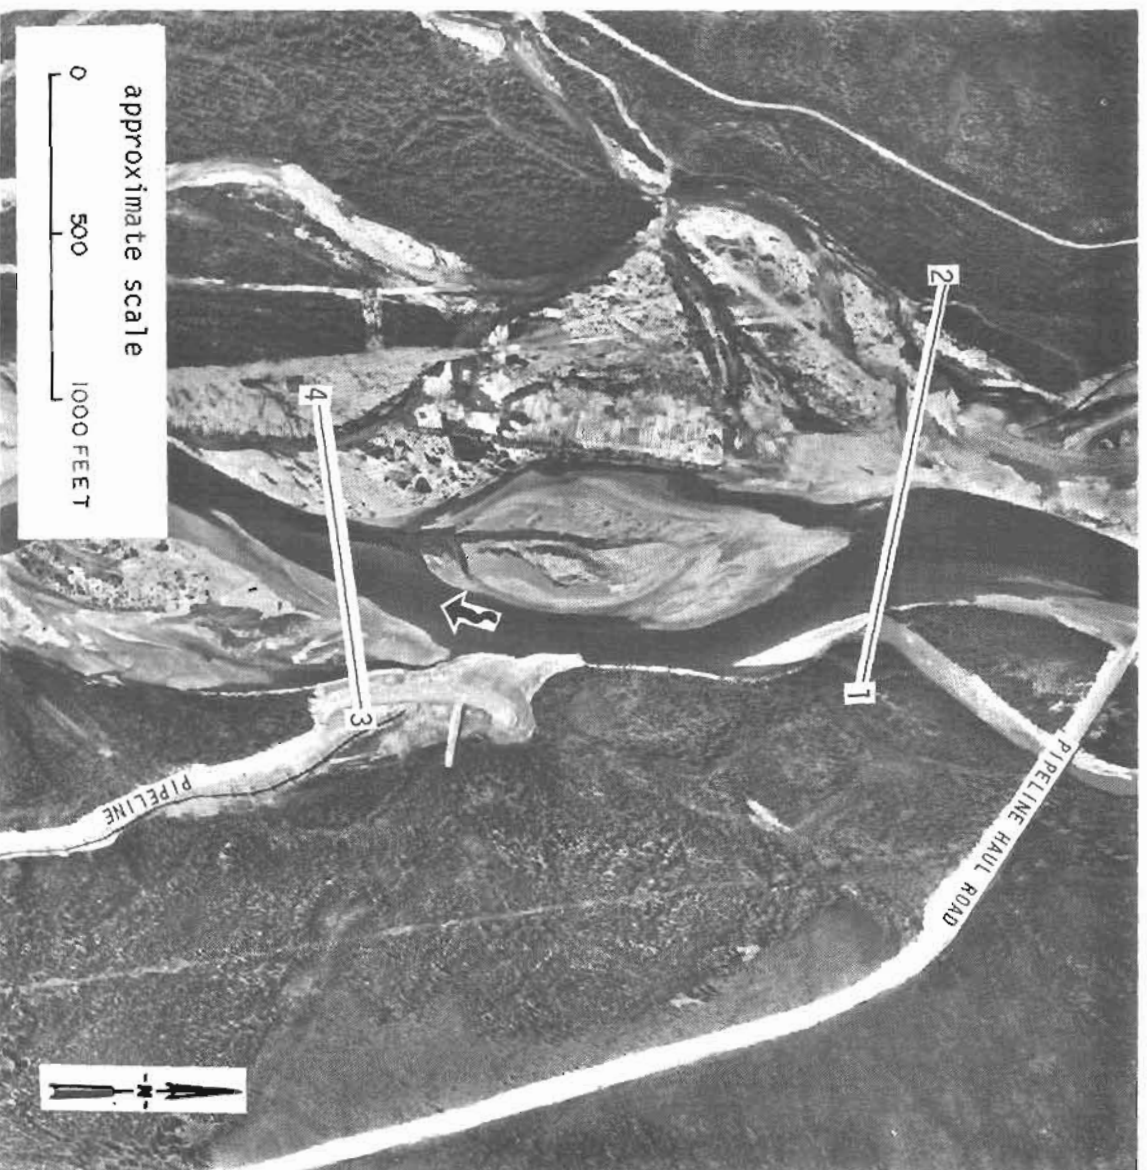
Figure 14. -- Middle Fork Koyukuk River near Wiseman, July 12, 1977.
AIR PHOTO TECH

1977 Surveillance.--Figure 14 shows the Middle Fork Koyukuk River near Wiseman crossing site on July 12, 1977. As noted in the discussion of the Middle Fork Koyukuk River at Hammond River site, a record flood occurred on this river during spring breakup. During the last year, construction has been largely completed. Protective dikes on both banks of the centerline have been finished, and the deep hole just off the right bank has been backfilled.

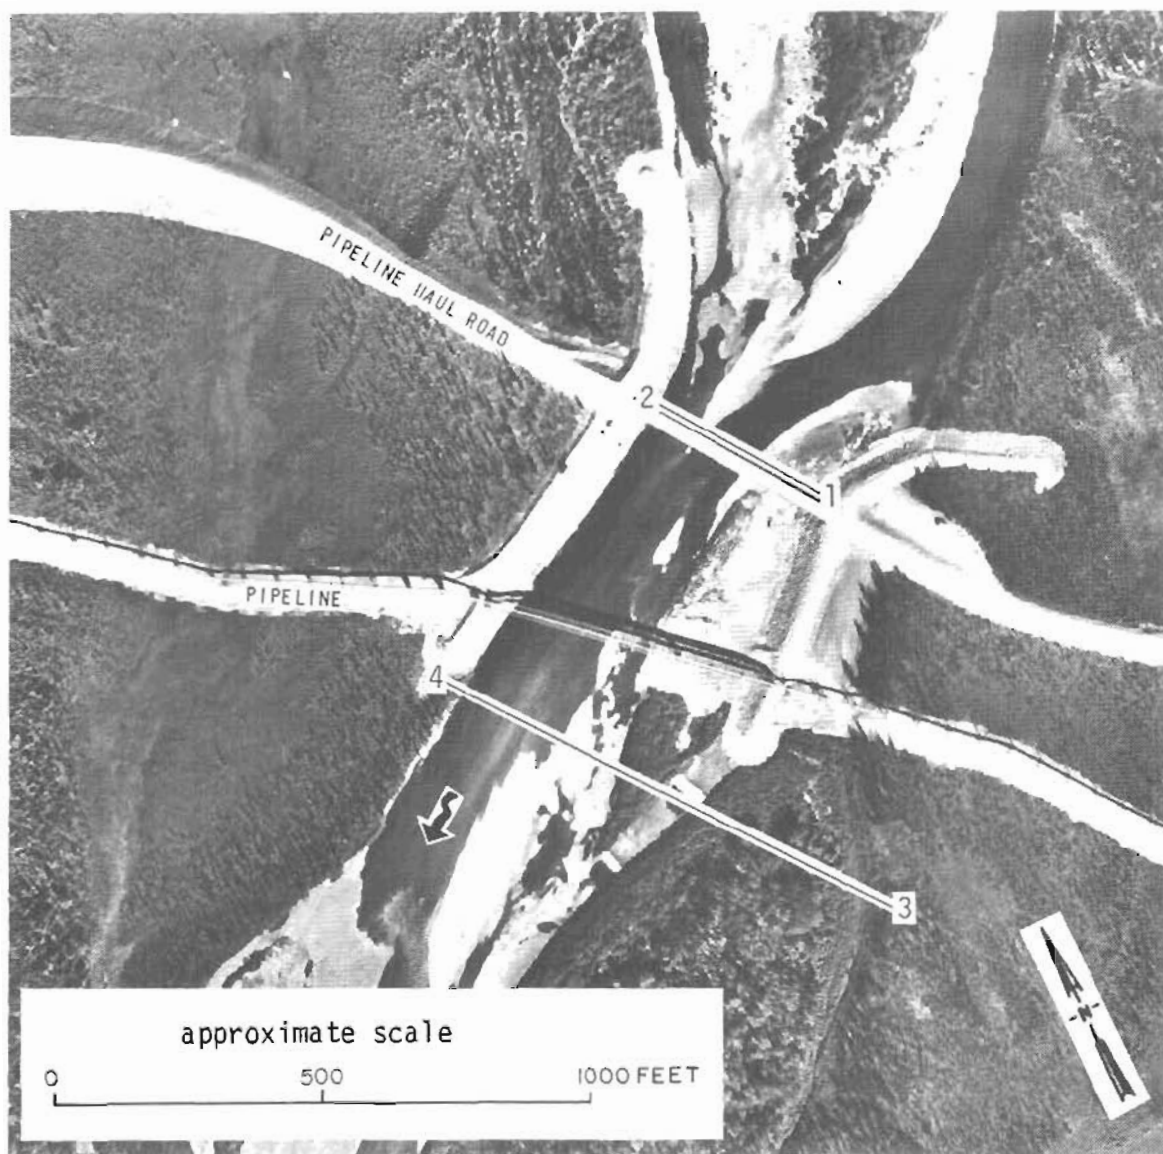
Figure 17. -- South Fork Koyukuk River near Wiseman, July 12, 1977.
AIR PHOTO TECH

1977 Surveillance. --Figure 17 shows the South Fork Koyukuk site on July 12, 1977. The site was resurveyed on September 17, 1977. There has been no significant change in the upstream cross section since 1975, but minor changes were found in both the centerline and downstream cross sections (fig. 18).

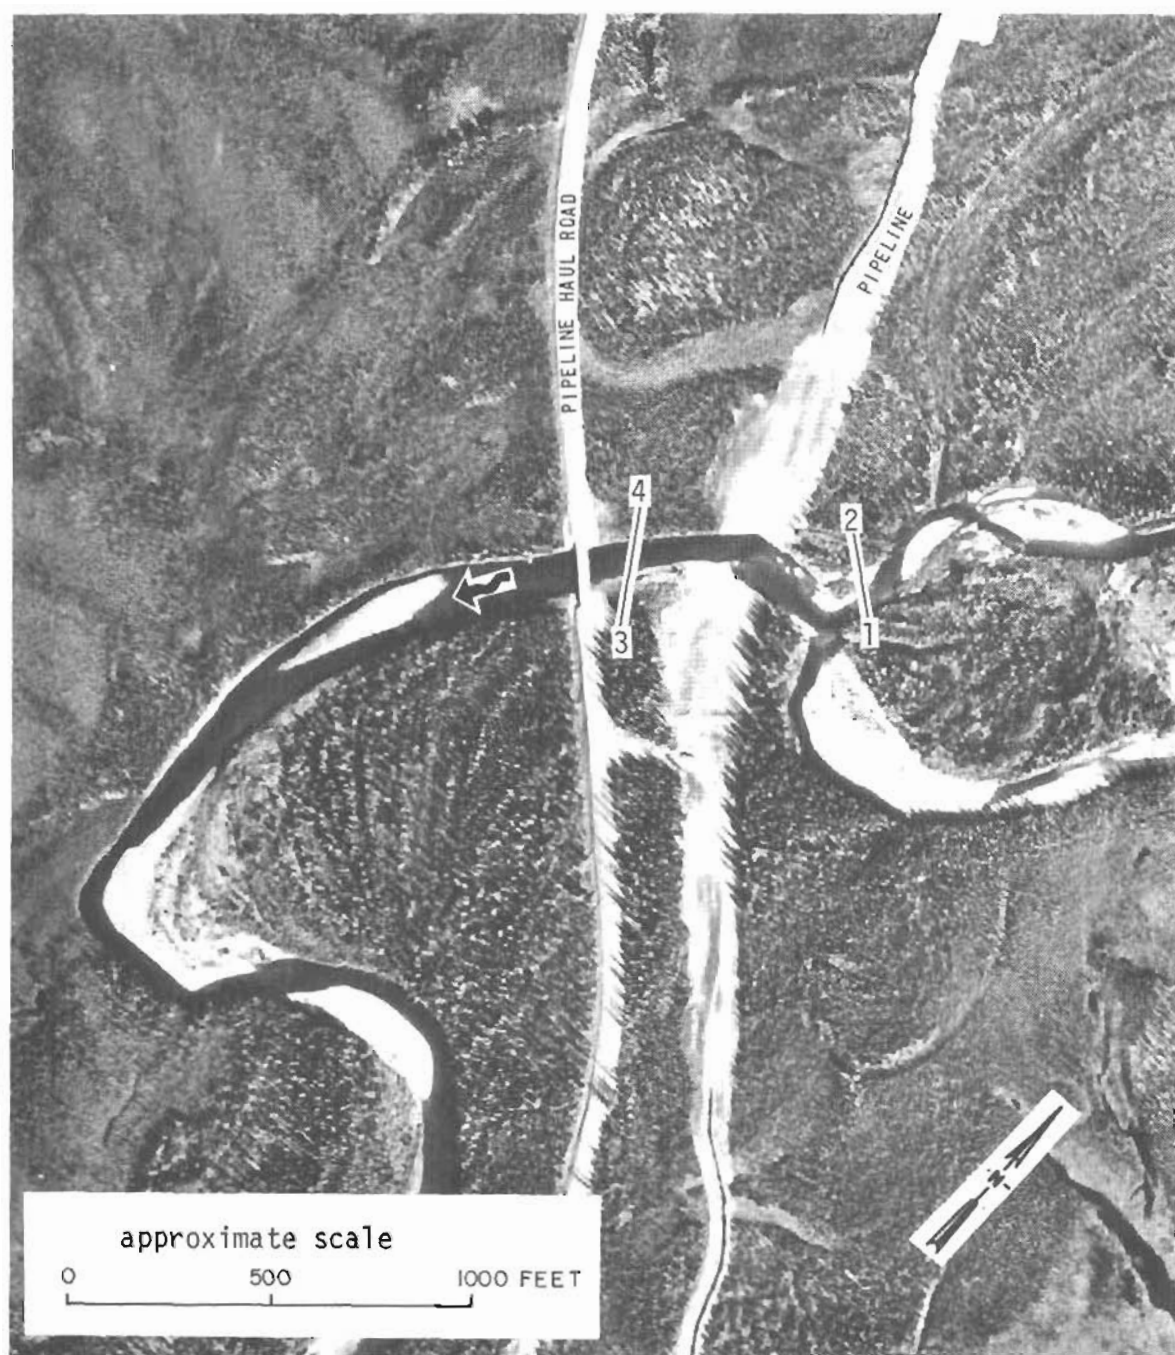
Figure 19. -- Jim River near Prospect Creek camp, September 1, 1977.
AIR PHOTO TECH

1977 Surveillance.--Figure 19 shows the Jim River crossing on September 1, 1977. The site was resurveyed on May 18, 1977. During the last year, backfilling and other construction activities have deepened the centerline cross section, the only significant change in the three measured sections (fig. 20). In addition, a berm has been constructed on the left bank at the centerline.

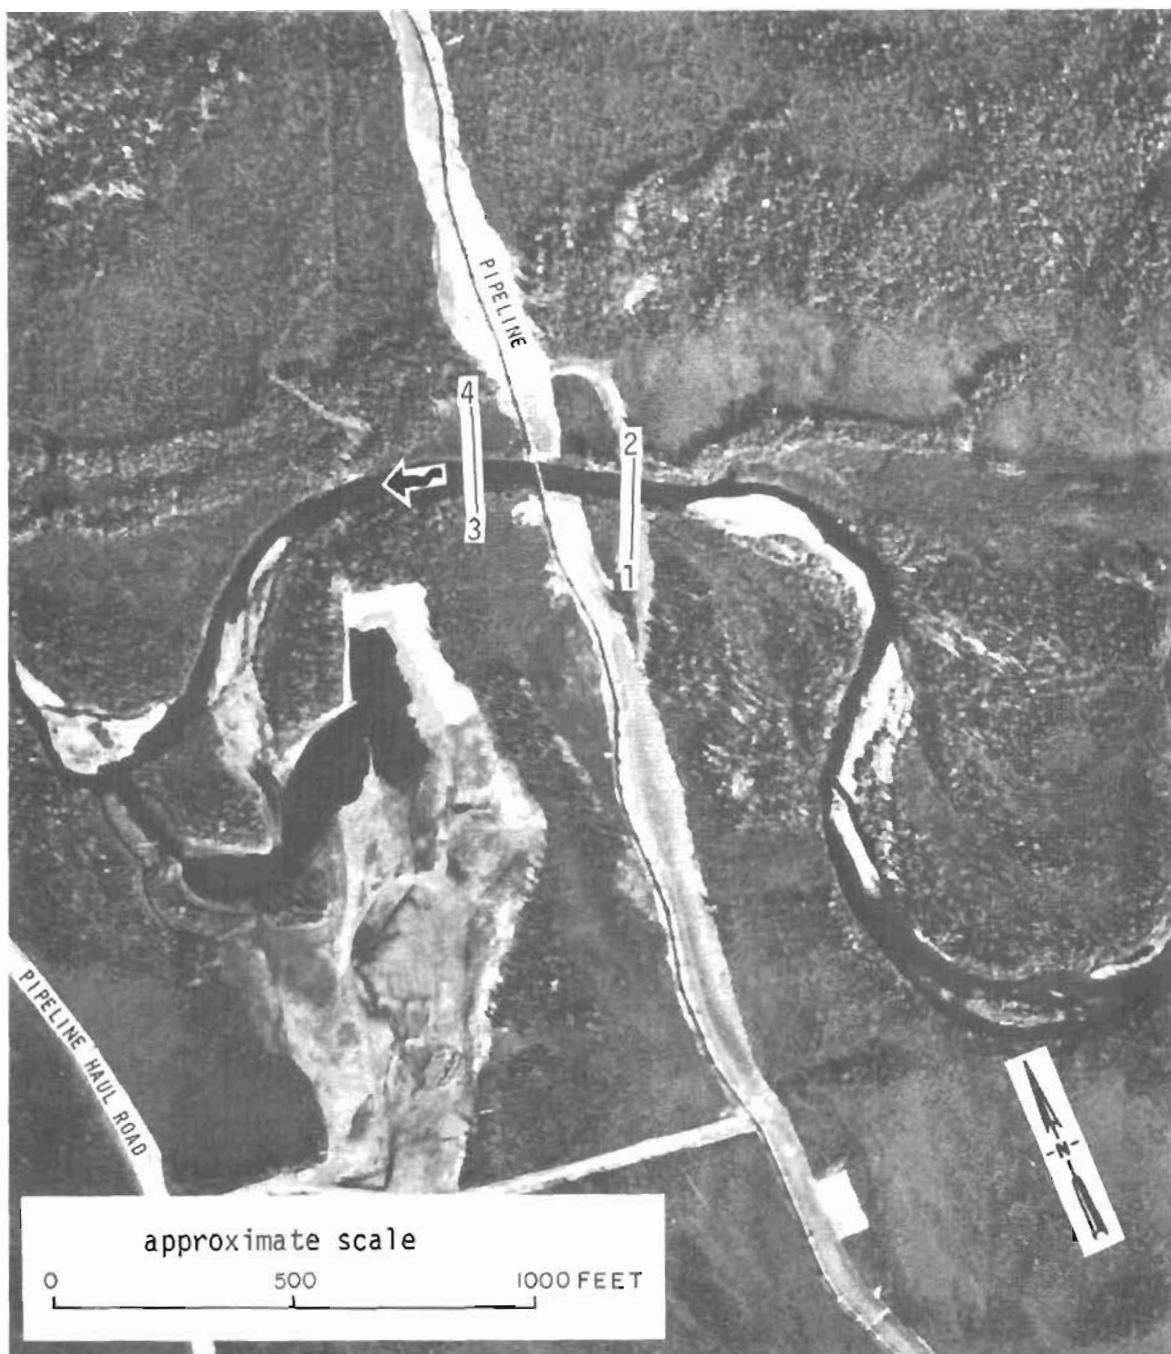
Figure 21. -- Prospect Creek near Prospect Creek camp, September 1, 1977.
AIR PHOTO TECH

1977 Surveillance.--Figure 21 shows the Prospect Creek site as of September 1, 1977. During the last year, there has been some grading on the upstream and centerline cross sections, and the access bridge over the upstream crossing has been removed. The site was resurveyed on September 17, 1977, and no significant changes were found in any cross section.

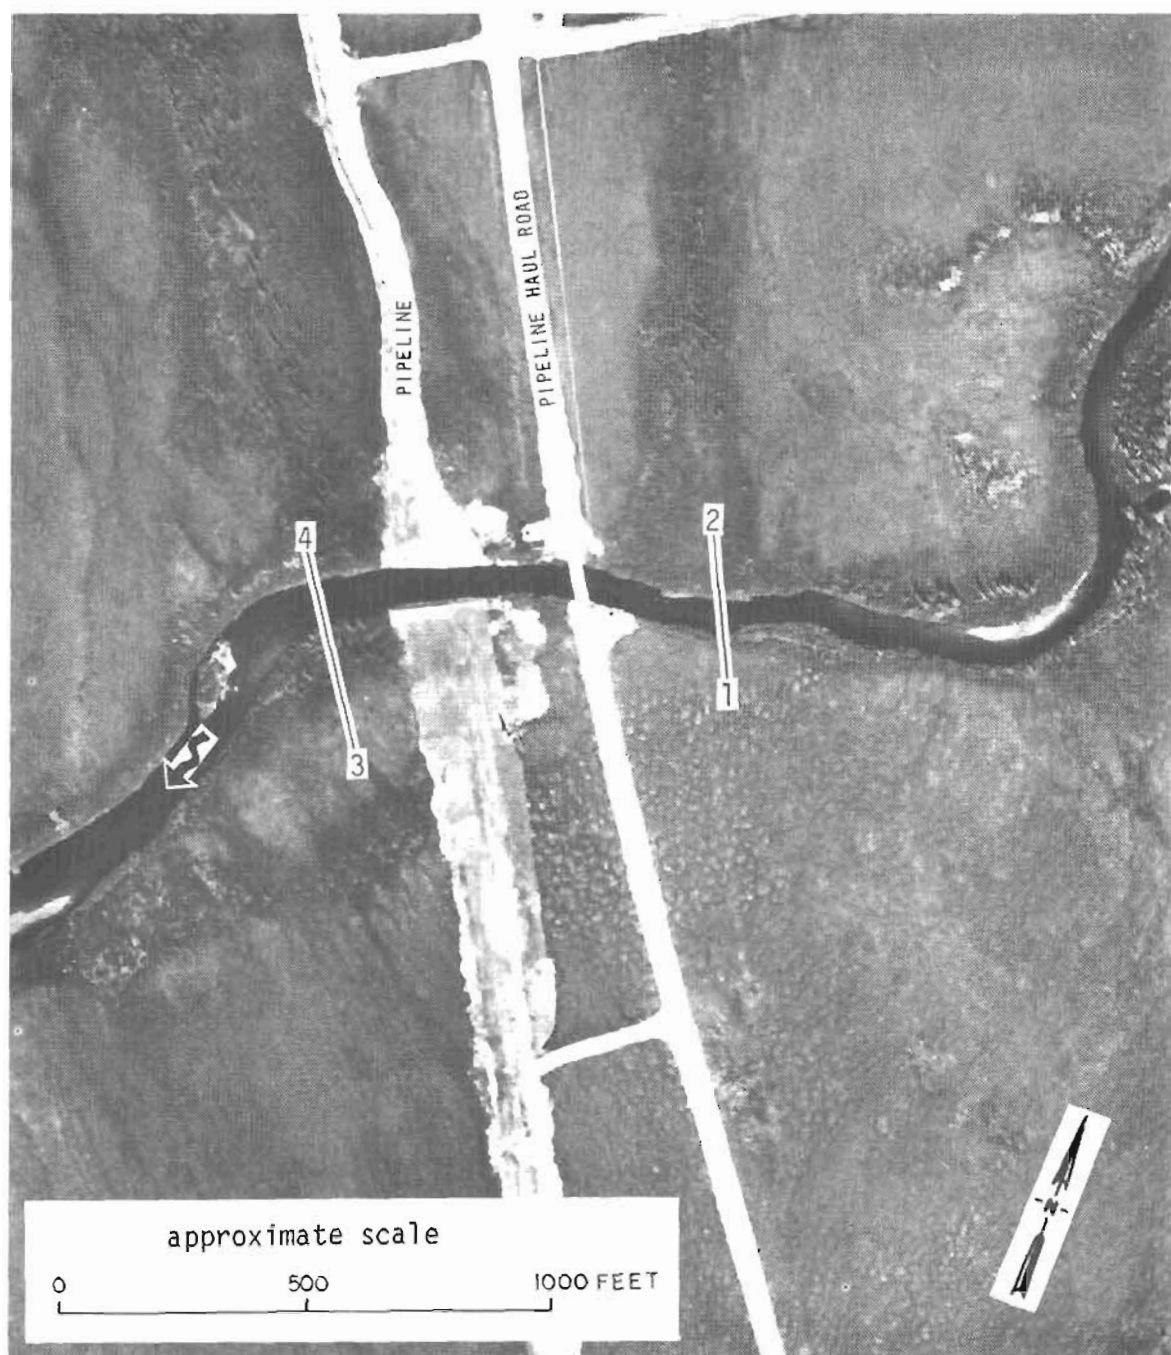
Figure 22. -- Kanuti River near Bettles, July 13, 1977.
AIR PHOTO TECH

1977 Surveillance.--Figure 22 shows the Kanuti River crossing site on July 13, 1977. The site was resurveyed on September 19, 1977. During the last year, protective dikes have been constructed on both banks of the centerline cross section. In addition, grading has changed the bank's profile, but that of the stream remains unchanged. There were no significant changes in either the upstream or downstream cross section.

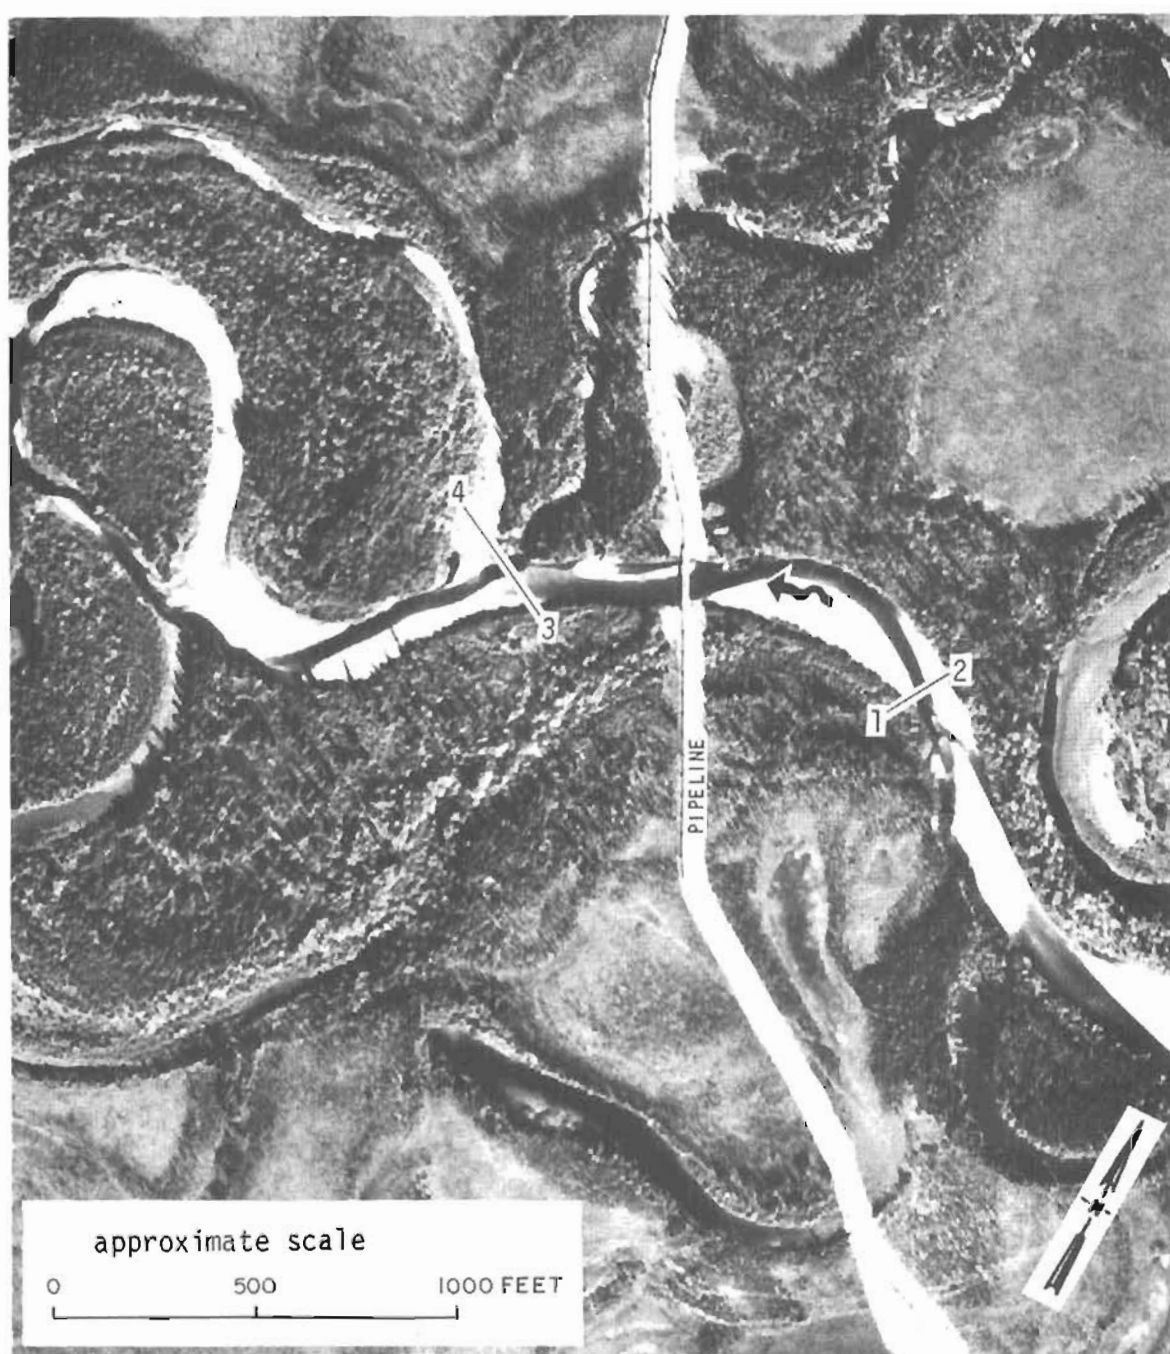
Figure 23. -- Hess Creek near Livengood, July 13, 1977.

1977 Surveillance.--Figure 23 shows the Hess Creek crossing site on July 13, 1977. The overhead pipeline crossing has been completed, and the temporary access bridge constructed last year has been removed. The Hess Creek and Castner Creek sites are the only channel erosion crossing sites to have the pipeline crossing completed between the 1976 and 1977 surveys. All others were finished before the 1976 survey. The crossing site was resurveyed on May 14, 1977. Figure 24 shows the construction-related changes in the centerline cross section.

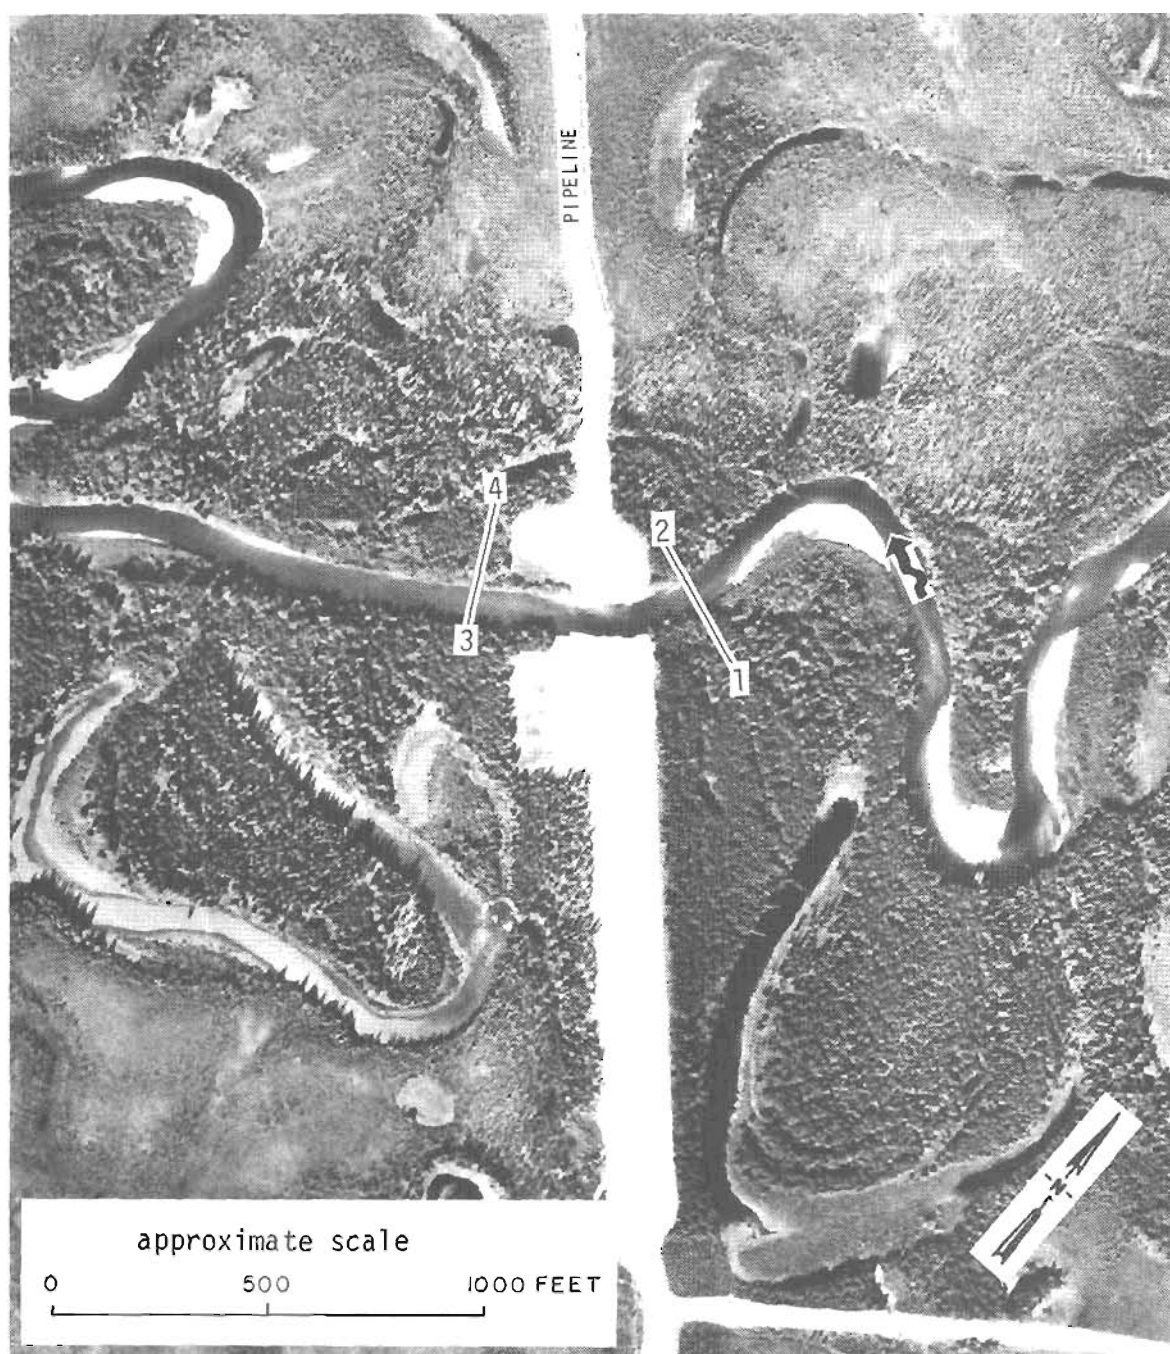
Figure 25. -- Chatanika River near Olmes, July 13, 1977.

1977 Surveillance.--Figure 25 shows the Chatanika River crossing site on July 13, 1977. The temporary access bridge installed before last year's survey had been removed.

The site was resurveyed on May 13, 1977. No significant change was found at the upstream cross section, but the downstream and centerline sections both displayed marginal deepening of their thalwegs (fig. 26).

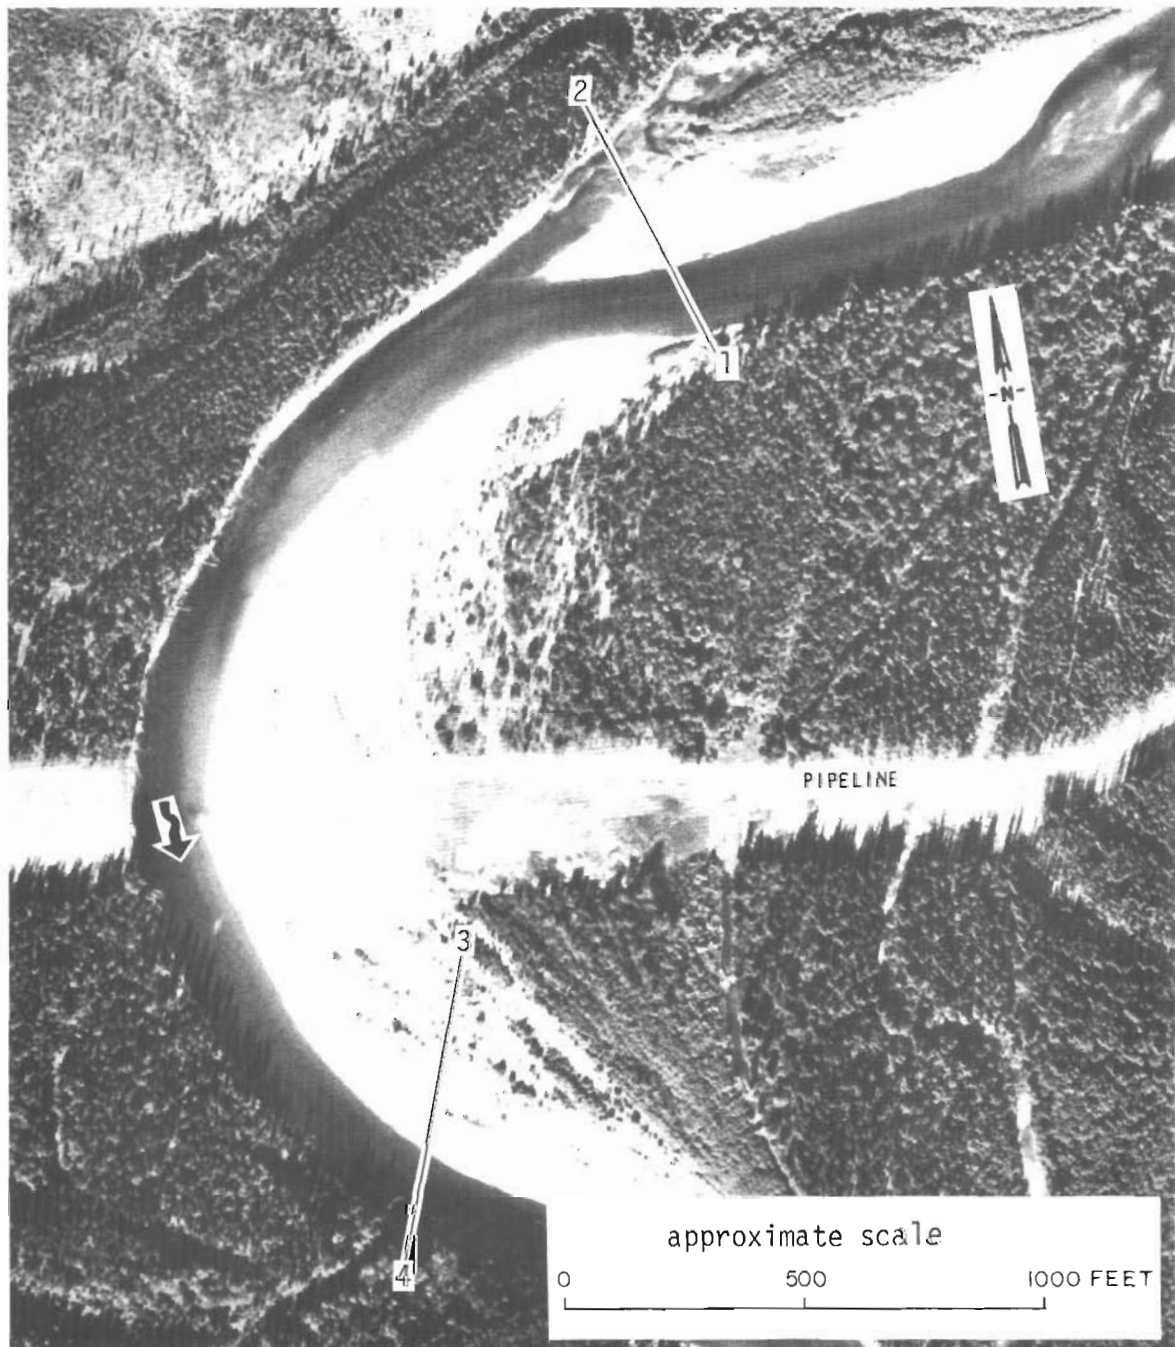
Figure 27. -- Salcha River near Salchaket, July 13, 1977.

1977 Surveillance.--Figure 27 shows the Salcha River crossing on July 13, 1977. The site was resurveyed on May 12, 1977. The river at this site continues to be active; changes were found in all three cross sections. In each case the right bank has been eroded. The most dramatic effects occurred at the centerline where over 10 ft of lateral erosion and over 6.2 ft of vertical scour (fig. 28) were measured during the breakup flood. The peak of the flood occurred on May 19. It was measured as 11,500 ft³/s at the Salcha River gage near Salchaket, and is considered a moderate flood.

Taken together, the three cross sections indicate that the meander has widened during the last year, continuing a trend noted in 1974.
