CHANNEL EROSION SURVEYS ALONG THE TAPS ROUTE, ALASKA, 1977

78-611

by
Robert M. Loeffler
and
Joseph M. Childers

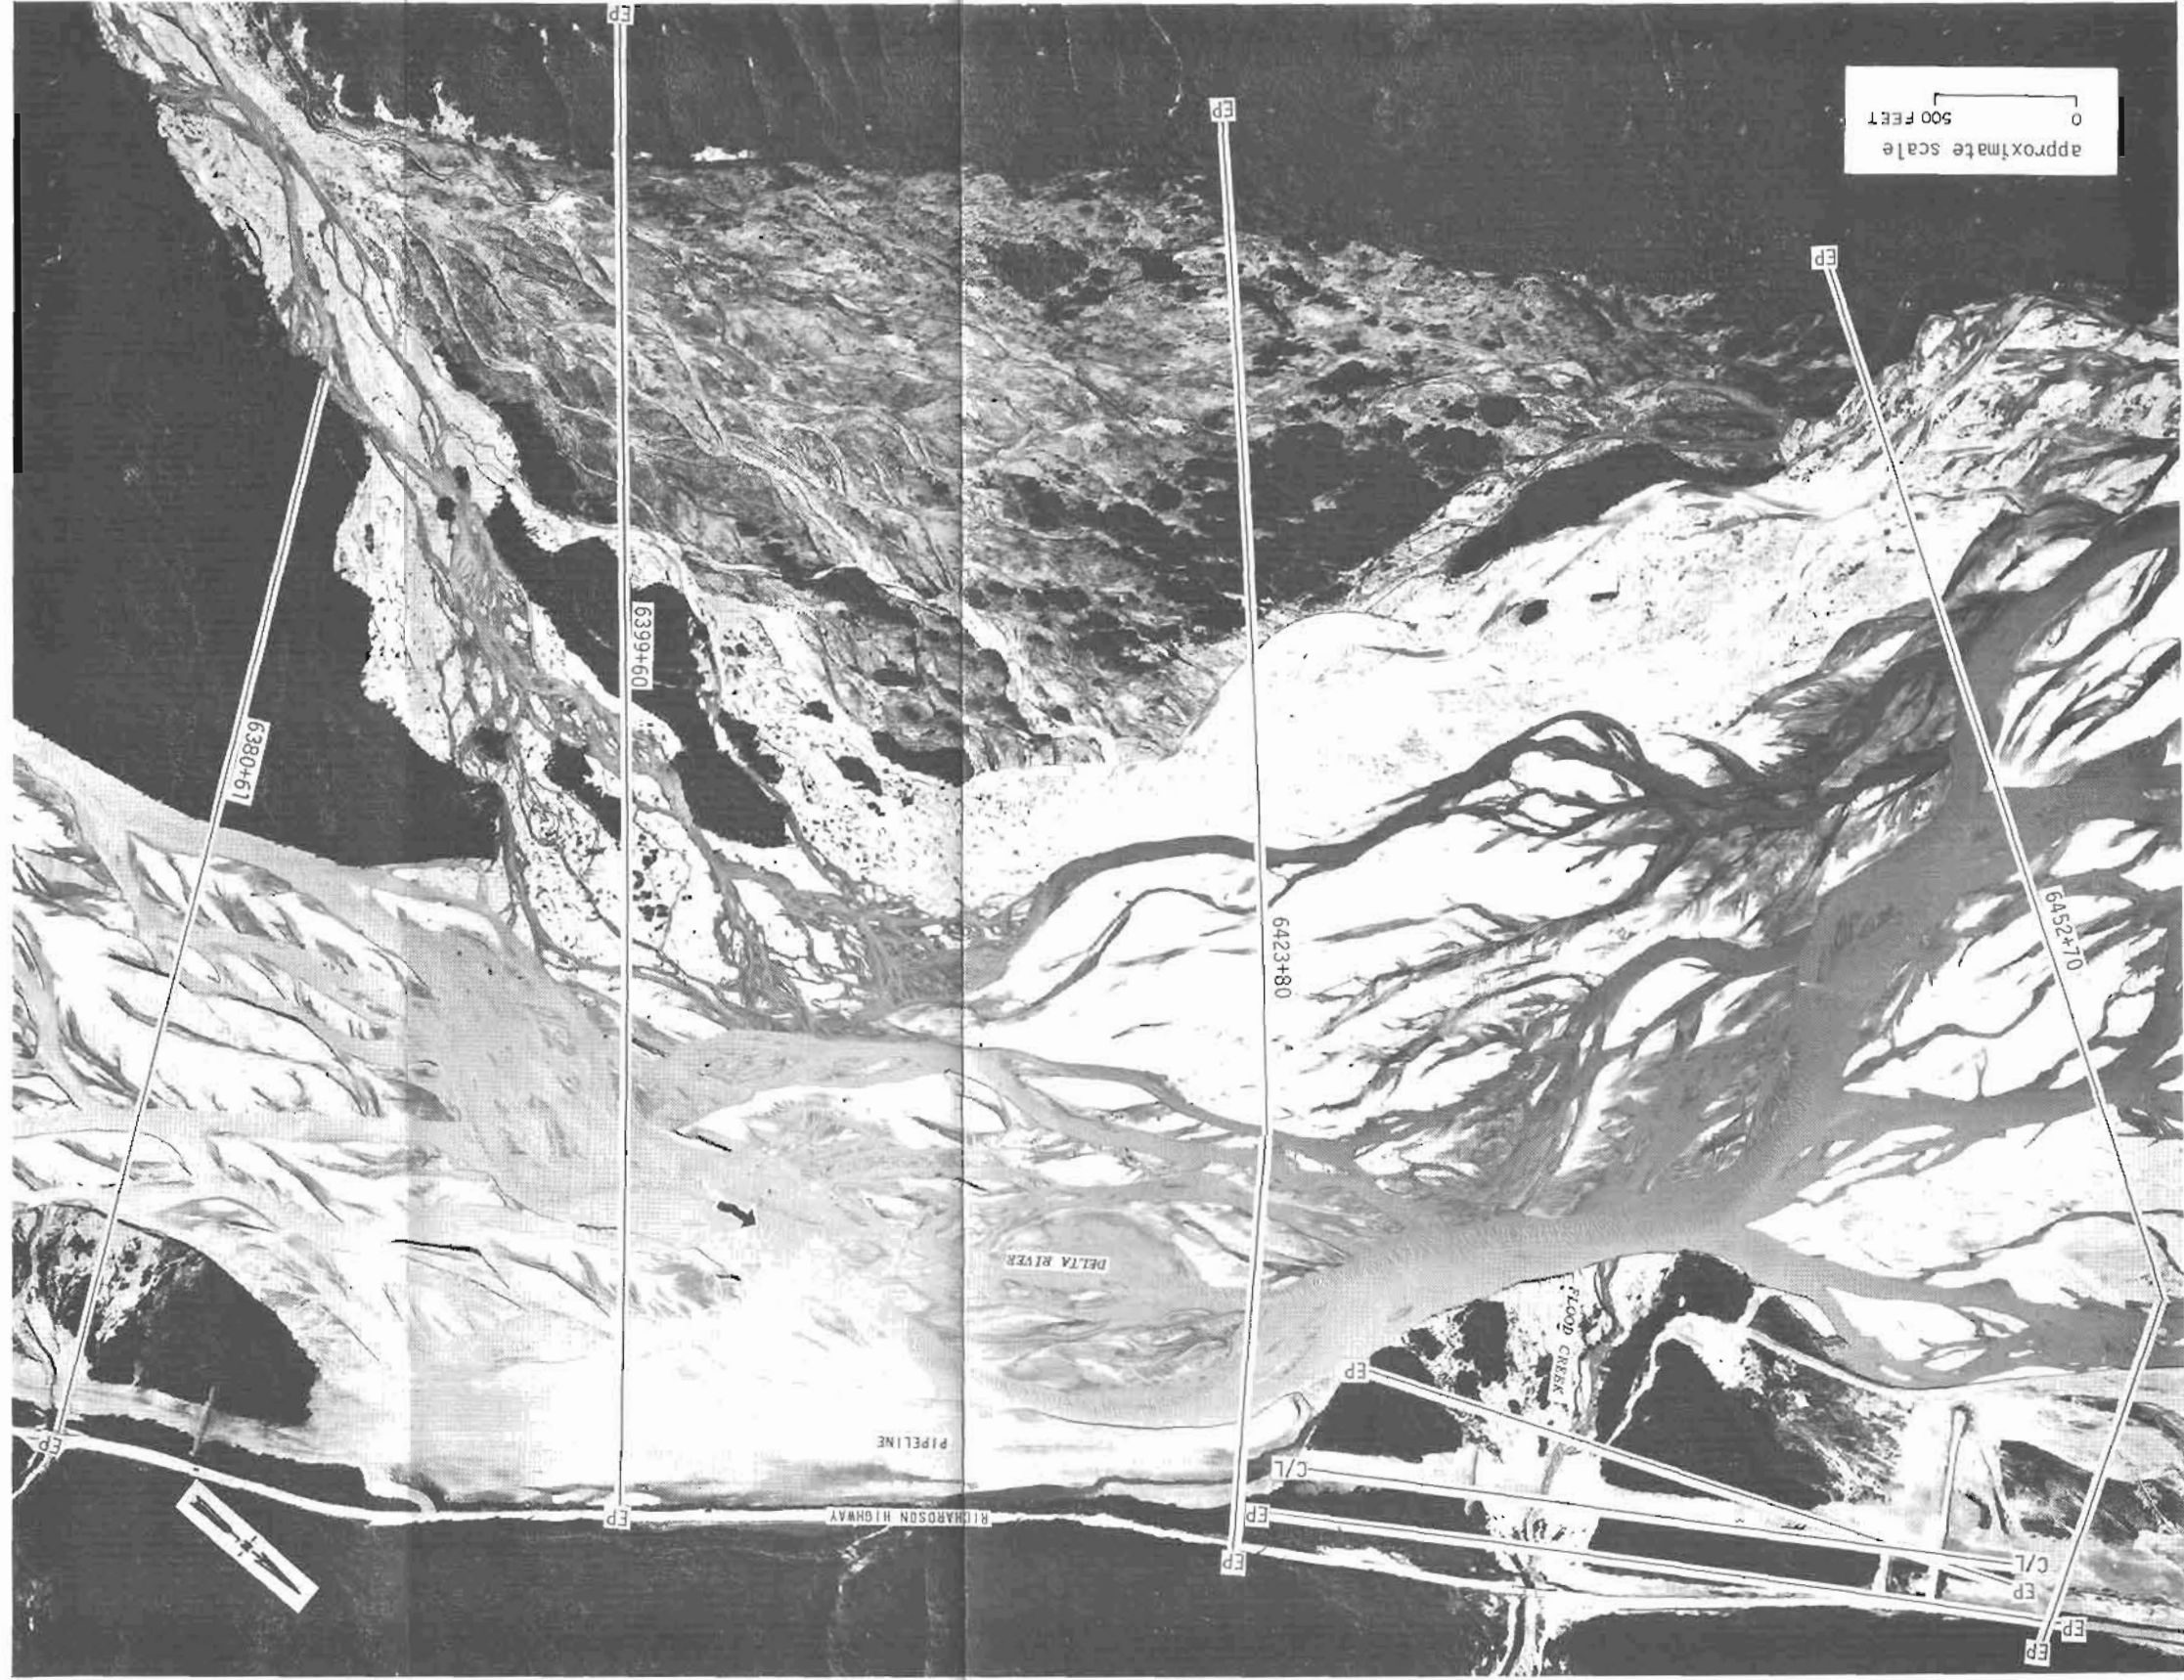
Figure 29. -- Flood Creek near Rapids, July 10, 1977.

1977 Surveillance.--Figure 29 shows the Flood Creek crossing on July 10, 1977. The crossing was resurveyed photogrammetrically on that date and a field inspection was made in September. It appears that the only significant change is below the downstream cross section where the channel is straightening.

There were no significant changes in either the upstream or centerline cross sections except for a berm construction on the centerline 250 ft southeast of Flood Creek. The only noticeable difference in the downstream cross section is that the channel has moved approximately 8 ft northwest (fig. 30).

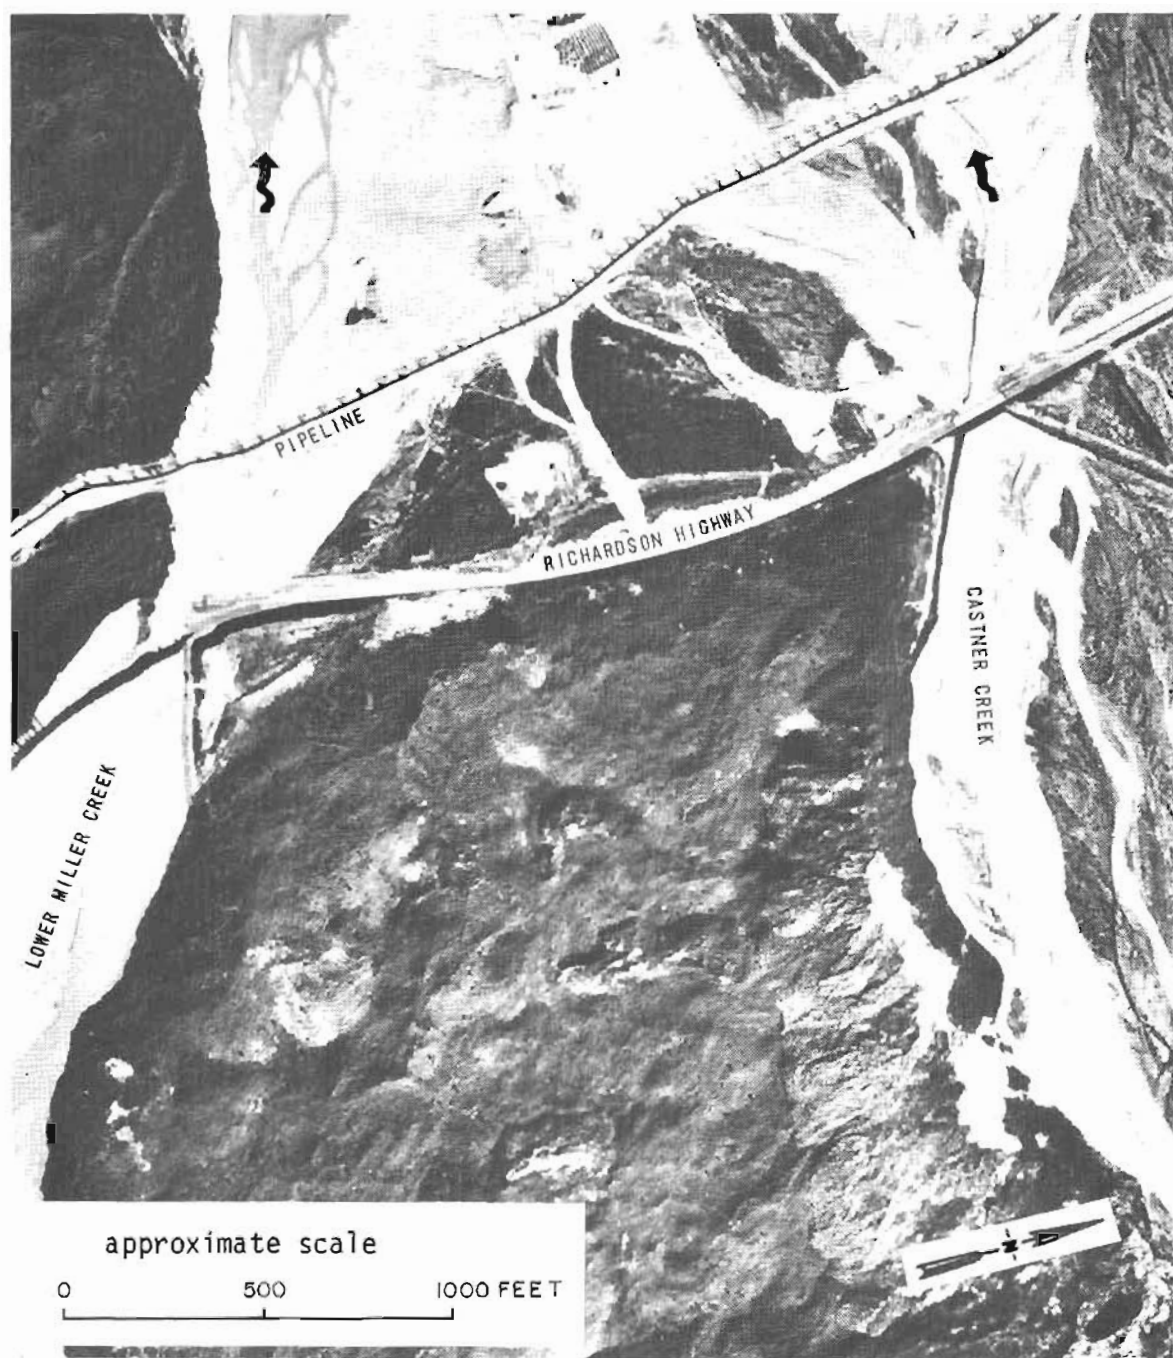
Figure 32. -- Castner and Lower Miller Creeks, July 29, 1977.

1977 Surveillance.--Figure 32 shows the Castner Creek and Lower Miller Creek near Rapids site on July 29, 1977. During the last year, overhead crossings have been completed across both streams.

Comparison of the 1976 and 1977 air photos, as well as a visual inspection of the site made on September 19, 1977, indicate that no significant change has occurred during the past year.

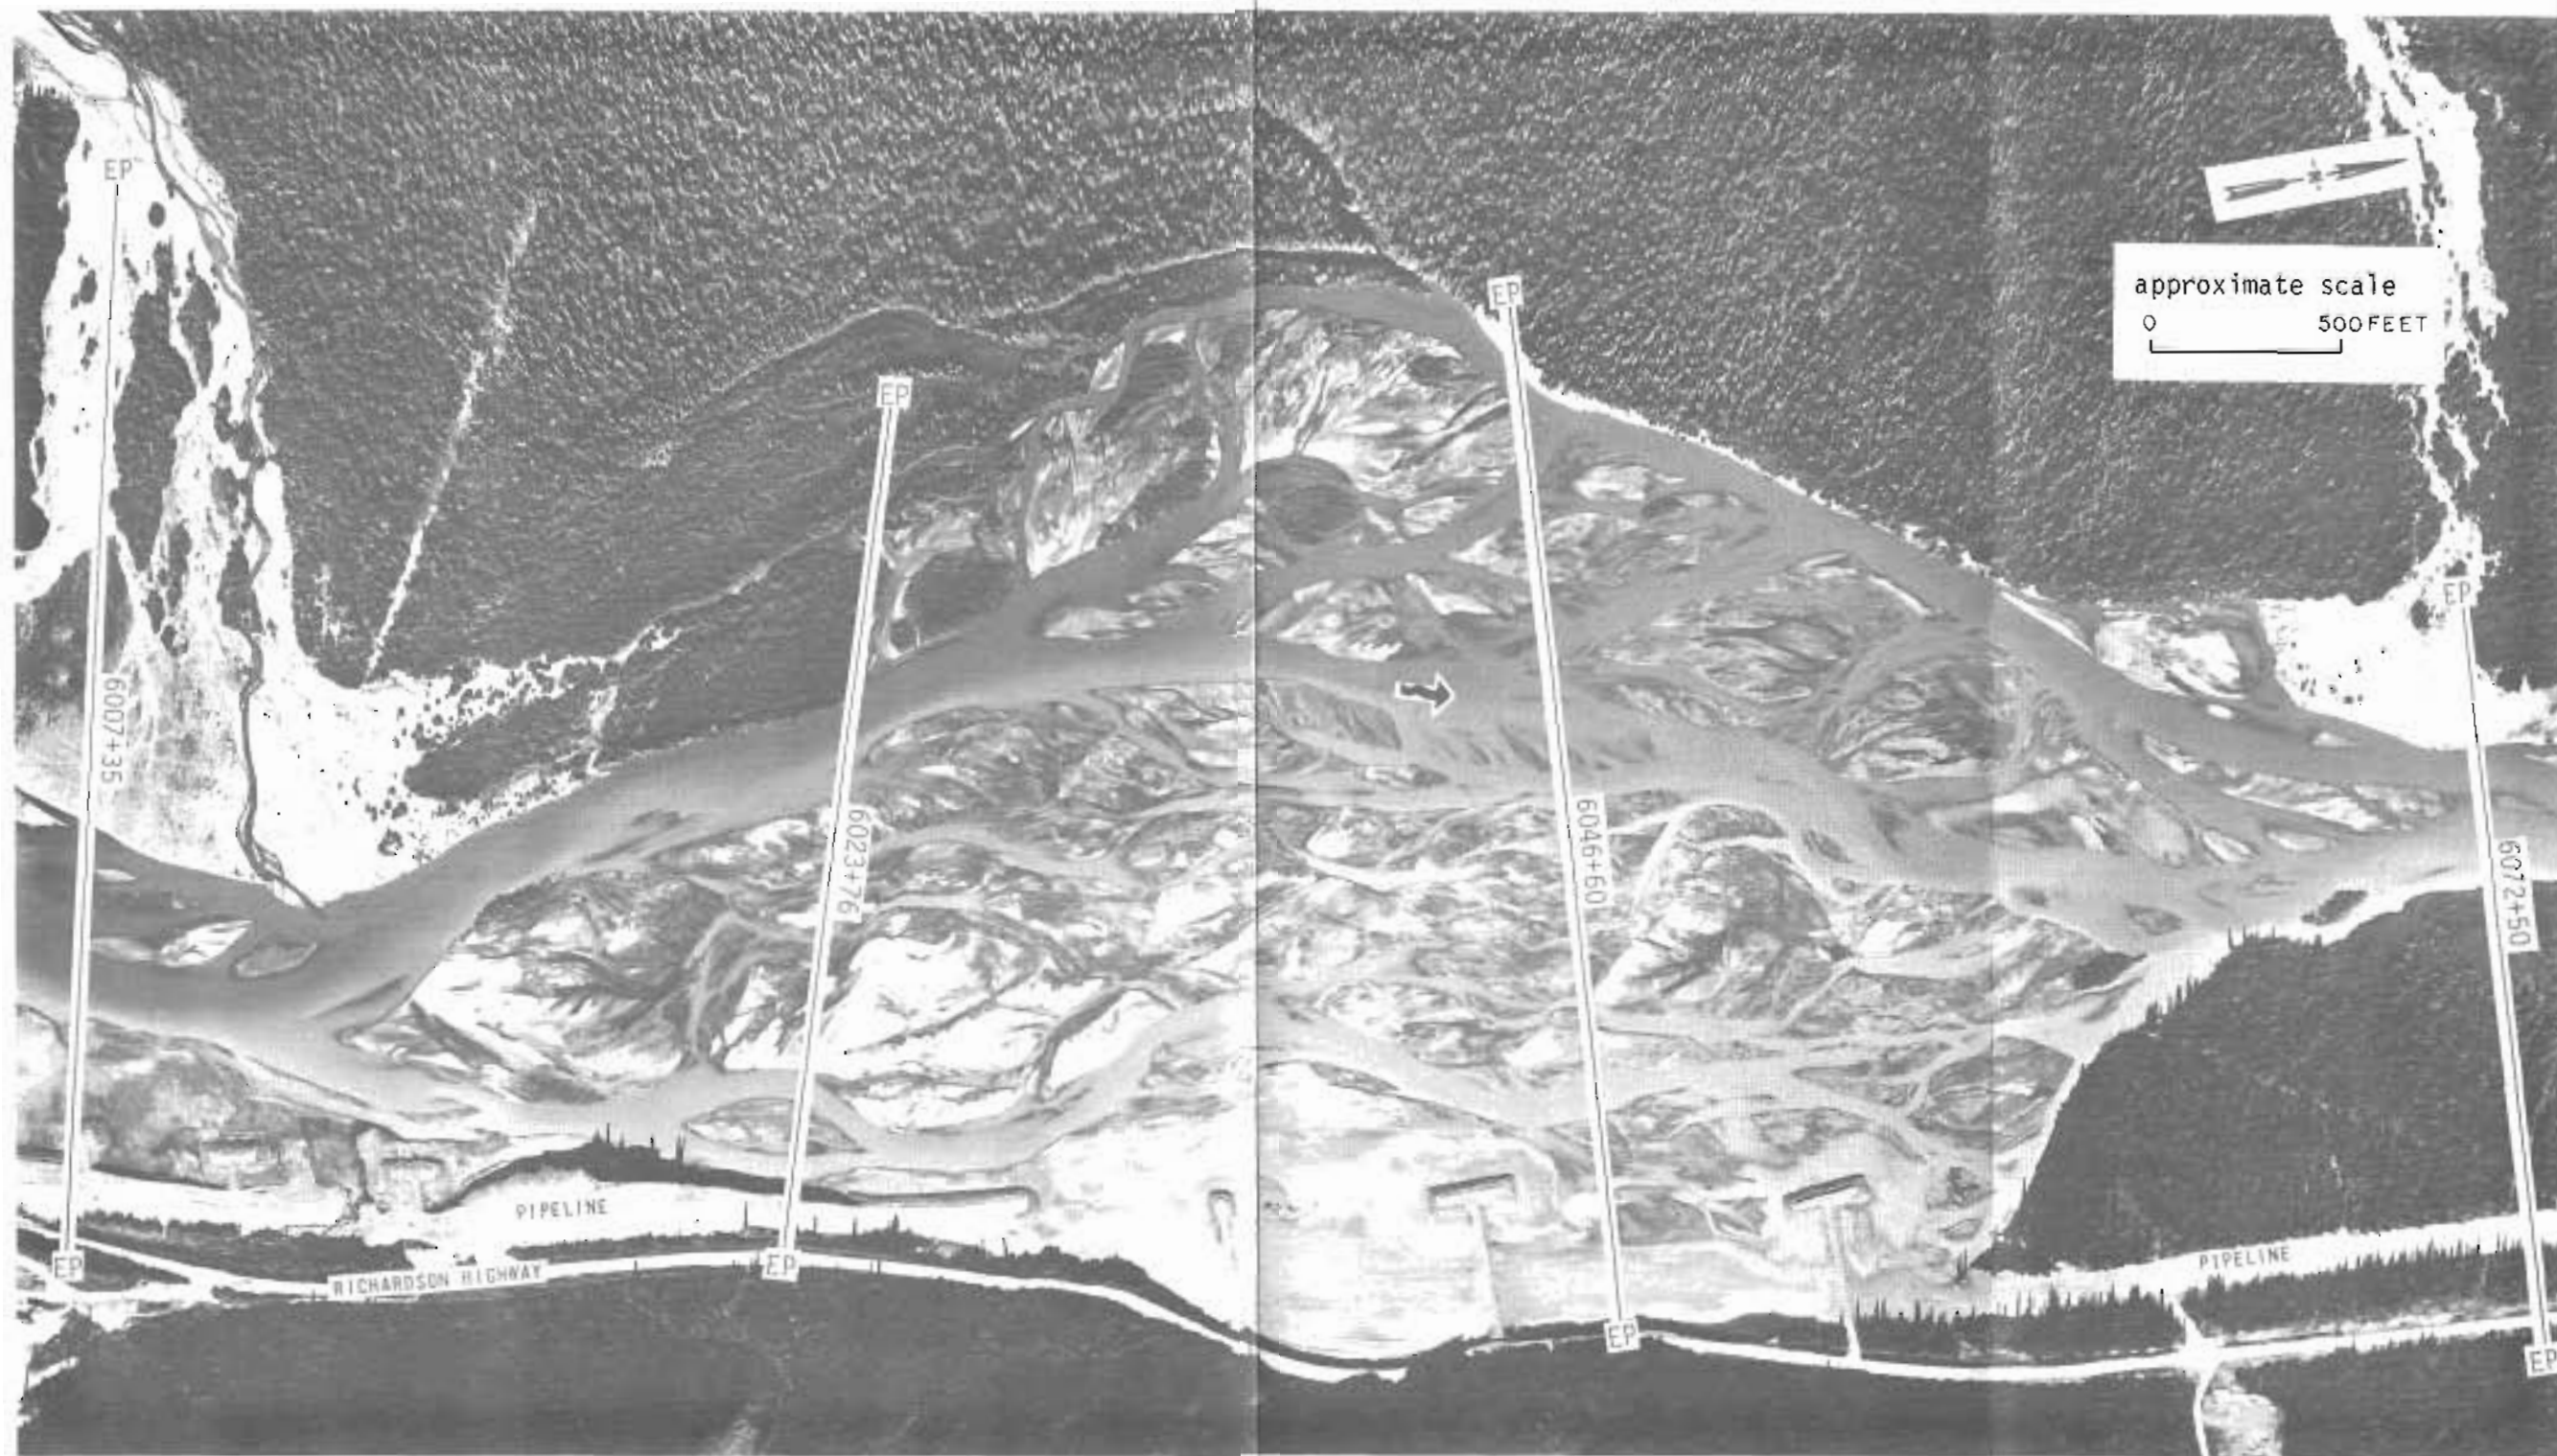
Figure 33. -- Delta River at Phelan Creek, July 10, 1977.
NORTH PACIFIC AERIAL SURVEYS

1977 Surveillance.--Figure 33 shows the Delta River at Phelan Creek site as of July 10, 1977. The three upstream spur dikes and the longshore dike near the center of the picture have been constructed during the last year. The picture shows part of the flow to be surrounding the downstream spur dike, but a field inspection of the site made in September indicated that this is no longer the case.

The site was resurveyed photogrammetrically in July. The different subchannels have continued to change position inside the flood plain, but no significant changes have been found in the surveyed cross sections since the site was established in 1975.

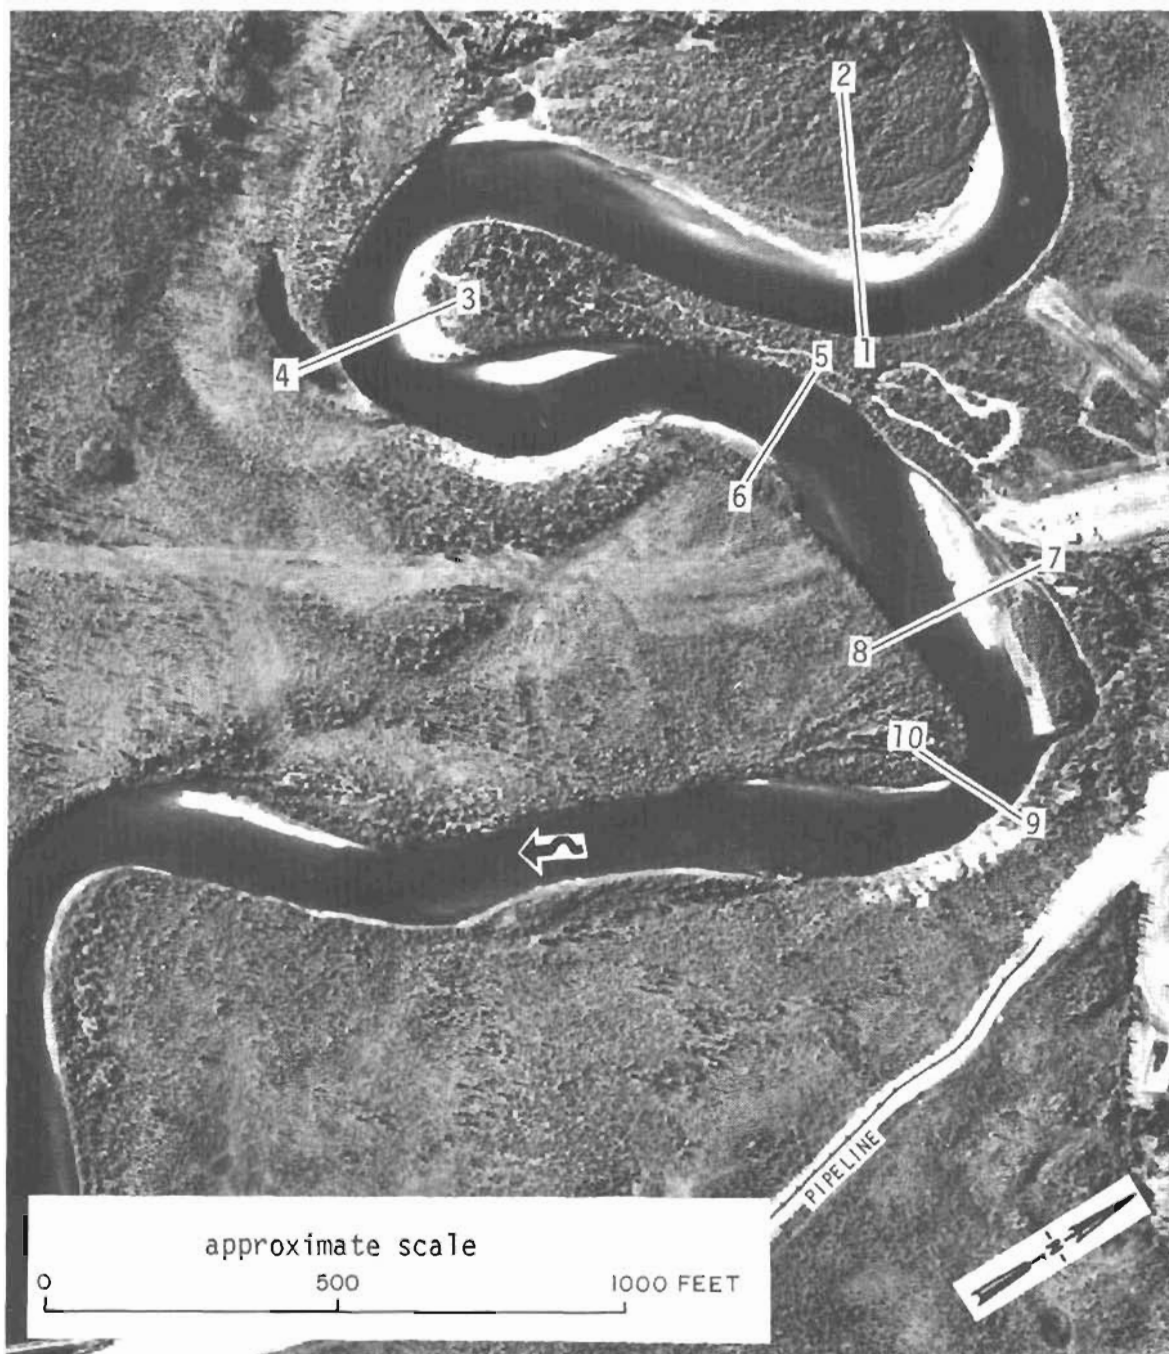
Figure 34. -- Gulkana River near Sourdough, July 29, 1977. AIR PHOTO TECH

1977 Surveillance.--Figure 34 shows the Gulkana River site on July 29, 1977.

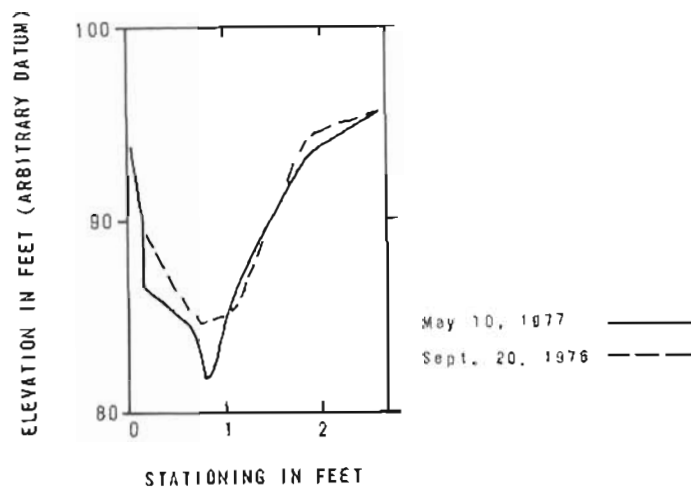
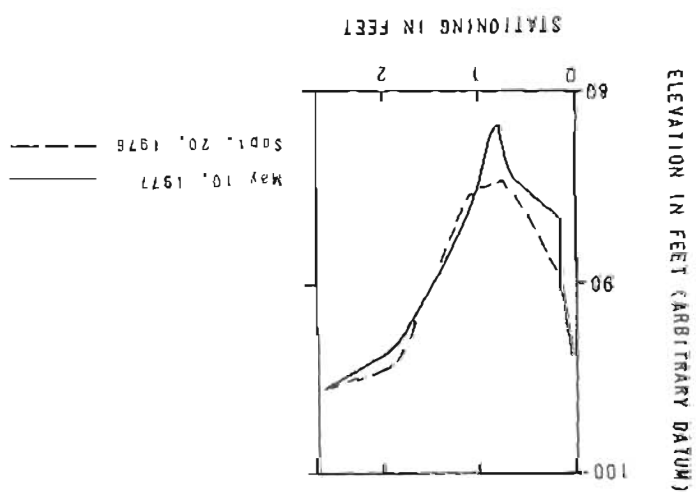
Figure 35.--Cross section No. 5 of the Galkana River near Sourdough.

The site was resurveyed on May 10, 1977. Only cross section No. 5 showed significant change (fig. 35). The left bank of cross section No. 5 has slumped every year since 1974. However, comparison of air photos of July 1977 and August 1976 shows the bank has not changed position laterally.

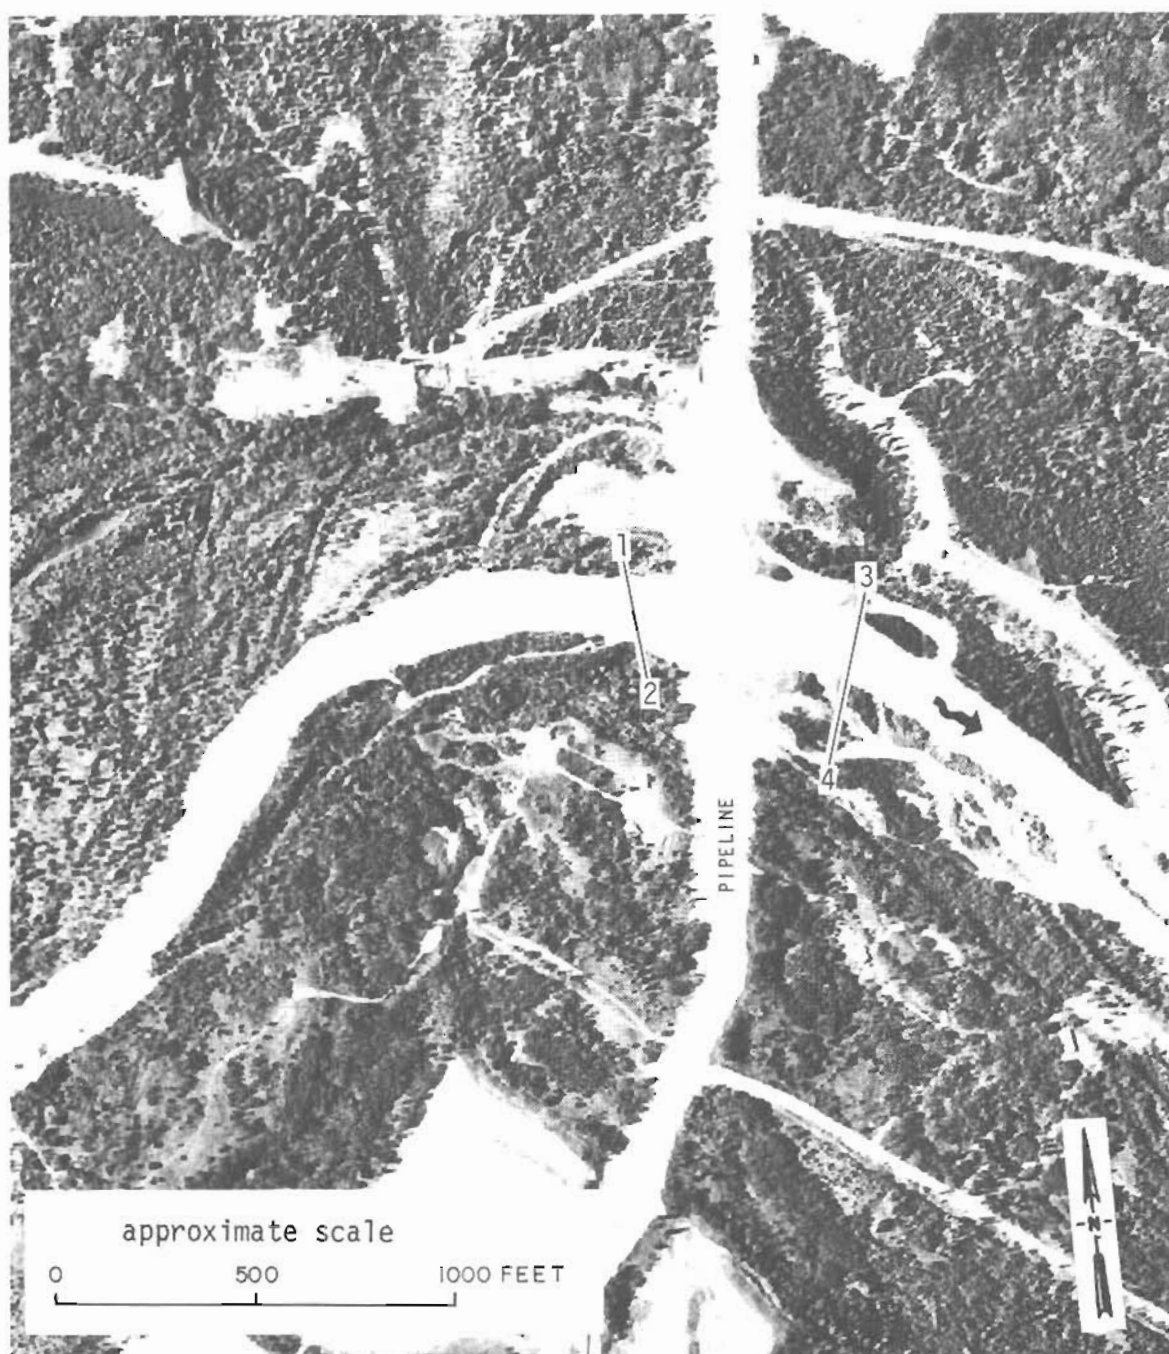
Figure 37. -- Klutina River near Copper Center, July 29, 1977.
AIR PHOTO TECH

1977 Surveillance.--Figure 37 shows the Klutina River site on July 29, 1977. Comparison of the 1976 and 1977 photography, and a visual inspection made on September 23, 1977, indicate that no significant change has occurred. No cross sections were measured.

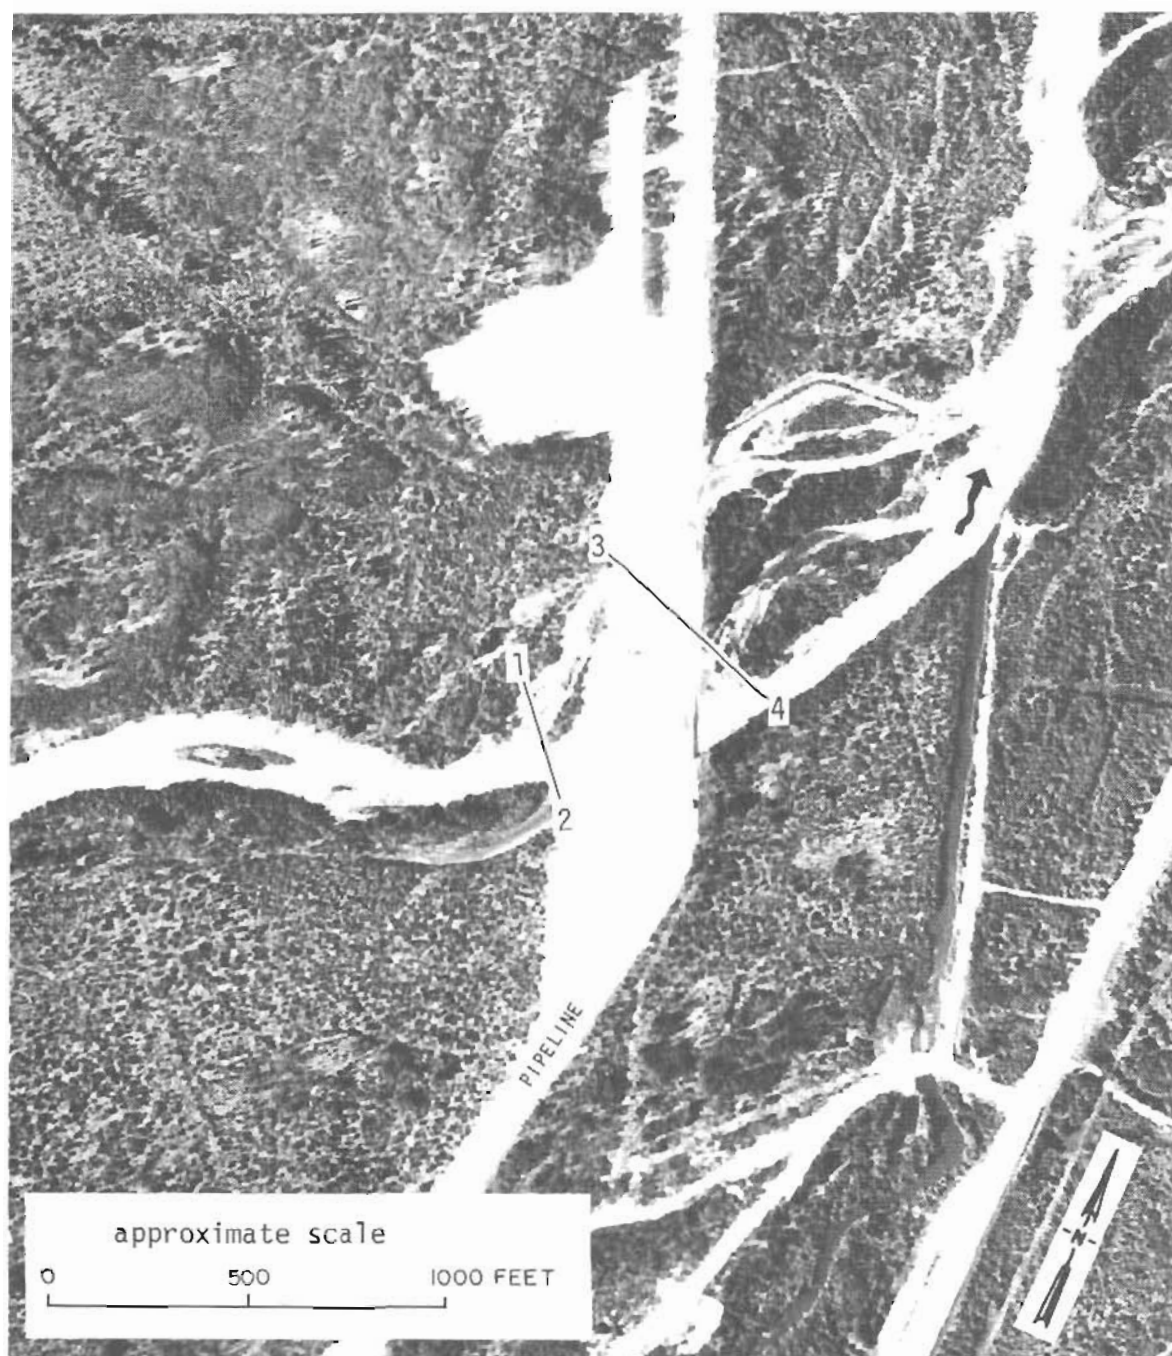
Figure 38. -- Tonsina River near Tonsina, July 29, 1977. AIR PHOTO TECH

1977 Surveillance.--Figure 38 shows the Tonsina River crossing site on July 29, 1977. During the last year considerable brush cutting has occurred on the upstream side of the access pad, and minor construction work along the centerline is still being completed.

This site was resurveyed on September 23, 1977. No significant changes were found in either the upstream or downstream cross sections, but the centerline section was found to have widened slightly (fig. 39).

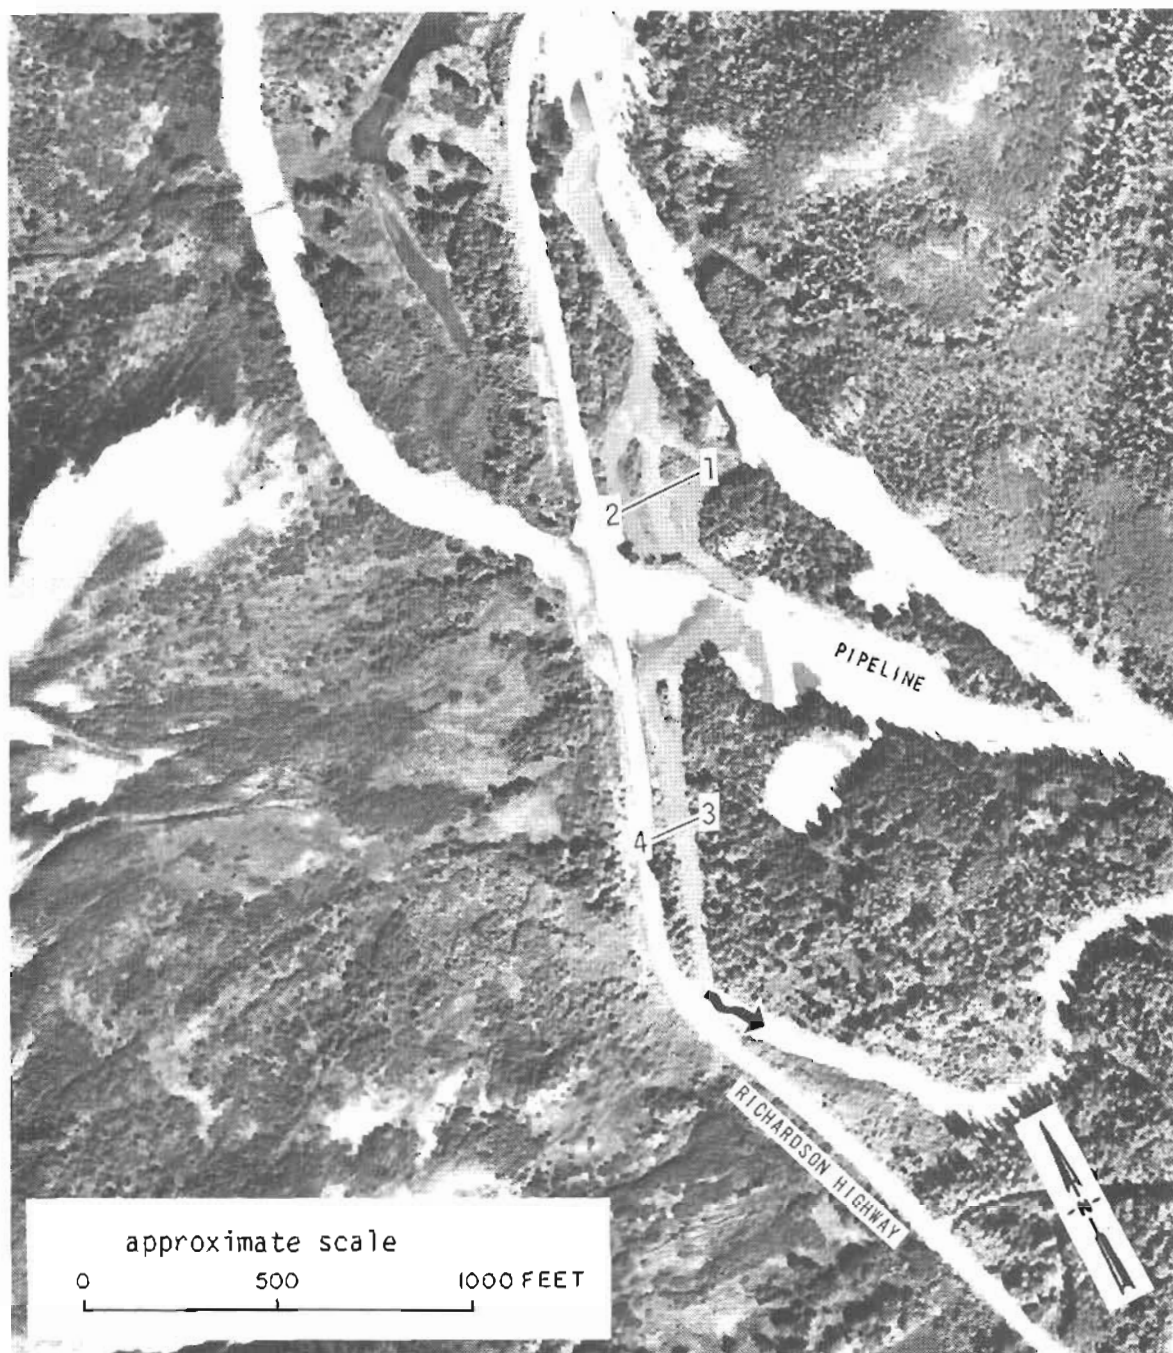
Figure 40. -- Tiekol River at Tiekol, July 11, 1977. AIR PHOTO TECH

1977 Surveillance.--Figure 40 displays the Tiekel River at Tiekel crossing site on July 11, 1977. The site was resurveyed on September 23, 1977; at that time the centerline appeared to be still under construction. Note that a new alignment for the Richardson Highway has been constructed near the crossing.

Apart from minor grading operations, no major change was found in the centerline cross section. Visual inspection indicated no significant change in either the upstream or downstream sections; in fact, none has been found since the site was established in 1973.

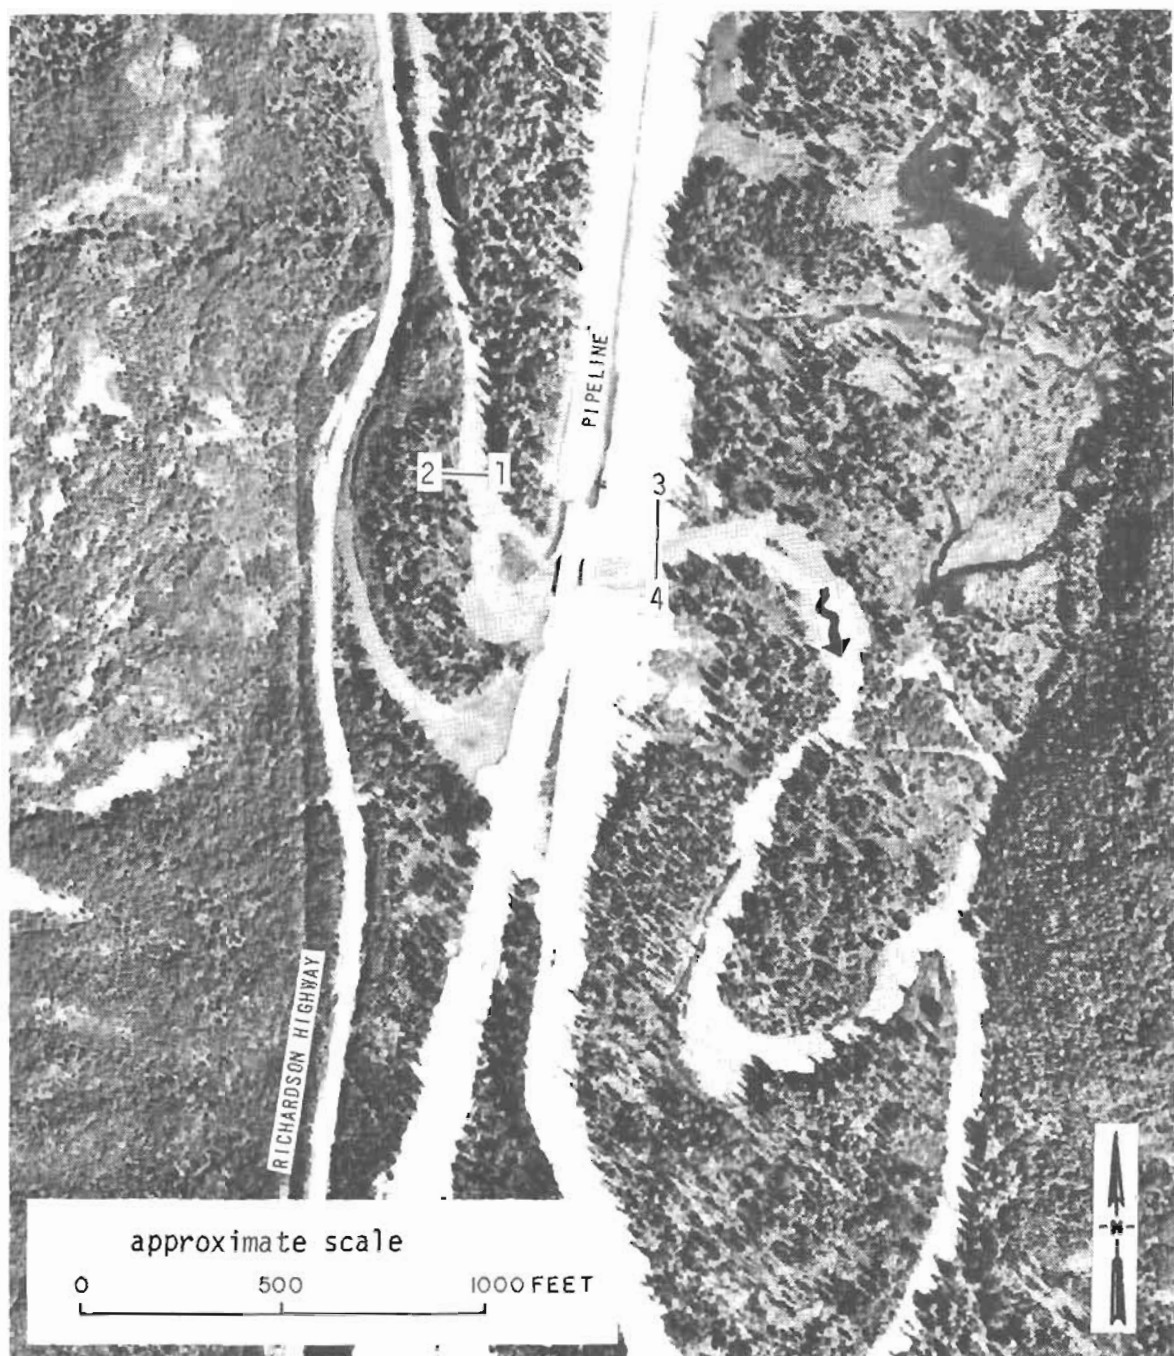
Figure 41. -- Tiekel River near Tiekel, July 11, 1977. AIR PHOTO TECH

1977 Surveillance.--Figure 41 shows the Tiekel River crossing site near Tiekel on July 11, 1977. A new alignment for the Richardson Highway was being constructed alongside the centerline. The highway bridge has been installed just upstream from the temporary access bridge for the pipeline.

The crossing site was resurveyed on September 22, 1977. No significant changes were found in any cross section. No changes have been found in the upstream or the downstream section since the site was established in 1973.

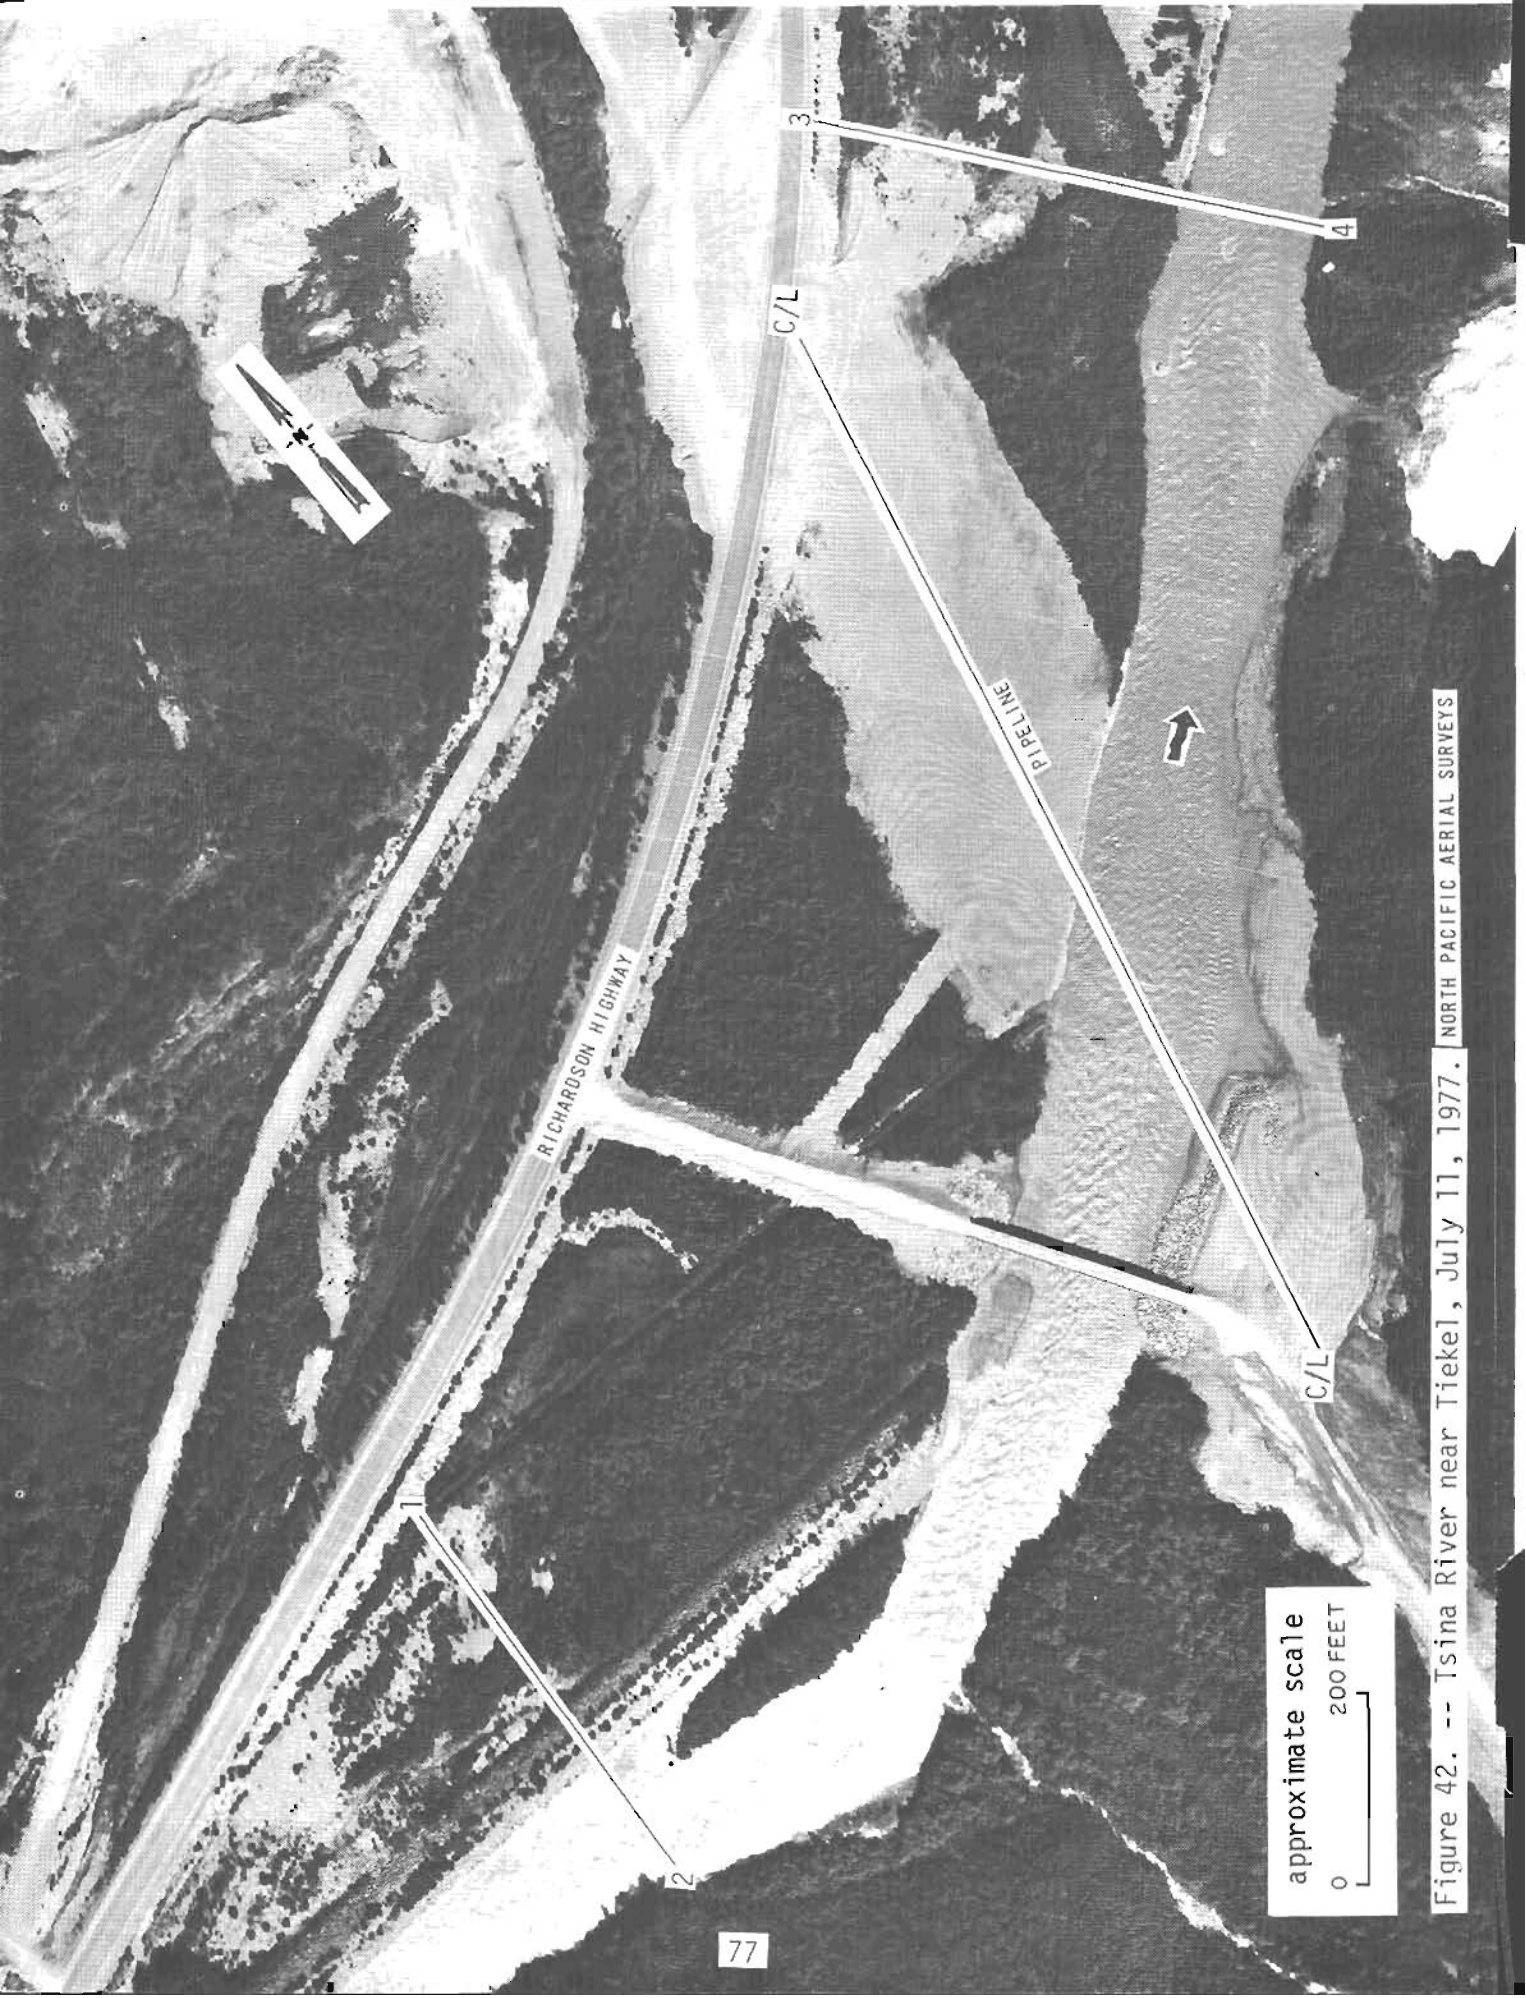
1977 Surveillance.--Figure 42 displays the Tsina River near Tiekel crossing site on July 11, 1977. The crossing was resurveyed photogrammetrically on that date and was visited in September. Except for a dike constructed across the right bank of the centerline, no significant changes were found in any of the three cross sections.

Figure 42. -- Tsina River near Tiekel, July 11, 1977. NORTH PACIFIC AERIAL SURVEYS
