CHANNEL EROSION SURVEYS ALONG THE TAPS ROUTE, ALASKA, 1977

78-611

by
Robert M. Loeffler
and
Joseph M. Childers

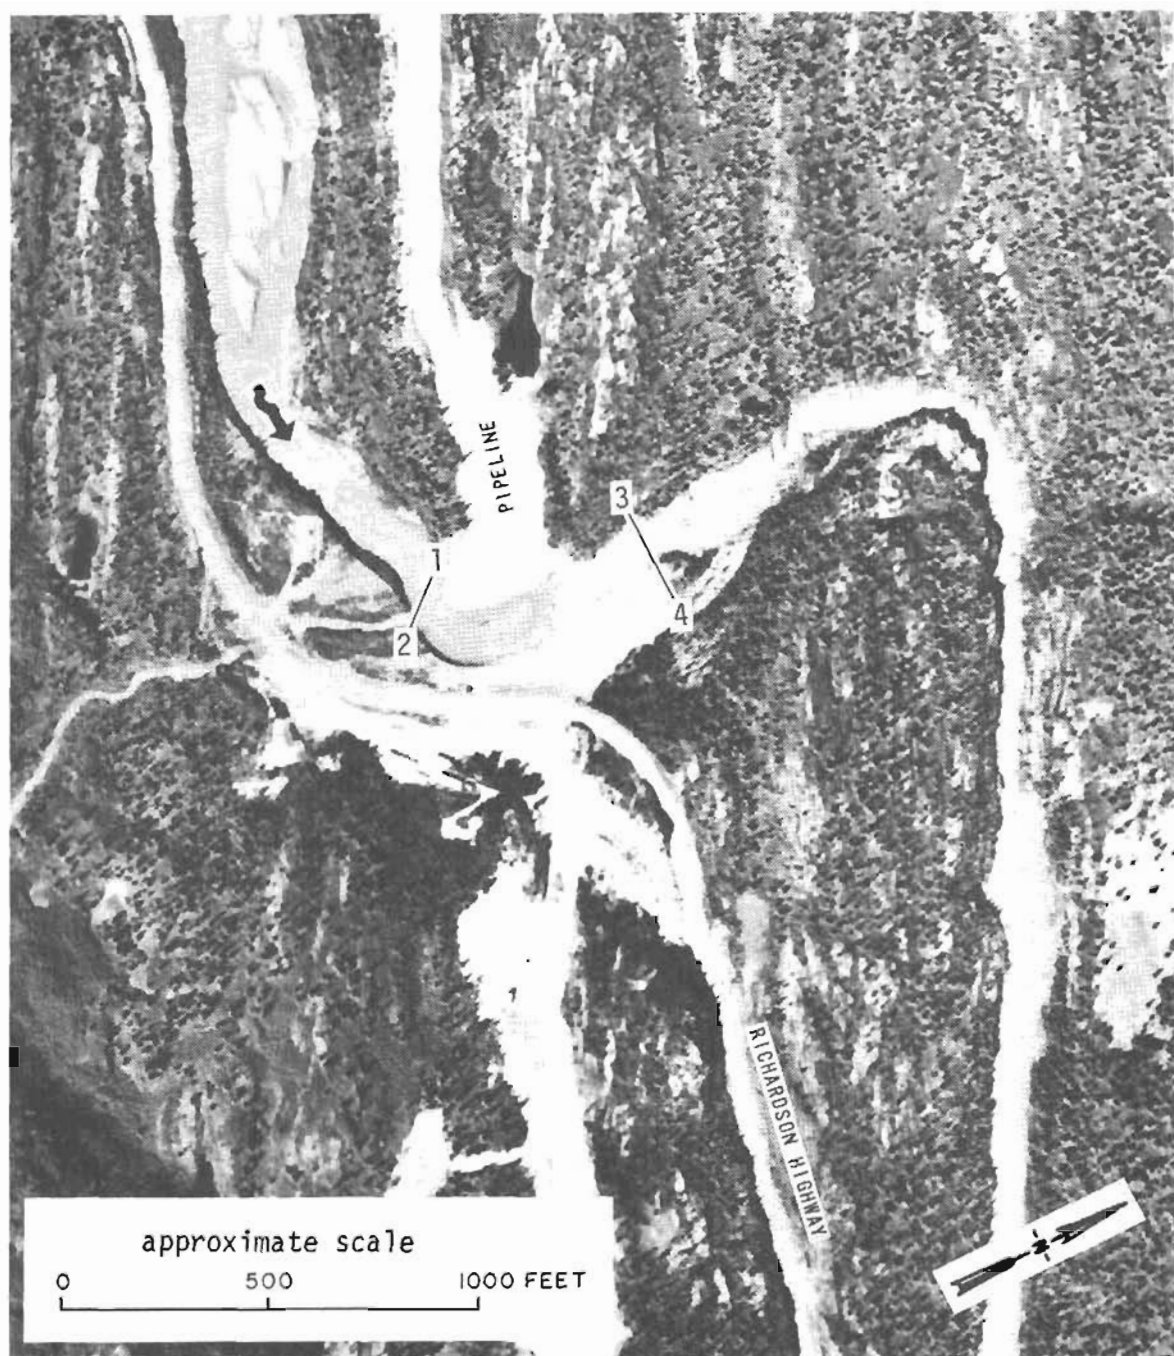
1977 Surveillance.--Figure 43 shows the Tsina River near Ptarmigan crossing site on July 11, 1977. This crossing was resurveyed on September 22, 1977. During the past year, the reference points for the upstream crossing have been destroyed, and the cross section could not be exactly resurveyed. A new upstream cross section was therefore established. Its shape and on-site visual observations indicate that there has been no significant change in this cross section. No changes have been noted in either the centerline or downstream sections since the site was established in 1973.

Figure 43. -- Tsina River near Ptarmigan, July 11, 1977. AIR PHOTO TECH

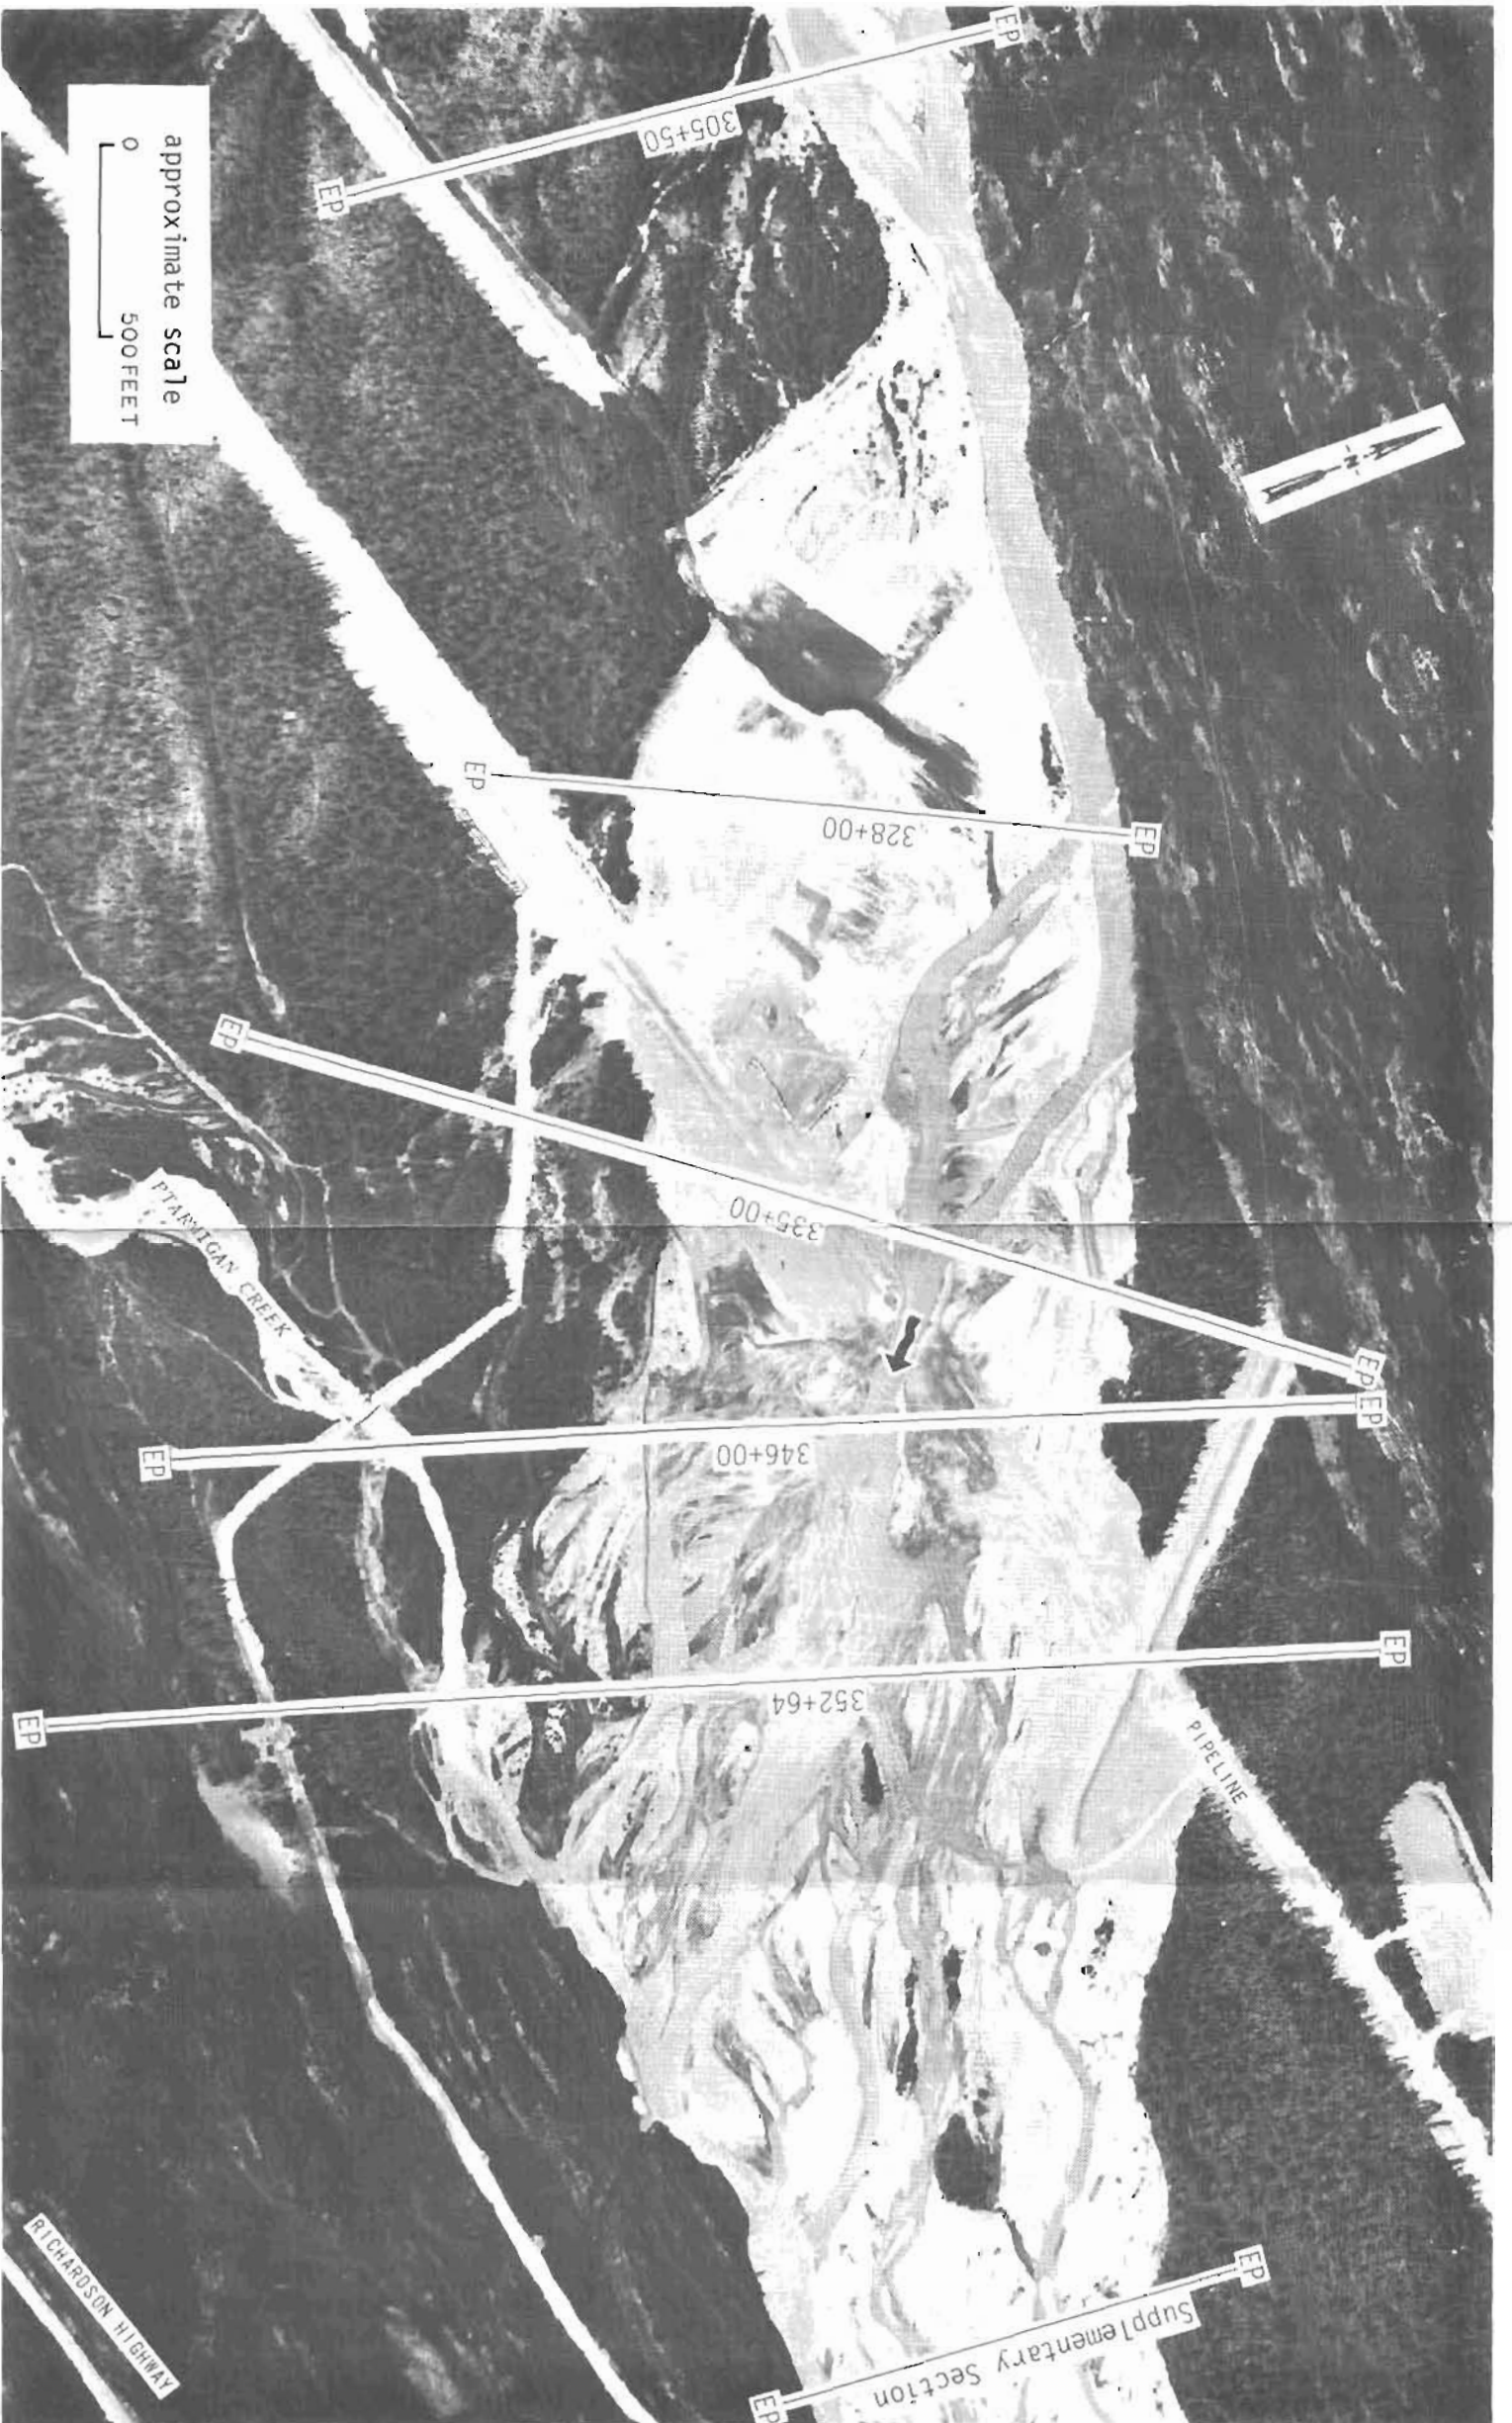
1977 Surveillance.--Figure 44 shows the Tsina River at Ptarmigan site on July 11, 1977. The site was resurveyed photogrammetrically on that date and visited in September. Dikes have been constructed along the channel upstream from the centerline. These have constricted the braiding pattern and moved it toward the right bank.

There has been no significant change in the channelway of the 305+50, 328+00 and 335+00 cross sections, but the big stockpile of gravel on the right side of the channel just north of the centerline has been removed since 1976. Cross sections 346+00, 352+64 and the supplementary section have changed considerably. However, the channels are within the major banks of the stream, and no significant erosion of vegetated area or the flood plain has occurred (fig. 45 a and b).

Figure 44. -- Tsina River at Ptarmigan, July 11, 1977.
NORTH PACIFIC AERIAL SURVEYS

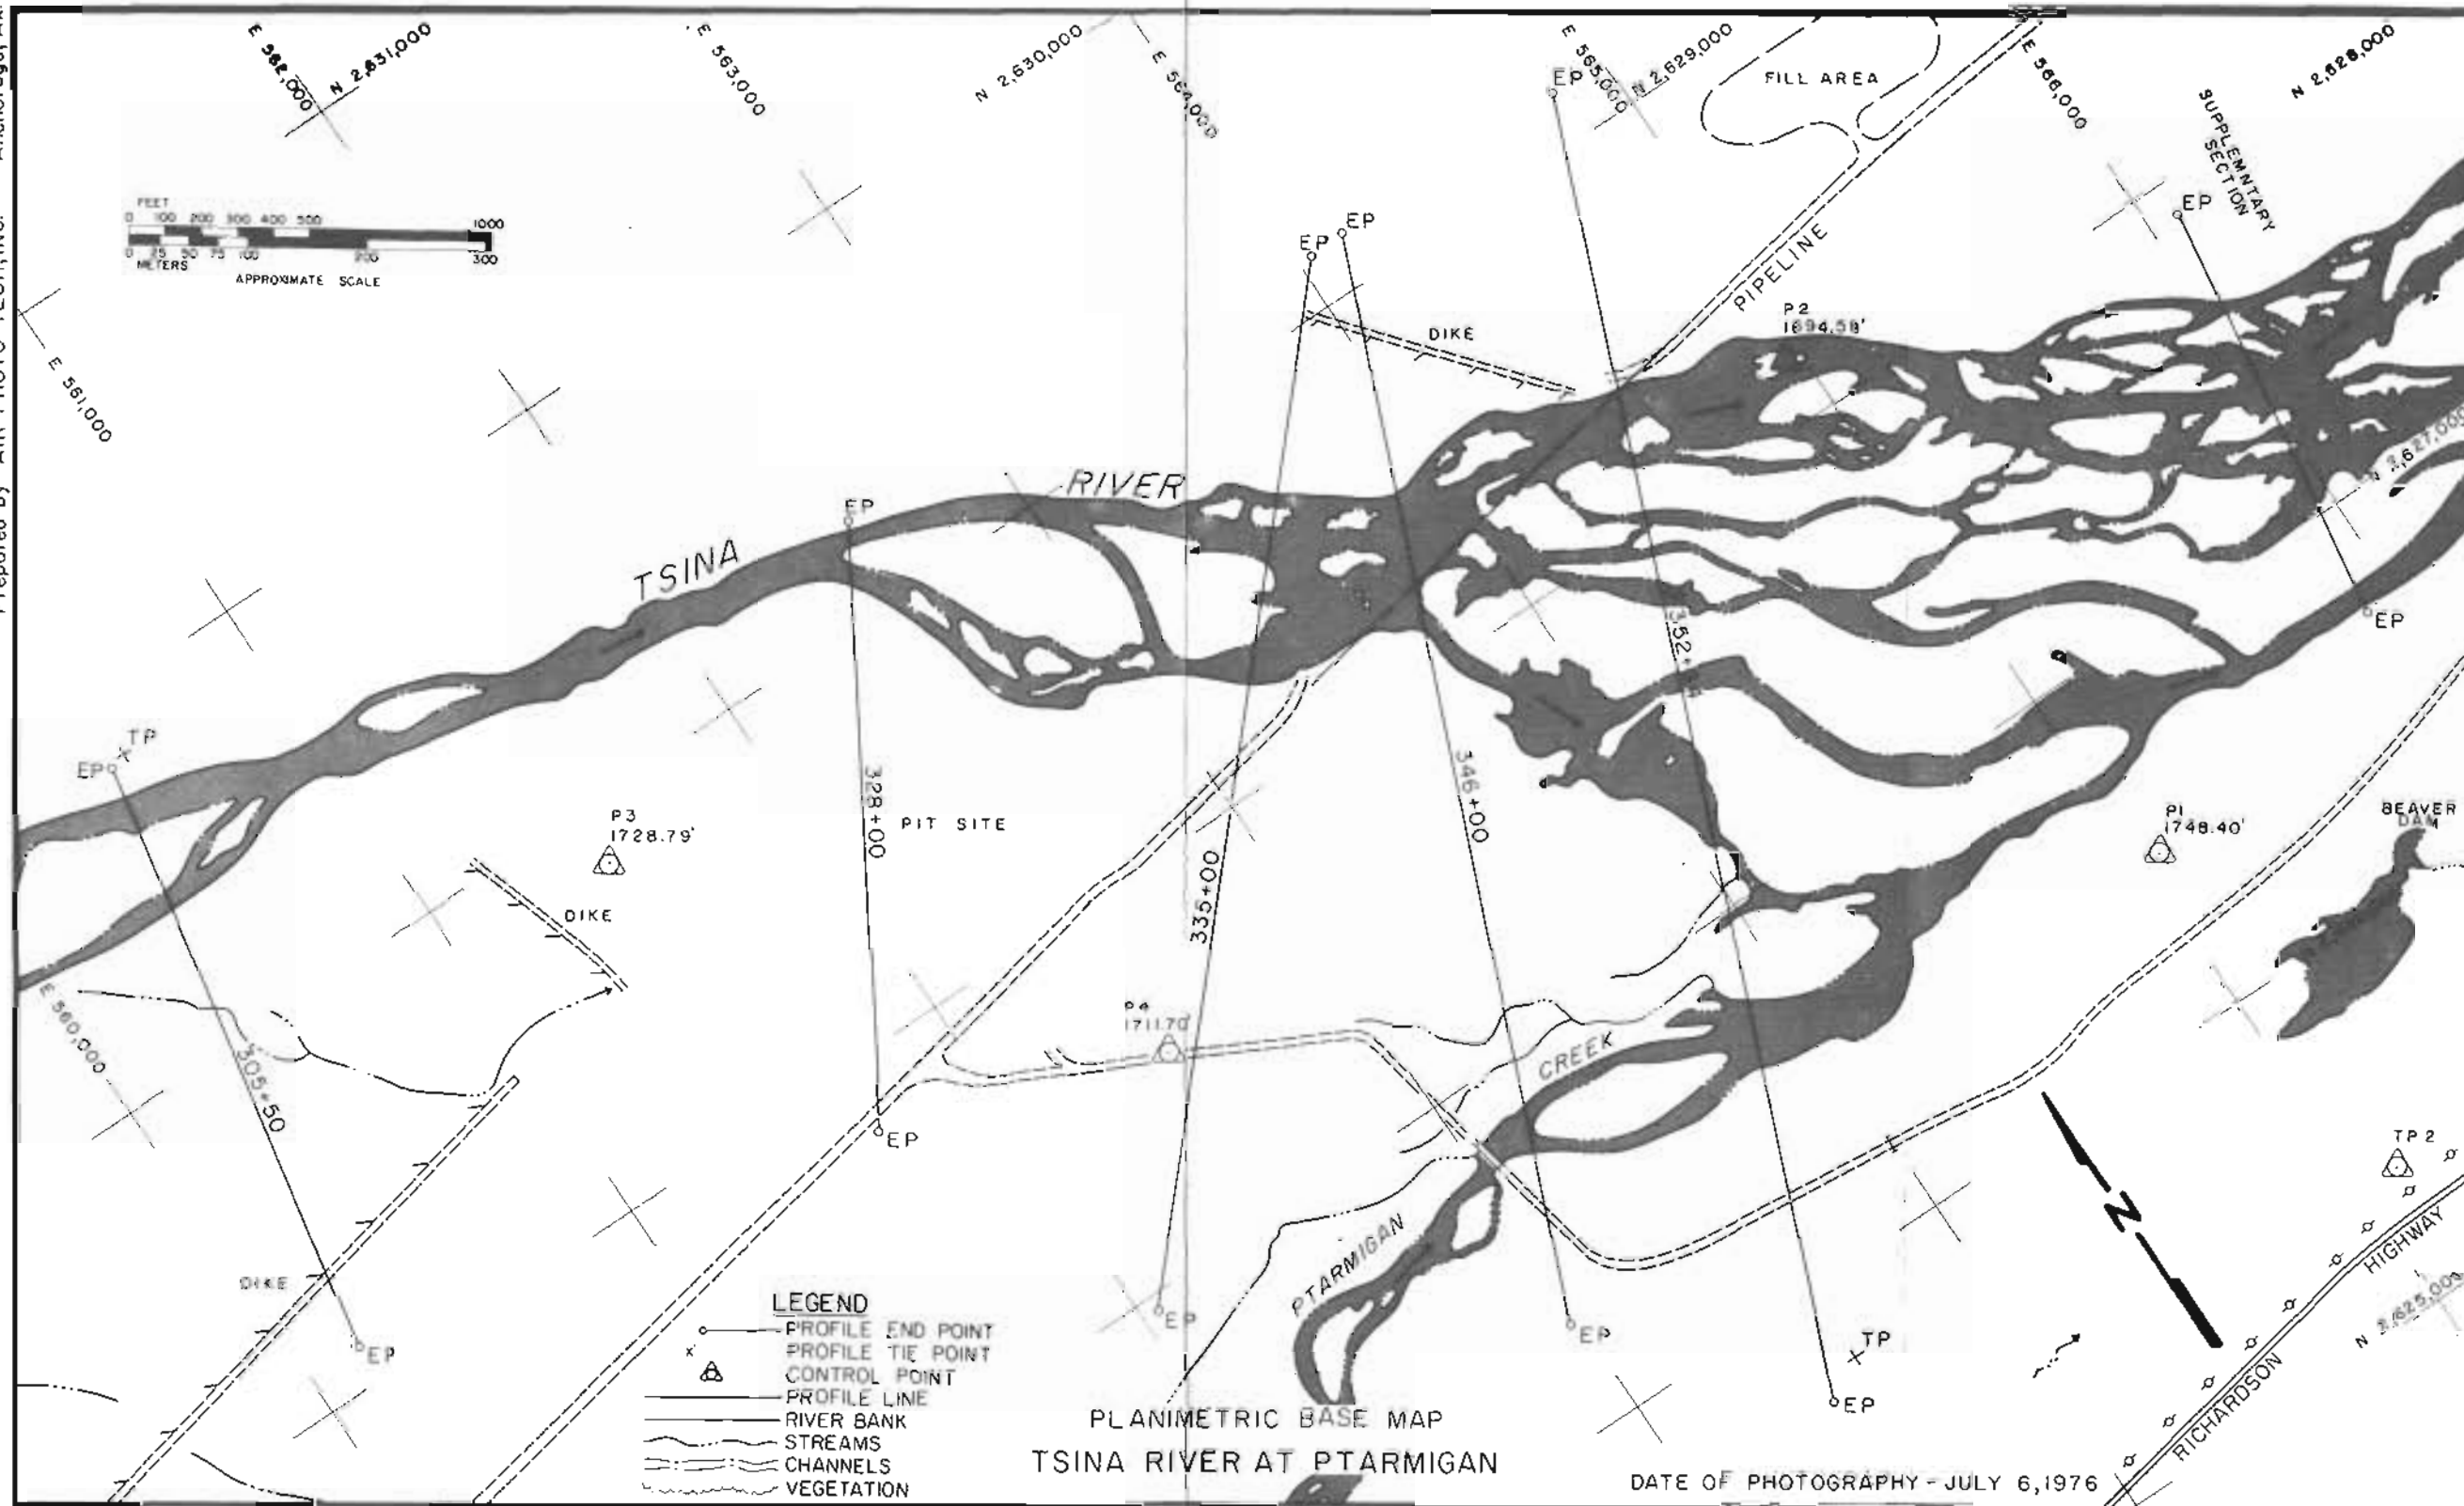
Figure 45a. -- Planimetric map of the Tsina River at Ptarmigan, July 6, 1976.

Figure 45b. -- Planimetric map of the Tsina River at Ptarmigan, July 11, 1977.

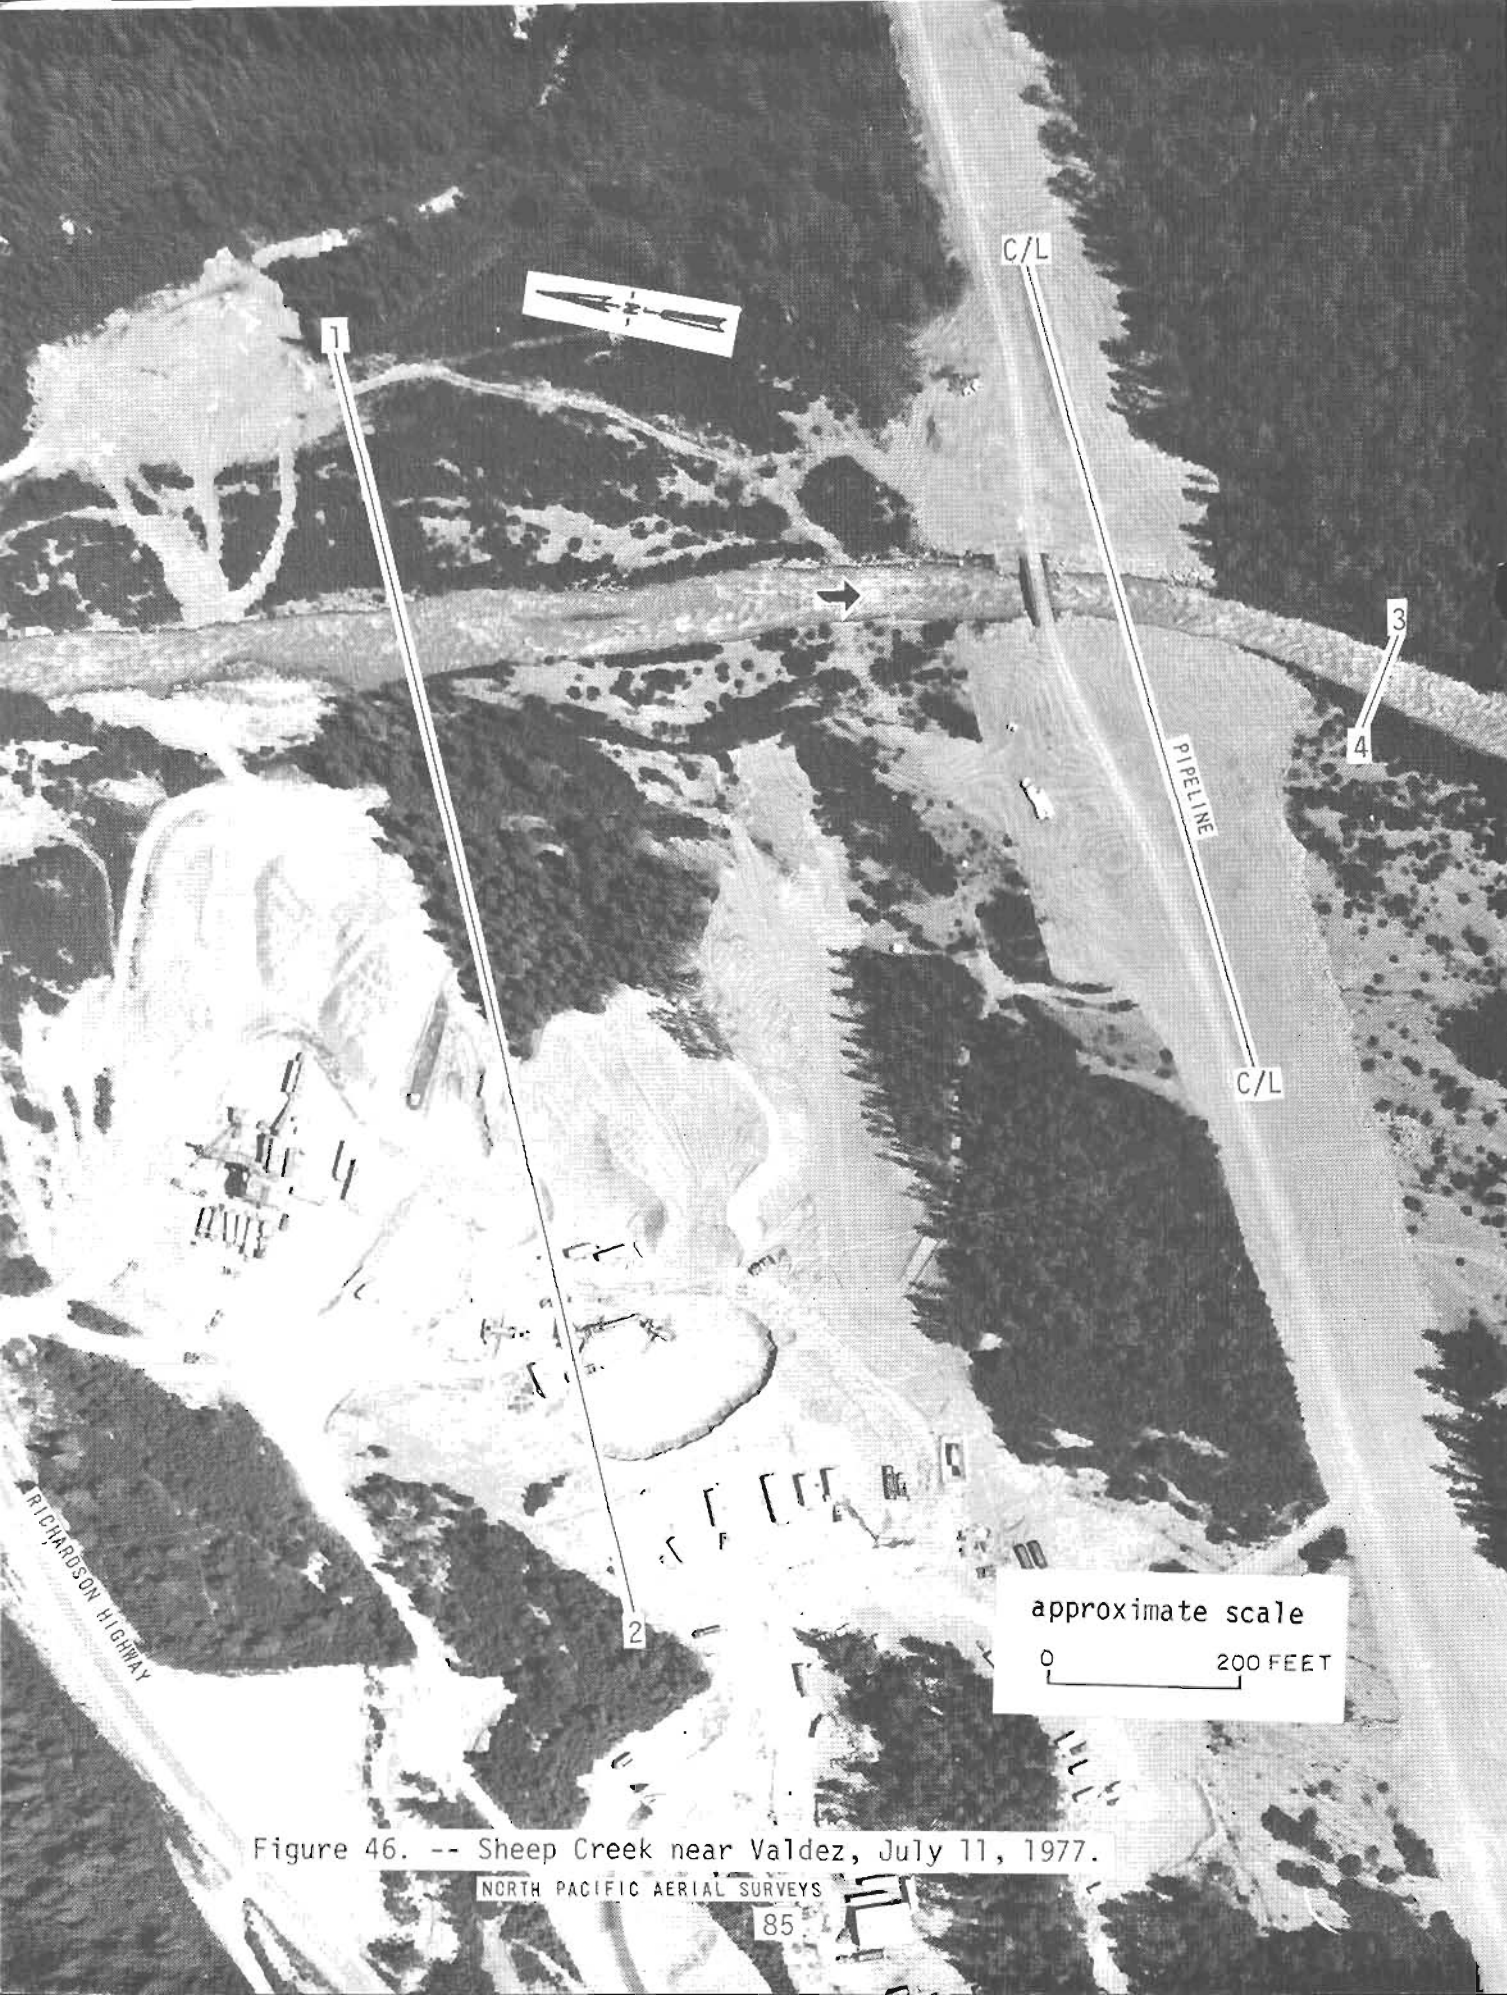
1977 Surveillance.--Figure 46 shows the Sheep Creek crossing site on July 11, 1977. The site was resurveyed photogrammetrically on that date and a field inspection was made in September.

No significant changes were found in either the upstream or downstream cross sections. Figure 47 displays changes made by construction equipment on the centerline in the last year.

Figure 46. -- Sheep Creek near Valdez, July 11, 1977.

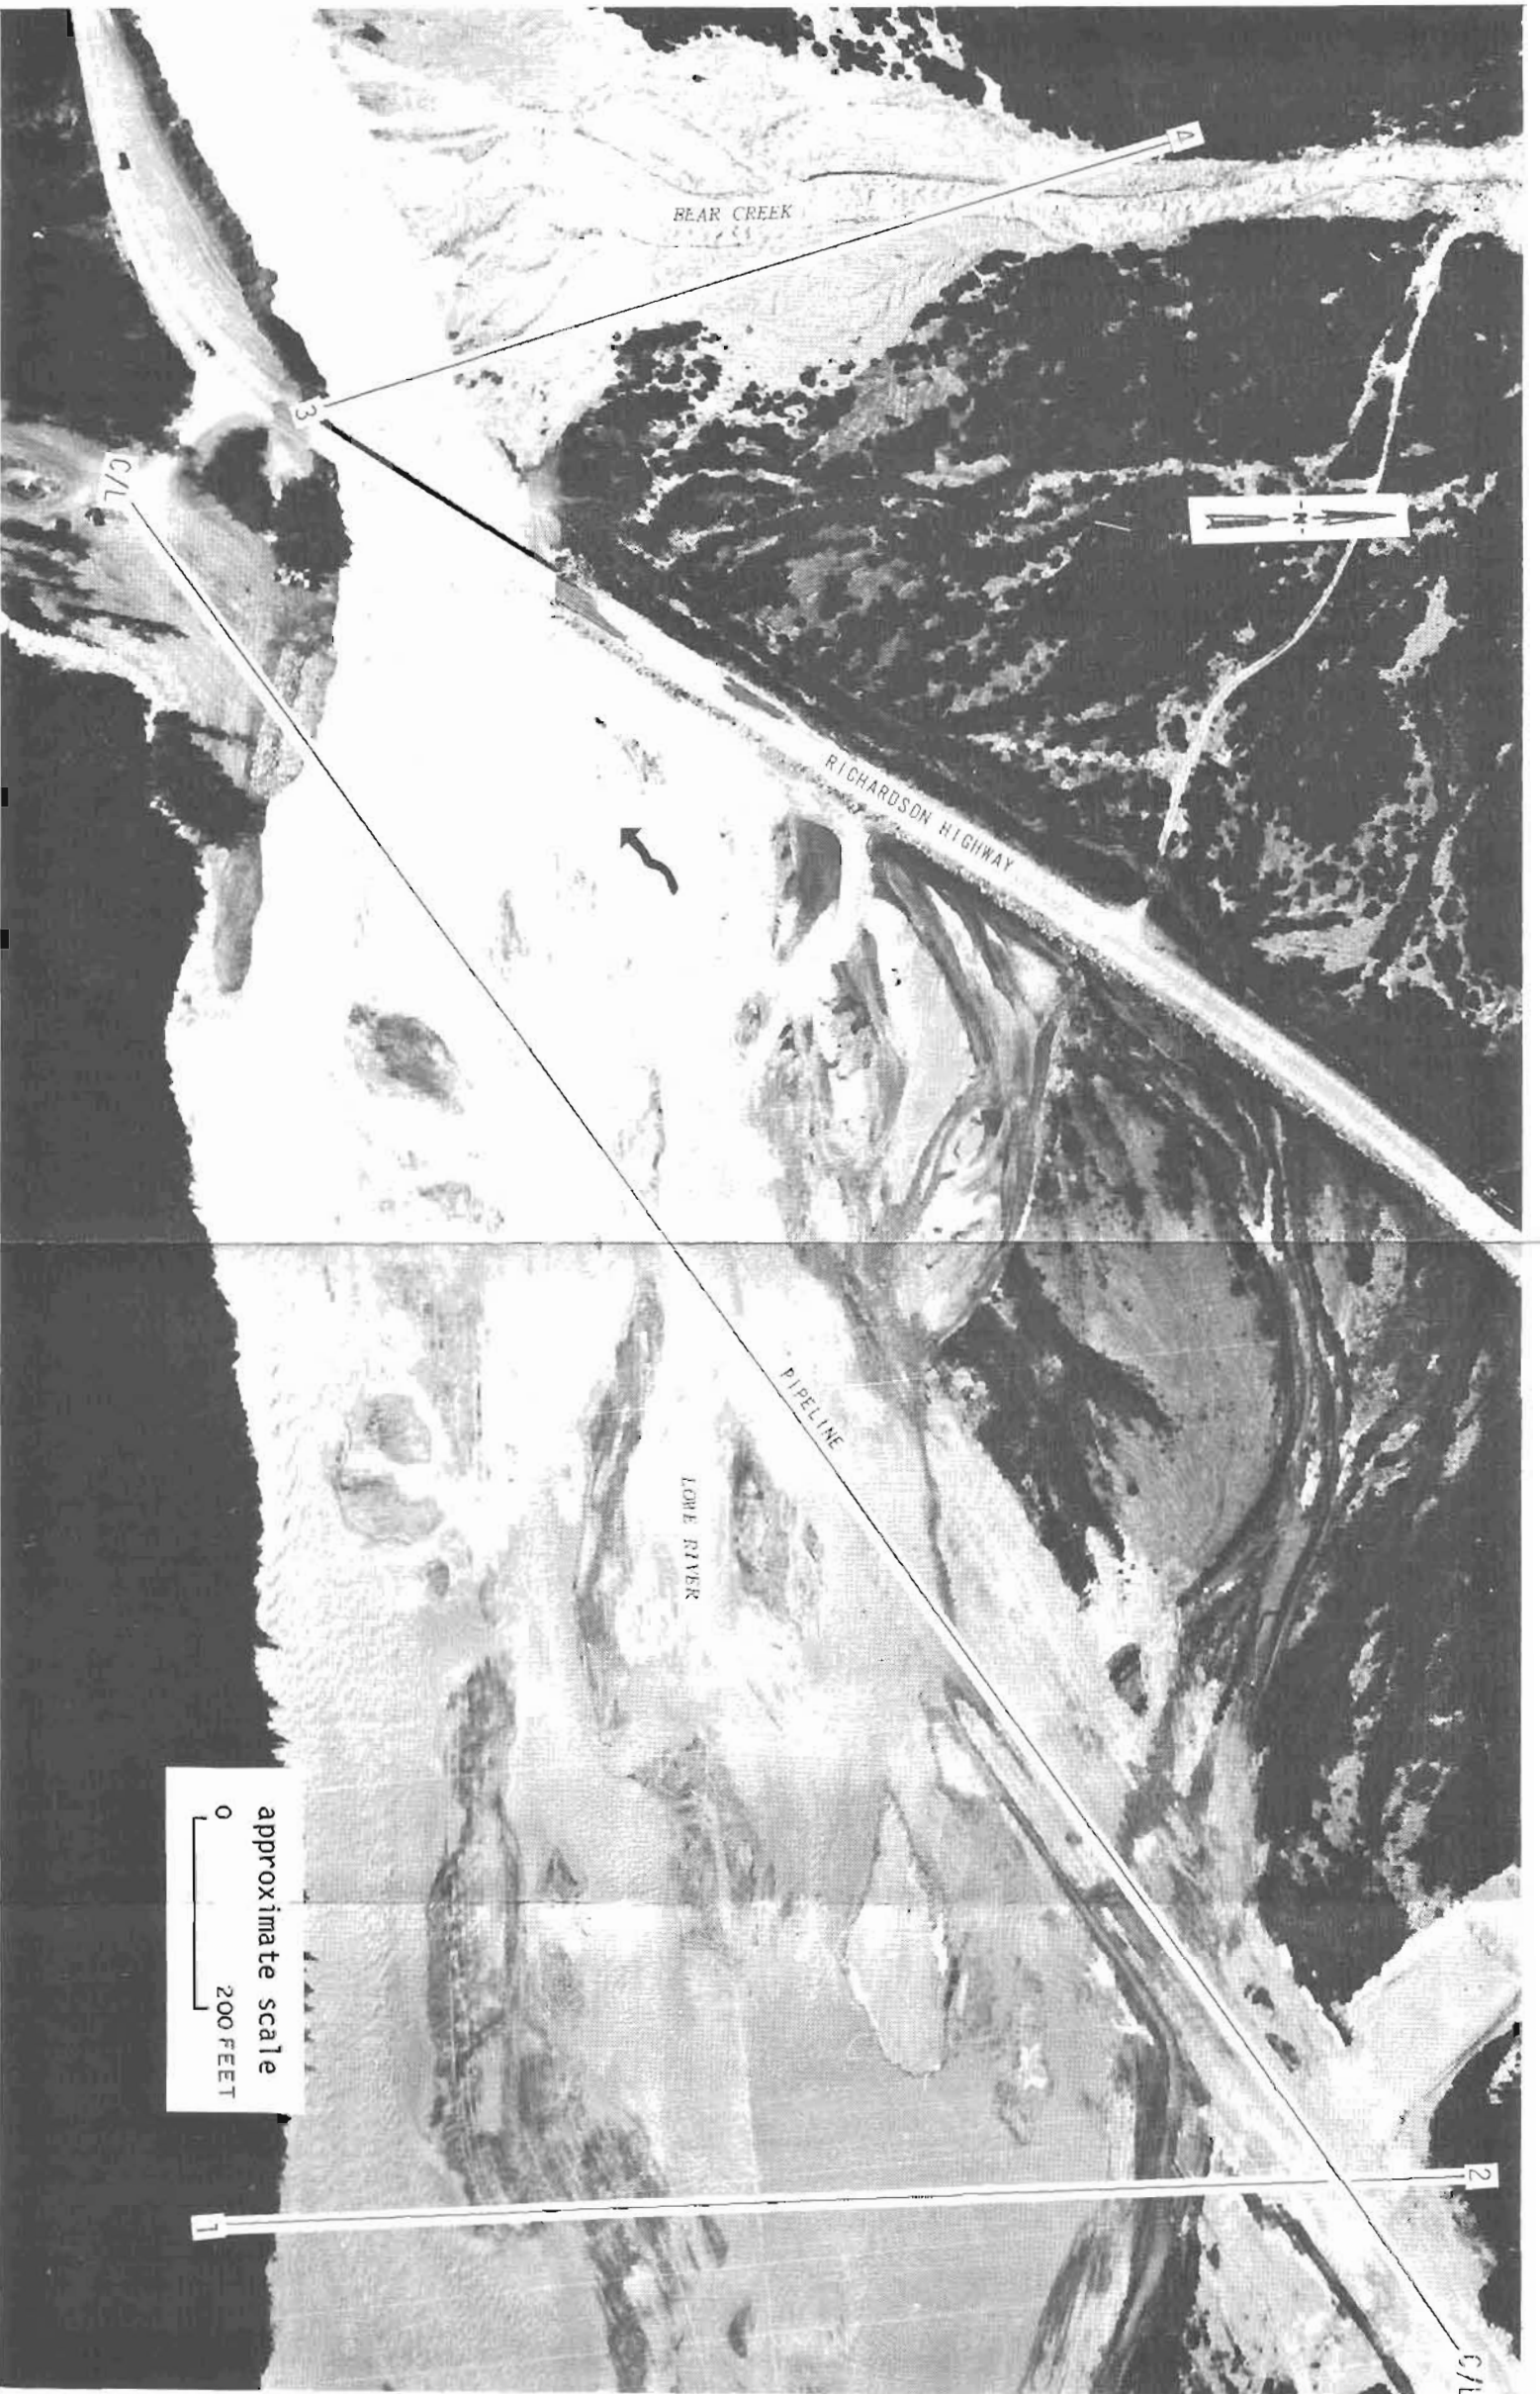
1977 Surveillance.--Figure 48 shows the Lowe River crossing site on July 11, 1977. The site was resurveyed photogrammetrically on that date, and a field inspection was made in September.

No significant change was found in the downstream cross section, but high water has covered the flood plain along the right bank at the upstream section. During the last year, the left bank of the centerline has been backfilled and a rip-rap dike has been constructed at the shore. This changed the profile of the left bank at the centerline, but the remainder of the cross section is identical to the last year's (fig. 49).

Figure 48. -- Lowe River near Valdez, July 17, 1977.
NORTH PACIFIC AERIAL SURVEYS
